WEST VALLEY DEMONSTRATION PROJECT

CATTARAUGUS COUNTY, NEW YORK

GIS-Based Historical Photographic Analysis

October 2009 Final Report

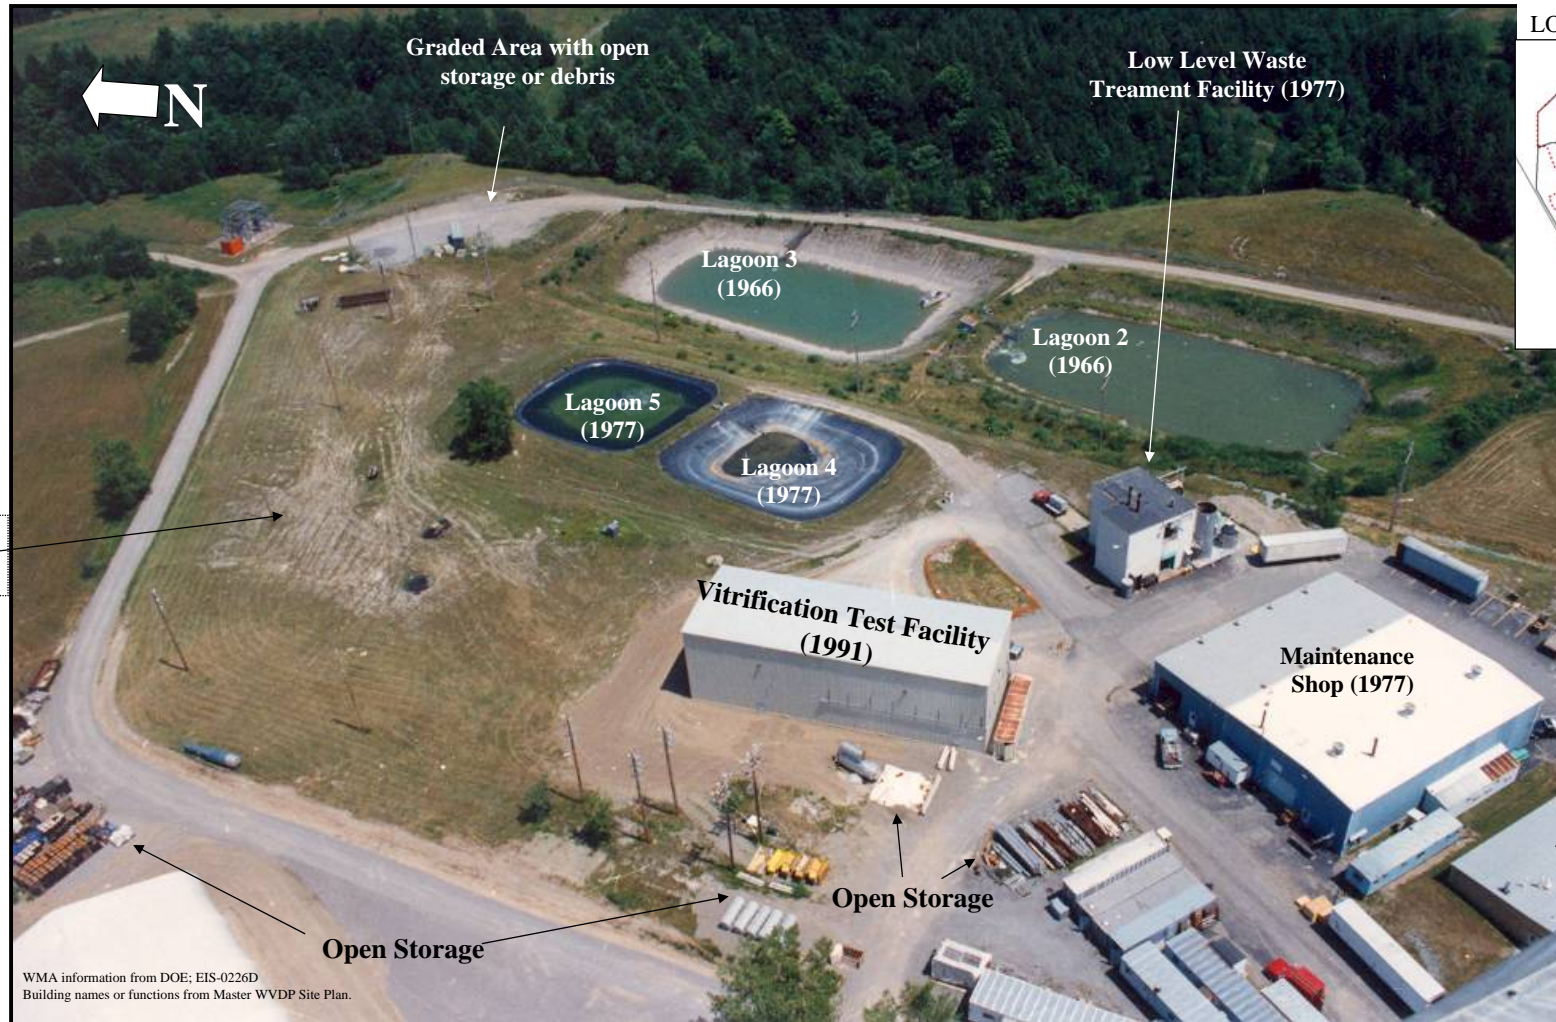
WMA 2 is the Low-Level Waste Treatment Facility Area. In this 1991 photo, the Vitrification Test Facility (VTF) is first seen. Large amounts of open storage near the building area, a graded area with debris or open storage at the northeast side (near Lagoon 2), and a disturbed ground with heavy vehicle tracks are observed in the photo.

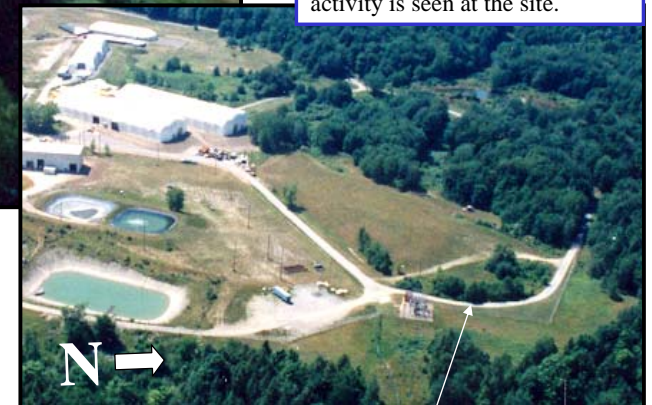
Construction and Demolition Debris Landfill
(CDDL)

This photo of CDDL shows a revegetated area. No additional activity is seen at the site.

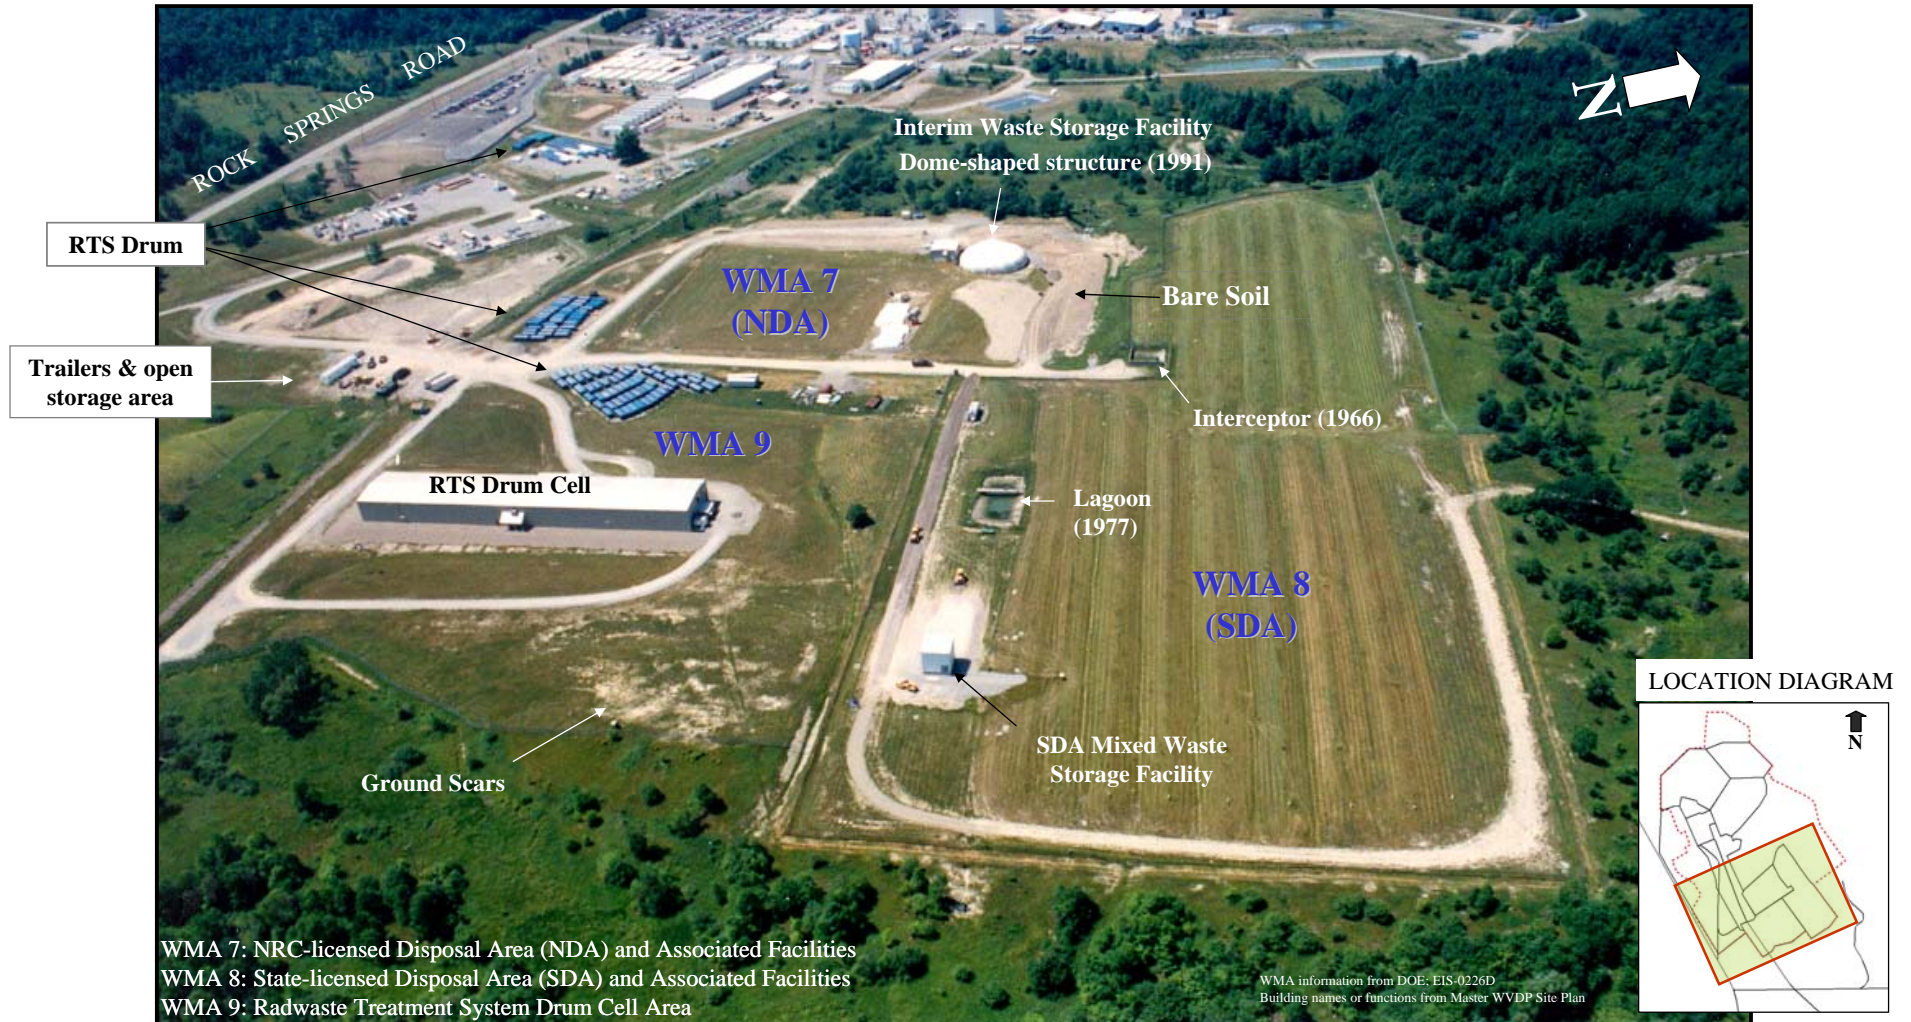
OBLIQUE AERIAL VIEW OF WMA 7, WMA 8, & WMA 9 - 1991

WMA 7: NRC-licensed Disposal Area (NDA) and Associated Facilities
WMA 8: State-licensed Disposal Area (SDA) and Associated Facilities
WMA 9: Radwaste Treatment System Drum Cell Area

In this 1991 image, many new facilities have been built since the 1984 photos: a dome-shape structure in the northeast of WMA 7, the SDA Mixed Waste Storage Facility in WMA 8, and the RTS Drum Cell in the center of WMA 9. WMA 7 may be still under construction with bare soil covering the north and the east sides. WMA 9 has some remaining ground scars. The trenches and berms of WMA 8 are covered with grass.

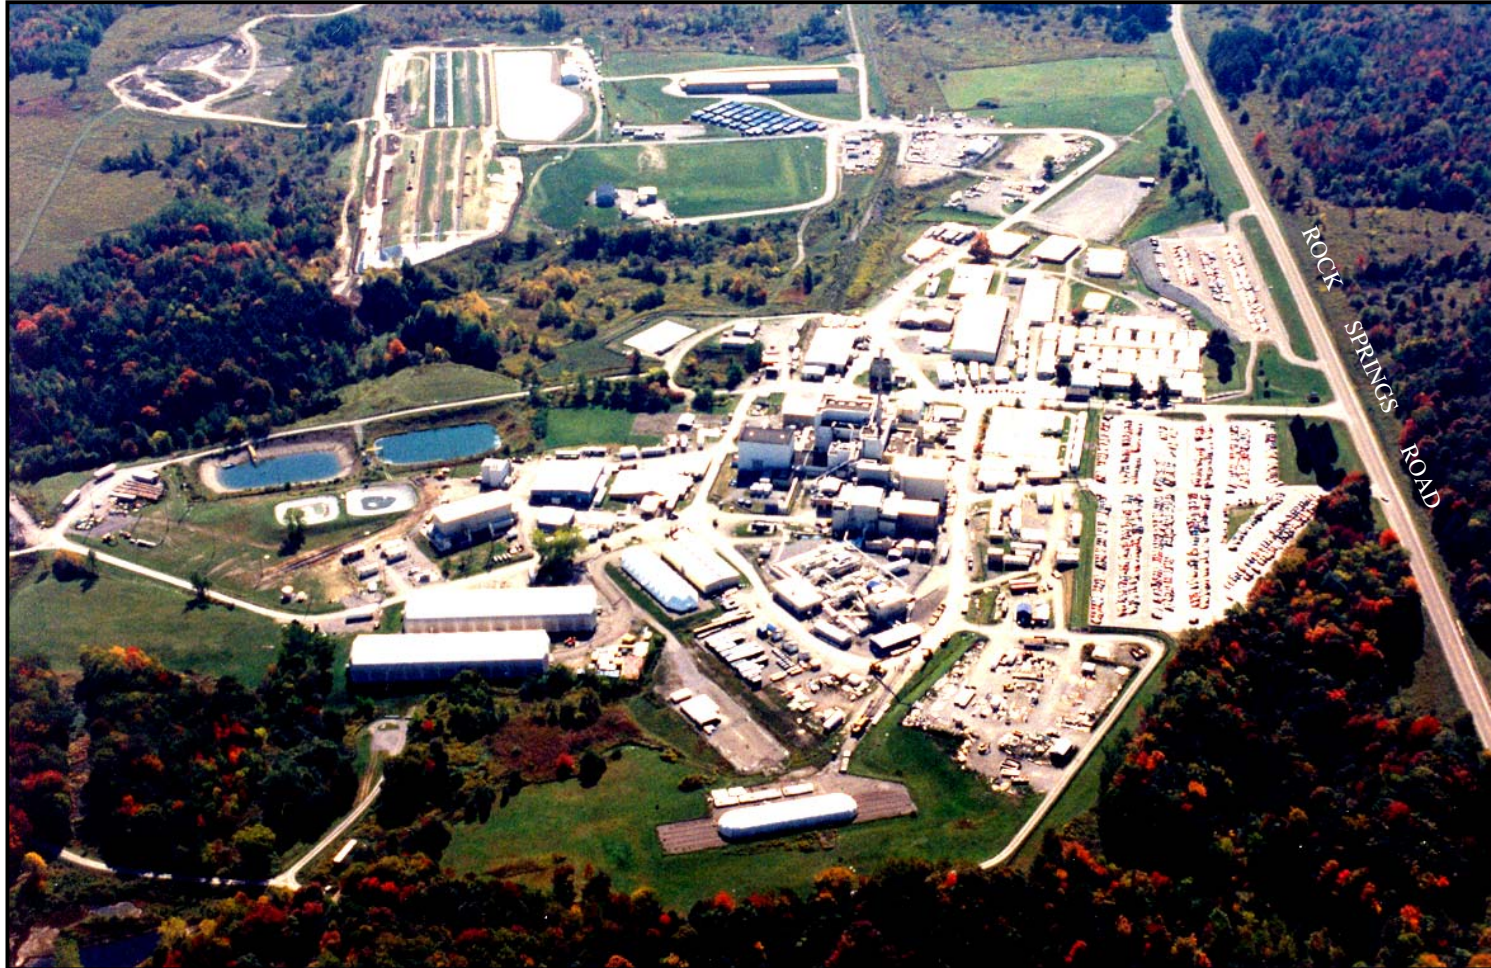
This 1995 imagery is an oblique aerial photograph and georeference is not available. In general, most of the structures, labs, and facilities seen in this photo are present in 2007 photography.

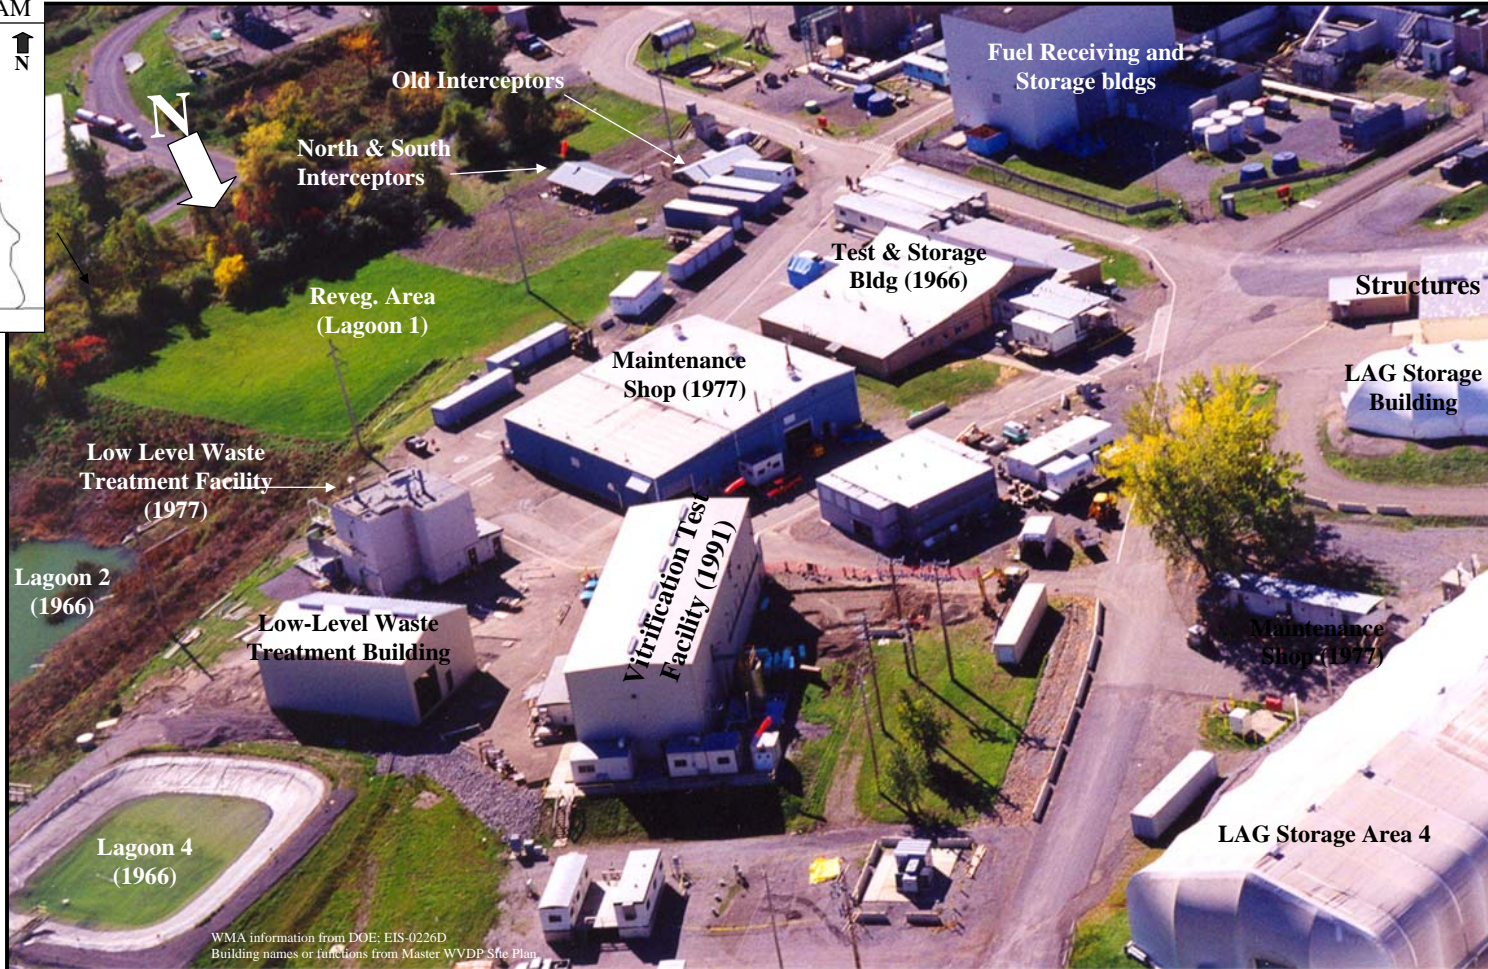
WMA 2 is the Low-Level Waste Treatment Facility Area. The Low-Level Waste Treatment Building is new since 1991. Lagoon 1 is no longer present, and the site is totally revegetated. The interceptors are now roof covered. Several trailers and open storage areas are seen.

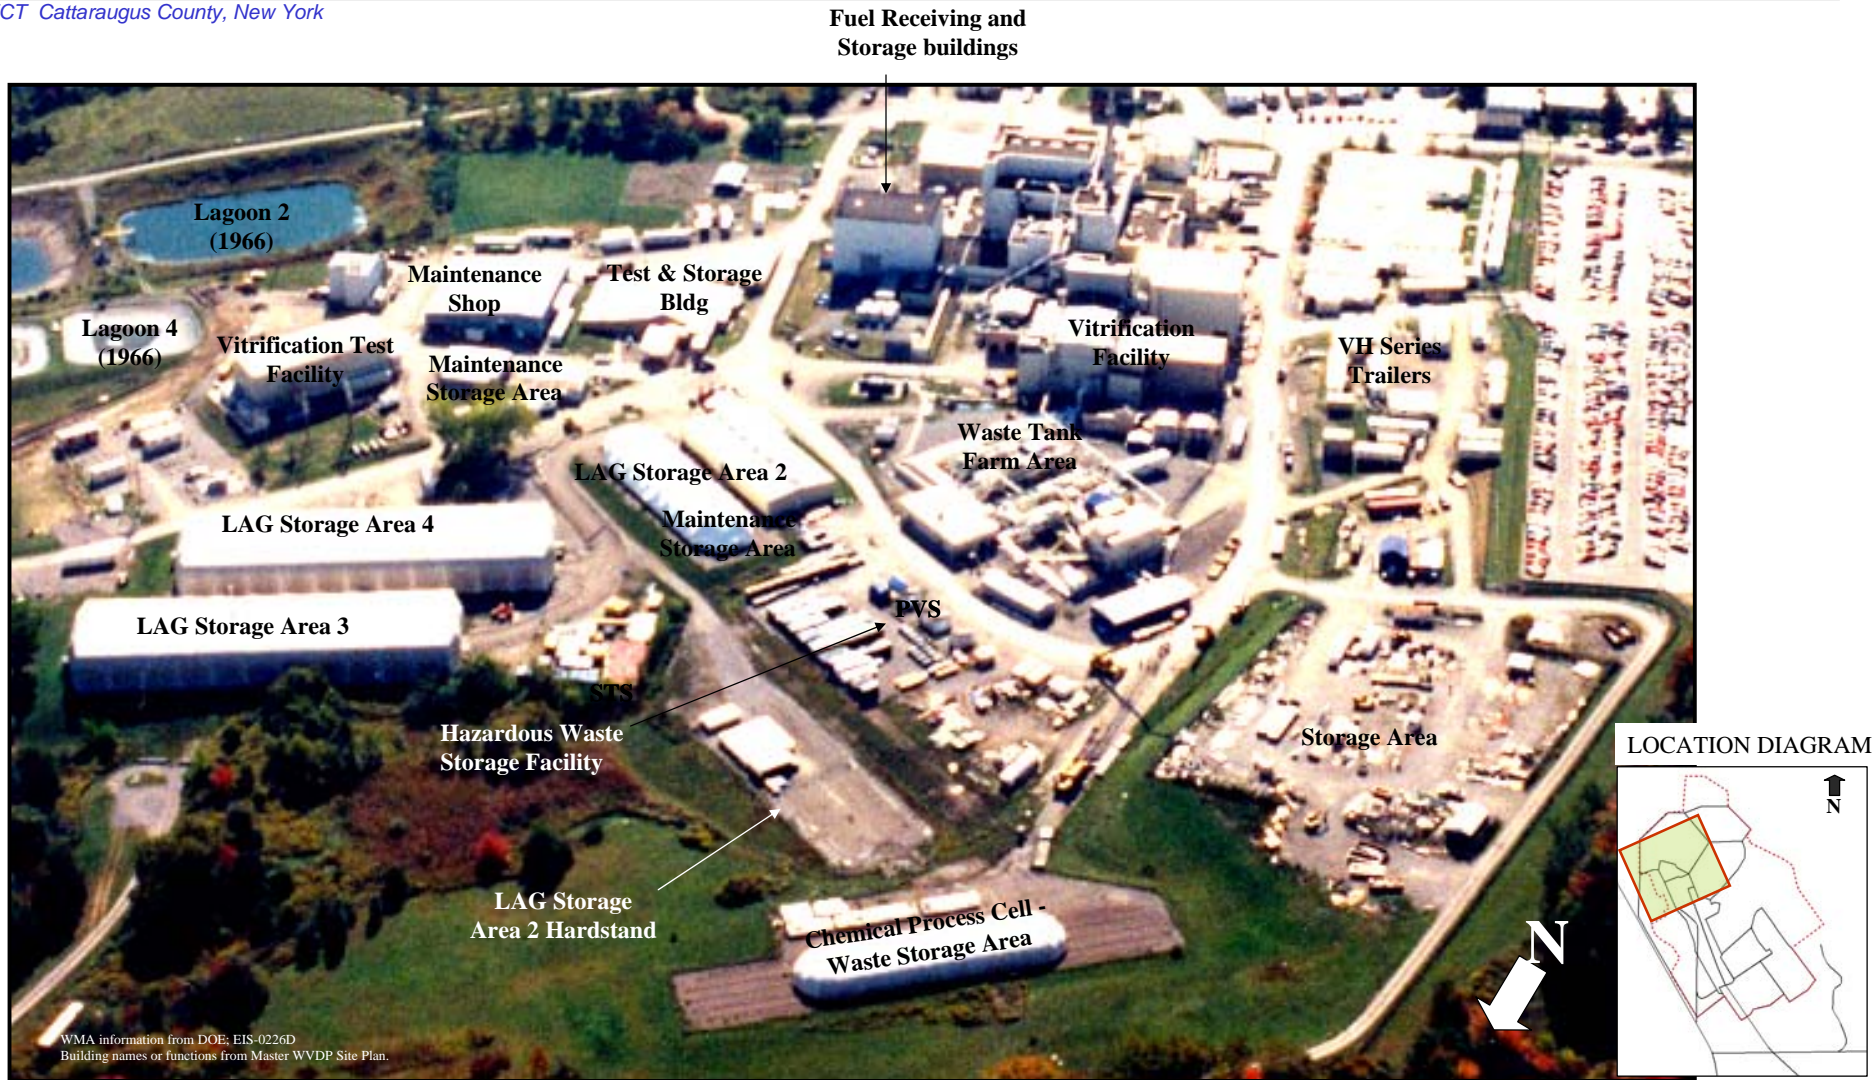
WMA 3, the Waste Tank Farm Area, has not change since the 1991 photos. In this 1995 photo, the Chemical Process Cell – Waste Storage Area - is first seen in the Northwest of WMA 5, the Waste Storage Area.

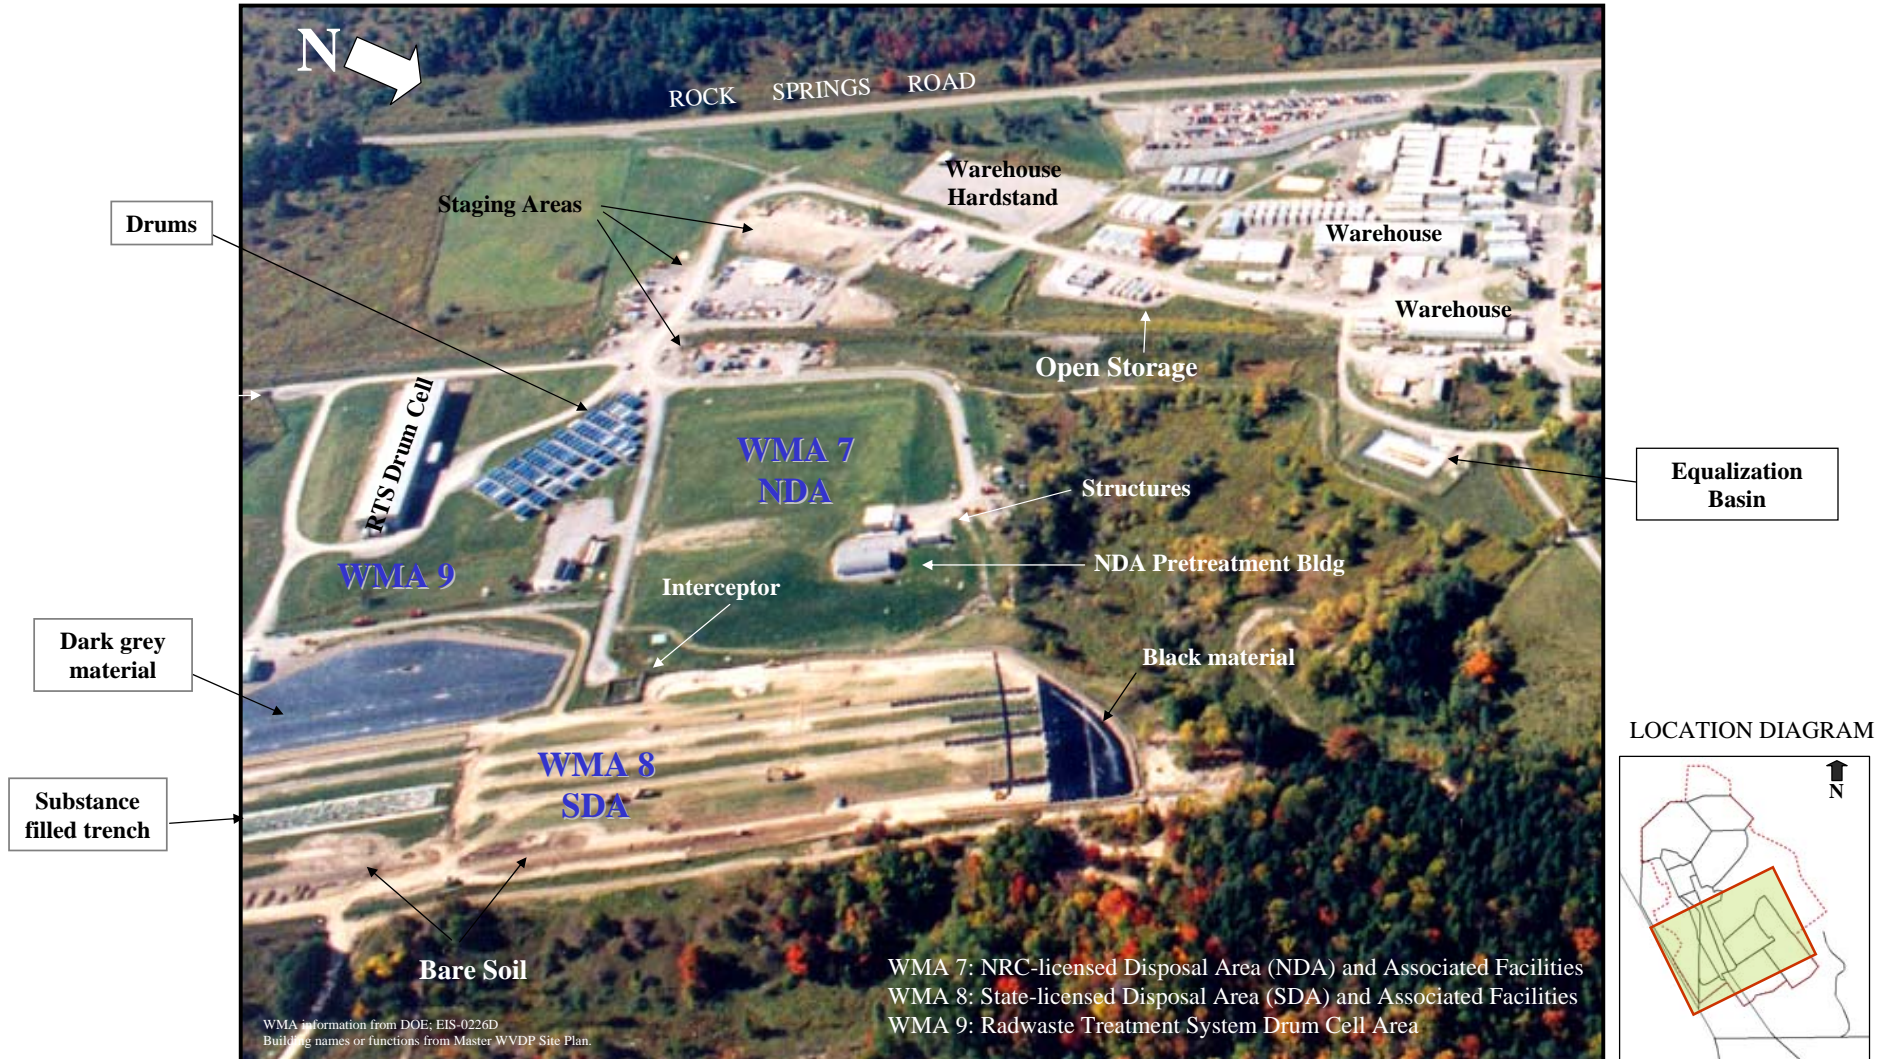
In this 1995 image, WMA 9 has not changed from the 1984 photos. In WMA 7, the dome-shape structure is replaced by the NDA Pretreatment Building. WMA 8 has three sections and may be under reconstruction. The south section is covered by a dark grey material. The northeast section still contains construction equipment. It is partially covered by black material, but mostly covered with bare soil. The southeast section has a trench filled with an unidentified substance.

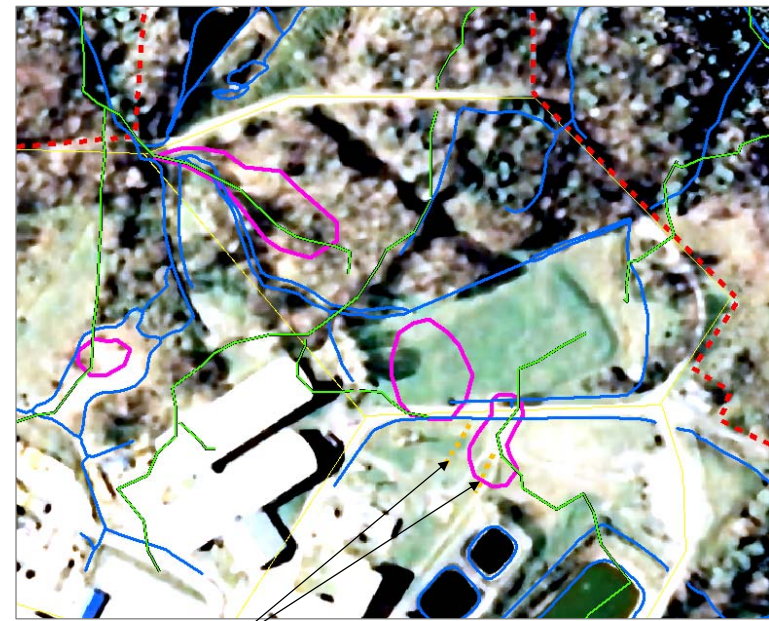
ANOMALIES FROM 2009 GEOPHYSICAL SURVEY SUPERIMPOSED ON 2007 DRAINAGE MAP

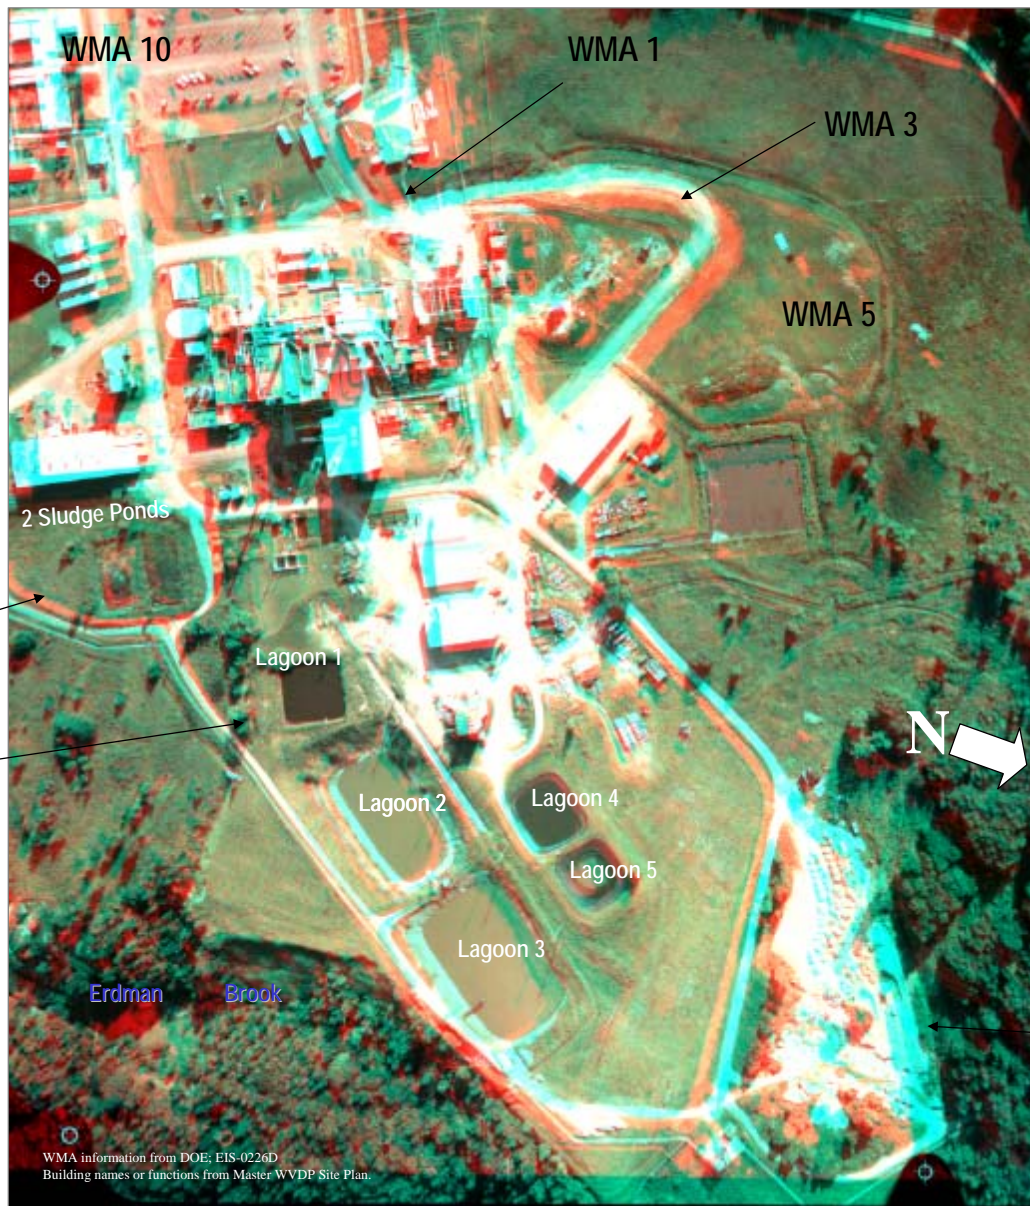
In order to make the 1984 anaglyph, the direction of the photos are required to be oriented to their stereo viewing position. North is to the right.

1984 photographs are large scale photos. No one frame covers the whole installation.

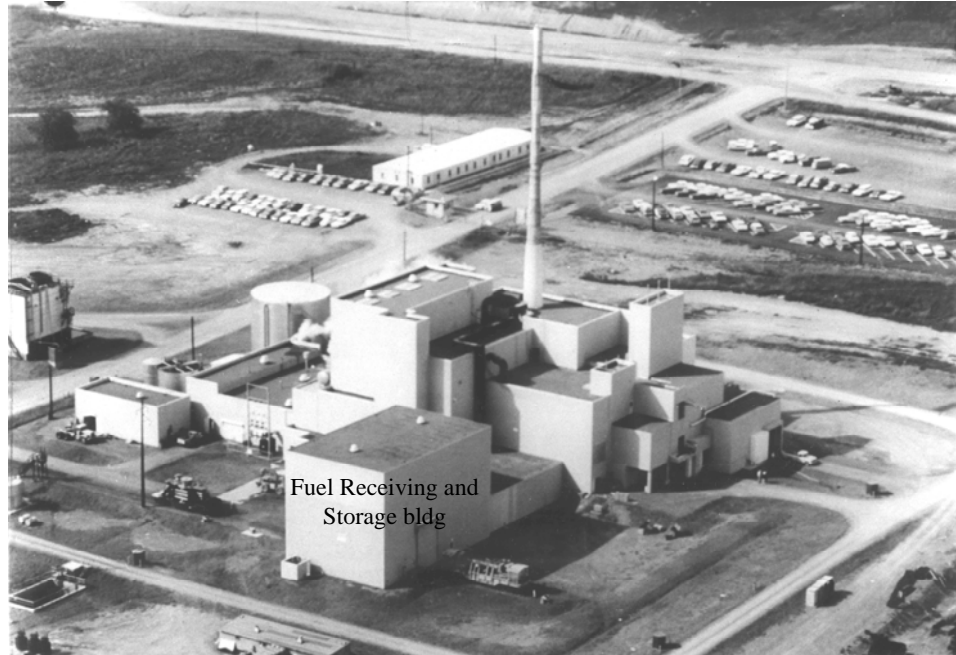
FUEL RECEIVING AND STORAGE BUILDING, CIRCA 1970s

Fuel Receiving and
Storage bldg

World's first privately-owned spent nuclear fuel reprocessing plant operated by Nuclear Fuel Services, Inc., a majority-owned subsidiary of W. R. Grace and Co. The plant is located on a 3,300-acre site in West Valley, N. Y., owned by the New York State Atomic and Space Development Authority.
