SUBJECT: Preliminary Jurisdictional Determination for Department of the Army Application No. LRB-2016-01548

I have reviewed the wetland delineation map you submitted for your request for a wetland boundary verification on the 124 acre property located east of Mount Read Boulevard and south of Ridgeway Road, in the Town of Greece, Monroe County, New York.

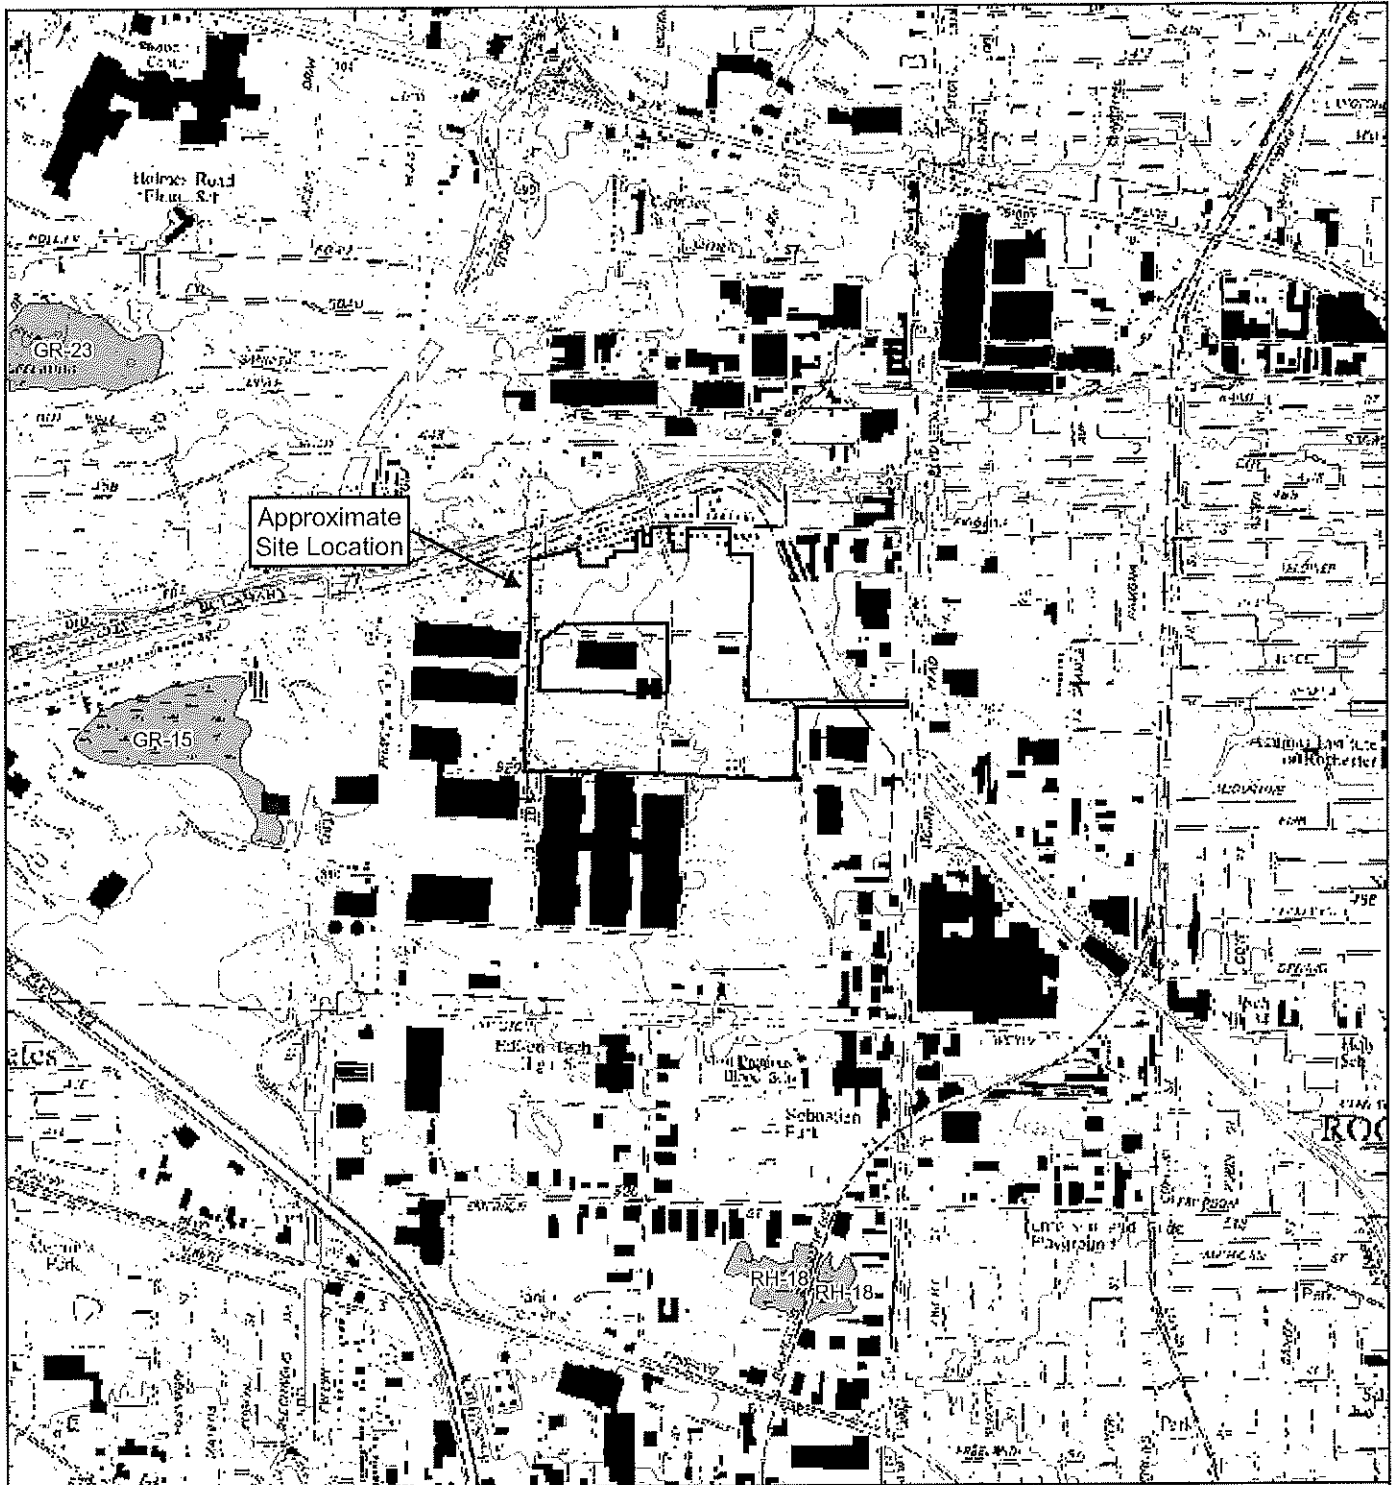
Figure 2. NYS Freshwater Wetlands Map

NYS Department of
 Environmental Conservation
cugir.mannlib.cornell.edu
 Monroe County
 2008

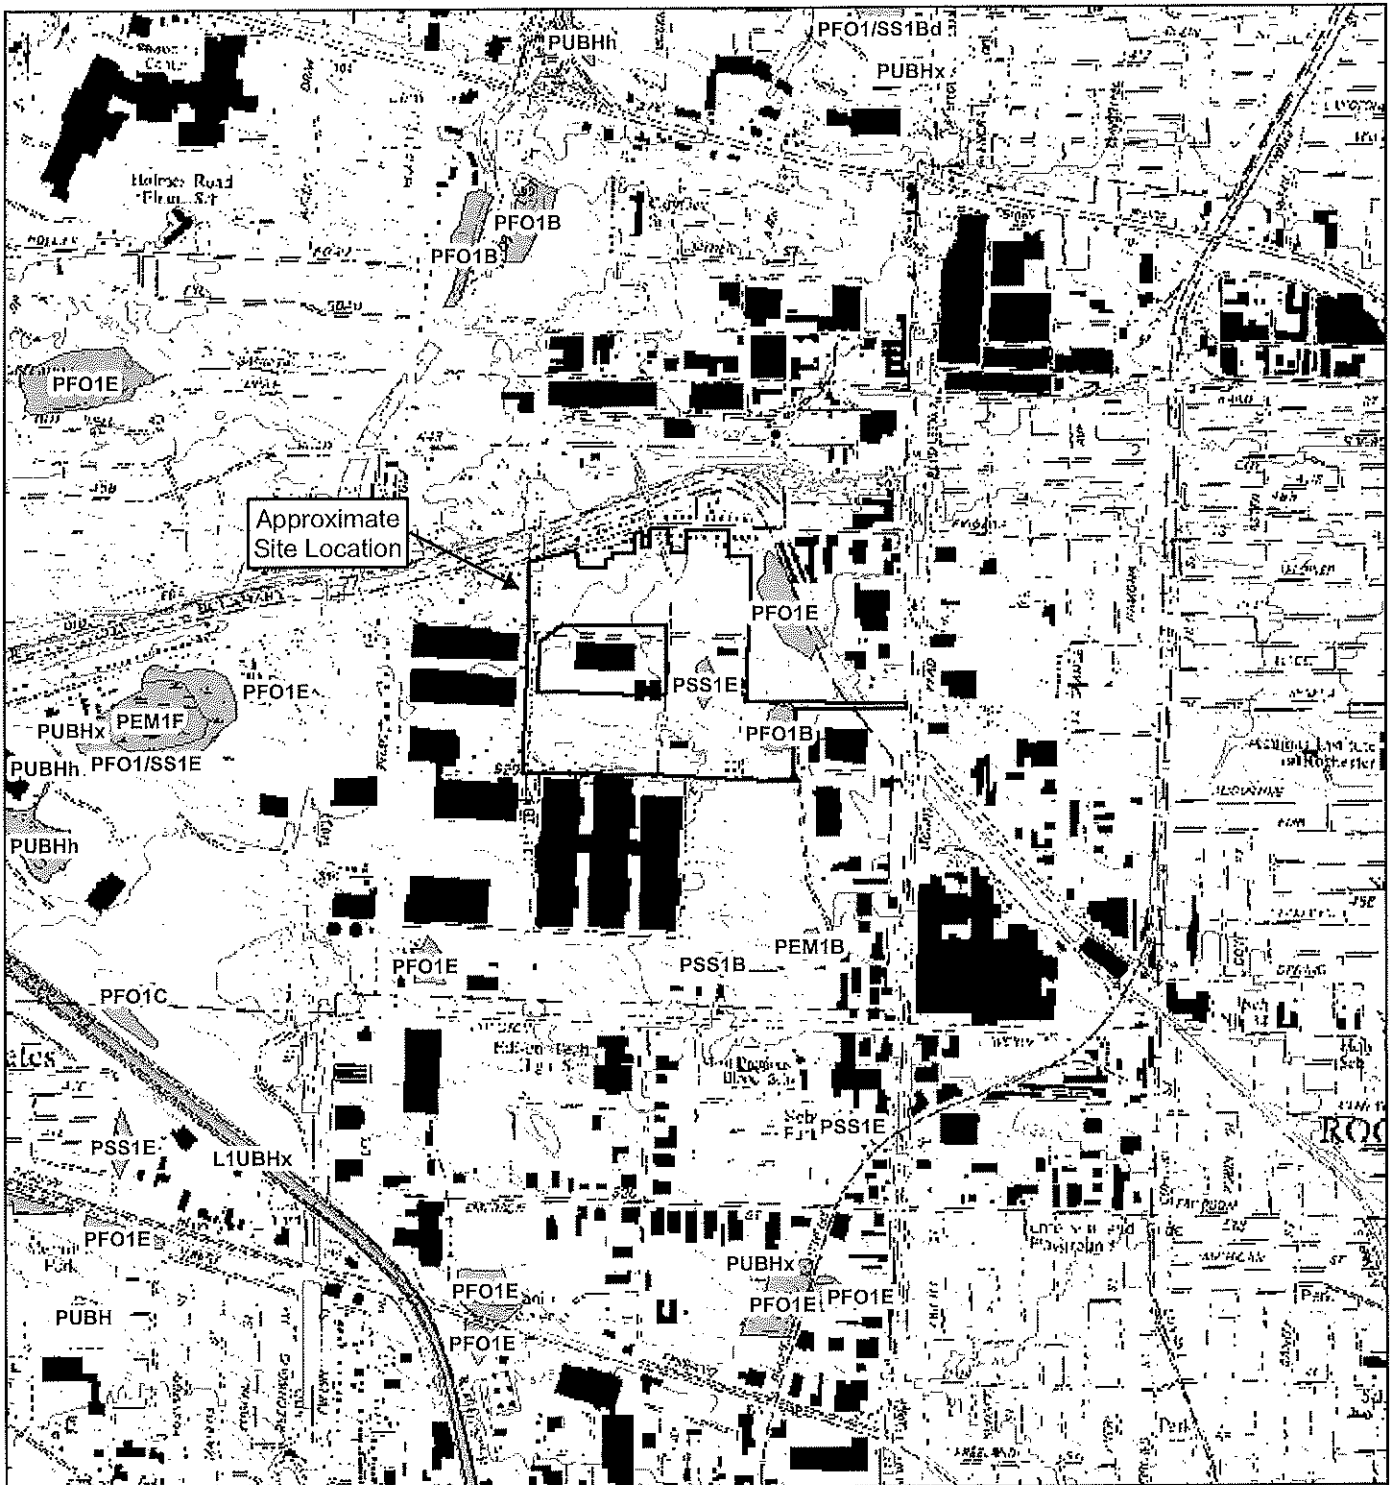
Figure 3. National Wetlands Inventory Map

U.S. Fish & Wildlife Service
www.fws.gov/nwi

An area mapped as a NWI wetland was investigated on the western edge of the site. Two upland sampling plots were taken within this area (Upland 5 and Upland 12). Green ash, box elder, and buckthorn were the dominant trees. Herbaceous vegetation included eastern star sedge (*Carex radiata*), garlic mustard (*Alliaria petiolata*), and fowl mannagrass (*Glyceria striata*). TES found upland soils within this area and no hydrology indicators during the field delineation.

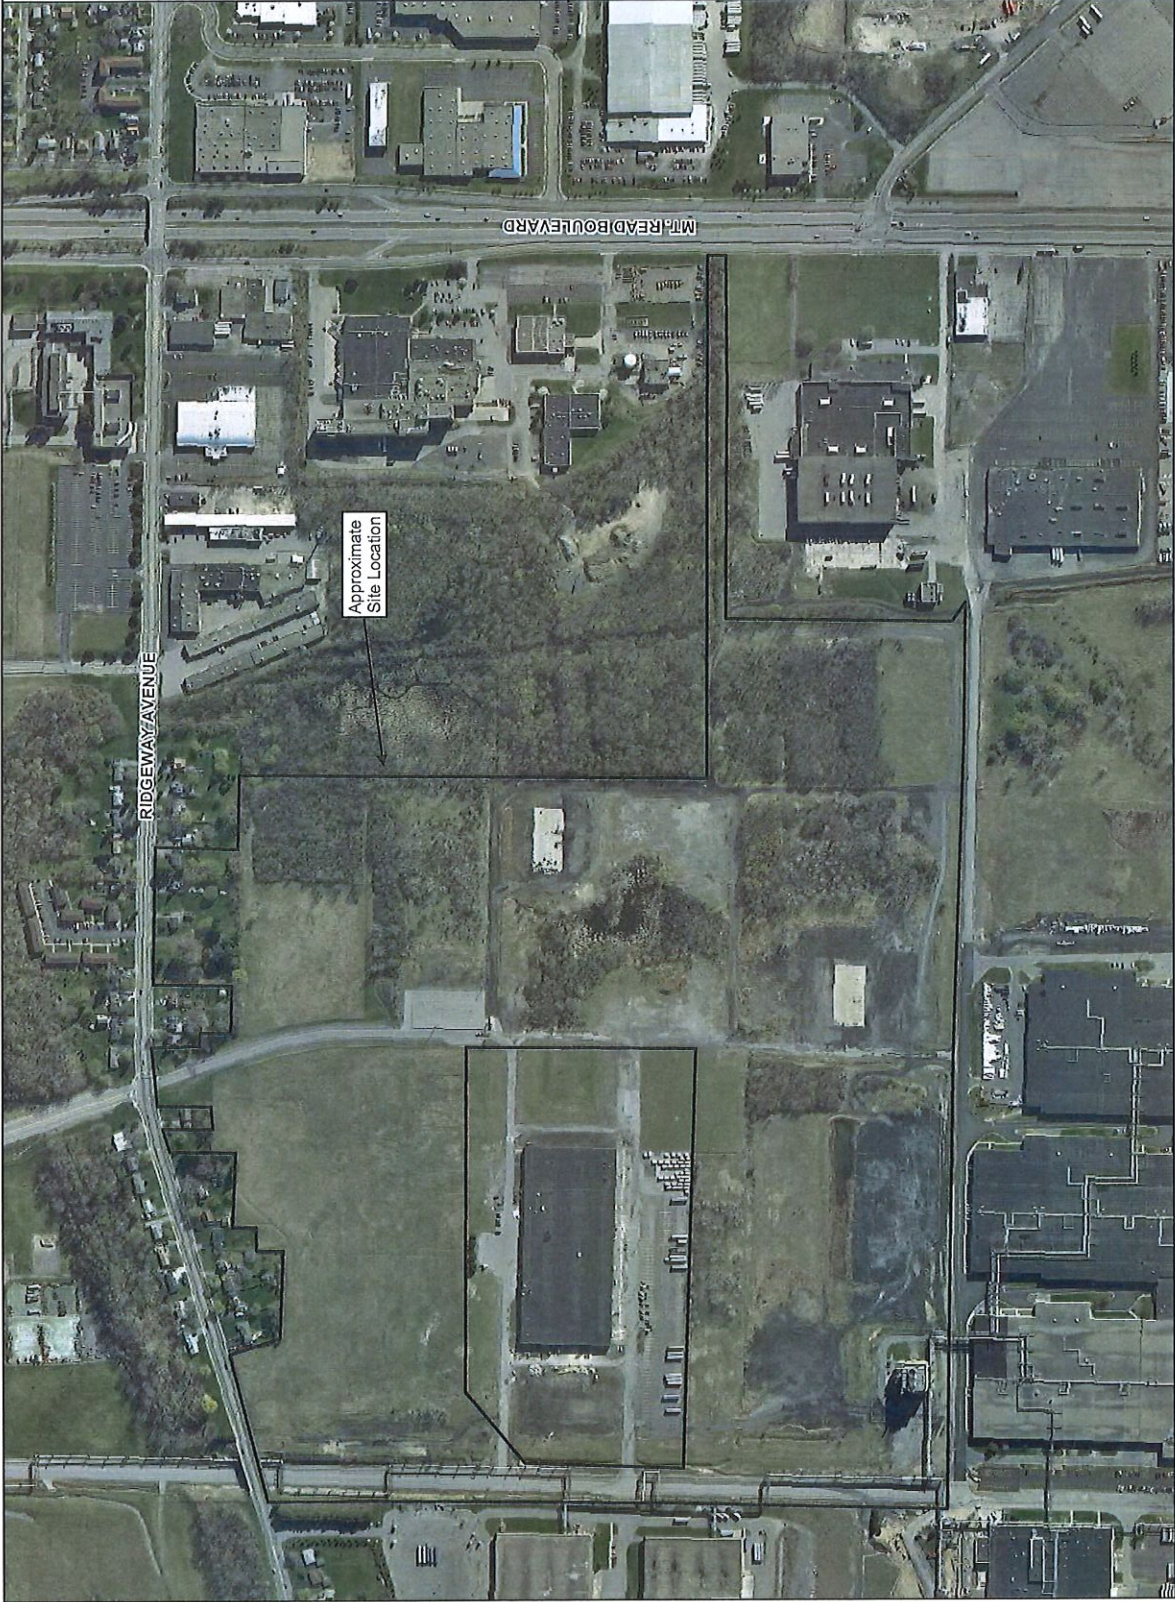
Figure 6.
Aerial Photograph
of Site

0 400
Feet

1 inch = 400 feet

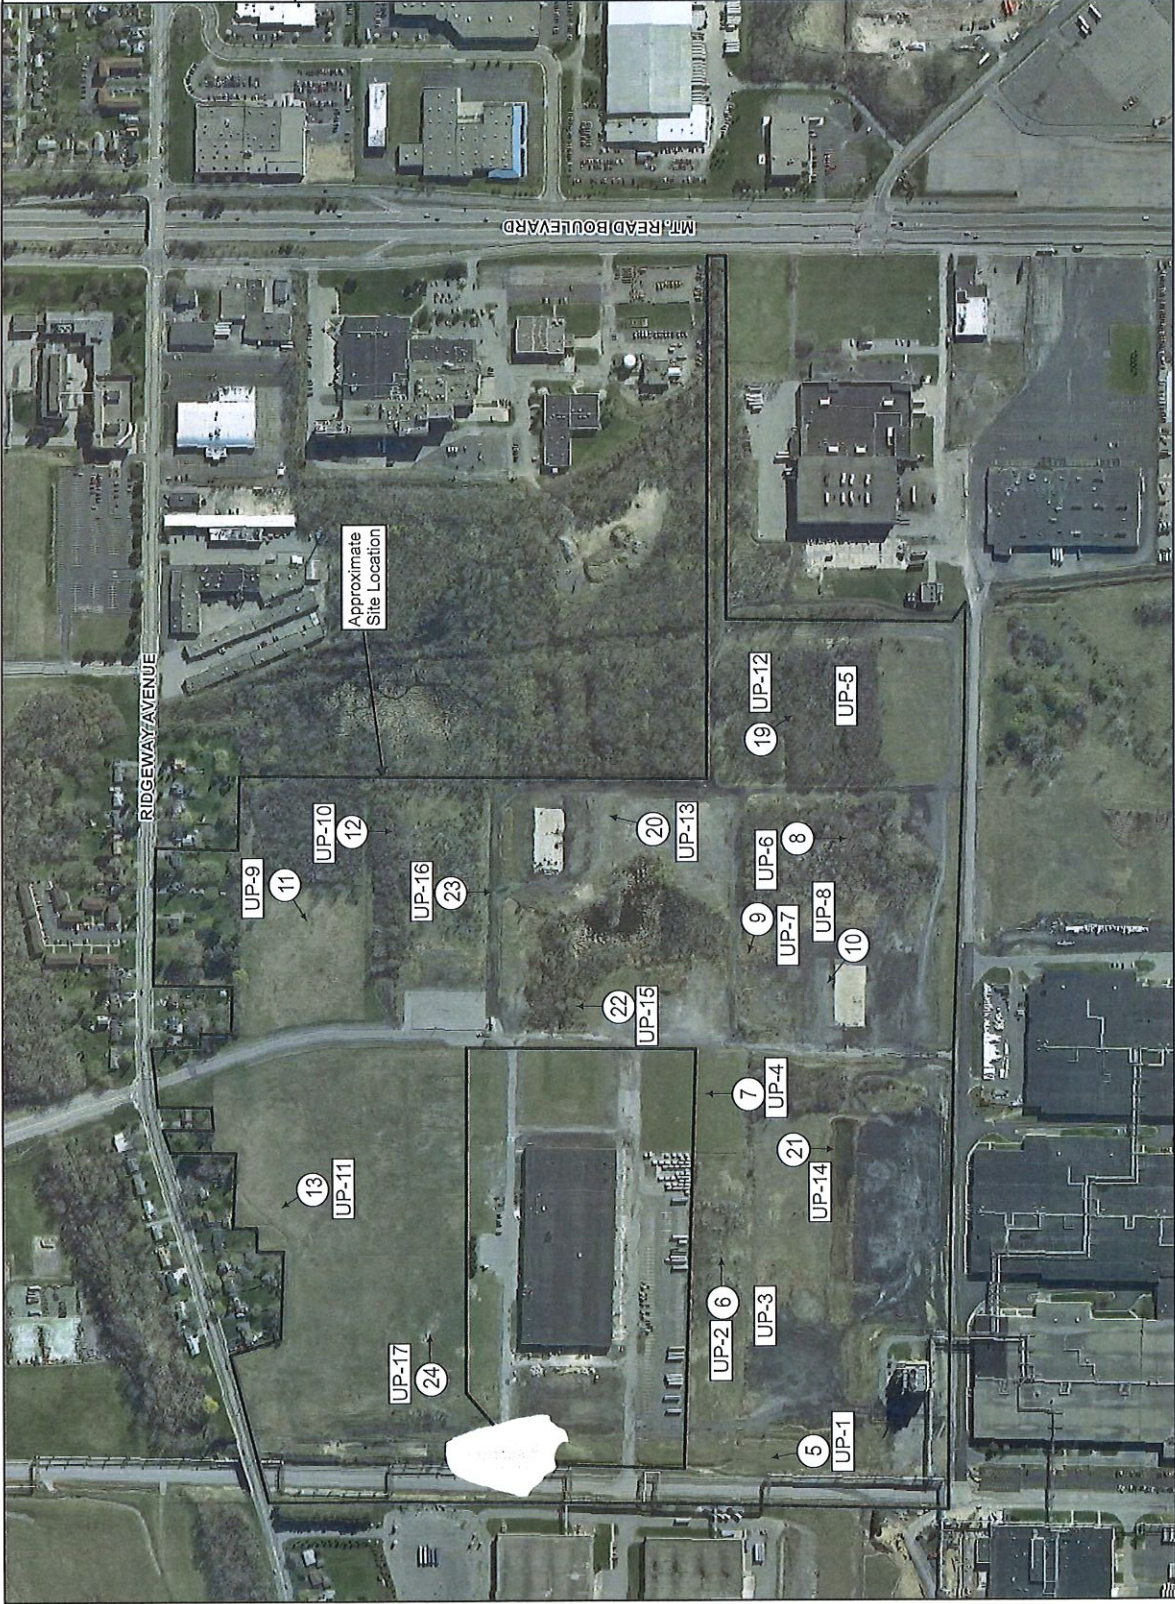
Figure 8b.

[A-1W] Sample Plot Location

Aerial Photographs with
Upland Sample Plot and
Photograph Locations
