FINAL
GAMMA RADIATION SCANNING REPORT
AREA IV RADIOLOGICAL STUDY
SANTA SUSANA FIELD LABORATORY
VENTURA COUNTY, CALIFORNIA

EPA Contract Number: EP-S7-05-05
Task Order Number: 0038

October 17, 2012

**HydroGeoLogic, Inc.
Building 204
5800 Woolsey Canyon Road
Canoga Park, California 91304**

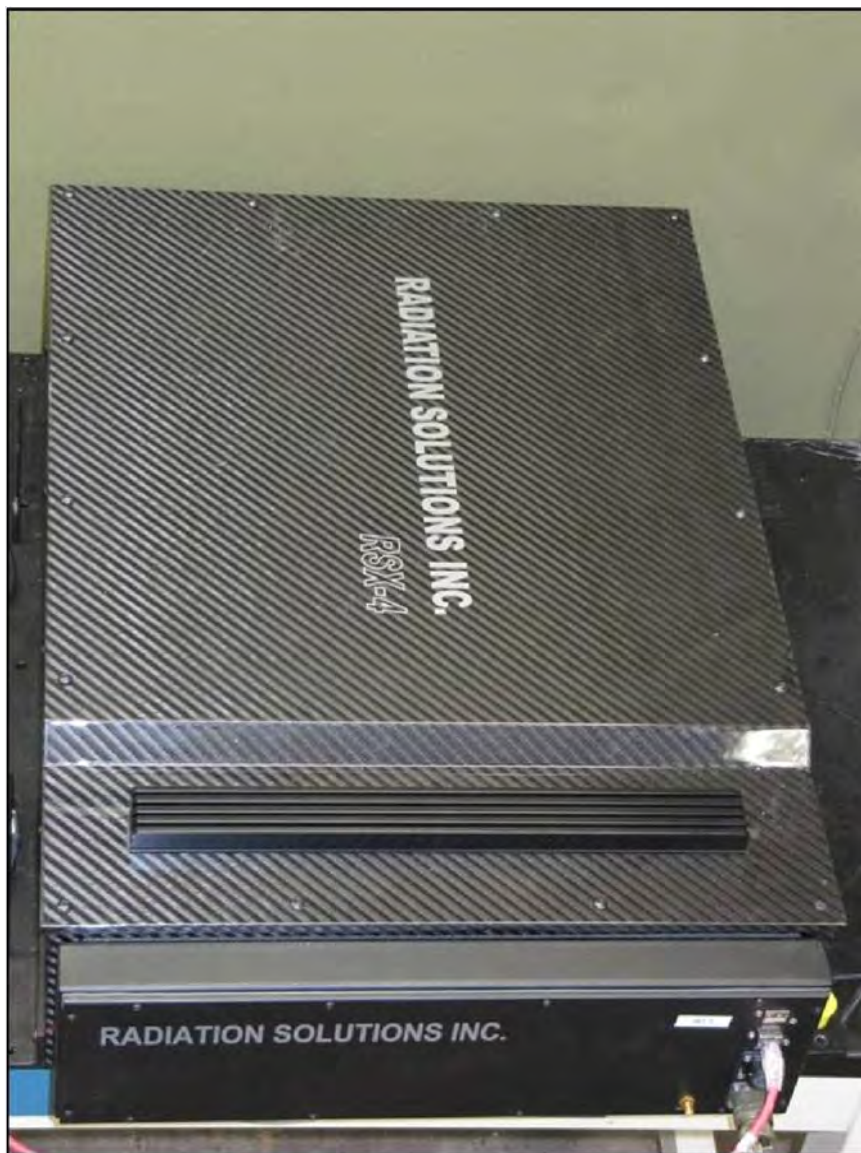
Figure 3.2

Radiation Solutions Inc. RSX-4 Detector

The NaI detectors used in the ERGS II detection system were manufactured by RSI. The shield assembly was designed by USEPA and constructed by Radiation Shielding, Inc. (Figures B.1 through B.4). The system consisted of two RSX-4 detector units. Each RSX-4 contained a set of four NaI detectors contained in a carbon fiber casing (Figure 3.2). The two carbon fiber cases were enclosed in a lead and stainless steel shield. The design schematics for the RSX-4 are illustrated on Figure B.5.

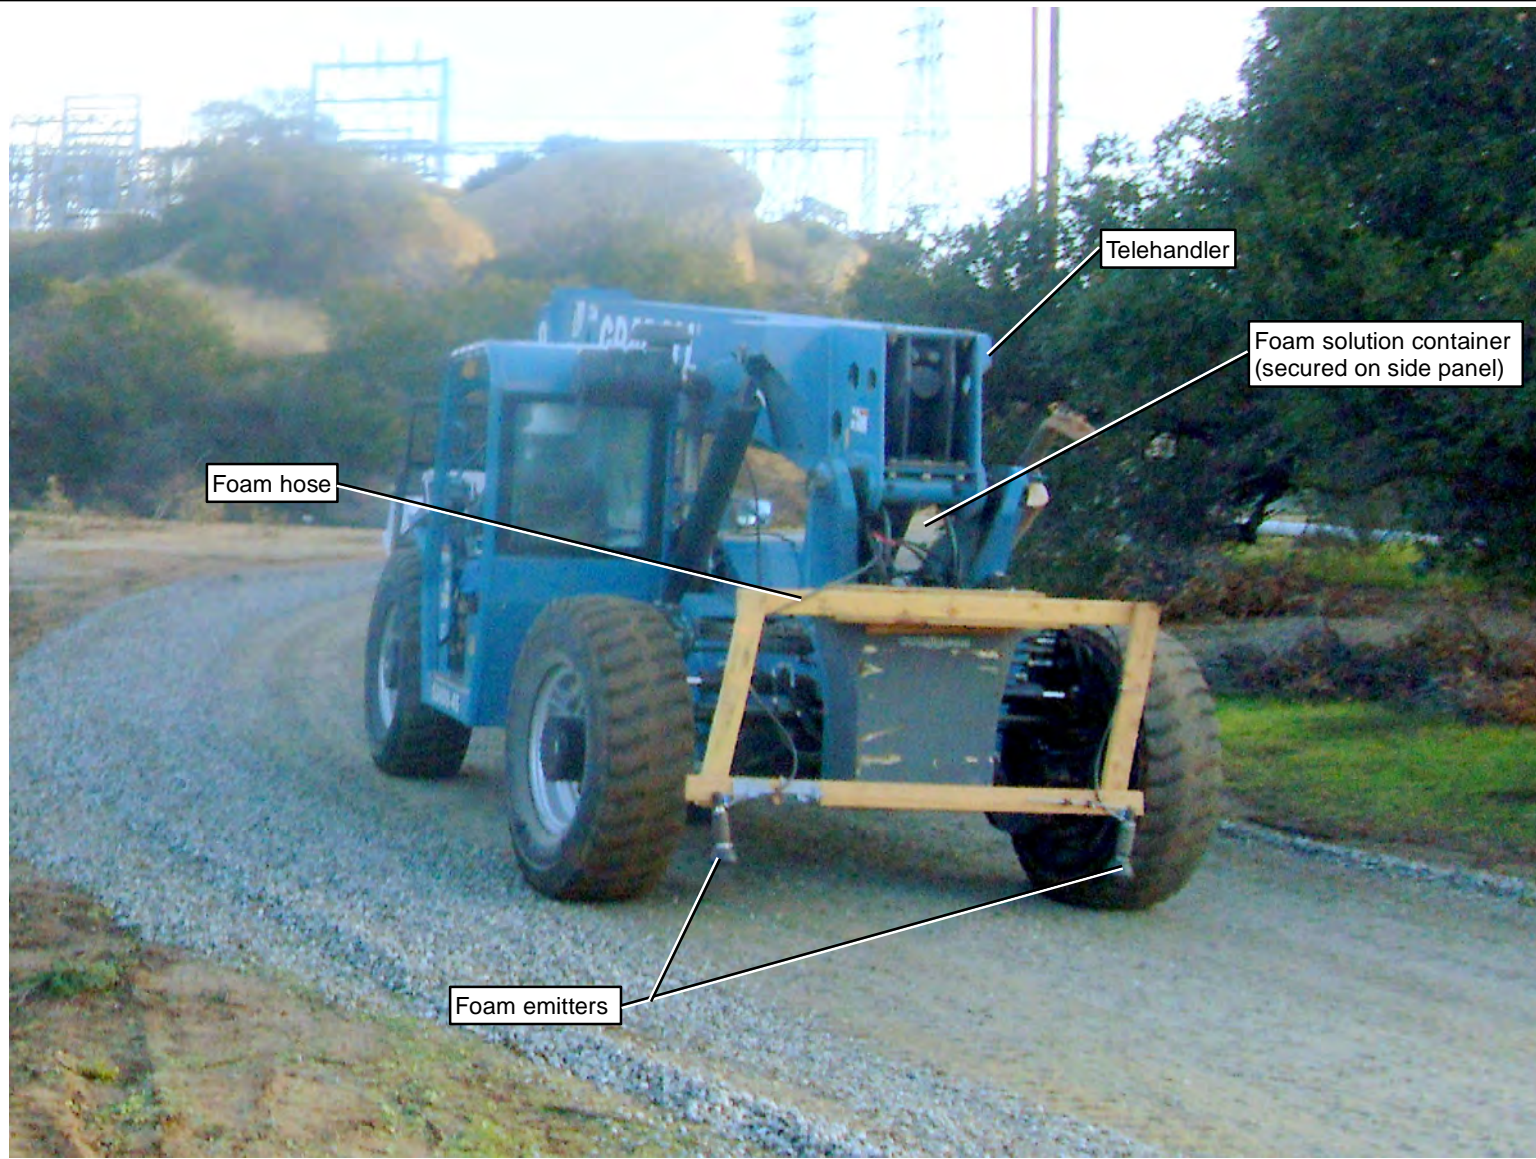
Figure 3.4

Telehandler

Foam solution container (secured on side panel)

**Enhanced Radiation Ground Scanner II
Foam Markers**

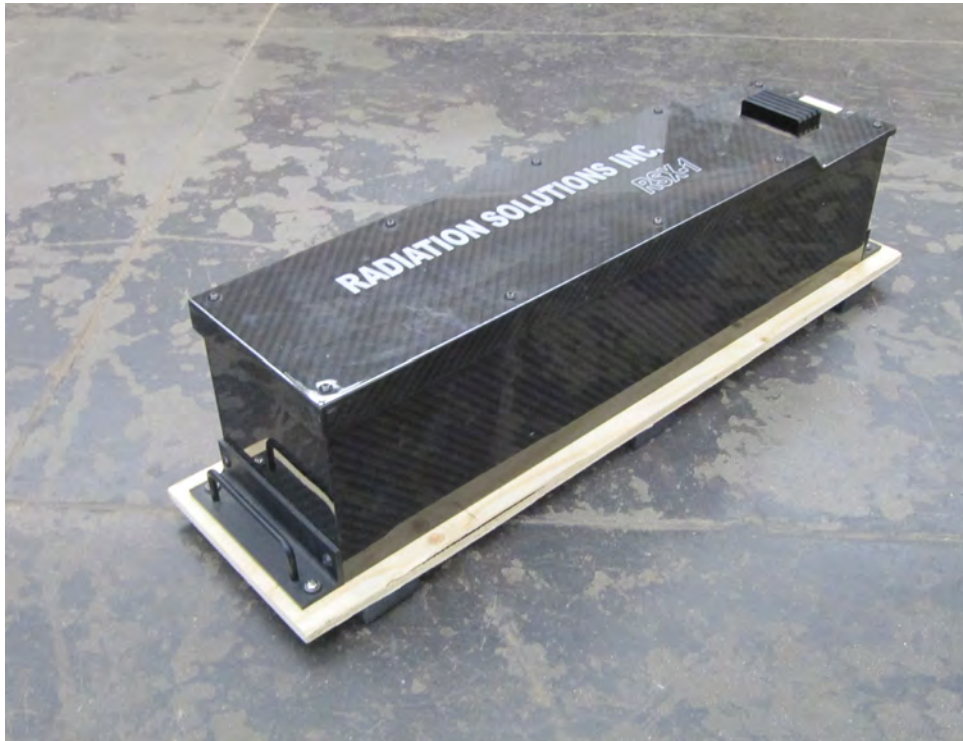
Figure 3.8

RSX-1 Detector

Shield

Radiation Solutions Inc. RSX-1 Detector and Shield

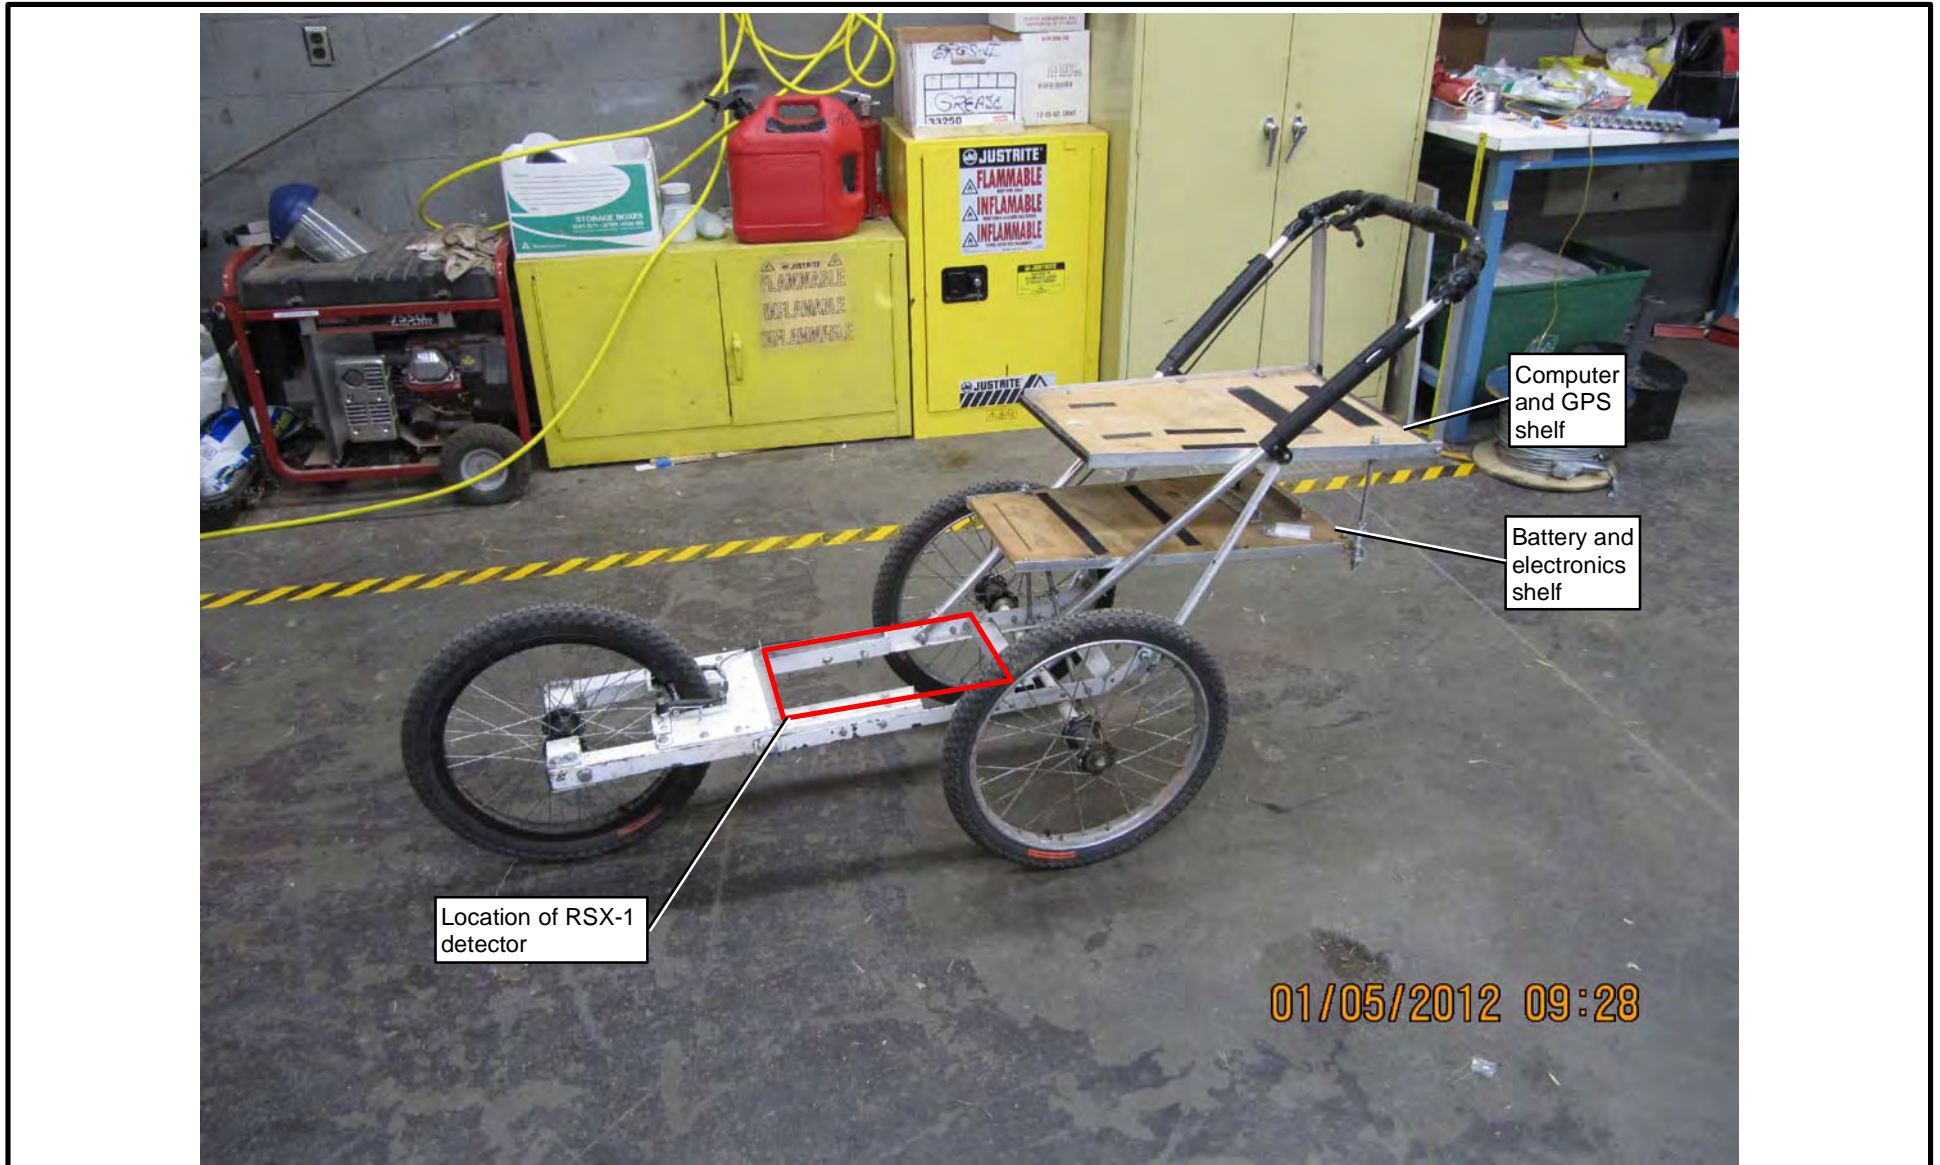
Figure 3.11

**Wheel Mounted Gamma Scanner
Transportation Mechanism**

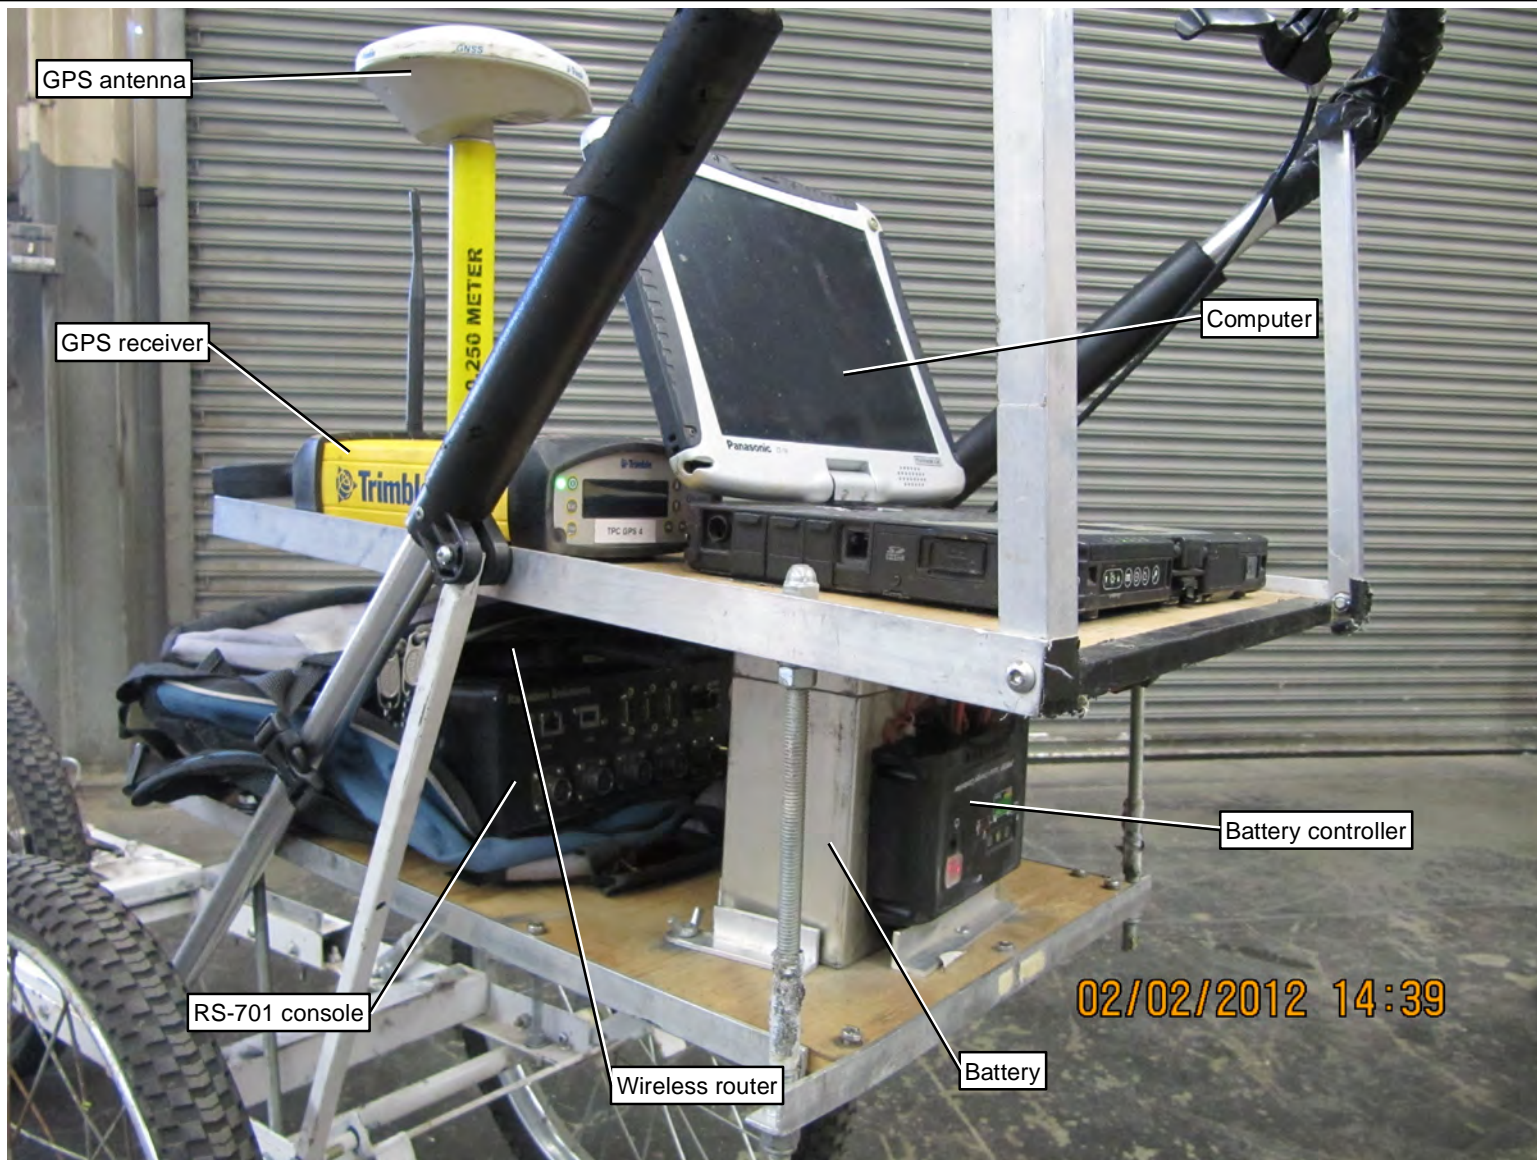
Figure 3.12

**Wheel Mounted Gamma Scanner
Electronic Components**

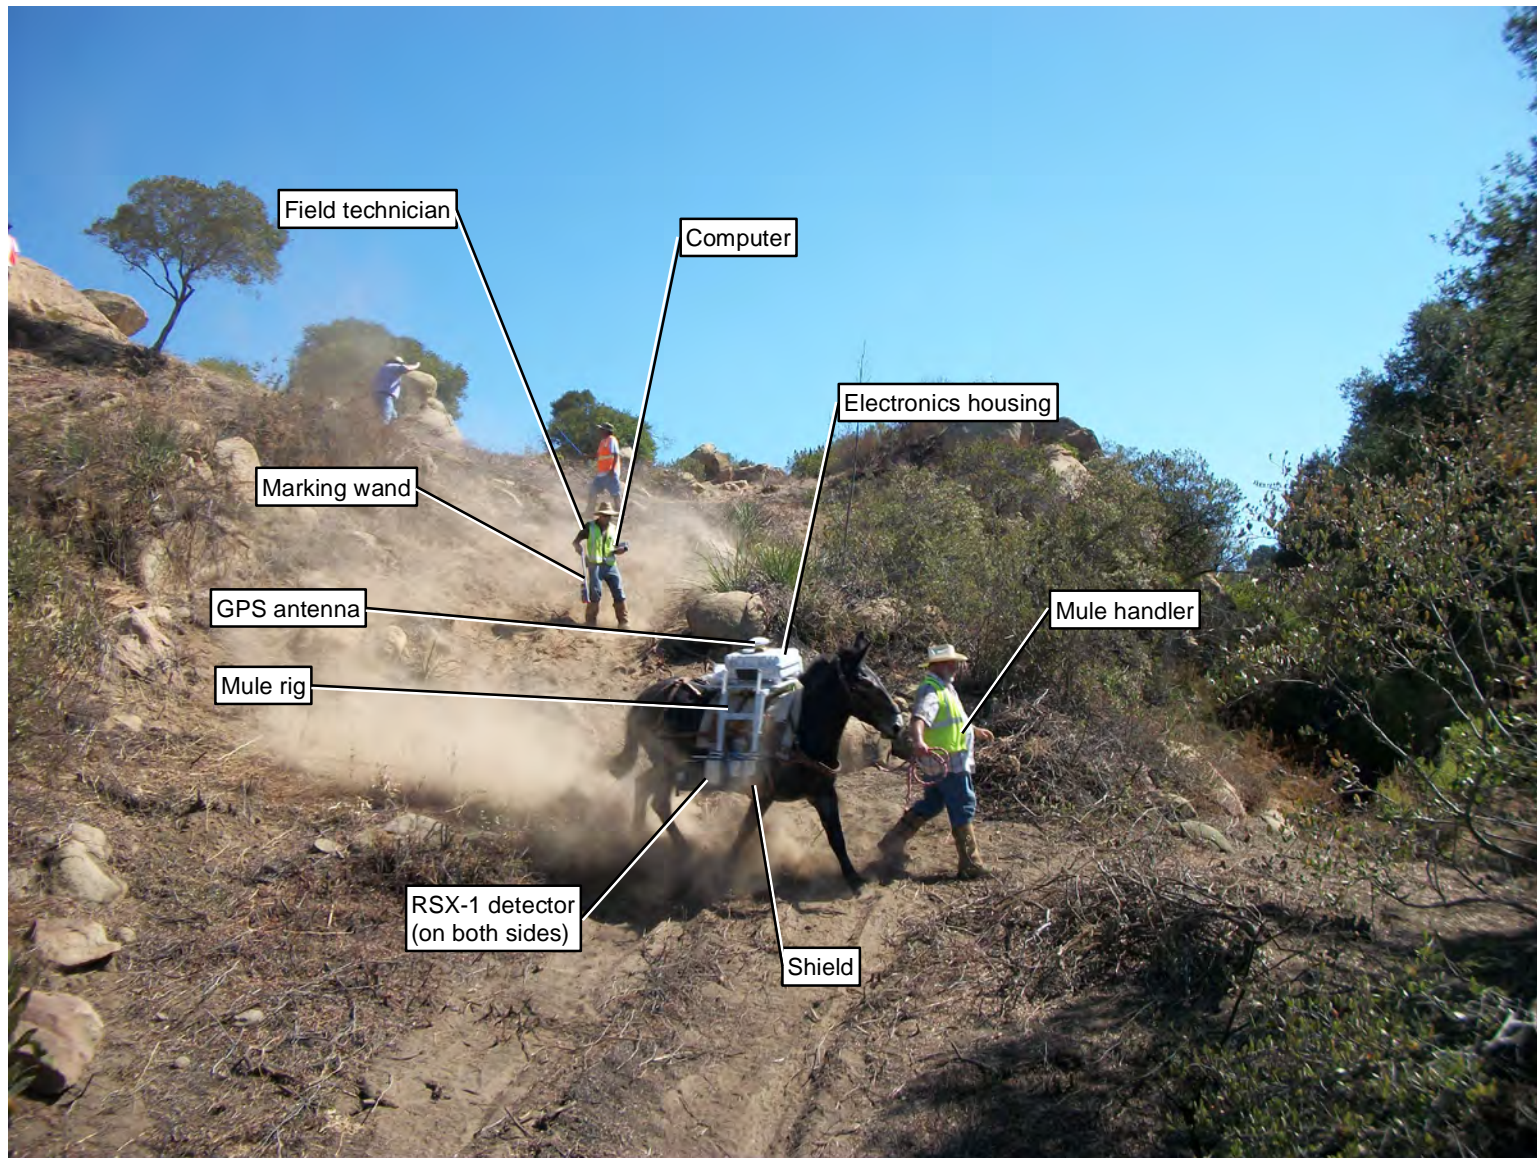
Figure 3.15

**Mule Mounted Gamma Scanner
Detection System**

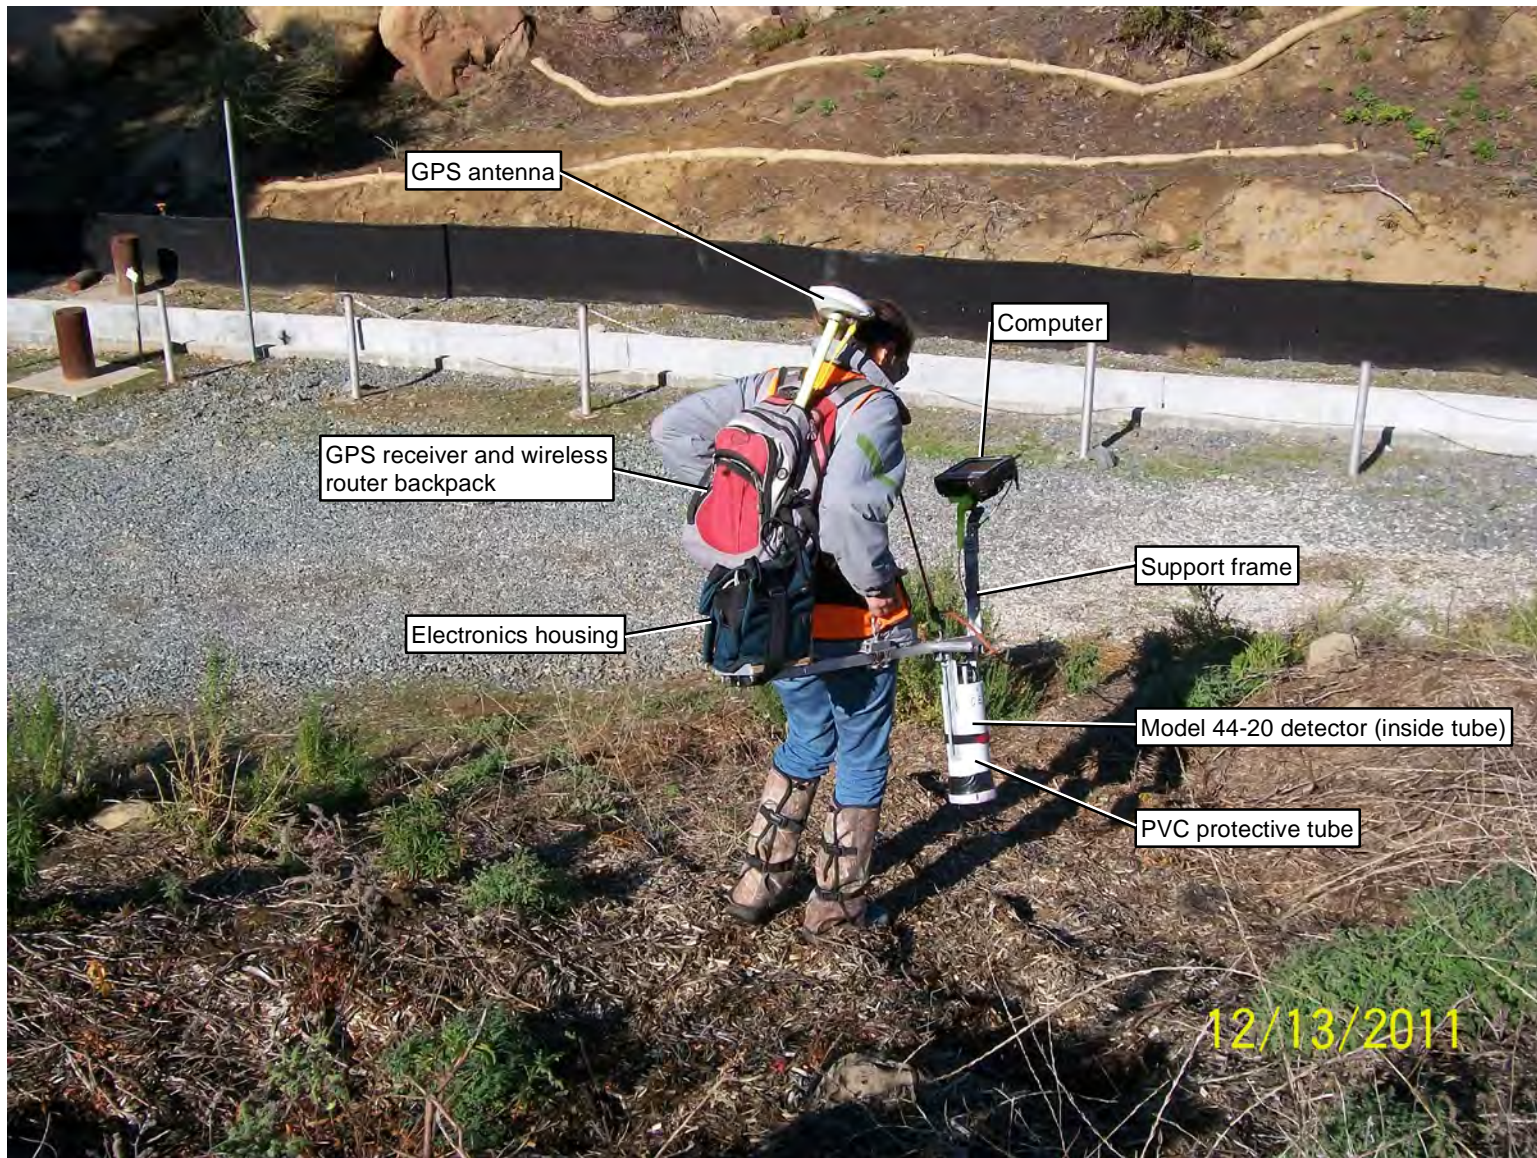
Figure 3.18

**Hand Held Gamma Scanner I
Detection System**

The first configuration consisted of a light-weight frame assembled from aluminum bar stock (Figures 3.18 and 3.19). The detector was enclosed in a polyvinyl chloride (PVC) protective tube and affixed to an aluminum bar with a counter balance of a bag containing the survey meter (Photograph A.12). A side view schematic of the HHGS I is illustrated on Figure B.15. The aluminum frame fastened onto a modified backpack frame worn by the operator to aid in distributing the weight of the device. The backpack contained the Trimble® Model SPS852 receiver, batteries, and the wireless router. A Zephyr™ II antenna was attached to the backpack frame (Figure 3.20). A handheld computer (Panasonic Toughbook® U-1) was mounted on an aluminum bar attached perpendicularly to the frame for the operator to track scanning coverage.

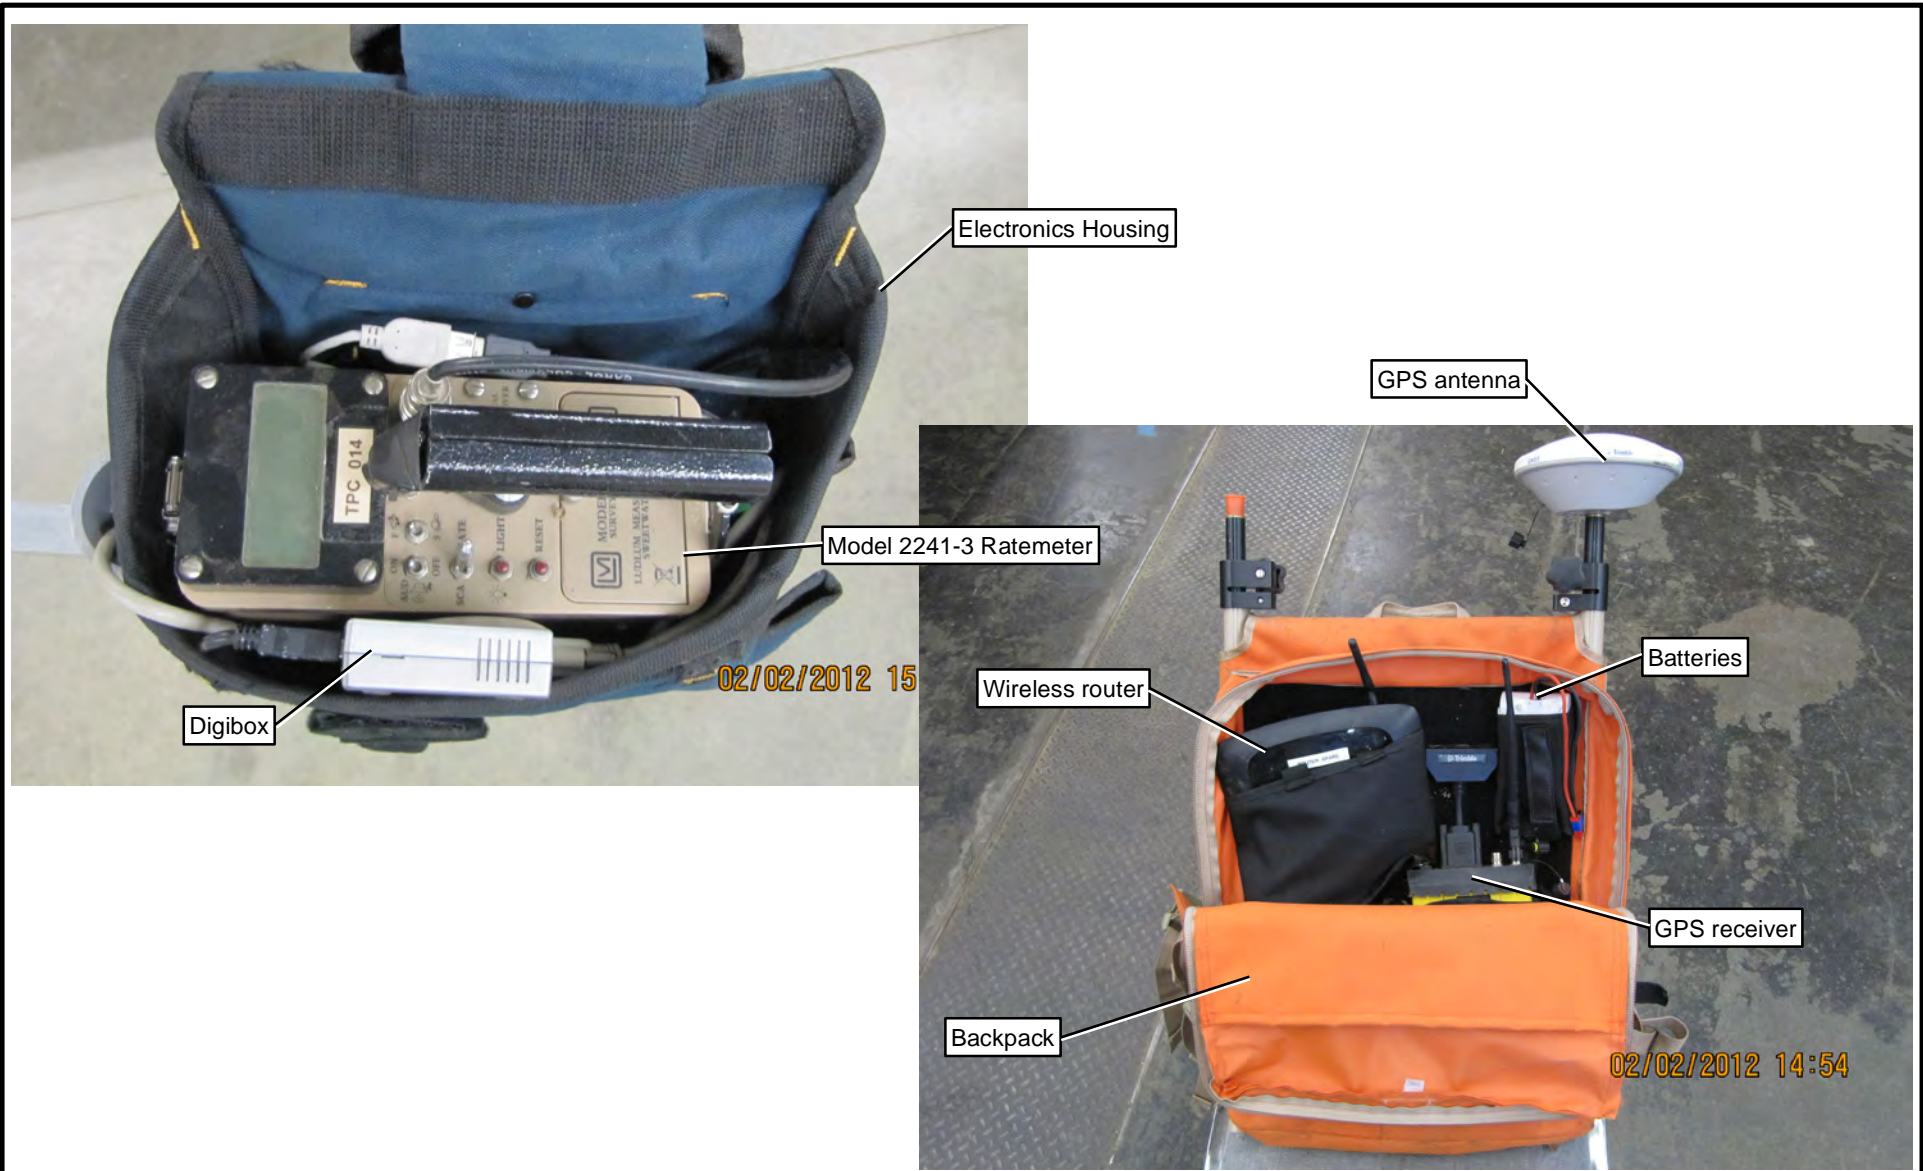
Figure 3.20

**Hand Held Gamma Scanner I and II
Components of Electronics Housing and Backpack**

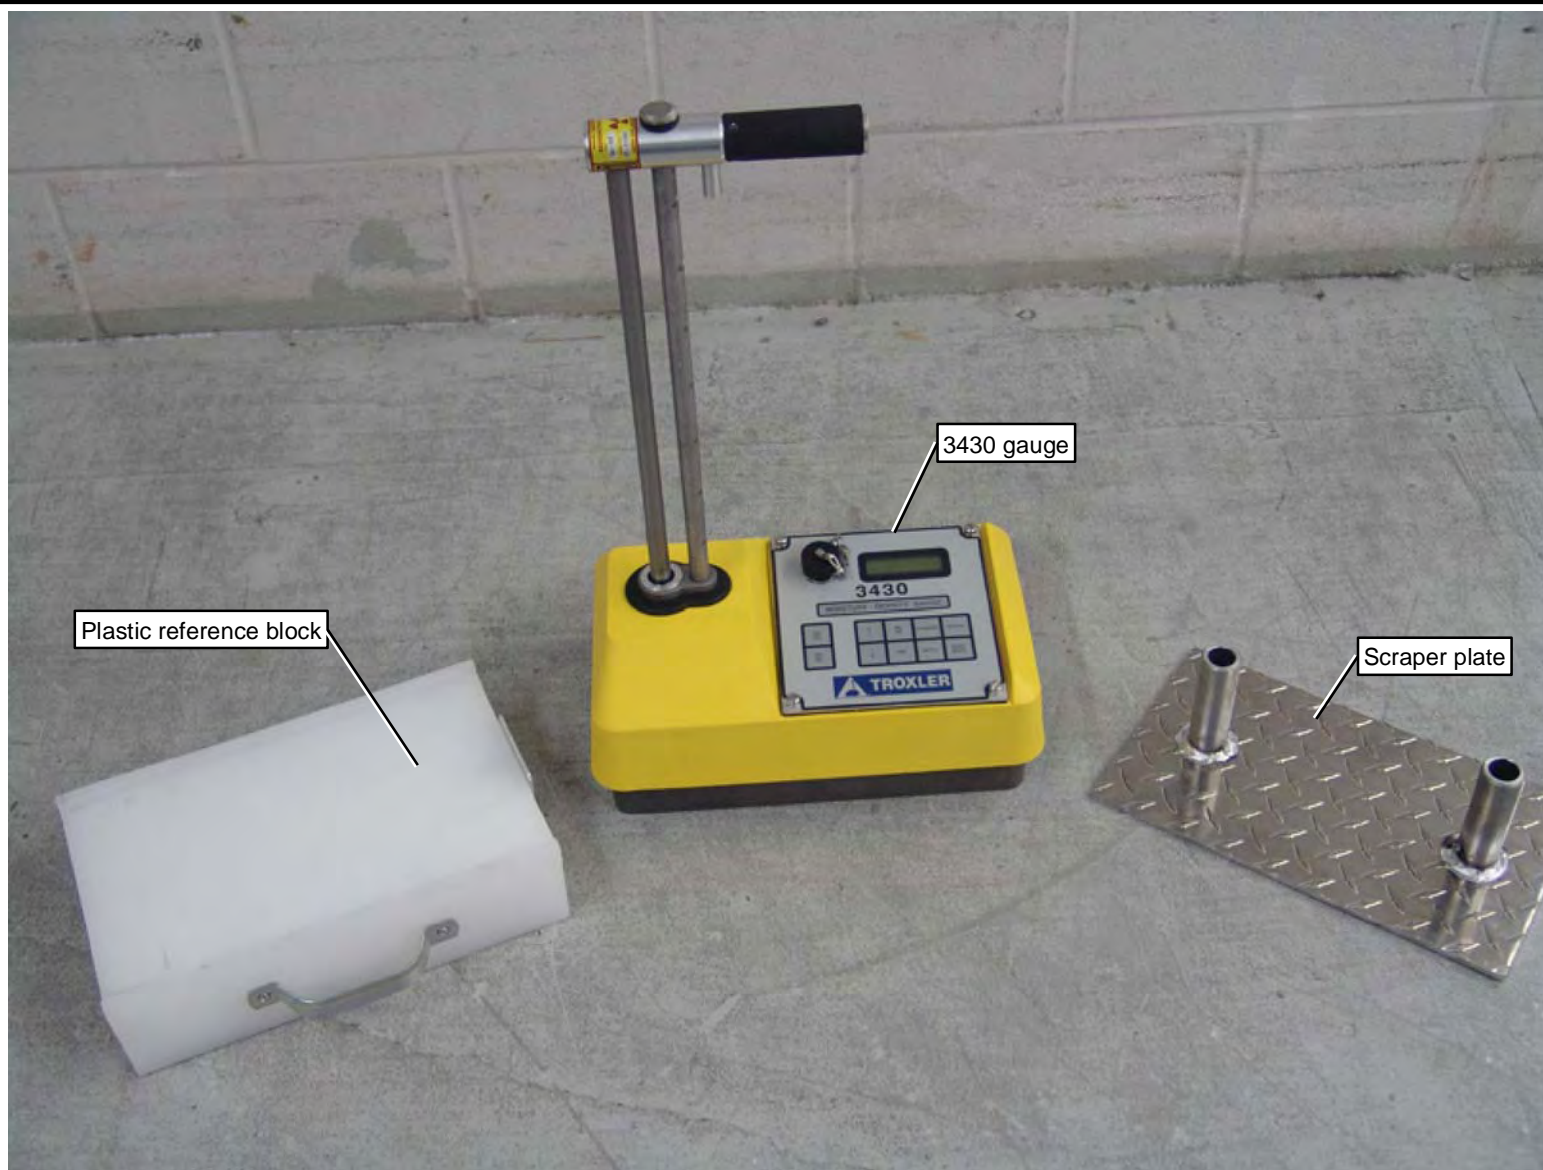
Troxler 3430 Nuclear Moisture Gauge

The Troxler™ 3430 nuclear moisture density gauge was a portable instrument used to determine soil moisture (Figure 3.26). Measurements were used to verify soil moisture did not exceed 15 percent, which was an operating requirement for gamma scanning activities, in accordance with the SAP (HGL and TPC, 2010a).

The main compartment of the Troxler™ 3430 contained sealed radioactive sources, detectors, shielding, electronic modules, and a battery pack. An americium-241 and beryllium neutron source and a helium-3 detector tube were used to measure soil moisture content. The Cs-137 source for density measurements was not used for this project.

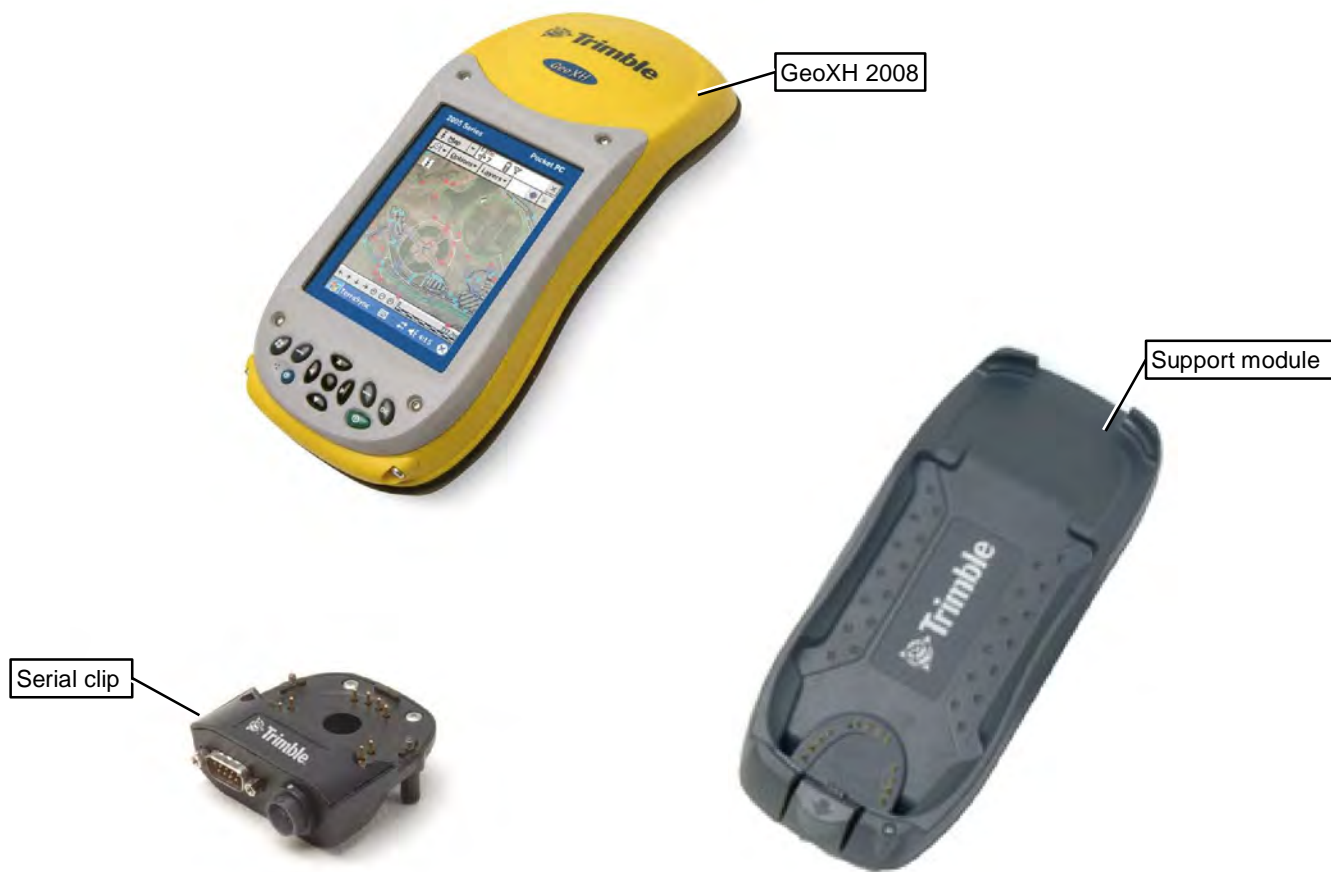
Trimble® Explorer GeoXH 2008 GPS

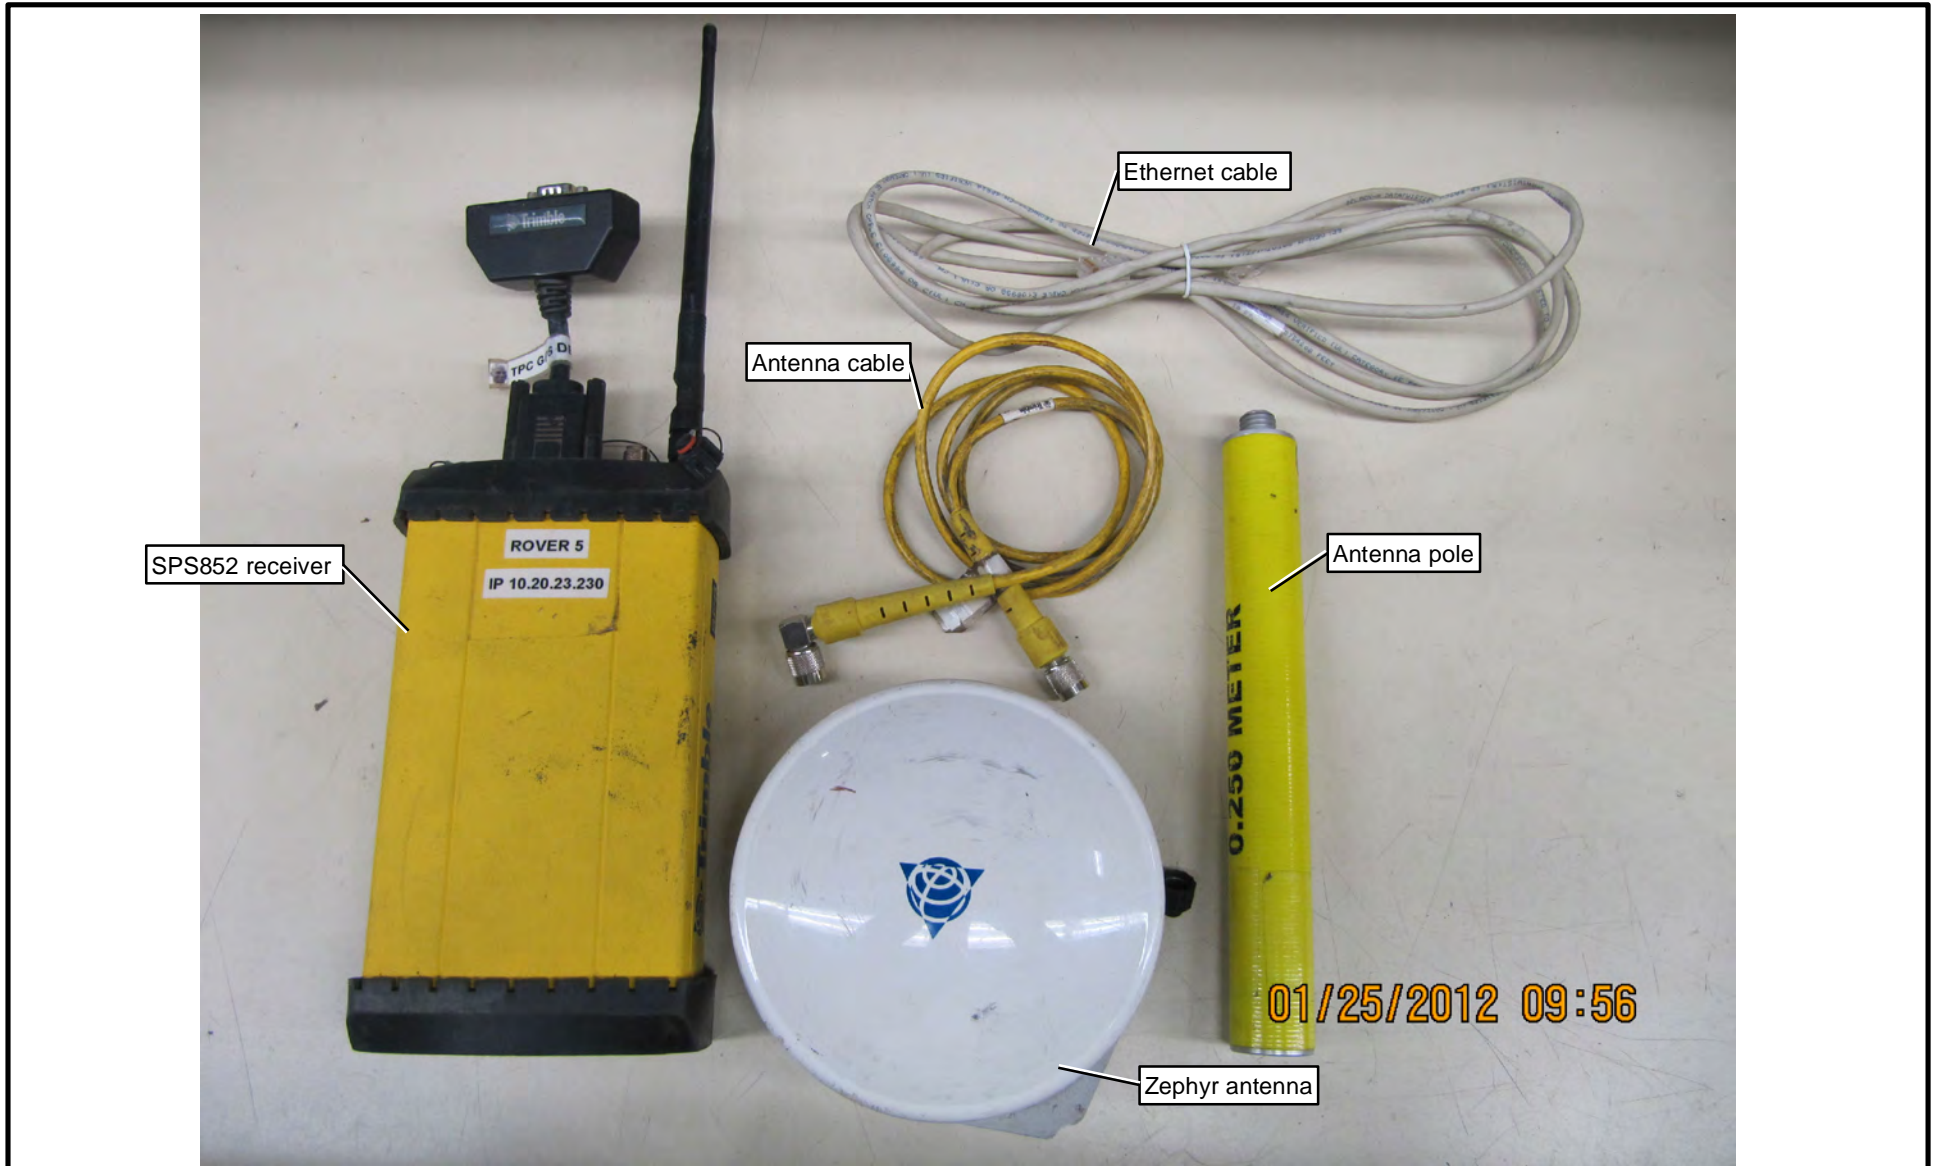
Trimble® SPS852 GPS

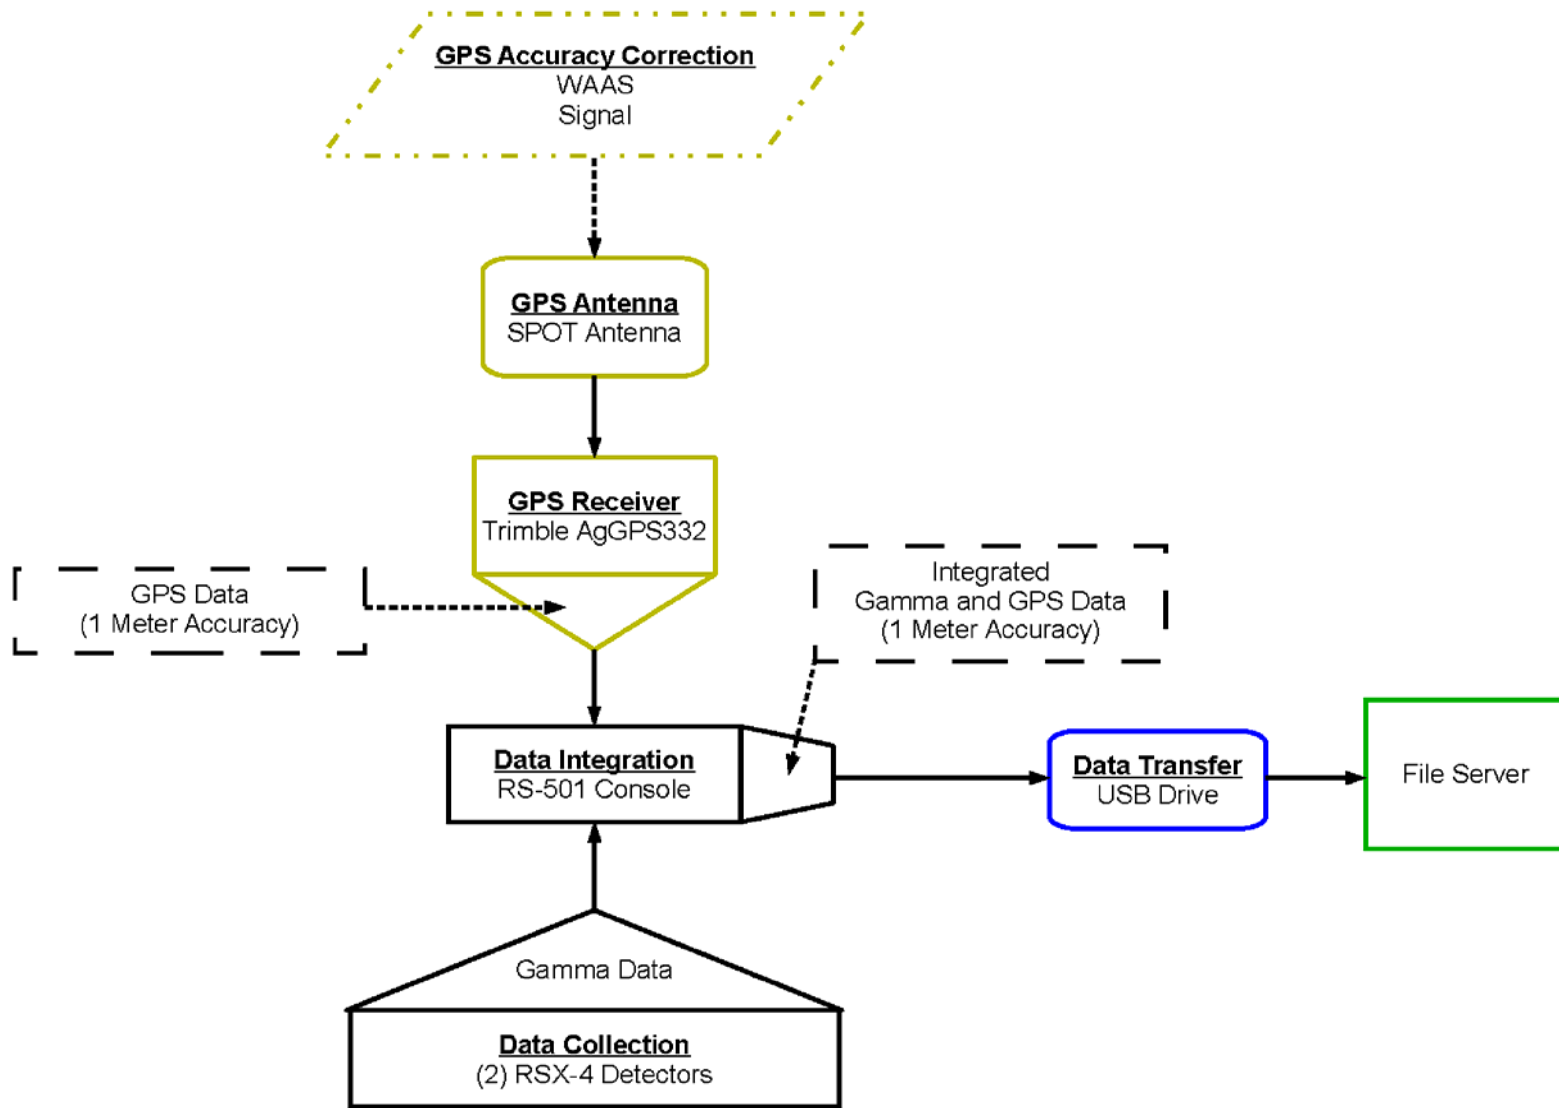
Initial ERGS II Data Collection Schematic
