FINAL
GAMMA RADIATION SCANNING REPORT
AREA IV RADIOLOGICAL STUDY
SANTA SUSANA FIELD LABORATORY
VENTURA COUNTY, CALIFORNIA

EPA Contract Number: EP-S7-05-05
Task Order Number: 0038

October 17, 2012

**HydroGeoLogic, Inc.
Building 204
5800 Woolsey Canyon Road
Canoga Park, California 91304**

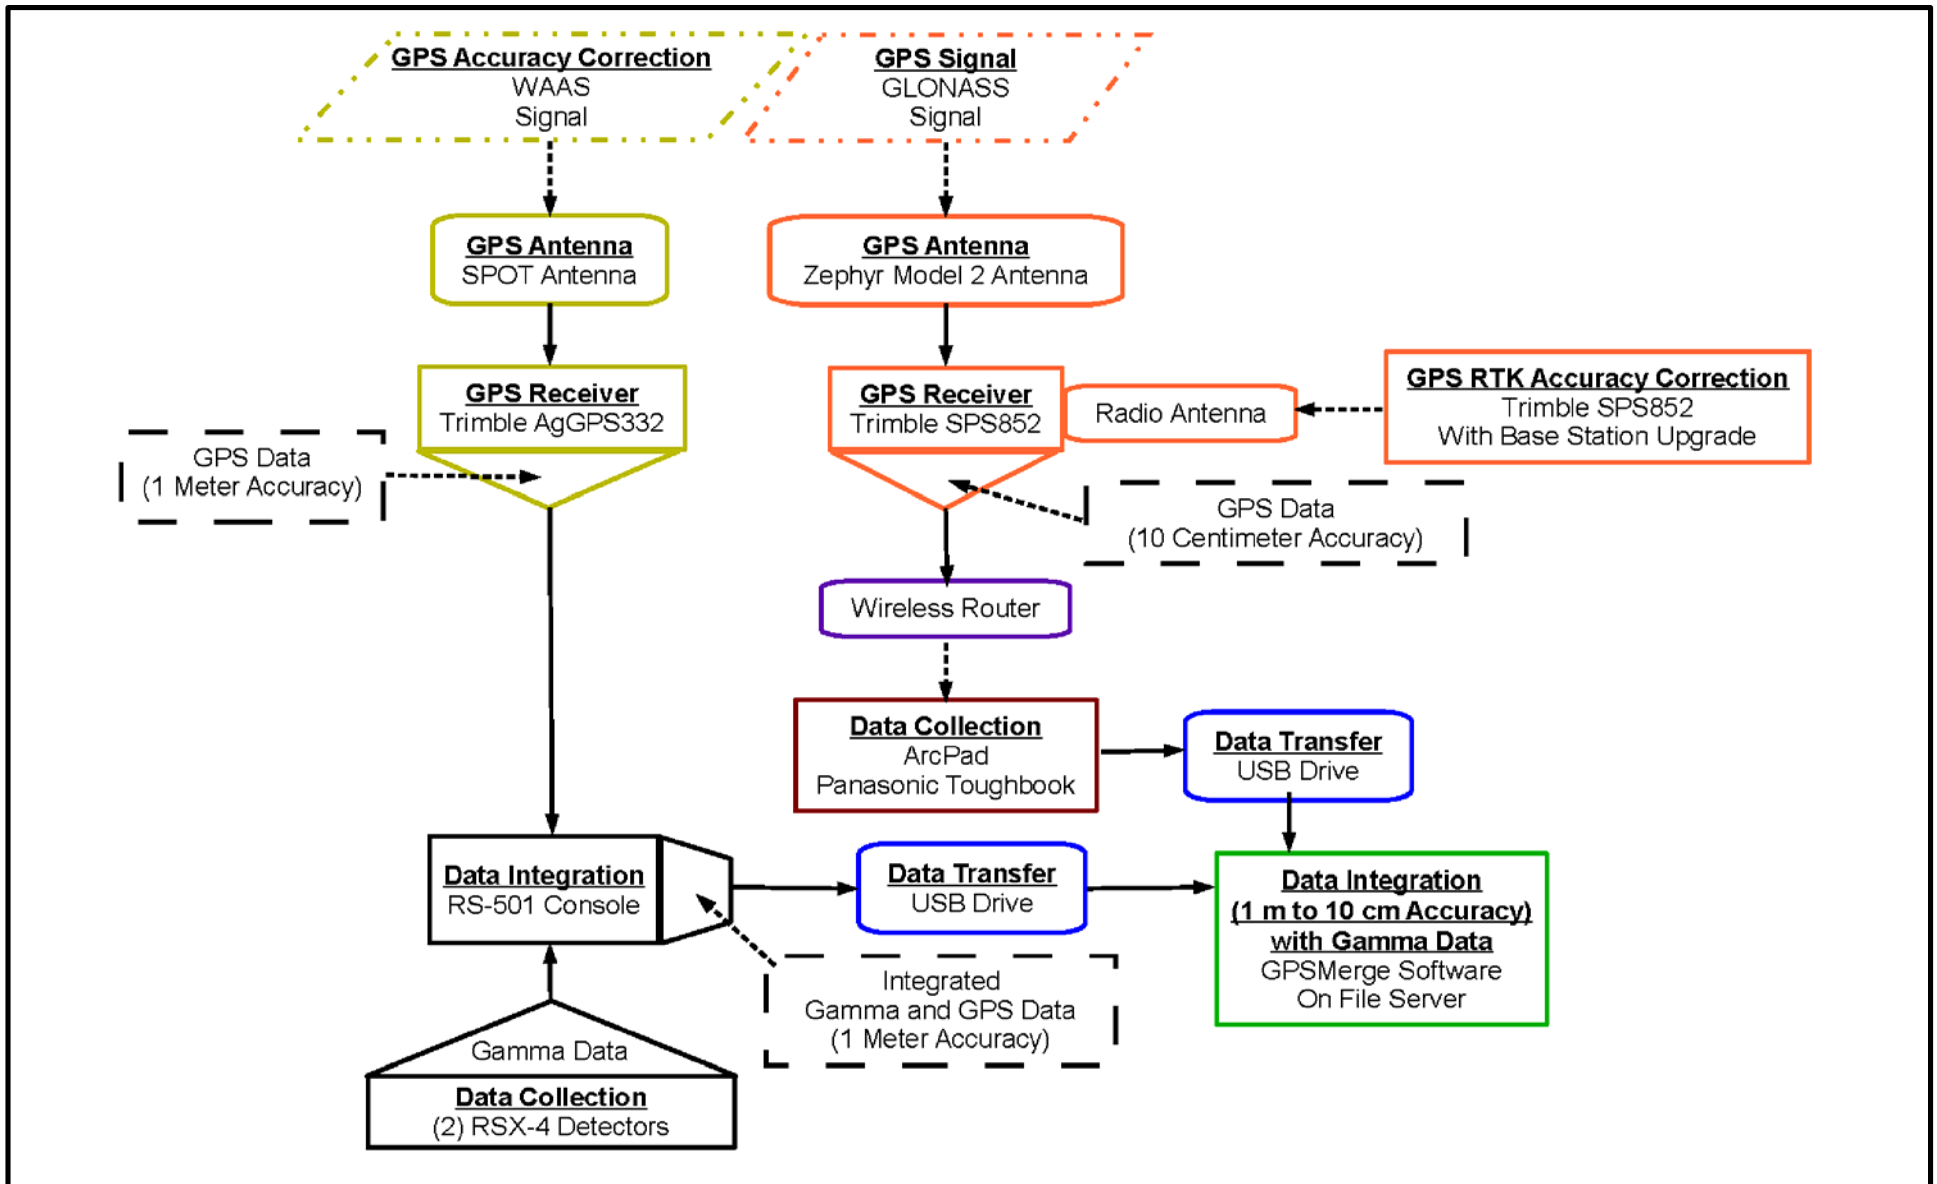
Final ERGS II Data Collection Schematic

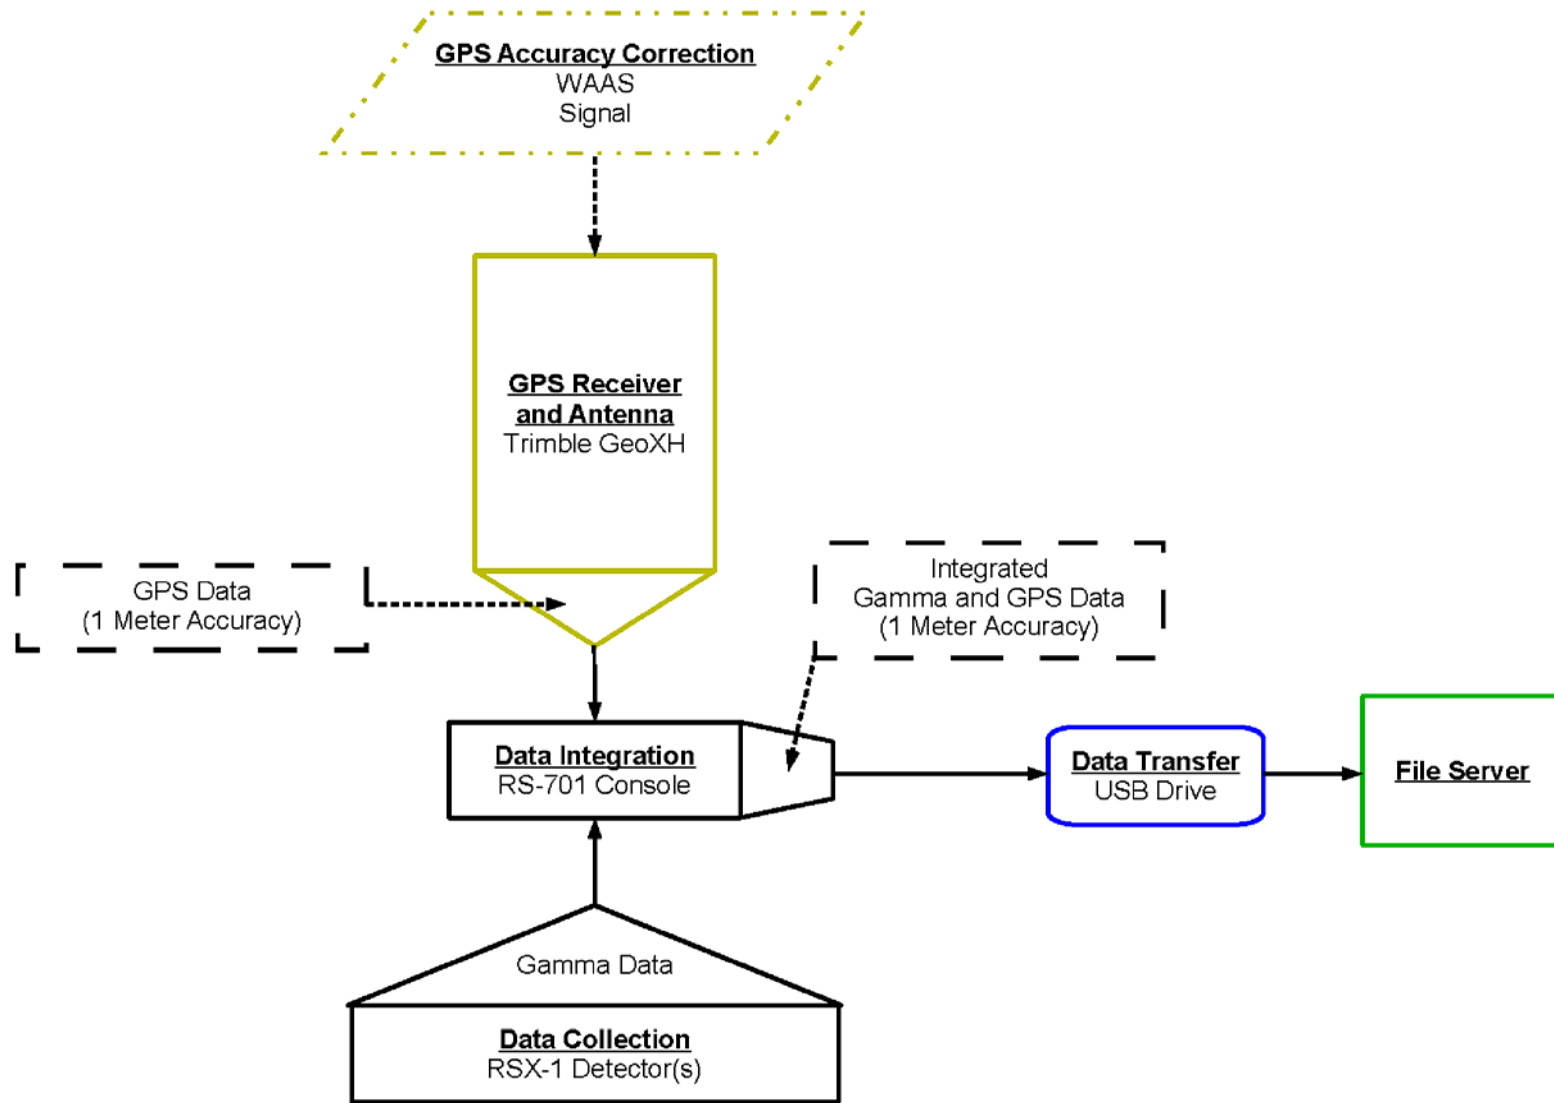
Initial WMGS/TMGS/STGS/MMGS Data Collection Schematic

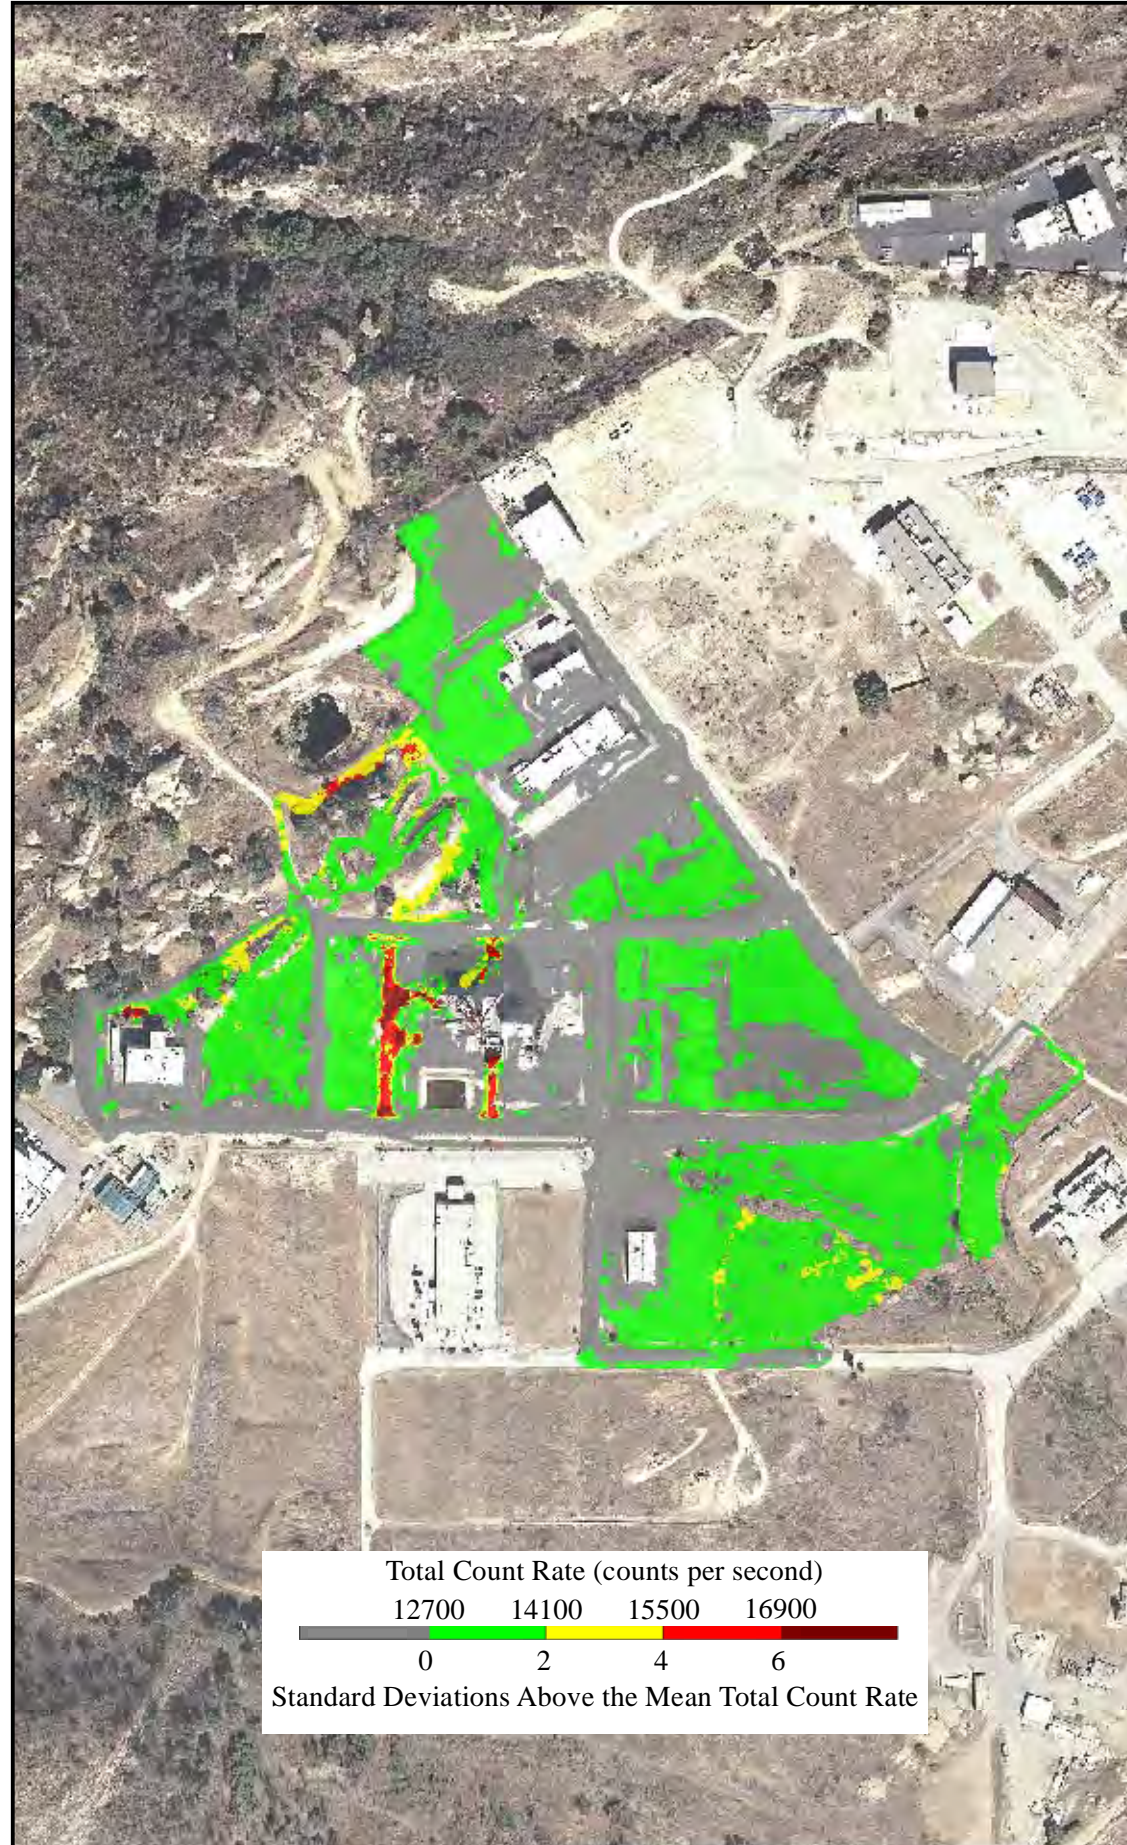
Lang Ranch RBRA Background Applied

Subarea 5C Background Applied

Figure 9.1
Comparison of Subarea 5C
Scanning Results with Lang Ranch
and Subarea 5C Backgrounds
Santa Susana Field Laboratory
