Subject: EPA Radiological Study of the Santa Susana Field Laboratory Area IV and the Northern Buffer Zone; **Quarterly Biological Monitoring Report #6**

# QUARTERLY BIOLOGICAL MONITORING REPORT #6

## RADIOLOGICAL STUDY OF THE SANTA SUSANA FIELD LABORATORY AREA IV AND NORTHERN BUFFER ZONE

February 7, 2012

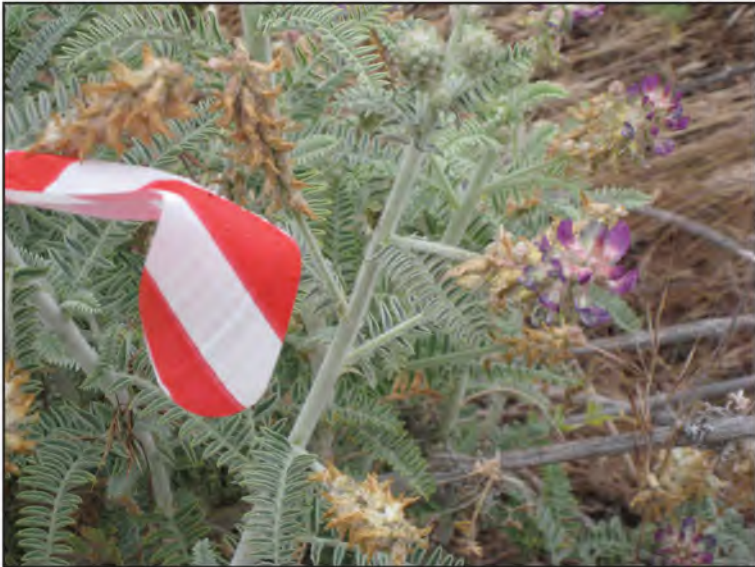
**Photo 1A** - Braunton's milkvetch flagged for identification.

During the monitoring period, project activities were conducted throughout a portion of the Designated Critical Habitat for Braunton's milkvetch in Subarea 5D South (SS-59). Activities within the milkvetch habitat consisted of vegetation clearance and gamma scanning involving the use of the TMGS. Vegetation clearance involved the use of a rotary mower attached to a skid steer tractor and weed whackers. These activities were monitored closely to avoid and reduce impacts to milkvetch plants, as documented in the Biological Monitoring Forms included in this report as Appendix 3. Monitoring activities included surveying the subareas where activities were to occur, and flagging individual plants or establishing a perimeter buffer area around groups of plants as shown in Appendix 1 (**Plate 1A**).

A total of three Braunton's milkvetch were impacted during the monitoring period. Impacts to individual Braunton's milkvetch are described in **Table 2**. These impacts were relatively minor, and did not result in the "take" of the plant. Stems of the three affected individuals were broken, but the plants were not uprooted or destroyed.

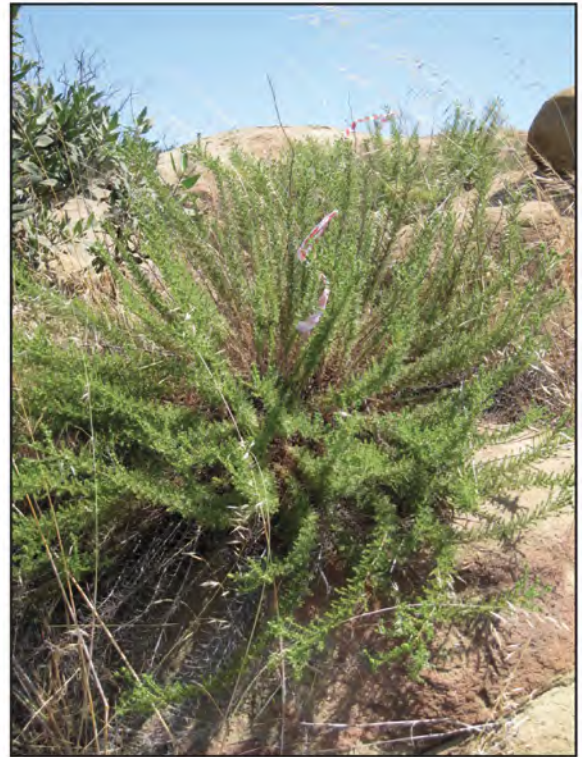
**Photo 1B** - Santa Susana tarplant flagged for identification.

This species is locally common in sections of Area IV with sandstone outcrops. These plants were flagged for identification during activities occurring within their vicinity (**Plate 1B**). No plants were impacted by project activities during the sixth quarterly monitoring period (**Table 4**).

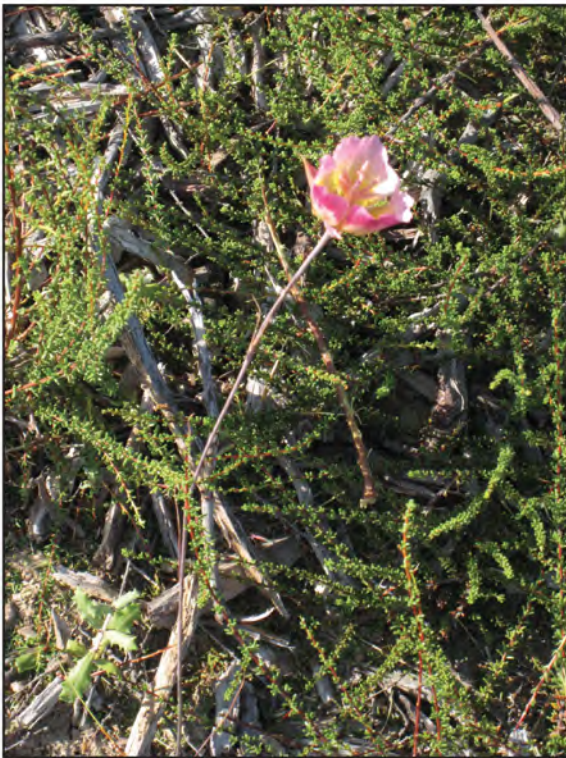
**Photo 1C** - Plummer's Mariposa Lily.

This species is found in suitable habitat throughout the project area. It was observed during project activities in 5D South, 7, NBZ-W, and NBZ-E (**Plate 1C**). One individual was severed at its base during vegetation cutting in Subarea 5D South (SS-59). All other specimens observed were protected from project activities.

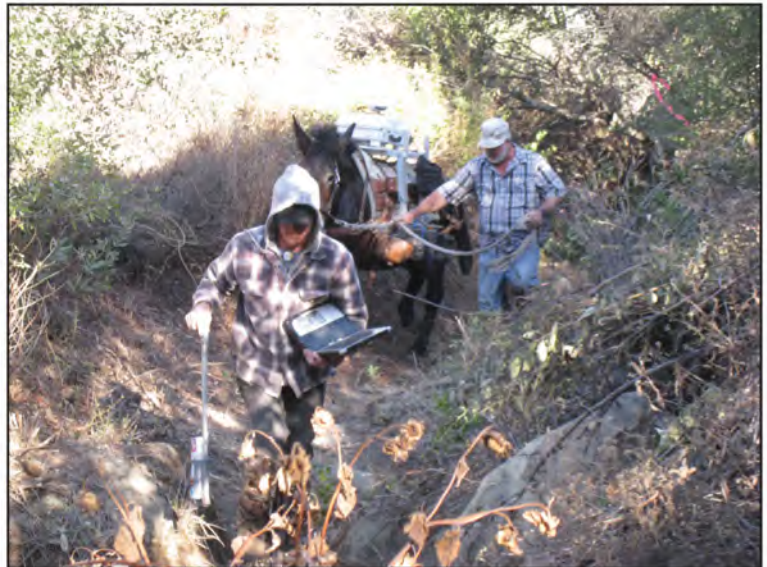
**Photo 1D** - Gamma scanning in a riparian zone by MMGS.

Riparian habitat areas were noted in monitoring areas of subarea NBZ-W (SS-P1A, SS-P1B, SS-P1C) as well as subarea NBZ-E (P1J, and SS-P2R), 5B (SS-1), and 7 (SS-39). These areas are ephemeral drainages. Recommendations were given to limit vegetation clearance and the use of the skid steer in these areas. Gamma scanning activities in these areas was performed by TMGS or MMGS (**Plate 1D**). **Table 6** summarizes activities within the riparian habitat areas that occurred during the sixth quarterly reporting period.
