# AERIAL PHOTOGRAPHIC ANALYSIS OF SANTA SUSANA FIELD LABORATORY - AREA IV

## Ventura County, California

EPA Region 9

TS-PIC-20909963S/21009965S  
March 2010

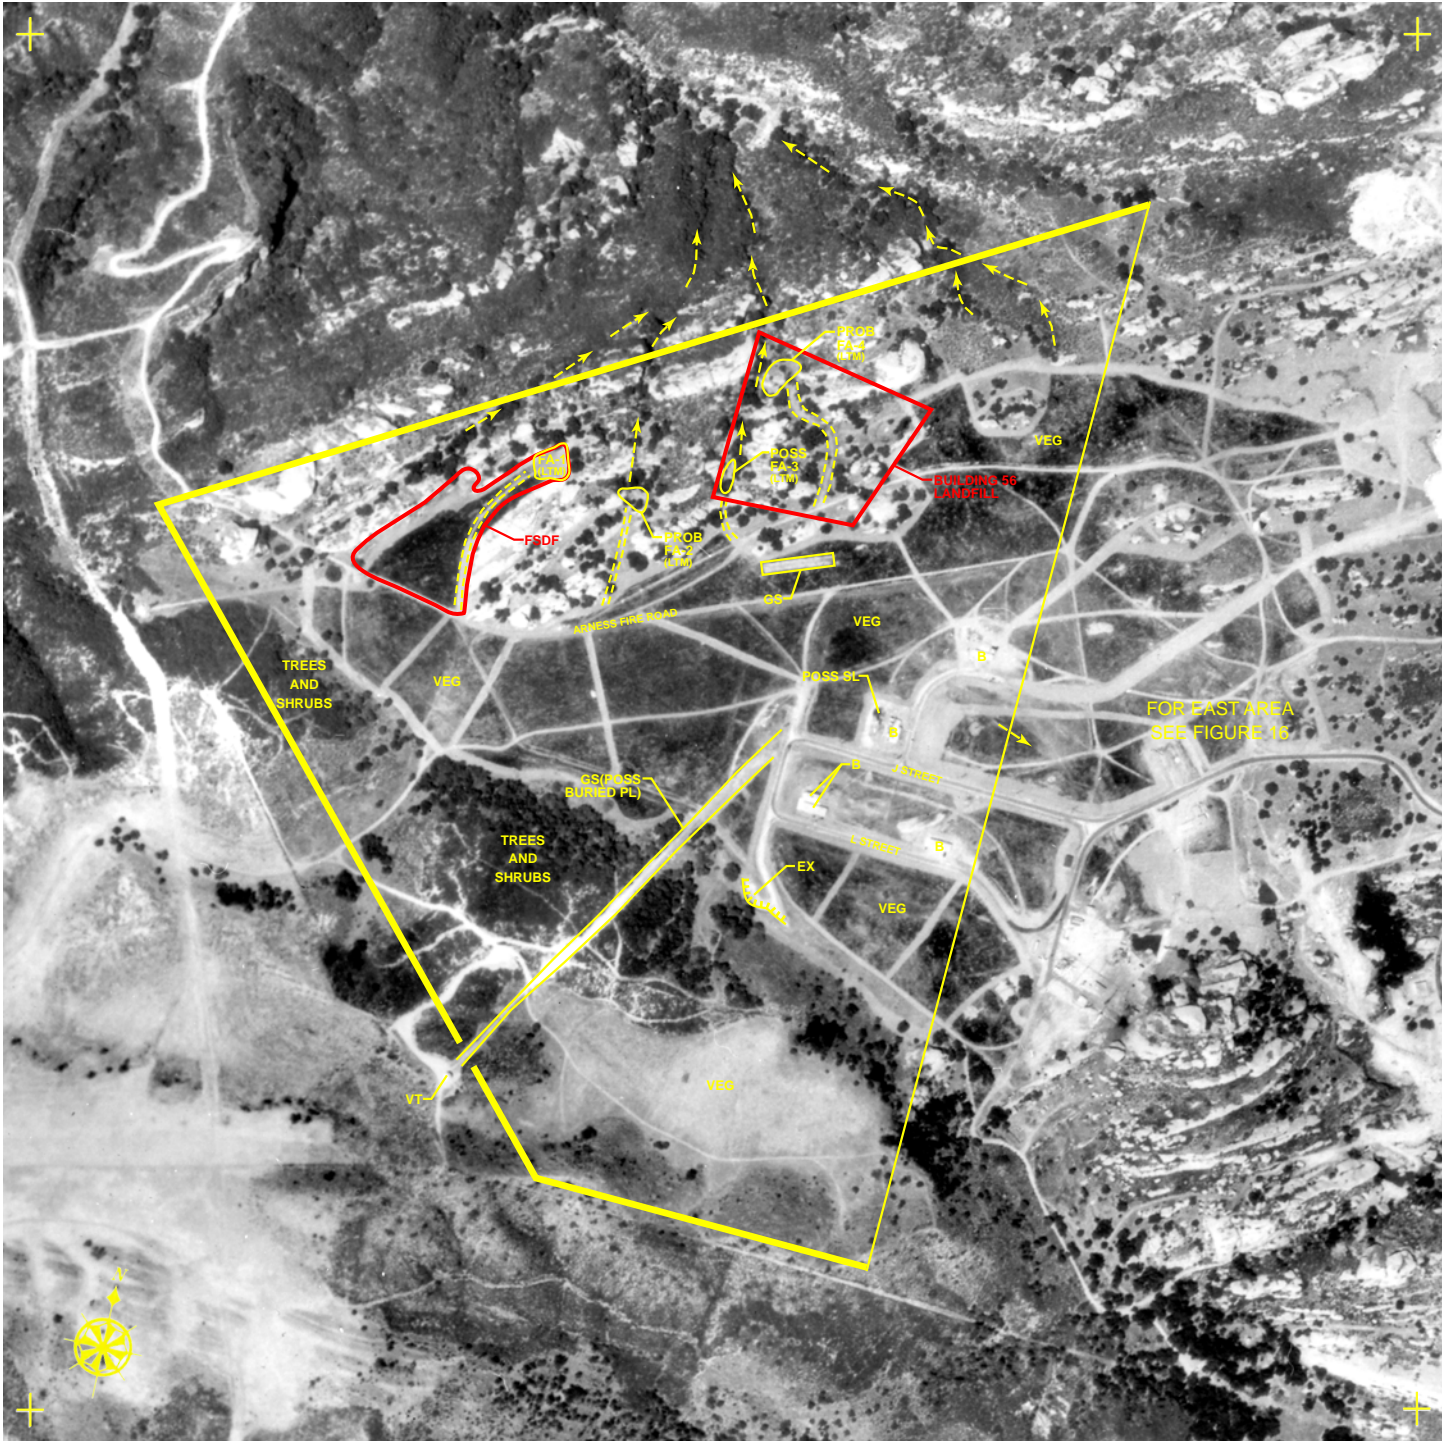
FIGURE 4. SANTA SUSANA FIELD LABORATORY - AREA IV, WEST SECTION, AUGUST 19, 1957.  
 APPROXIMATE SCALE 1:3,750.

SWMU 7.1 - Building 56 Landfill is located at the terminus of access roads extending from unnamed roads and F Street in the northern part of the Santa Susana Field Laboratory-Area IV. This area was active in 1957 (Figure 4). Fill areas FA-3, FA-4 and FA-9, and waste disposal area WDA-3 were located on the Building 56 Landfill. In addition, in 1965 an excavation area (EX) was noted, and by 1967 the excavation pit was filled with liquid. Liquid was in this excavation through the remainder of the analysis.

FA-3: FA-3 is located at the head of a drainage ravine. An access road extends north from Arness Fire Road and terminates at this fill area. The deposition of light-toned material (LTM) occurred at this location before 1957 (Figure 4) and ended by 1967. In 1959 partial vegetation was observed on the surface of the fill area. No evidence of fill activity was observed in 1962/63, but by 1965 light-toned material had again been deposited near the head of the drainage ravine. This deposited material may have come from a nearby excavation area. Deposition slowed or ceased by 1967, and ground scars (GS) and scattered vegetation were observed. By 1972 this fill area was partially vegetated (PV) and approximately ten light-toned objects were observed. From 1978 through 2005, this fill area remained vegetated and there were no signs of disturbance.

SWMU 7.3 - Former Sodium Disposal Facility is located in the far western part of the Santa Susana Field Laboratory-Area IV, north of Arness Fire Road. This area was active by 1957 (Figure 4) and fill area FA-1 was in place. Waste disposal area WDA-1; impoundments IM-2, IM-3, and IM-7; and fill area FA-1 are located on the Former Sodium Disposal Facility. In addition, trenches (TR), stains (ST), and dark-toned material (DTM) were also visible on the Former Sodium Disposal Facility.

WDA-1: By 1959 (Figure 4) light-toned solid waste material had been deposited on WDA-1. In 1962/63 only a ground scar and probable disposal activity were visible within a trench at this location. By 1965 the trench had been filled. A possible trench extending to the north, which terminated near a rock outcrop, was seen nearby. By 1967 the possible trench was no longer observed and may have been filled. In 1978 two possible derelict (DER) storage tanks were seen near a rock outcrop. Also in 1978, a possible burn area and disturbed ground (DG) were visible on and along the western containment berm (not annotated) of impoundment IM-3. This area was stained in 1980 and possible stains were noted in 1983.

FA-1: By 1957 (Figure 4) light-toned material had been deposited at this fill area, which is located between rock outcrops at the terminus of an access road. By 1959 deposition activity appeared to have ceased. Parts of the surface were graded (GR) and supported possible vegetation (not annotated). In 1962/62 approximately six light-toned objects (LT OBJ), approximately one-fourth the size of an automobile, and a rectangular-shaped graded area were noted. In 1965 light-toned material and vegetation were noted, and by 1972 the fill area was partially vegetated. In 1978 stains were present and immediately northwest of the fill area was a possible pit. The surface of this fill area remained disturbed through at least 1983. Ground scars and vegetation were noted through 1988. By 1995 the fill area was mostly vegetated. In 2002\* through 2005 this fill area was covered with a dark-toned material.

PA-5: This processing area is located between J and L streets. Buildings were visible at this location as early as 1957 (Figure 4), but environmentally significant activity was not observed until 1978. During the years of operation, probable storage tanks, stains, and probable overhead pipelines were observed. This processing area remained active through the early 1990s, after which, it appeared to be abandoned. By 2003\* all structures related to this processing area had been removed from this location.

FA-2: FA-2 is located at the head of a drainage ravine. An access road extends north from Arness Fire Road and terminates at this probable fill area. The deposition of light-toned material was initiated on FA-2 by 1957 (Figure 4) and terminated prior to 1962/63, when medium-toned material and ground scars were visible. By 1965 the fill area and the mound of material had become partially vegetated. Ground scars and scattered vegetation were noted in 1967 and the mound had been removed. From 1972 through 1987\*, the fill area was vegetated and there were no signs of disturbance, but in 1988, possible disturbed ground was noted. From 1990\* through 2005, this fill area remained covered with vegetation and no activity of environmental significance was observed.

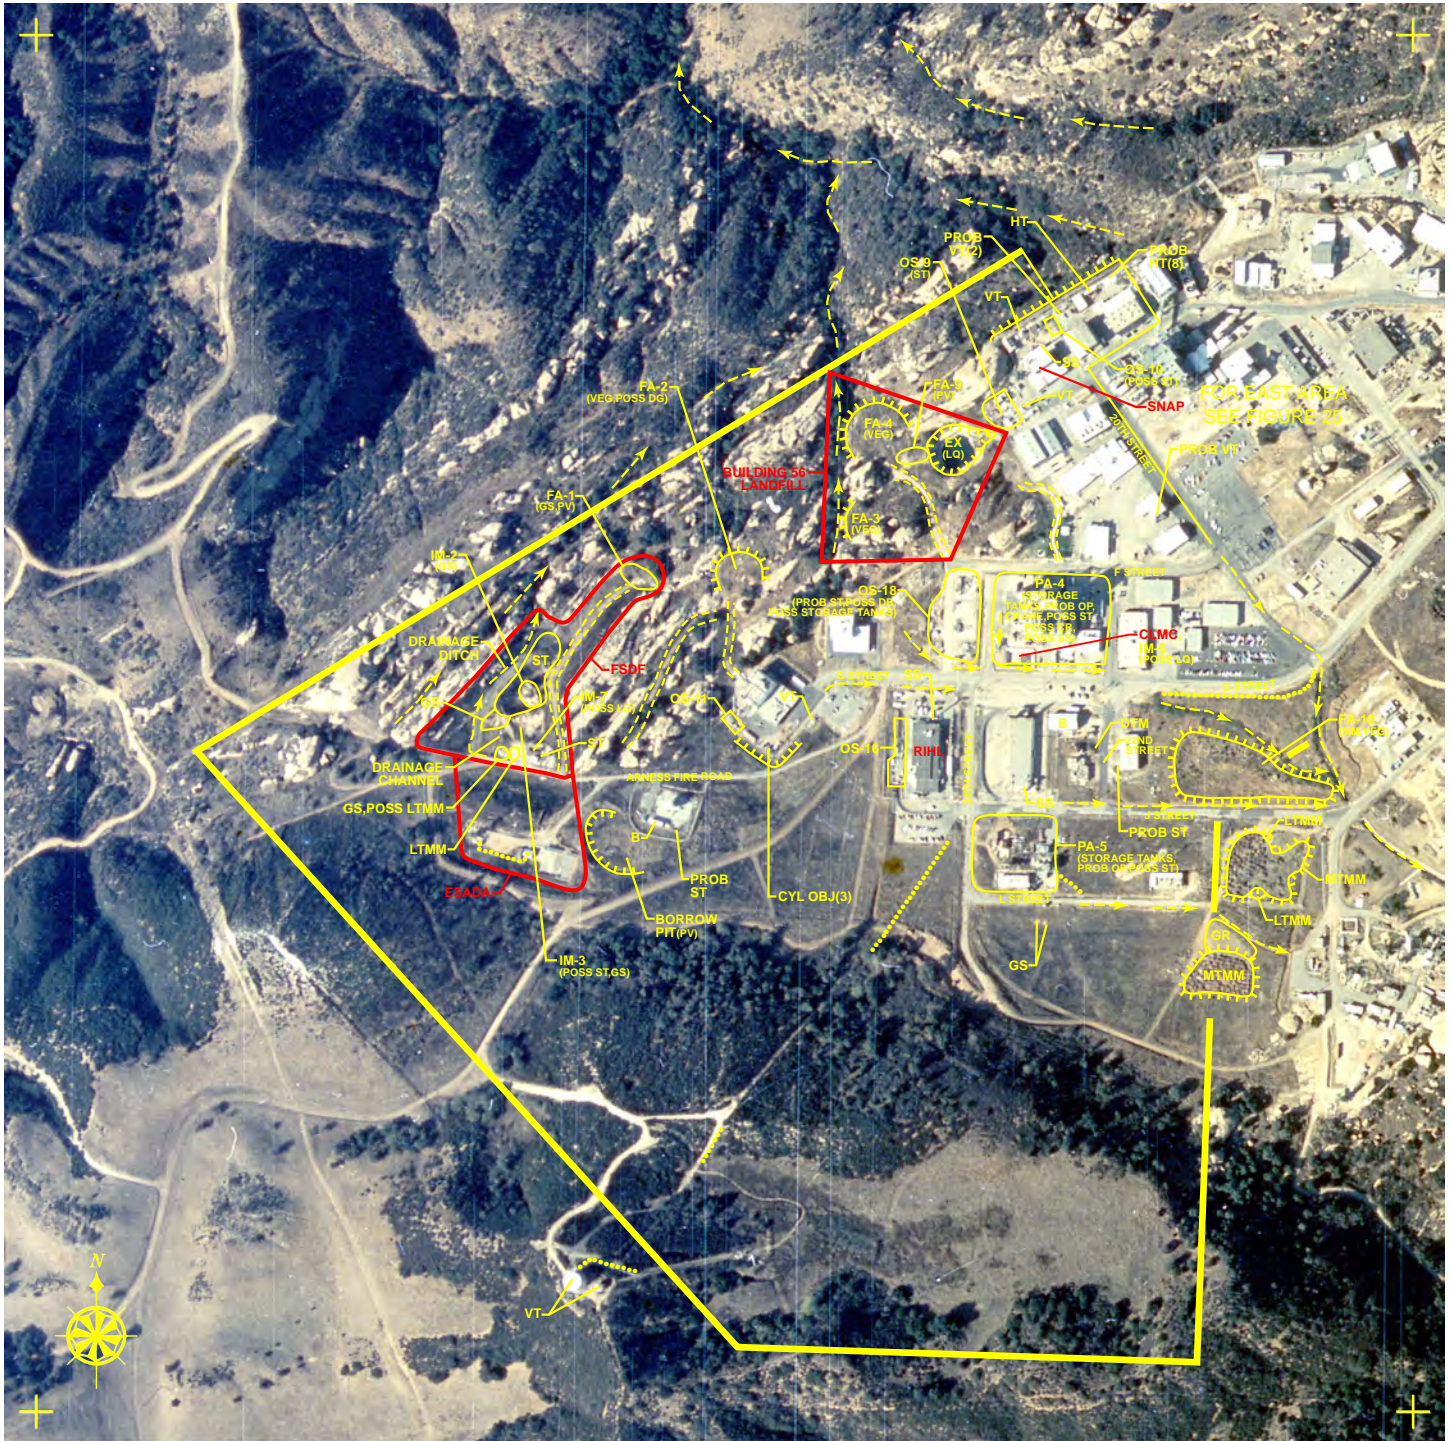
FIGURE 13. SANTA SUSANA FIELD LABORATORY - AREA IV, WEST SECTION, OCTOBER 10, 1988. APPROXIMATE SCALE 1:3,360.

OS-18: OS-18 is located just west of processing area PA-4. It was used to store material from 1986\* (Figure 13) to 1995. Probable stains, horizontal storage tanks, possible debris and ground scars could be seen until 1995.

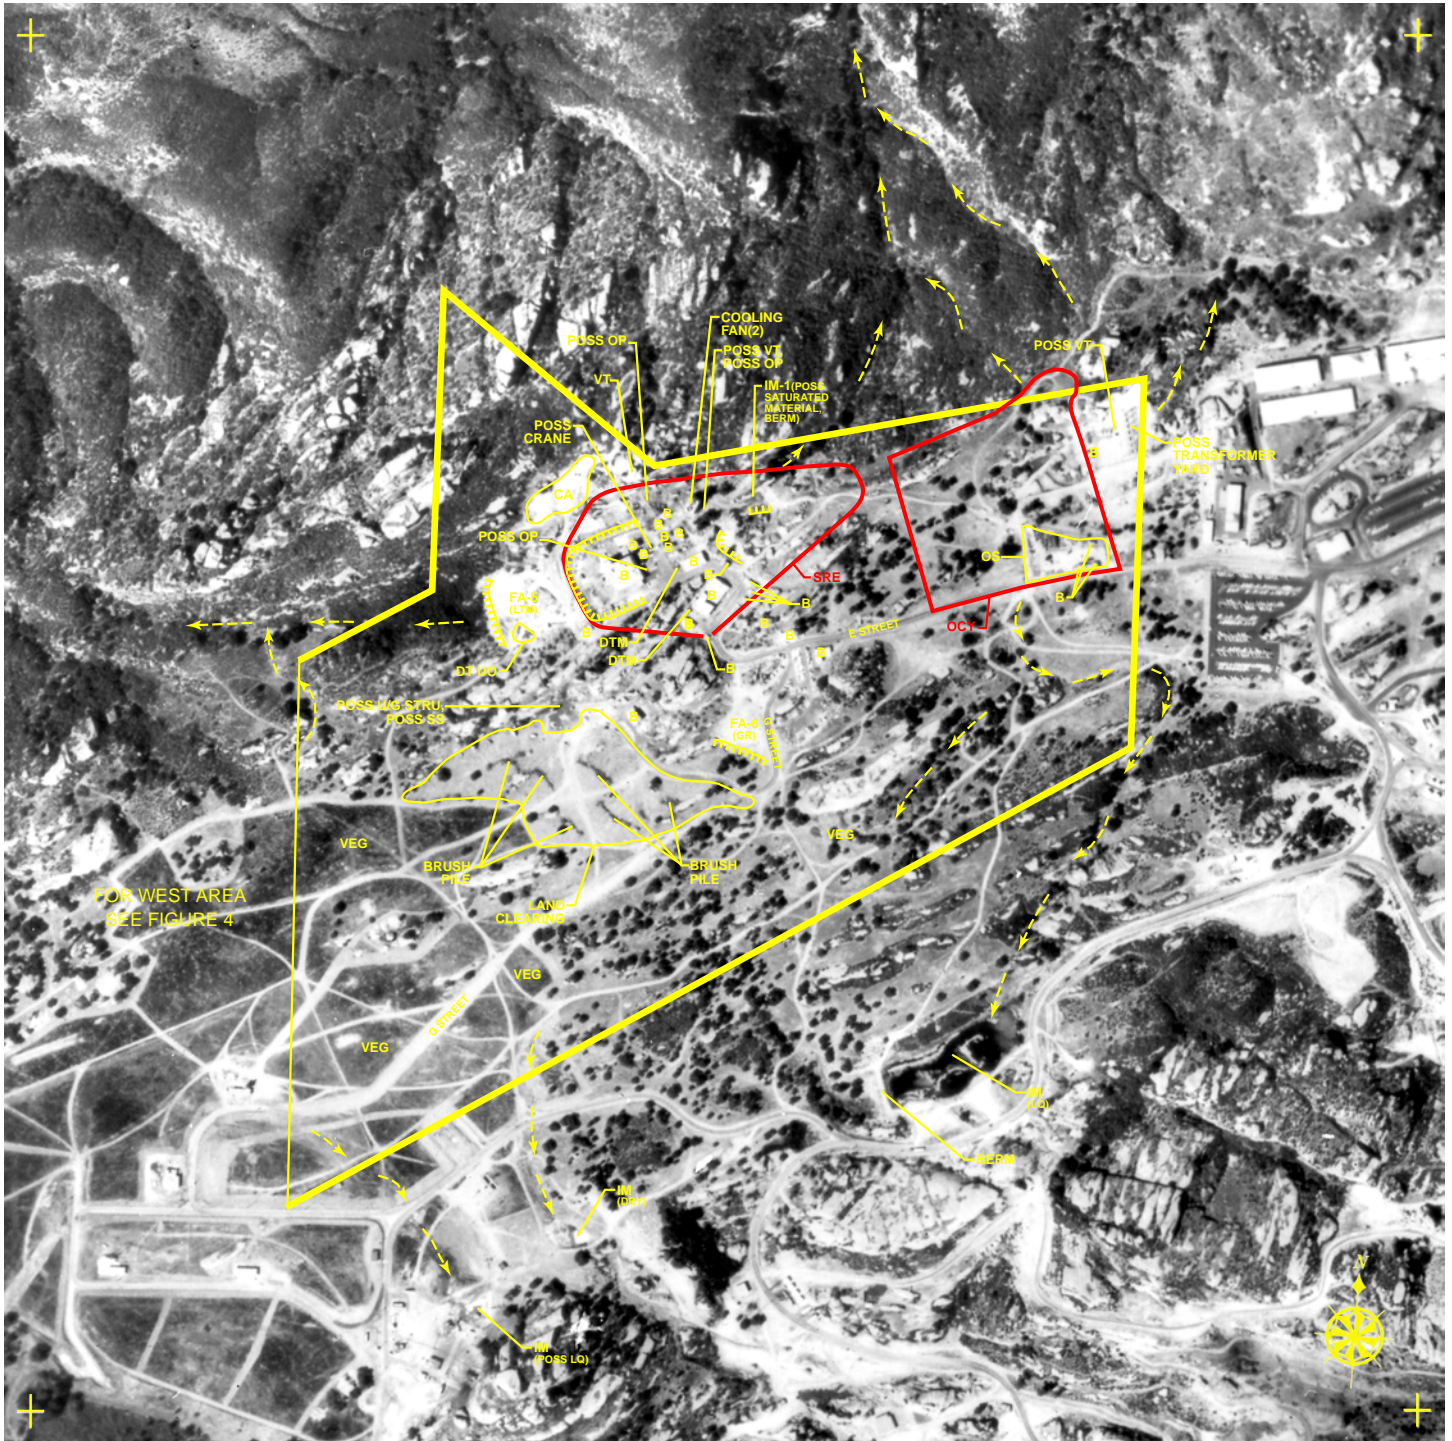
FIGURE 16. SANTA SUSANA FIELD LABORATORY - AREA IV, EAST SECTION, AUGUST 19, 1957.  
 APPROXIMATE SCALE 1:4,020.

OS-4: An open storage area was active at this location in 1957 (Figure 16), but no features of environmental significance were observed. In 1959 possible stains were noted at this open storage area. Materials were contained at this location until 1998\*. In 1959 through 1980, stains, probable stains, and possible stains were noted. Probable debris piles could be seen in 1983 but were removed prior to 1986\*. In 1988 a tanker, several transportation trailers (TT), and possible stains were observed. Only transportation trailers were noted by 1995. Refuse containers and stains were identified in 1998\* and were removed by 2002\*. After 2002\* ground scars and vegetation could be seen at this location.

PA-2: In 1957 (Figure 16) a collection of buildings was visible at this location. By 1967 a building with two cooling fans was removed. This processing area remained active through at least 1998\*. By 2002\* all structures had been removed. In 2002\* ground scars and vegetation were seen at this location. During the years this processing area was operating, storage tanks, aboveground pipelines, overhead pipelines, open storage areas, stains, light- and dark-toned material, and trailers were identified. Connected to this processing area were several aboveground pipelines. On the 1978 and February 1980\* photographs, an excavation area

IM-1: A drainage channel leads from processing area PA-1 to this impoundment located at the head of a drainage ravine. In 1957 (Figure 16) saturated material was seen in this impoundment. From 1959 through 1983 liquid or possible liquid was observed within this impoundment. By 1986\* the impoundment was dry. This impoundment supported vegetation through the remainder of the analysis period and was not utilized.

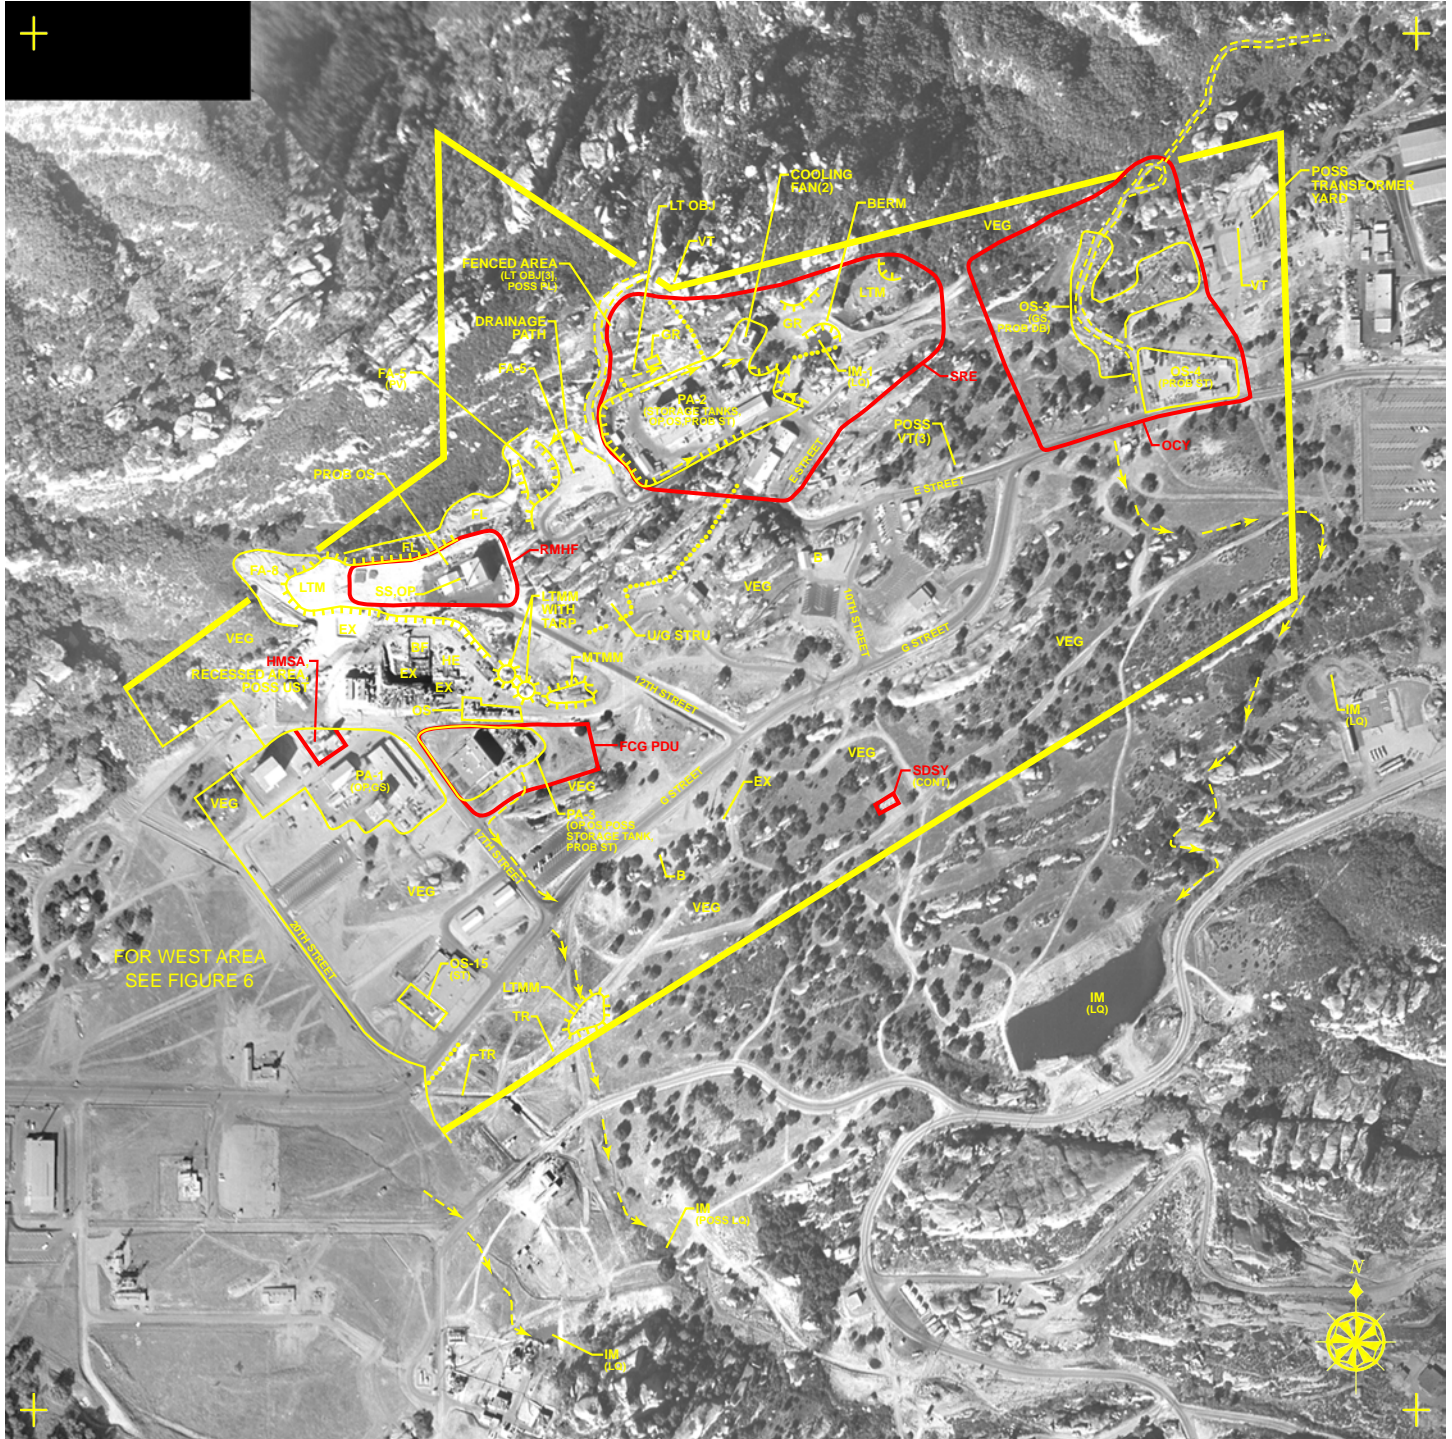
**FIGURE 18. SANTA SUSANA FIELD LABORATORY - AREA IV, EAST SECTION, 1962/1963. APPROXIMATE SCALE 1:3,380.**

OS-1: The open storage area was in use in 1962/63 (Figure 18), but no features of environmental significance were observed. In 1965 possible stains were noted at this open storage area. Material was contained at this location through the remainder of the analysis period. Possible stains, probable stains, and stains were identified through 1978. Also noted in 1978 were probable debris and a possible crane. From 1980 through 1987\*, no environmentally significant features or conditions were observed. In 1988 and 1990\*, stains and probable stains were again identified. After 1990\* no environmentally significant features or conditions were observed at this open storage area.

The AOC - SE Drum Storage Yard is located near the southern boundary of the Santa Susana Field Laboratory-Area IV. This open storage area was visible only on the 1962/63 photographs (Figure 18) and contained containers at that time. No features or conditions of environmental significance were observed at this location through the analysis period.

OS-15: OS-15 is located near the intersection of G and 20th streets. It contained material from 1962/63 (Figure 18), when stains were observed, to 1967. Probable and possible stains could be seen in 1967.

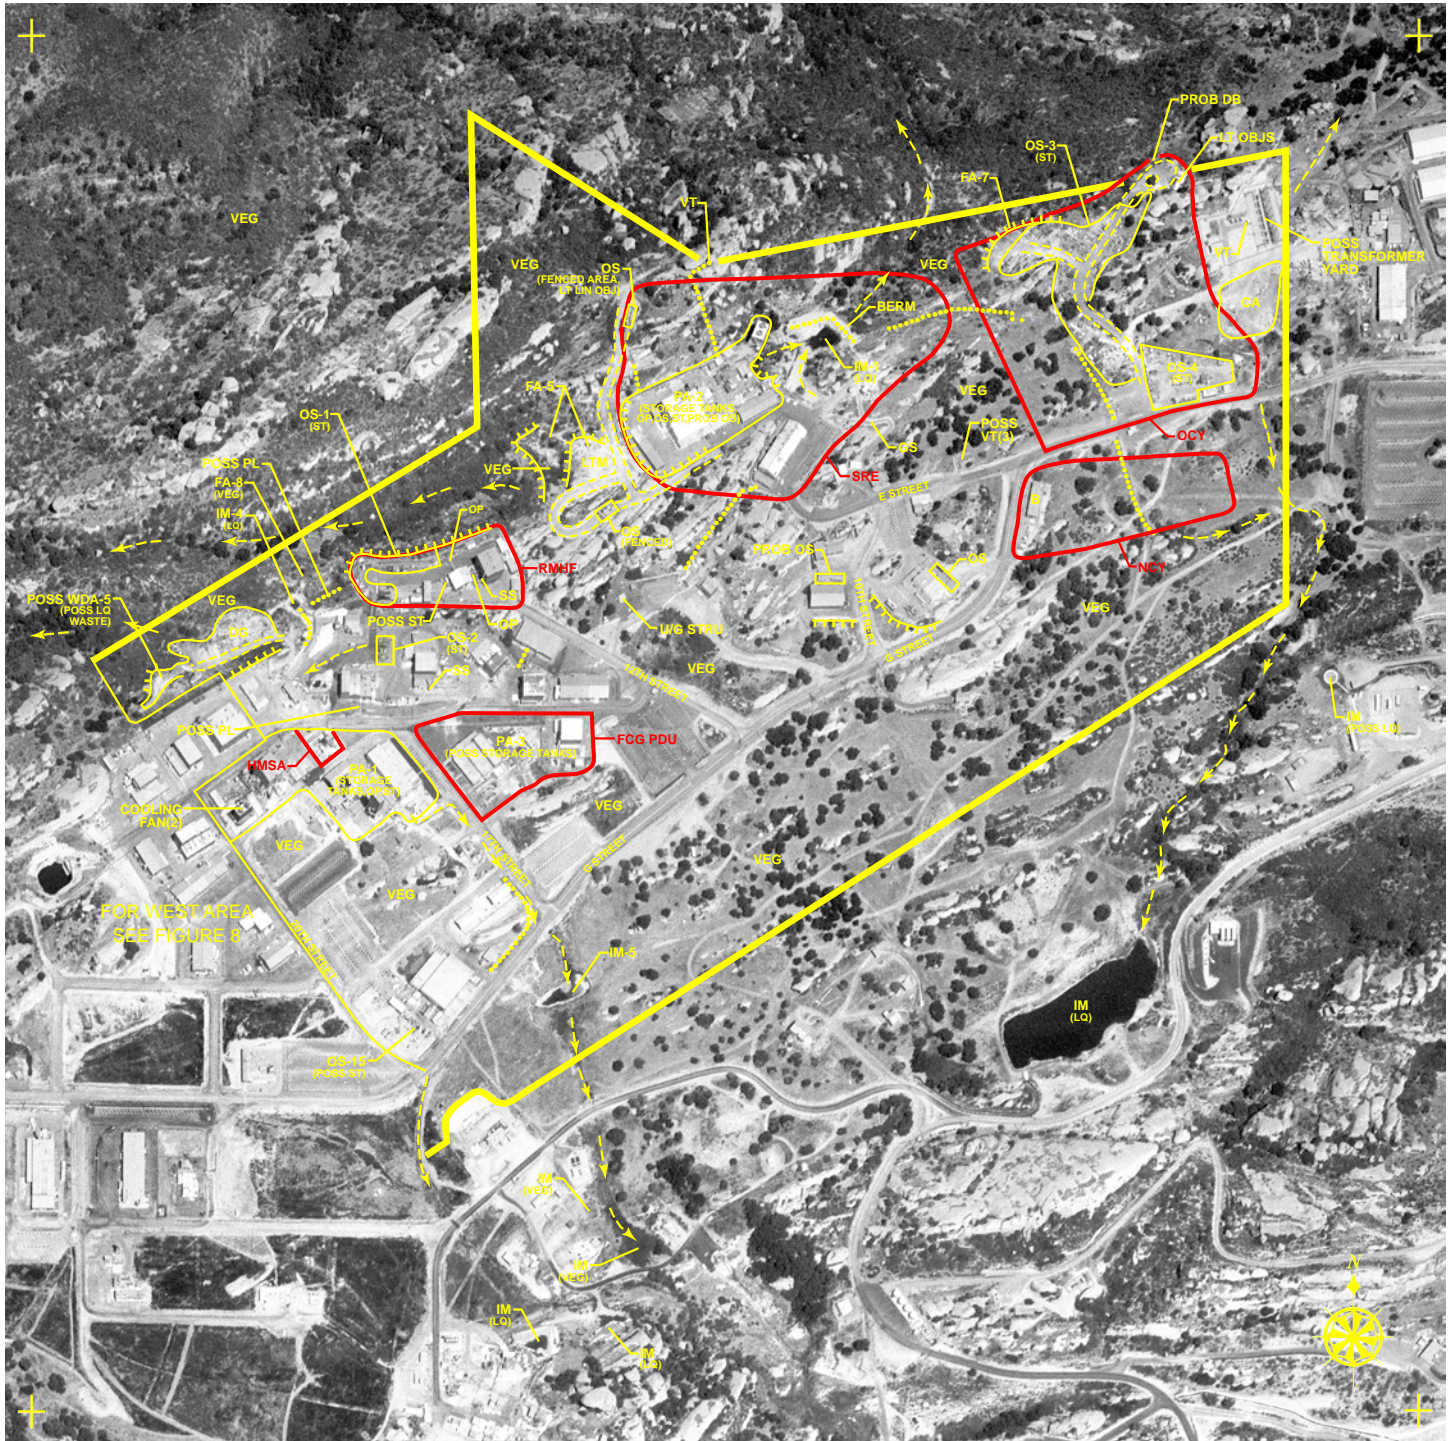
FIGURE 20. SANTA SUSANA FIELD LABORATORY - AREA IV, EAST SECTION, AUGUST 13, 1967. APPROXIMATE SCALE 1:3,350.

WDA-5: In 1967 (Figure 20) a possible waste disposal area was noted atop an area of disturbed ground to the northwest of processing area PA-1. In 1972 only a ground scar and partial vegetation were observed.

OS-2: OS-2 is located immediately south of the SWMU 7.6 - Radioactive Materials Handling Facility. This area was first noted in use in 1967 (Figure 20). Stains were identified on the 1967 photographs. From 1972 through 1990\*, this open storage area was infrequently used and no environmentally significant conditions or features were noted during this time period.

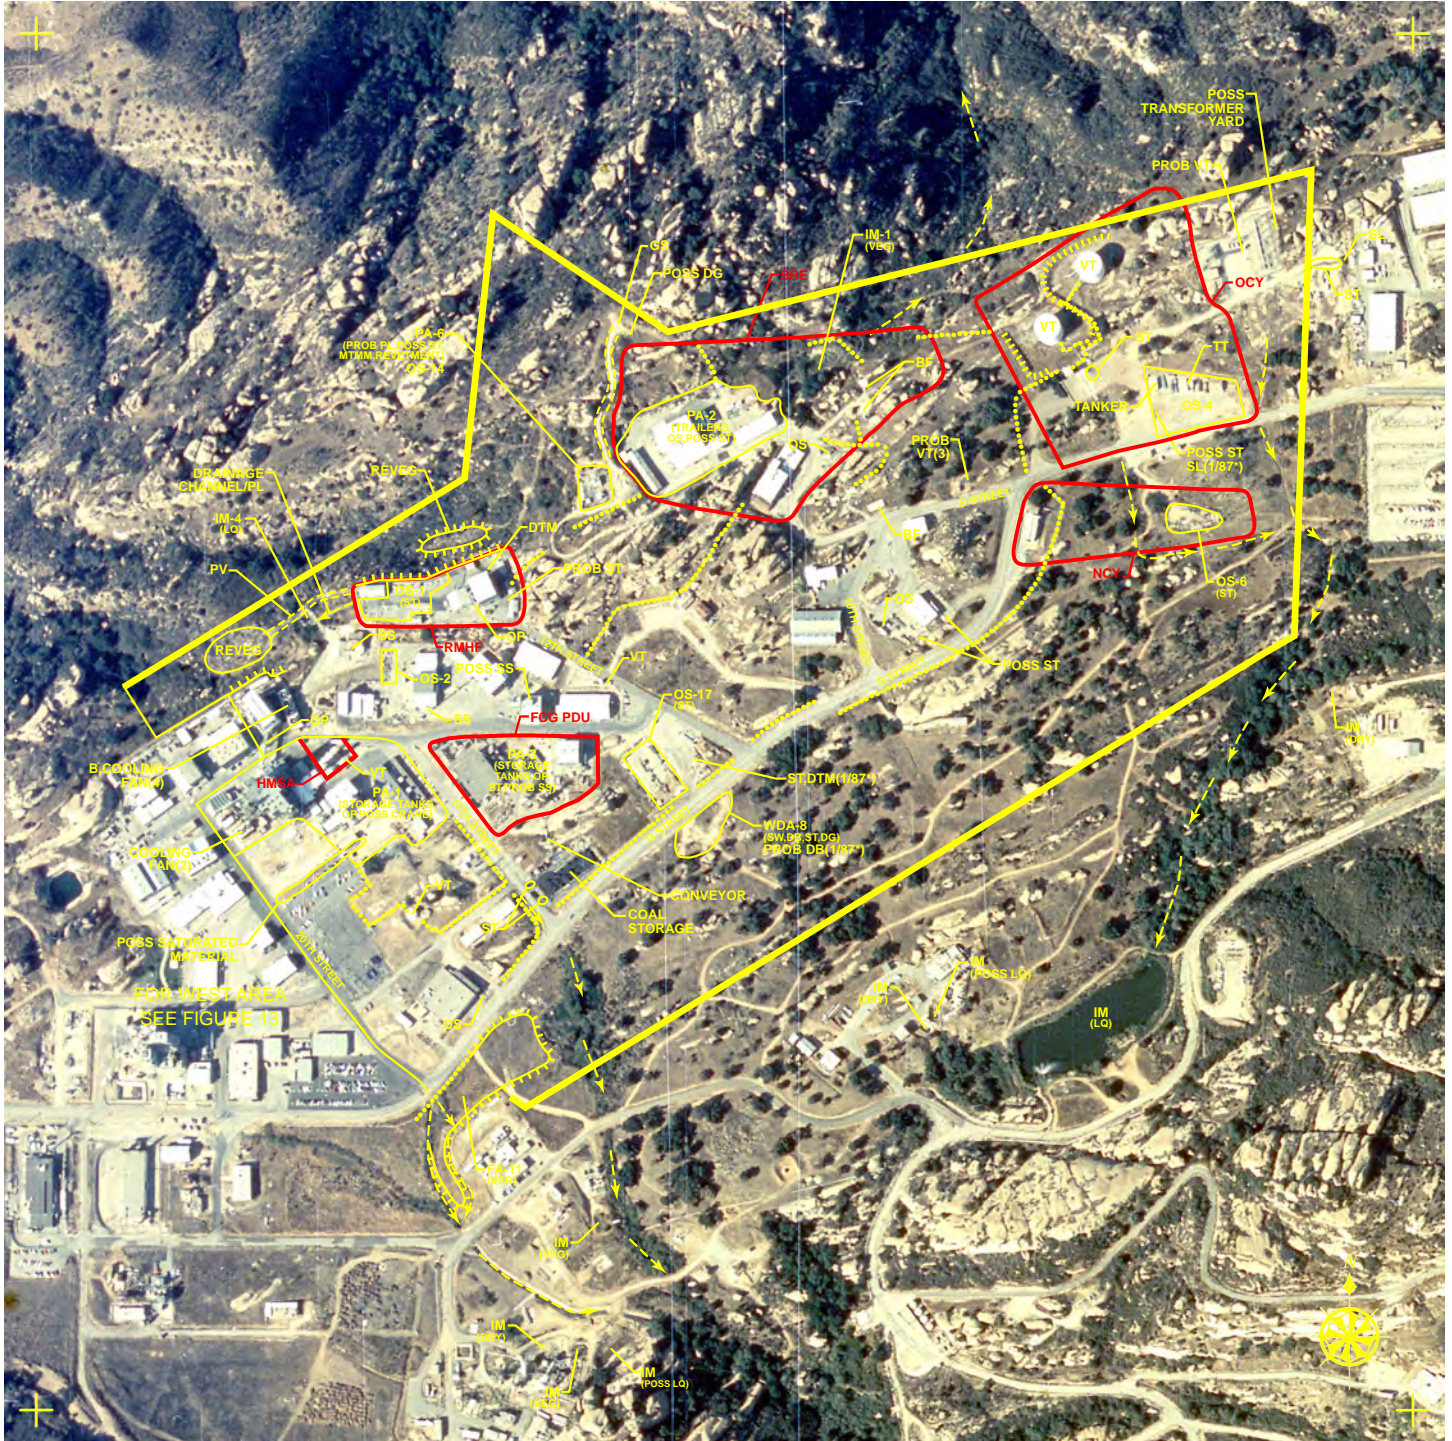
FIGURE 25. SANTA SUSANA FIELD LABORATORY - AREA IV, EAST SECTION, OCTOBER 10, 1988. APPROXIMATE SCALE 1:3,420.

WDA-8: In 1988 (Figure 25) this waste disposal area could be seen adjacent to the southern side of G Street. In 1988 solid waste, debris, stains, and disturbed ground were observed. Probable debris was noted at this location in 1987\* and in June 1990\*. No further activity was observed, and by 1995 this area was partially vegetated.
