**FINAL
TECHNICAL MEMORANDUM
SUBAREA HSA-5C
HISTORICAL SITE ASSESSMENT
SANTA SUSANA FIELD LABORATORY SITE
AREA IV RADIOLOGICAL STUDY
VENTURA COUNTY, CALIFORNIA**

**EPA Contract Number: EP-S7-05-05
Task Order Number: 0038**

**U.S. Environmental Protection Agency, Region 7
901 North 5th Street
Kansas City, KS 66101
and
U.S. Environmental Protection Agency, Region 9
75 Hawthorne Street
San Francisco, CA 94105**

October 2012

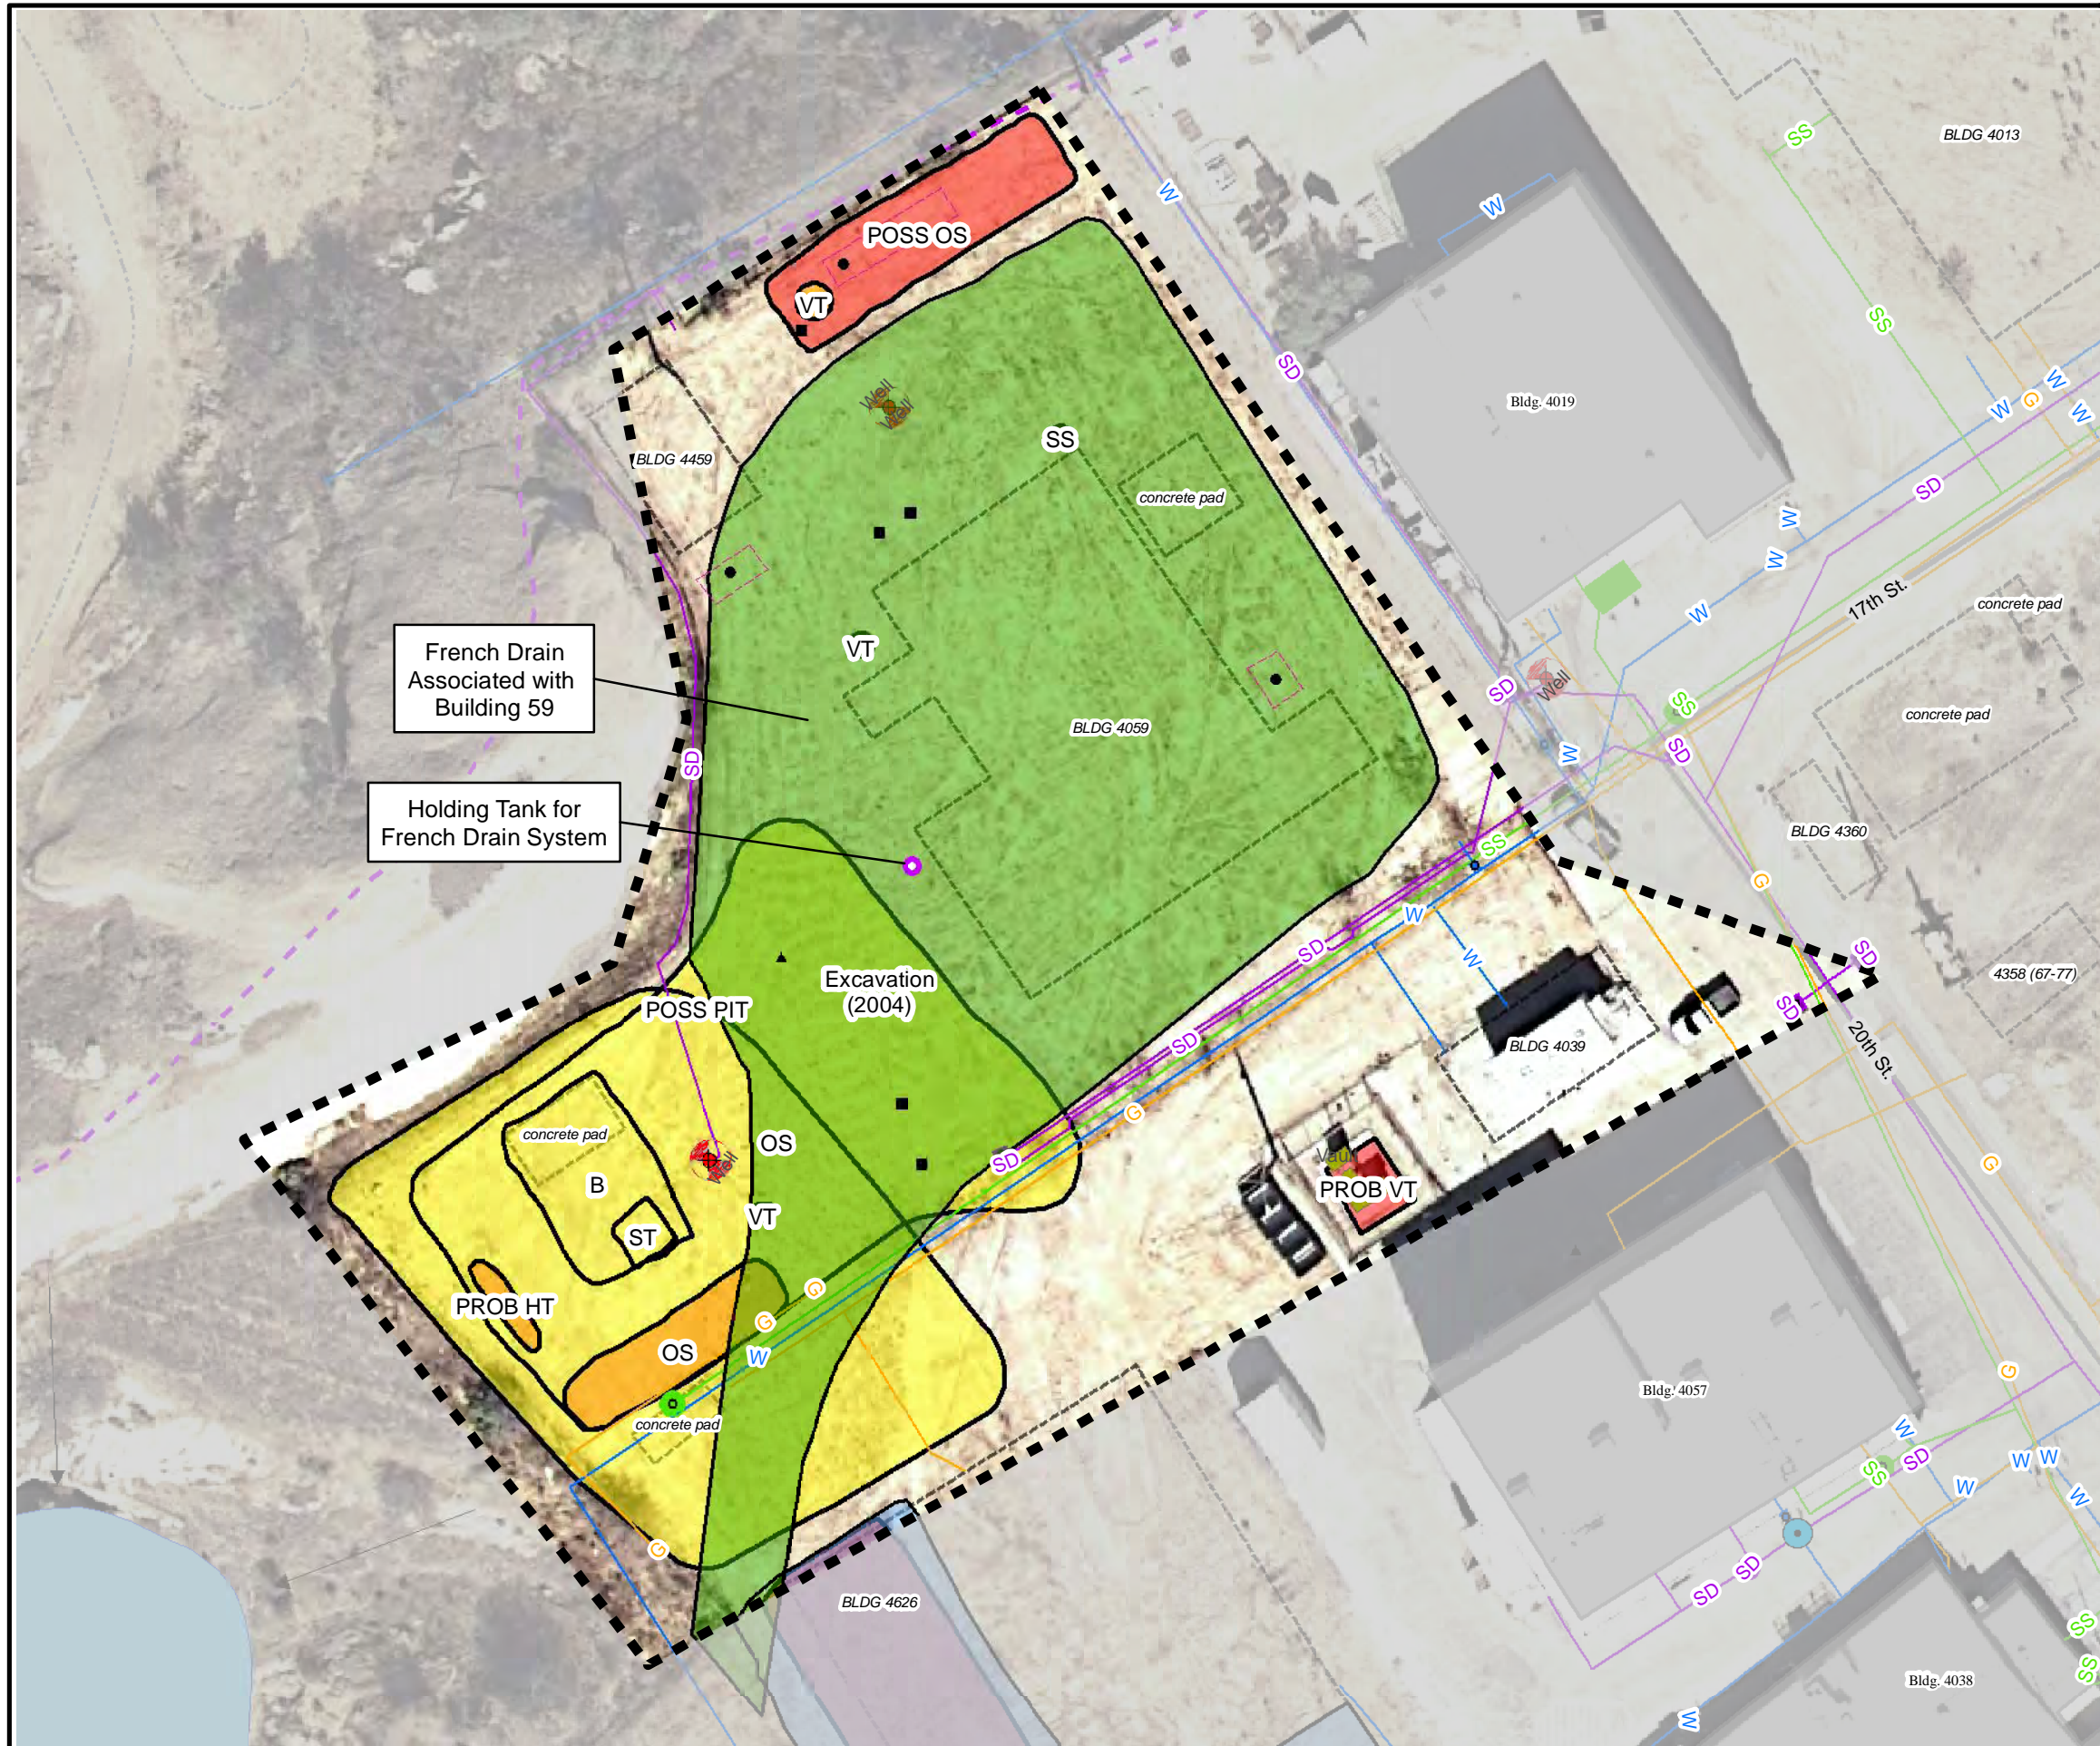
Figure 2.1
Area IV Subarea 5C-1
Santa Susana Field Laboratory

French Drain
Associated with
Building 59

Holding Tank for
French Drain System

Plate 1 and Figure 2.1 provide a convenient reference for the following recommendations.

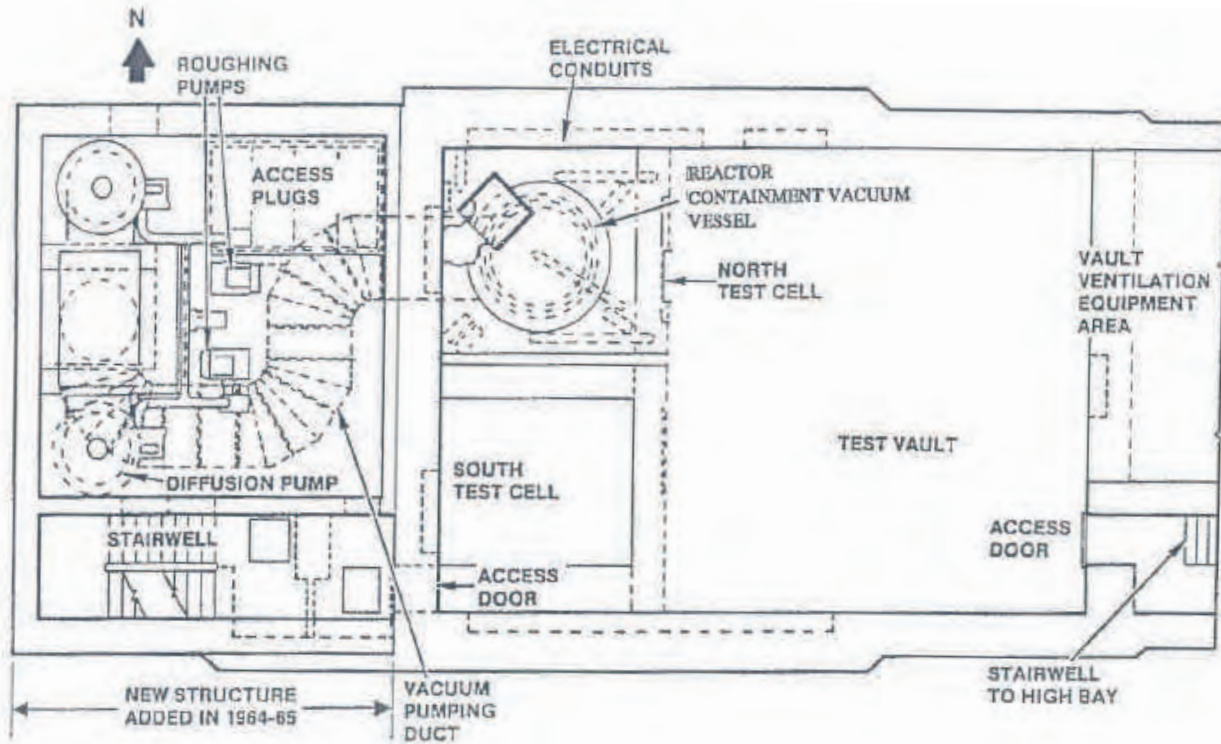
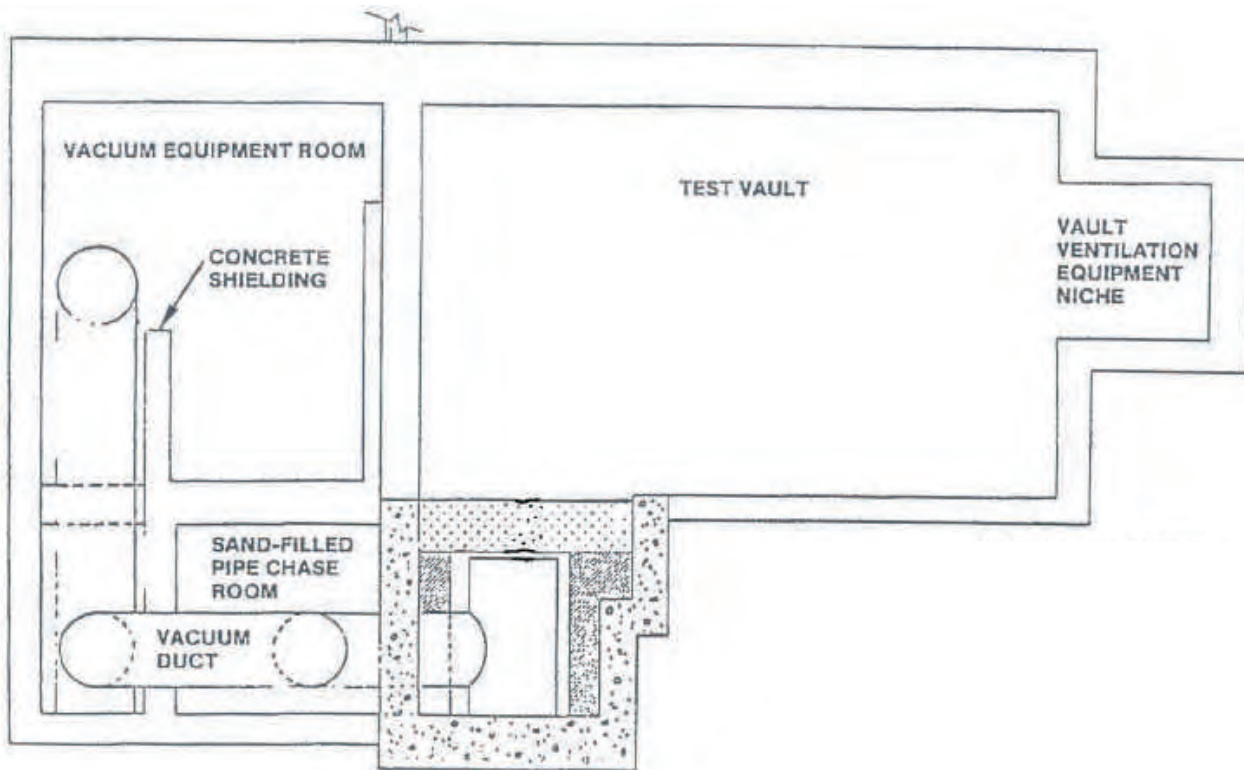
Figure 2.1.2b
 Building 4059
 Floor Plan

Plan View

Elevation View

- ORDINARY CONCRETE
 $\rho = 2.3 \text{ g/cm}^3$
- ORDINARY CONCRETE
1% BORON
- HIGH DENSITY CONCRETE
 $\rho = 3.2 \text{ g/cm}^3$ 0.25% BORON
- HIGH DENSITY CONCRETE
0.5% BORON

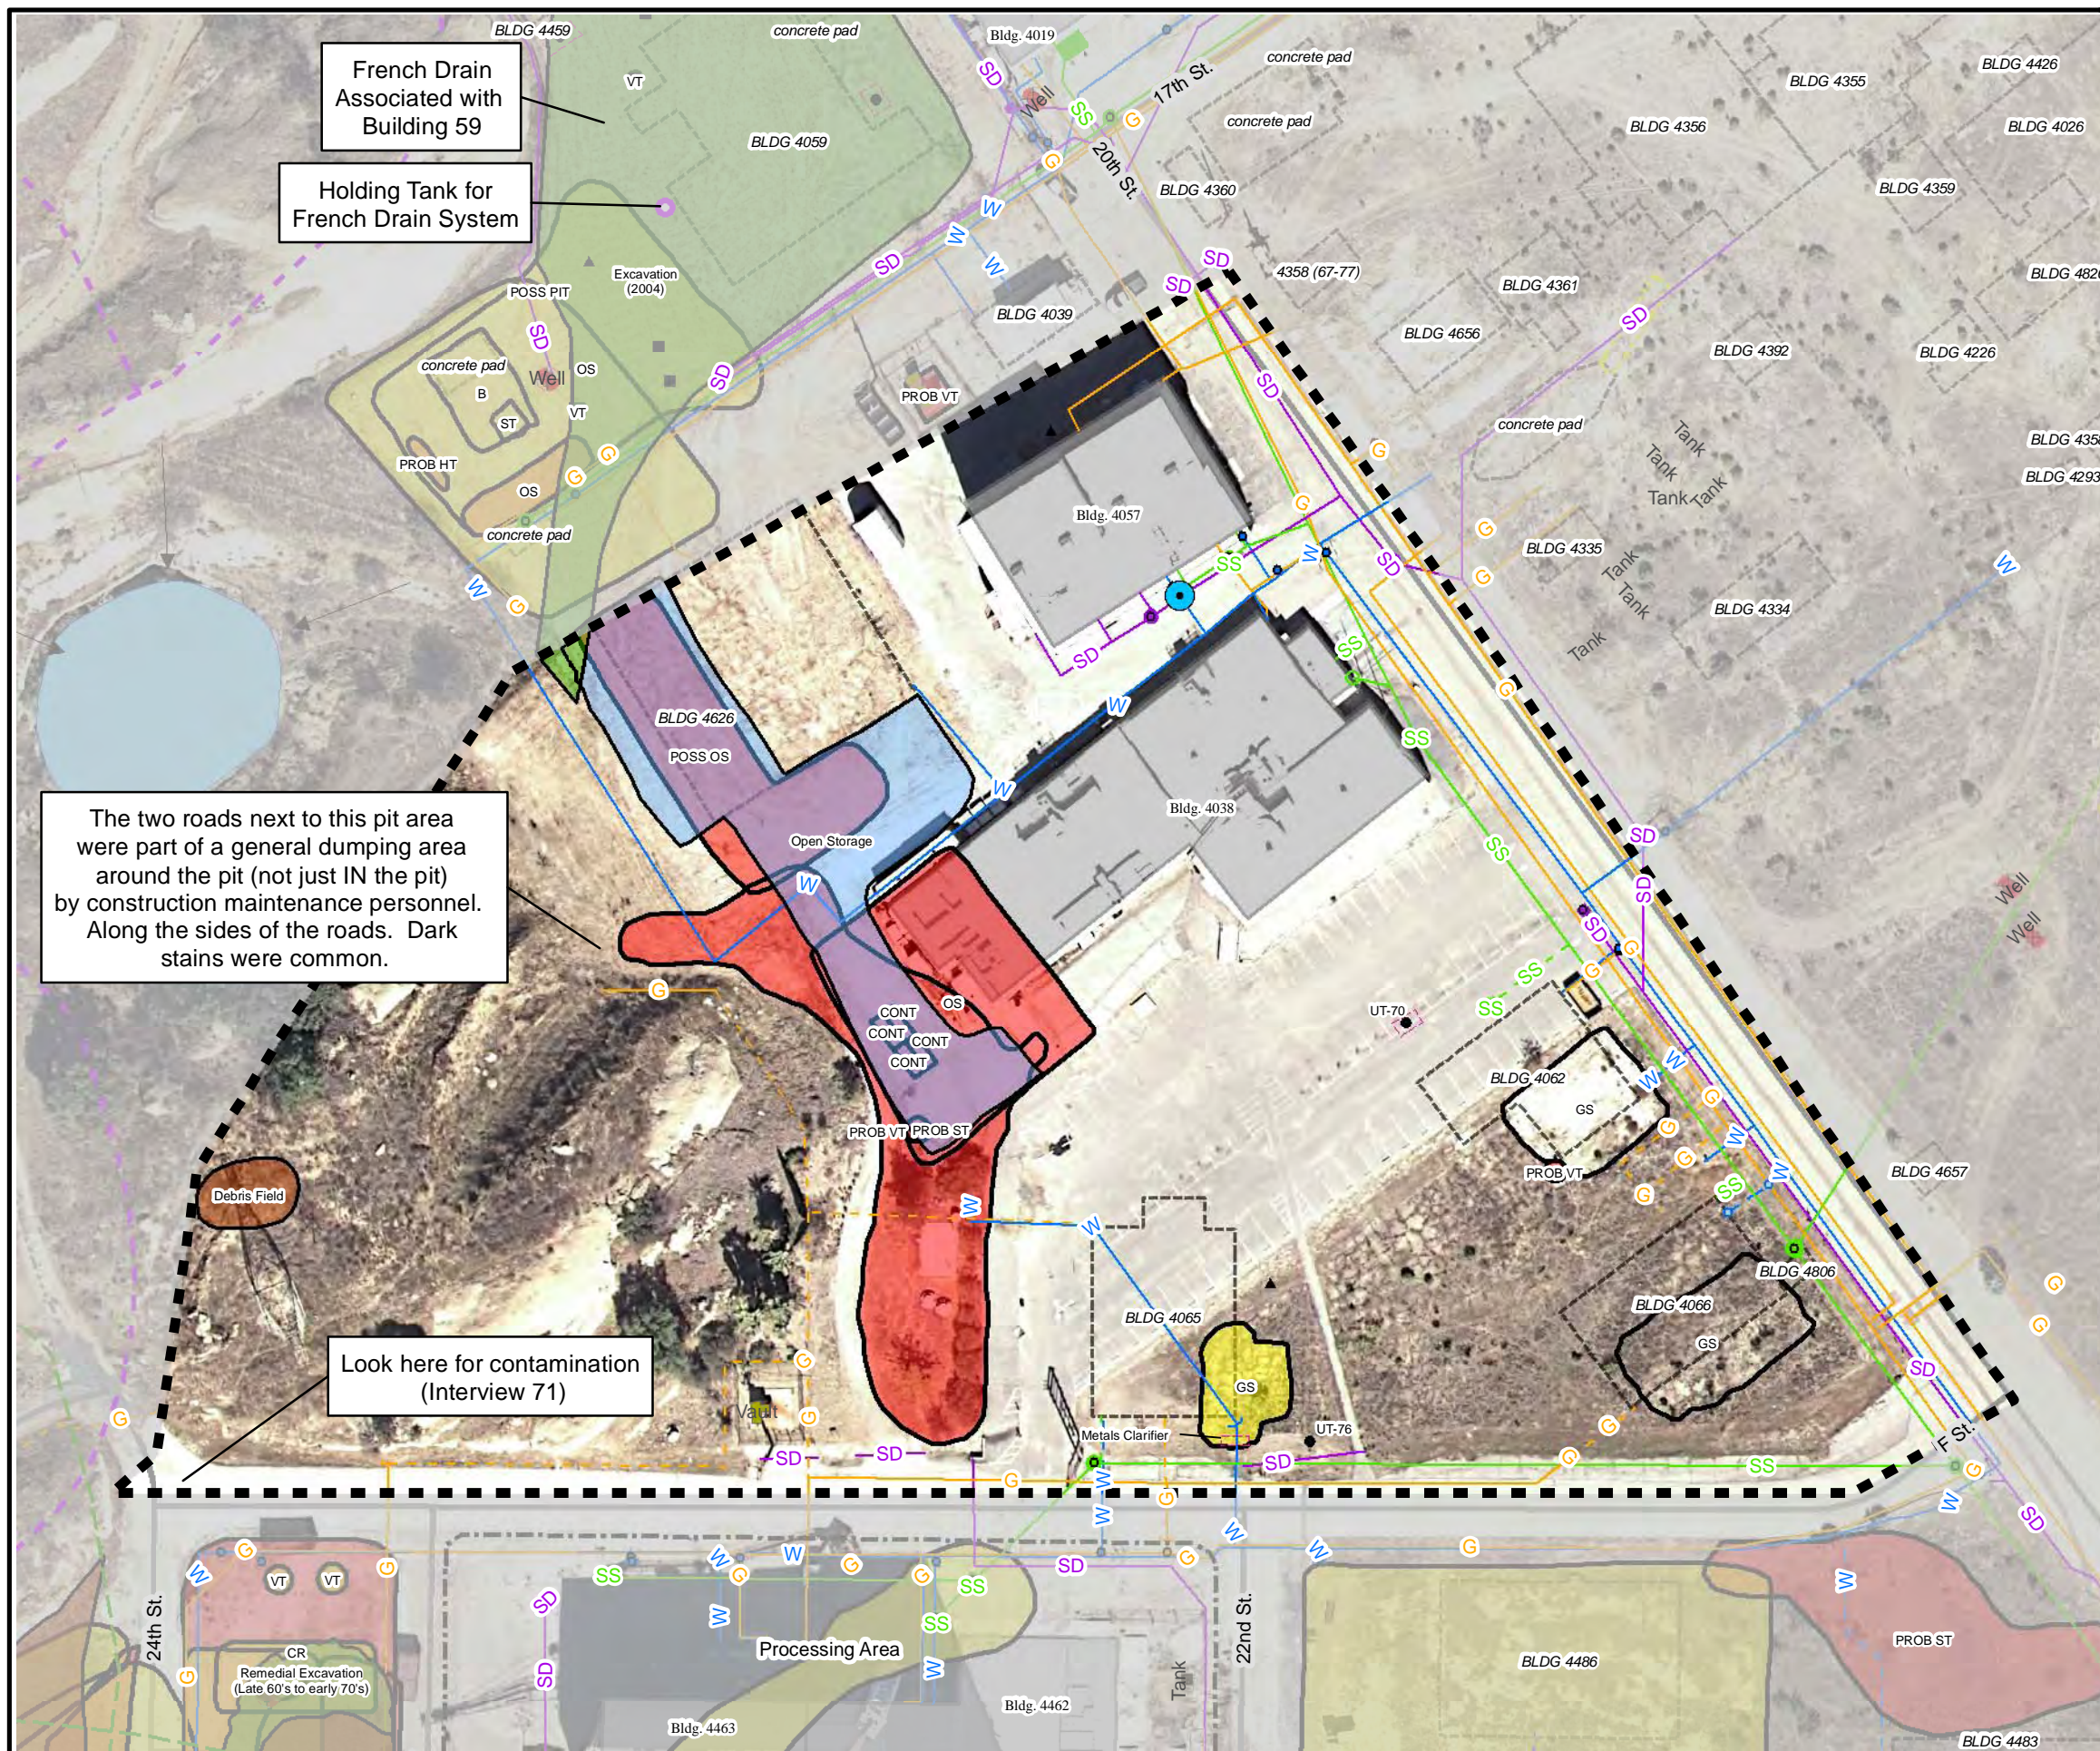
Figure 2.2
Area IV Subarea 5C-2
Santa Susana Field Laboratory

The two roads next to this pit area were part of a general dumping area around the pit (not just IN the pit) by construction maintenance personnel. Along the sides of the roads. Dark stains were common.

Look here for contamination (Interview 71)

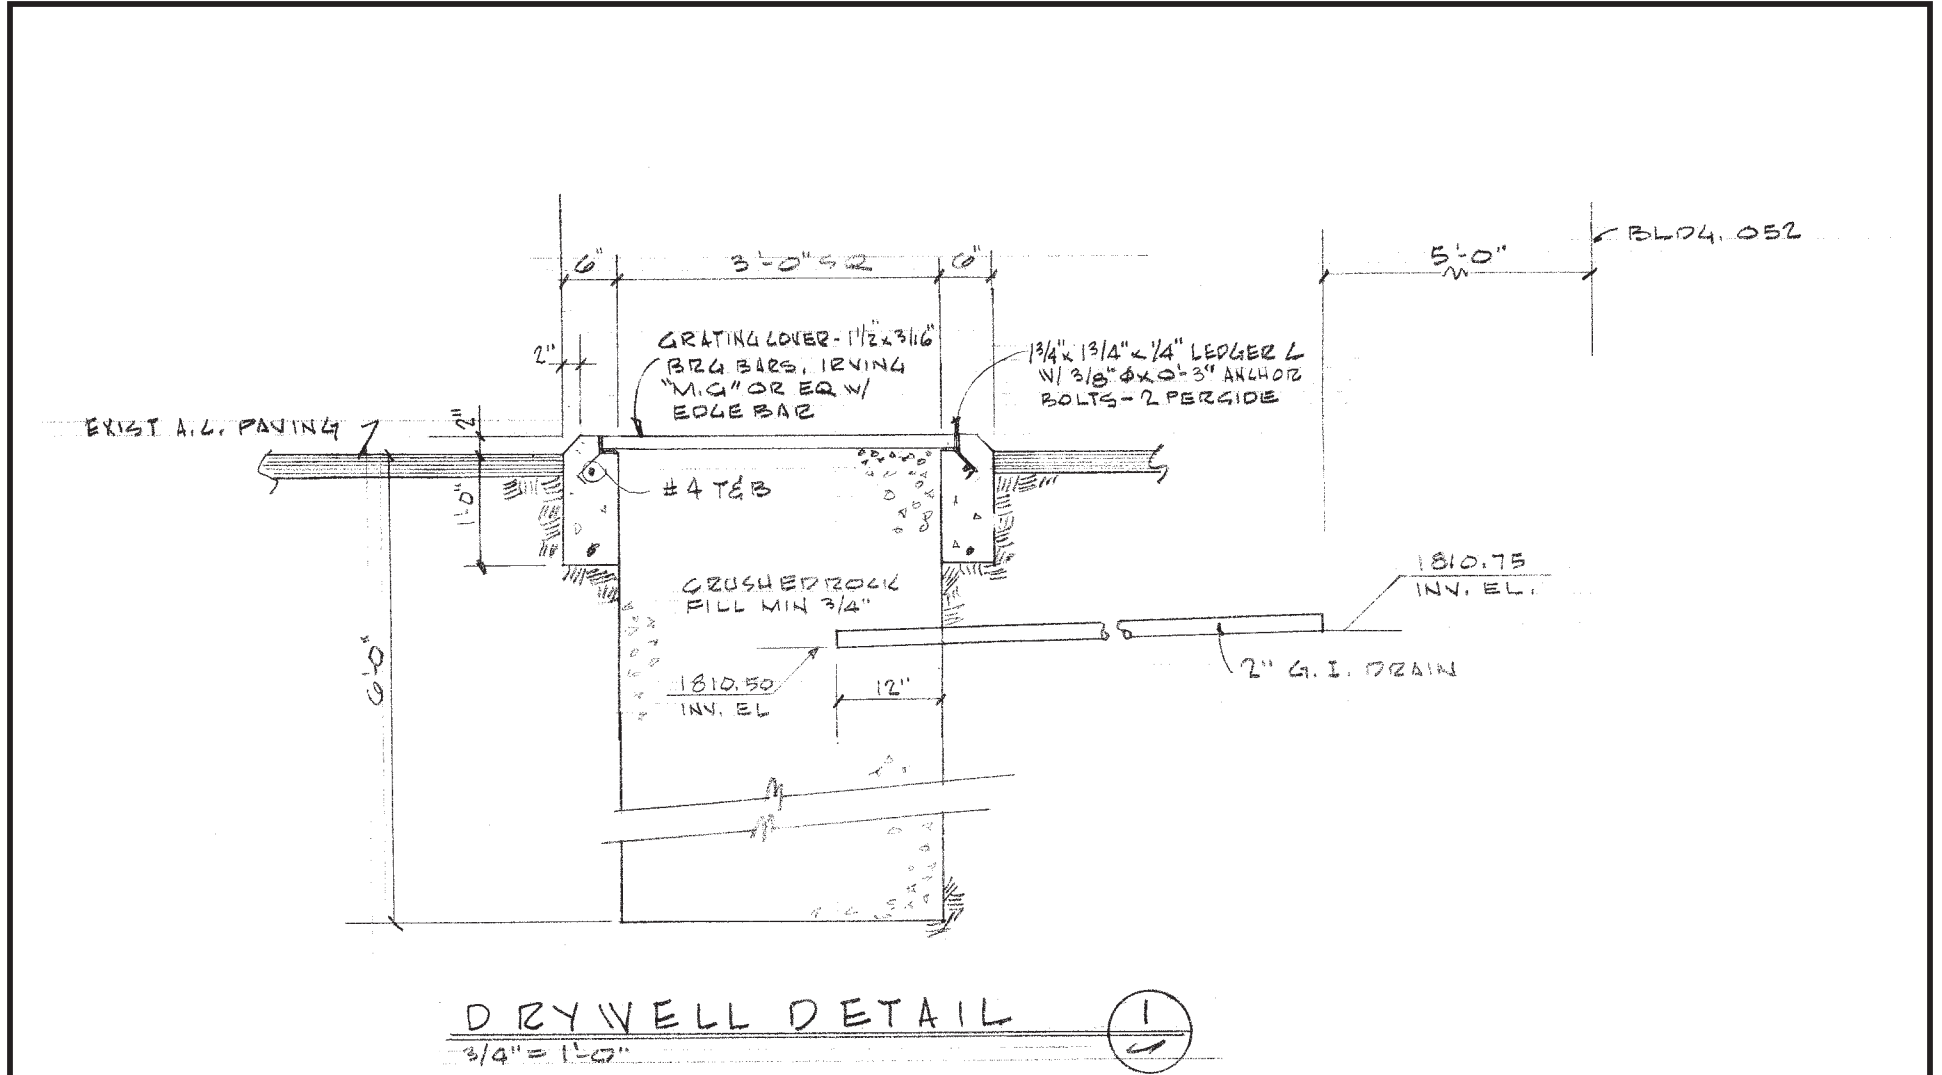
Figure 2.2.2c
Building 4057
Dry Well

DRY WELL DETAIL (1)
3/4" = 1'-0"

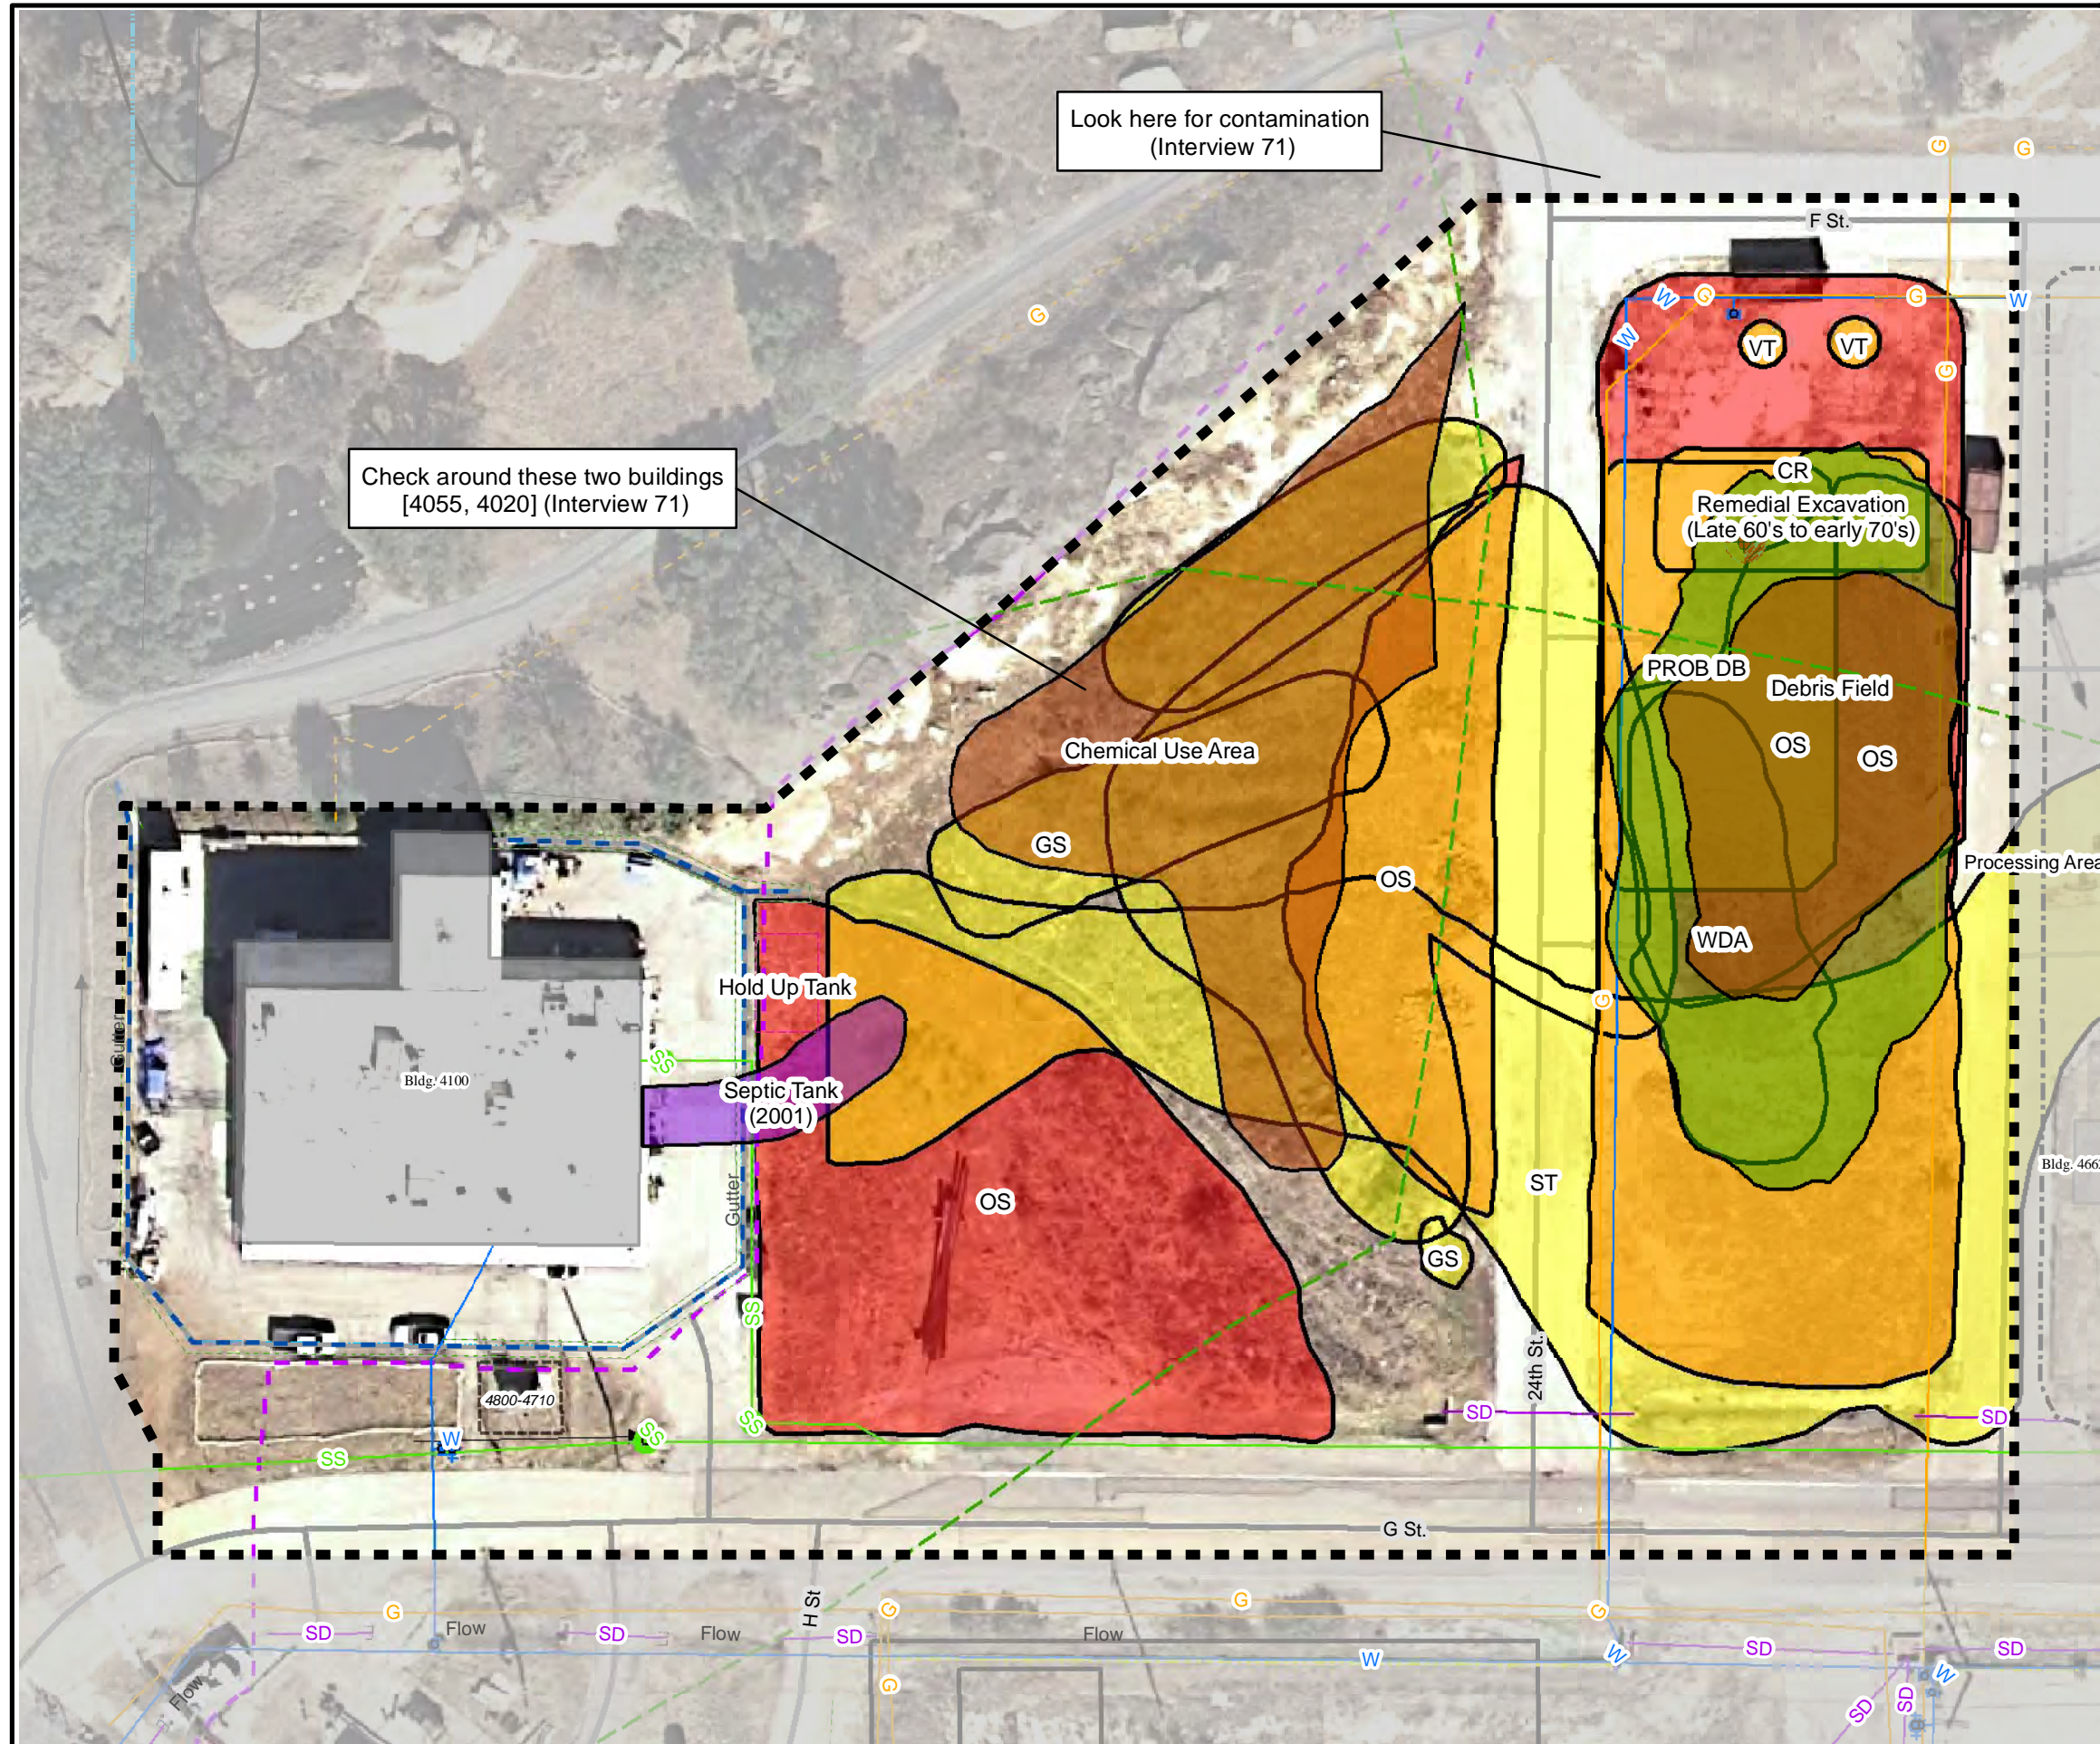
Figure 2.3
Area IV Subarea 5C-3
Santa Susana Field Laboratory

The Group 3 index map is presented in Figure 2.3. Following Figure 2.3, the site photograph and layout drawings for the building area within HSA-5C Group 3 are presented. HSA-5C Group 3 includes one building area containing criticality test facilities as well as adjacent disposal areas including trenches.

Plate 1 and Figure 2.3 provide a convenient reference for the following recommendations.

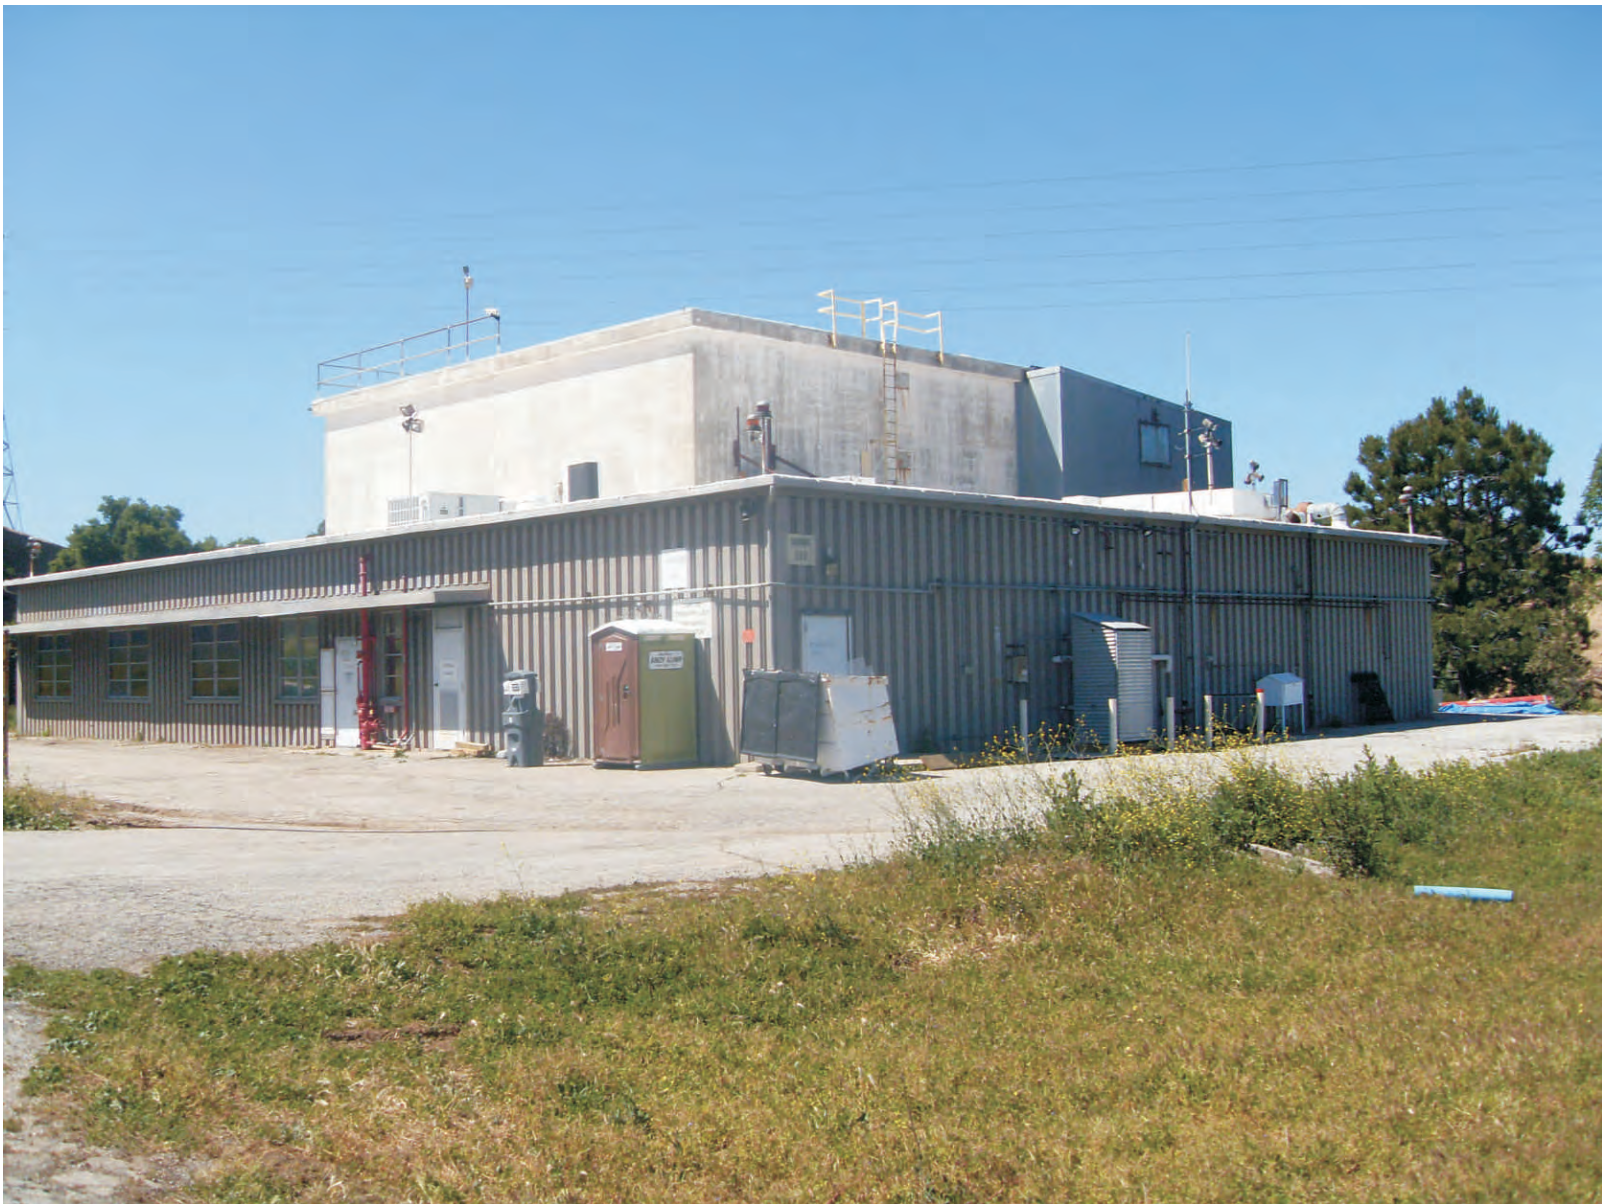
Figure 2.3.1a
Building 4100
Site Photograph

wide.^{1, 2} Figures 2.3.1a through 2.3.1b provide a current photograph and the best available building-specific drawing(s) that the research team could find. Plate 1 presents a summary of all identified features for this site.

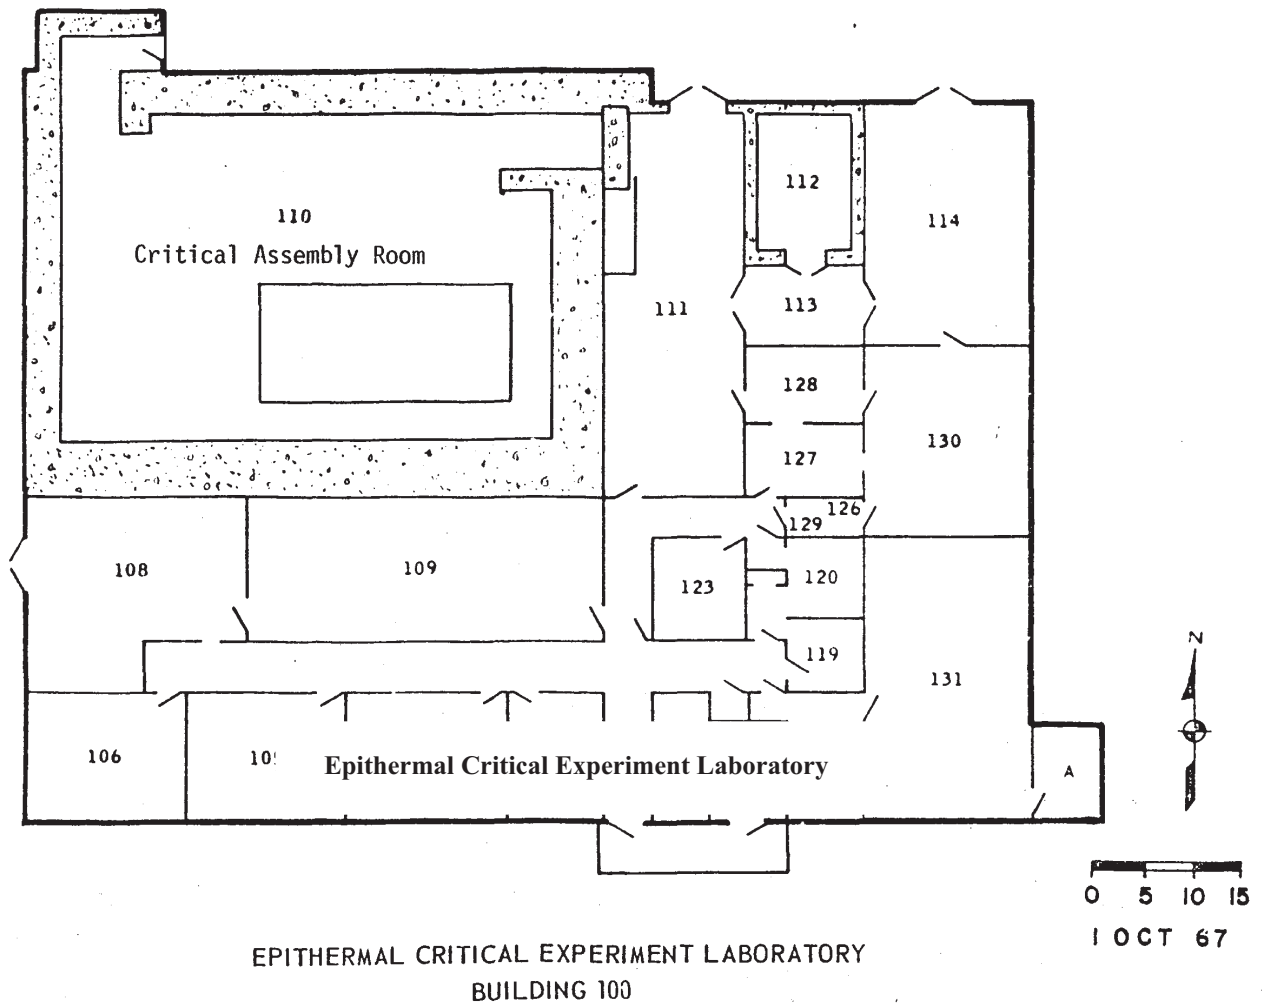
Figure 2.3.1b
Building 4100
Floor Plan

Building Features: Building 4100 contained an experimental critical assembly located within a high bay (Room 110), special nuclear material stored within a vault (Room 112), supporting rooms, and a control room (Room 109). The facility included a ventilation system with filtered exhaust for the high bay area, a storage vault, and laboratories. A pit adjacent to the facility contained a liquid holdup tank system for liquid wastes.¹ Building 4100 also had a septic tank, a leach field, a trench outside the building, and two stacks, the higher of which reached 50 feet. Building 4100 currently houses one of the largest computed axial tomography (CT) scanners in the world. Figure 2.3.1b provides a floor plan of Building 4100 in 1967. This figure provides the most applicable floor plan available for Building 4100 and represents only a snapshot in time of the building layout, which was modified over time.

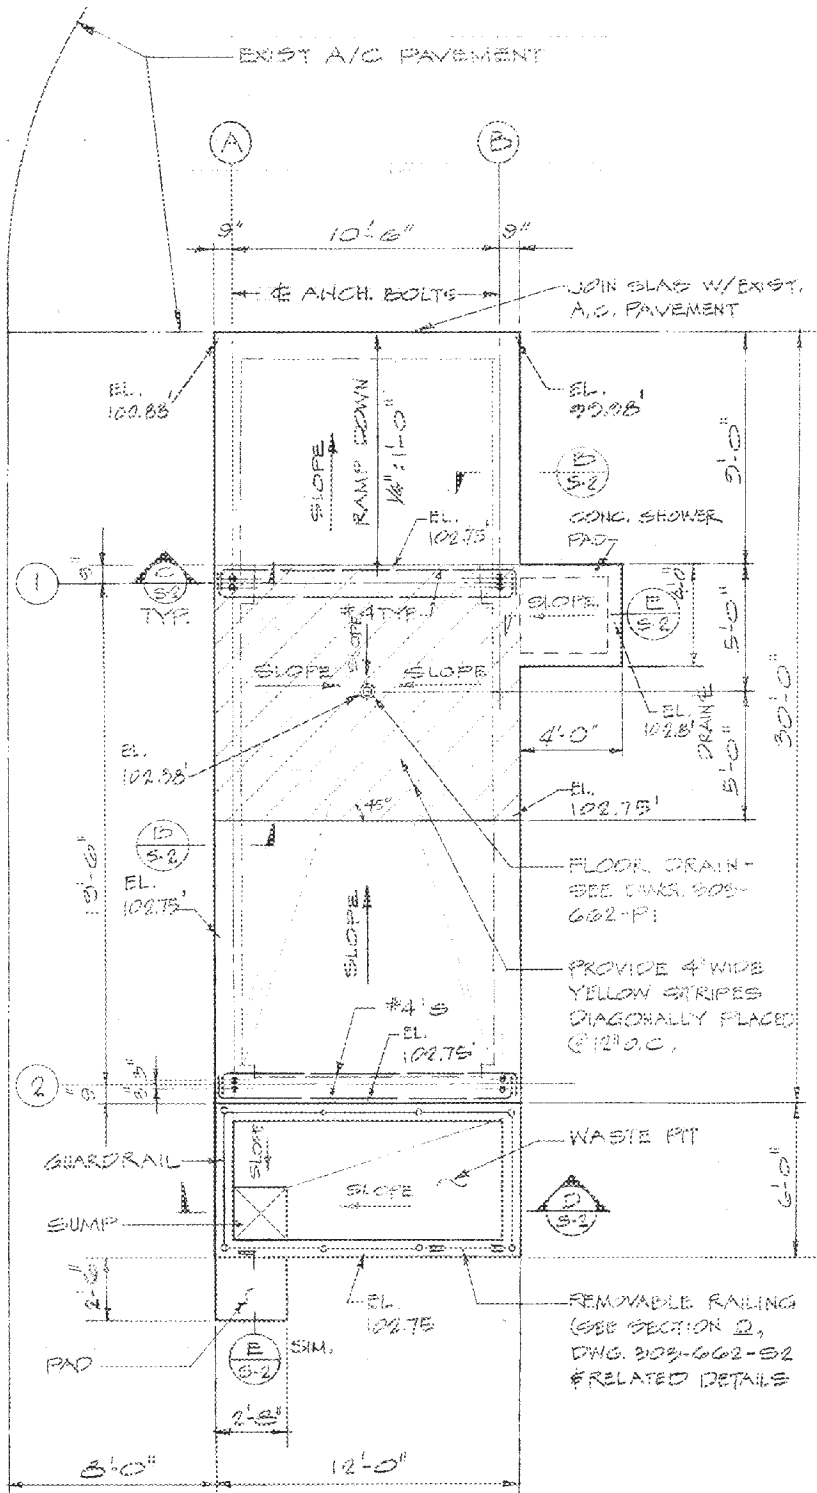
**Figure 2.4.4b
 Building 4662
 Foundation Plan**

FOUNDATION PLAN
 1/4" = 1'-0"
