**FINAL
TECHNICAL MEMORANDUM
SUBAREA HSA-5C
HISTORICAL SITE ASSESSMENT
SANTA SUSANA FIELD LABORATORY SITE
AREA IV RADIOLOGICAL STUDY
VENTURA COUNTY, CALIFORNIA**

**EPA Contract Number: EP-S7-05-05
Task Order Number: 0038**

**U.S. Environmental Protection Agency, Region 7
901 North 5th Street
Kansas City, KS 66101
and
U.S. Environmental Protection Agency, Region 9
75 Hawthorne Street
San Francisco, CA 94105**

October 2012

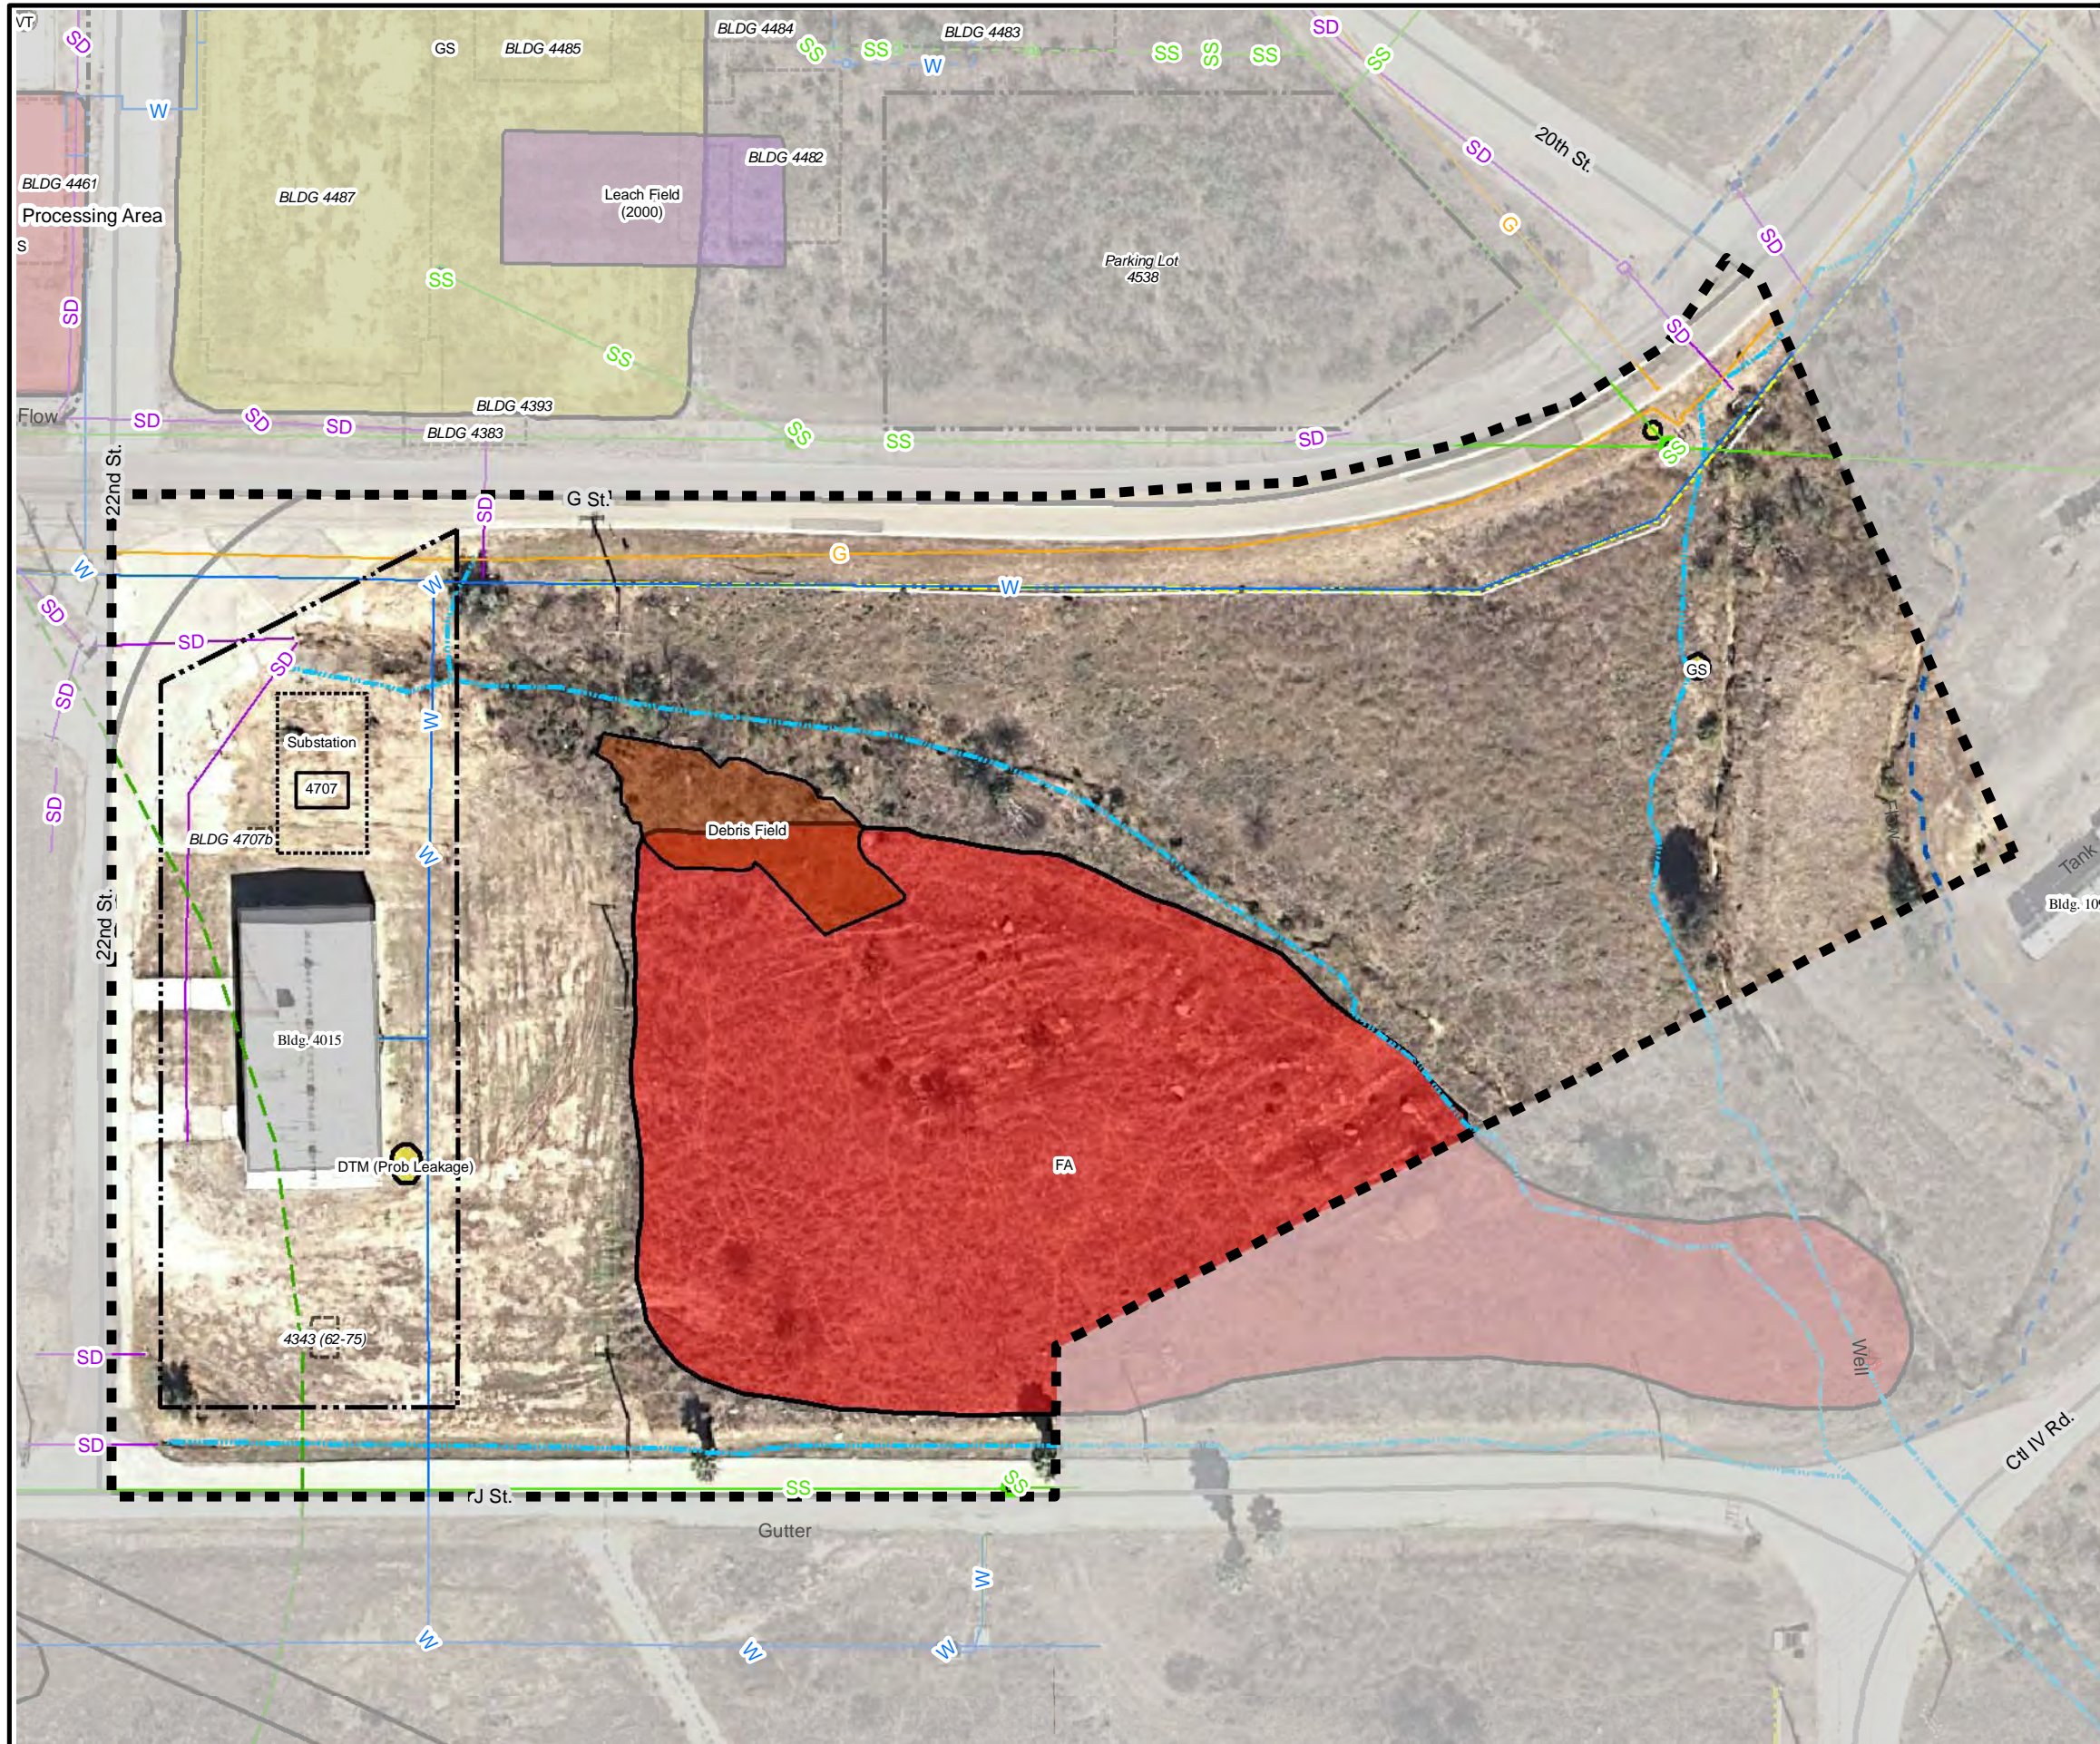
Figure 2.6
Area IV Subarea 5C-6
Santa Susana Field Laboratory

The Group 6 index map is presented in Figure 2.6. Following Figure 2.6, the site photograph and layout drawings for the building areas within HSA-5C Group 6 are presented. HSA-5C Group 6 includes one building area containing a warehouse building constructed over a former parking lot.

Plate 1 and Figure 2.6 provide a convenient reference for the following recommendations.

Previous characterization studies for the Building 4015 area were focused on delineating the extent of contamination to standards that were applicable at the time. Therefore, additional characterization is recommended for the Building 4015 area. This includes the following Building 4015 areas and appurtenances:

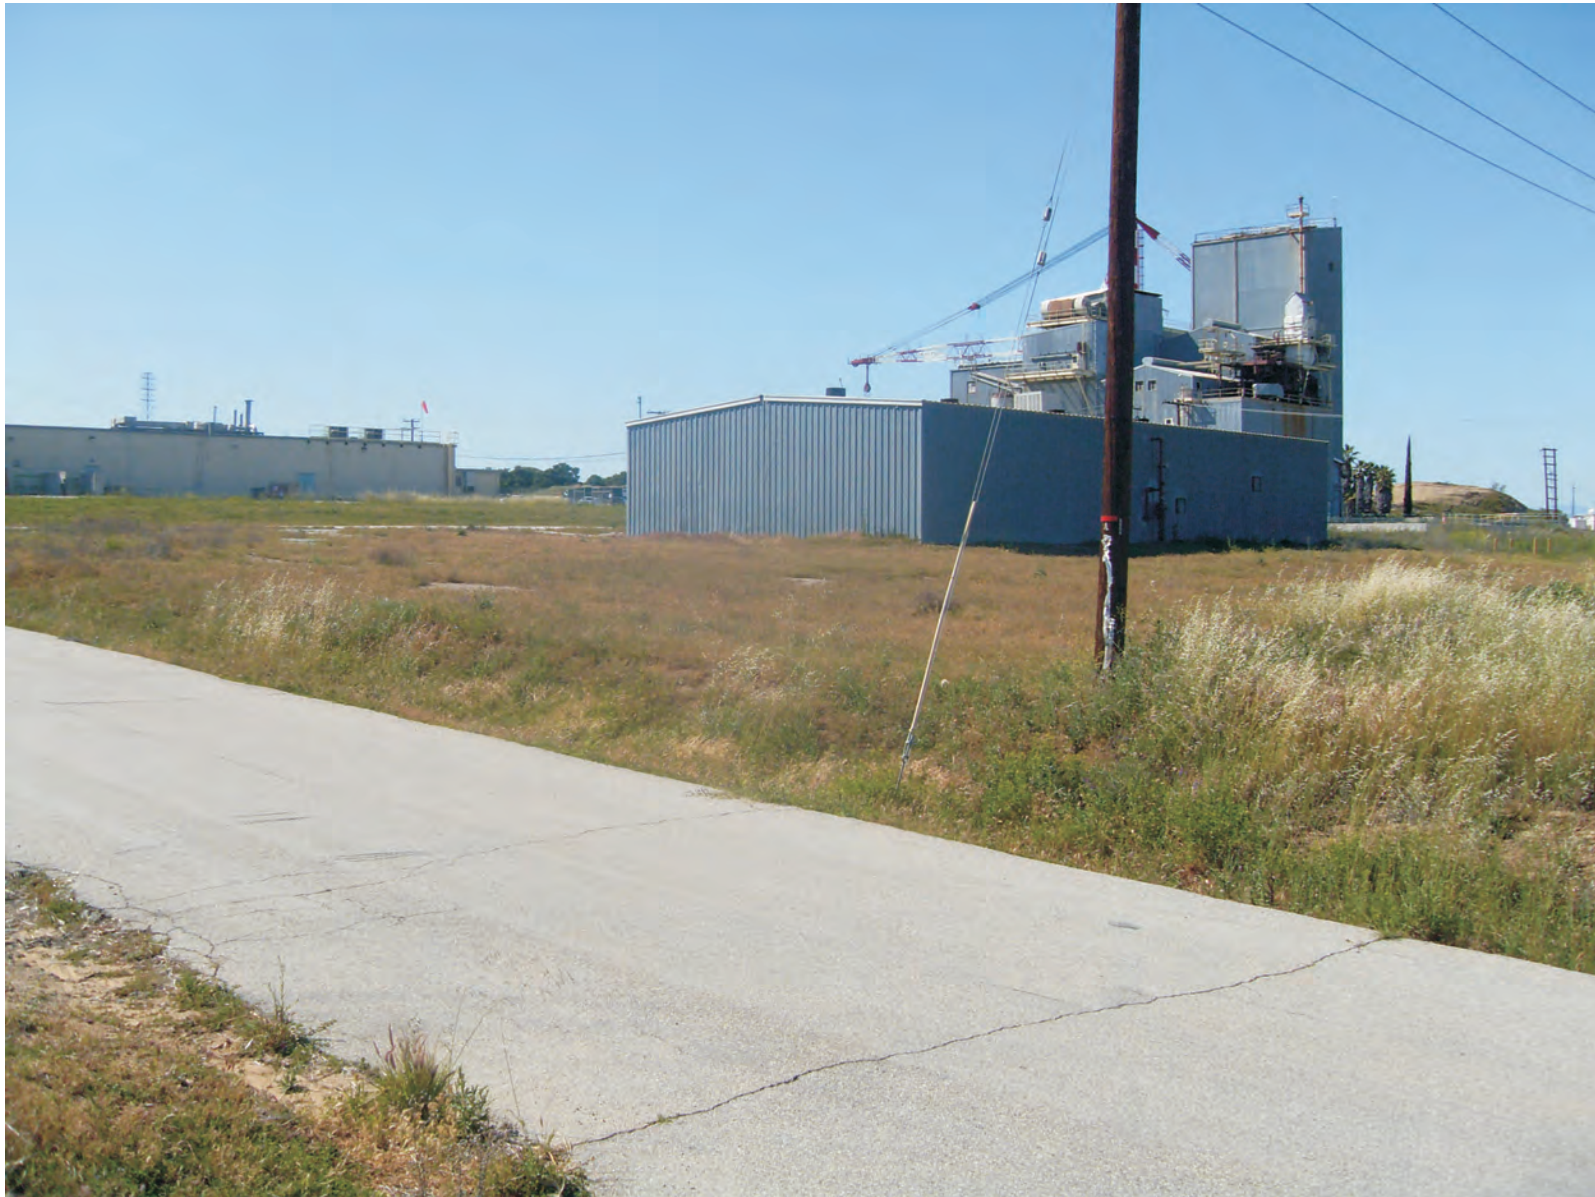
Figure 2.6.1a
Parking Lot 4573
Site Photograph

Site Description: The Building 4015 area comprises Building 4015, substation Building 4707, and the land surrounding these two buildings located on the eastern side of 22nd Street. Building 4015 was constructed sometime after March 1975 on former unimproved Parking Lot 4573, which was constructed in 1956.^{2, 3} Figure 2.6.1a provides a current photograph. The research team was unable to find building-specific drawing(s) and no as-built drawings were located for Building 4015. Building 4343, located south of Building 4015, served as the time clock building for Parking Lot 4573. Buildings 4373 and 4848 are located approximately 75 feet west of Building 4015, across 22nd Street. Building 4373 was a Systems for Nuclear Auxiliary Power (SNAP) criticality test facility, and radioactive materials were used in this building. A leach

Aerial Photographs: Aerial photographs show undeveloped land until the 1957 photograph when Parking Lot 4573 can be seen. This parking lot is observed in 1959 and 1962/63 photographs. Disturbed ground can be seen around the edges of the parking lot in 1965, 1967, and 1972 photographs. Building 4015 is observed in 1995, 2005, and 2009 aerial photographs.³ An area that was interpreted by the EPIC aerial photograph analysis as being “probable leakage” is observed in the 1972 photograph. In the 1988 photograph, a probable stain is identified at the southwest corner of Building 4015. A debris field, located approximately 140 feet from Building 4015, was identified in the aerial photo analysis. Based on the aerial photo analysis, it appears that debris was disposed in this area after 1983, and the disposal was discontinued prior to 1986. A “fill area,” located east of Building 4015, was also identified in the aerial photo analysis. This area was identified in the 1988 through 2005 aerial photos. It is unclear if this is an area of historic dumping.
