**FINAL
TECHNICAL MEMORANDUM
SUBAREA HSA-8
HISTORICAL SITE ASSESSMENT
SANTA SUSANA FIELD LABORATORY SITE
AREA IV RADIOLOGICAL STUDY
VENTURA COUNTY, CALIFORNIA**

**EPA Contract Number: EP-S7-05-05
Task Order Number: 0038**

**HydroGeoLogic, Inc.
Northway 10 Executive Park
313 Ushers Road
Ballston Lake, New York 12019**

October 2012

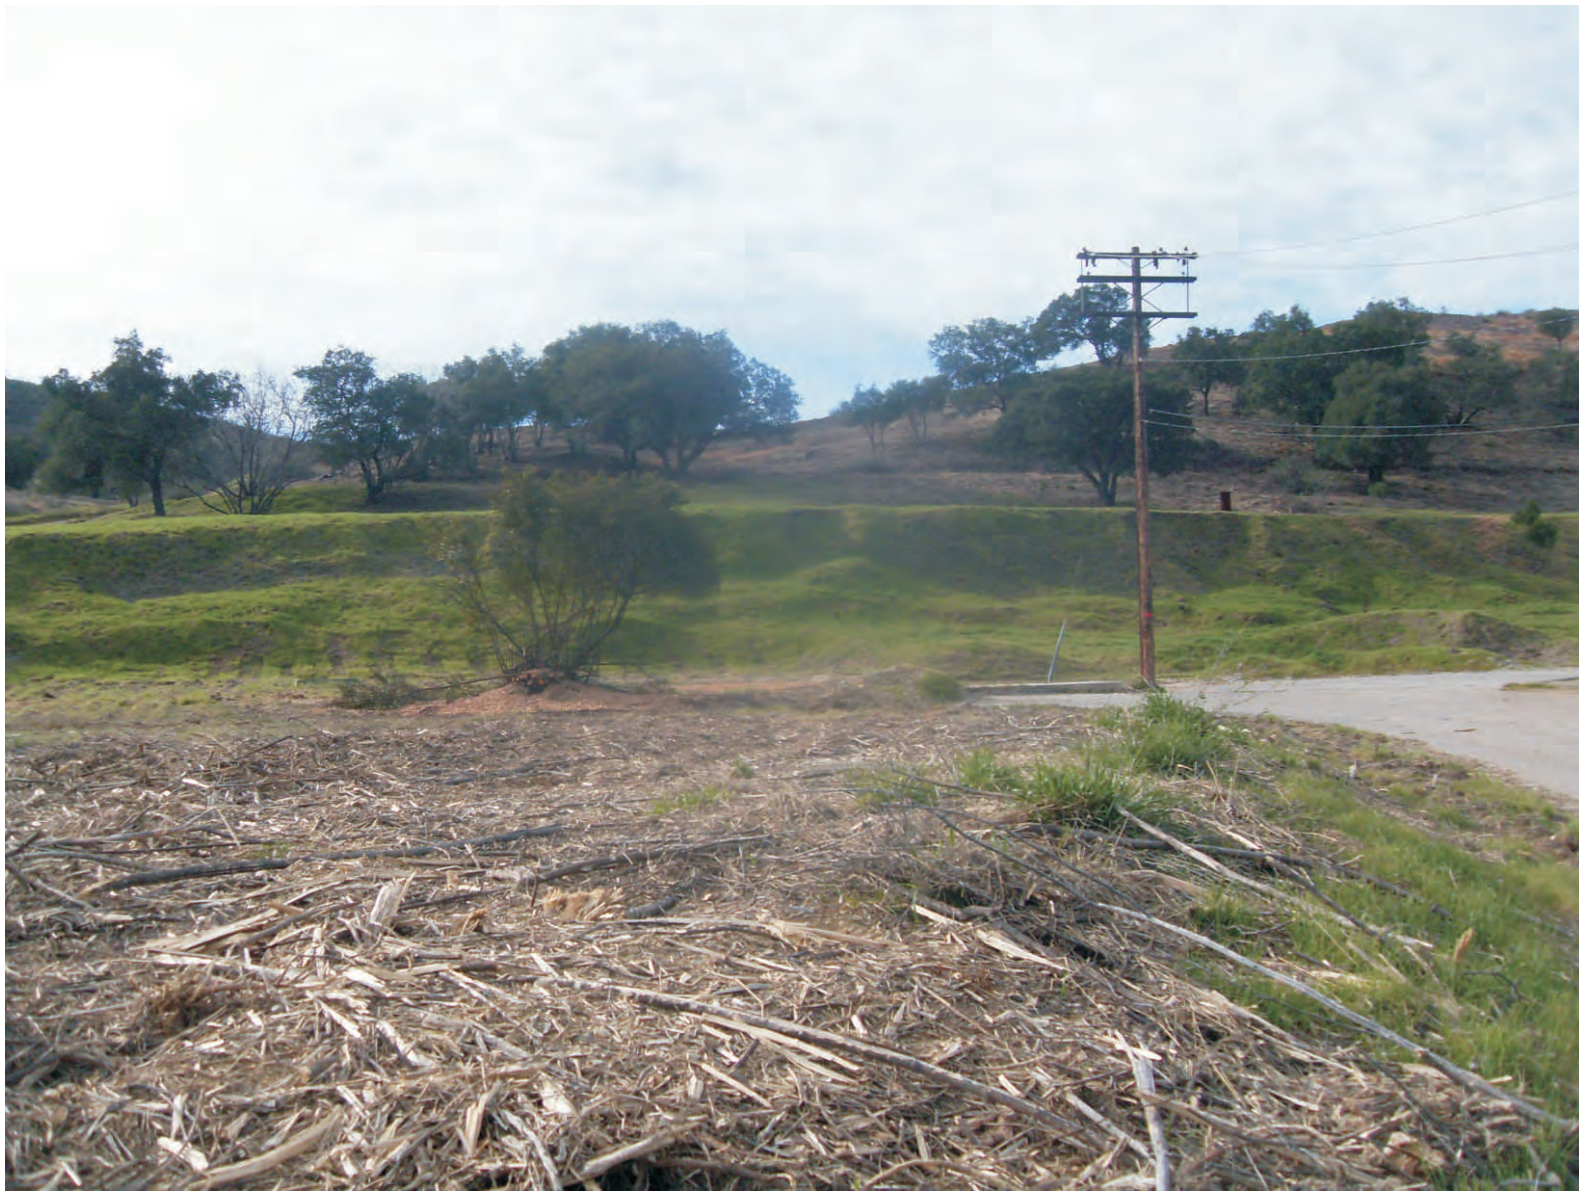
Figure 2.1.1a
Building 4317/4730
Site Photograph

Aerial Photographs: Aerial photographs show undeveloped land until the 1965 photograph when a small square building is observed that is identified as Building 4730. This is also seen in the 1967, 1972, and 1978 photographs. In the 1980 photograph, a new long rectangular building is seen that is identified as Building 4317. This is also seen in the 1983 and 1988 photographs. Building 4317 appears to have been demolished in the 1995 photograph. Disturbed ground is seen in this area. In the 2005 and 2009 photographs, the site is mostly covered with vegetation although the footprint of Building 4317 can still be seen.²

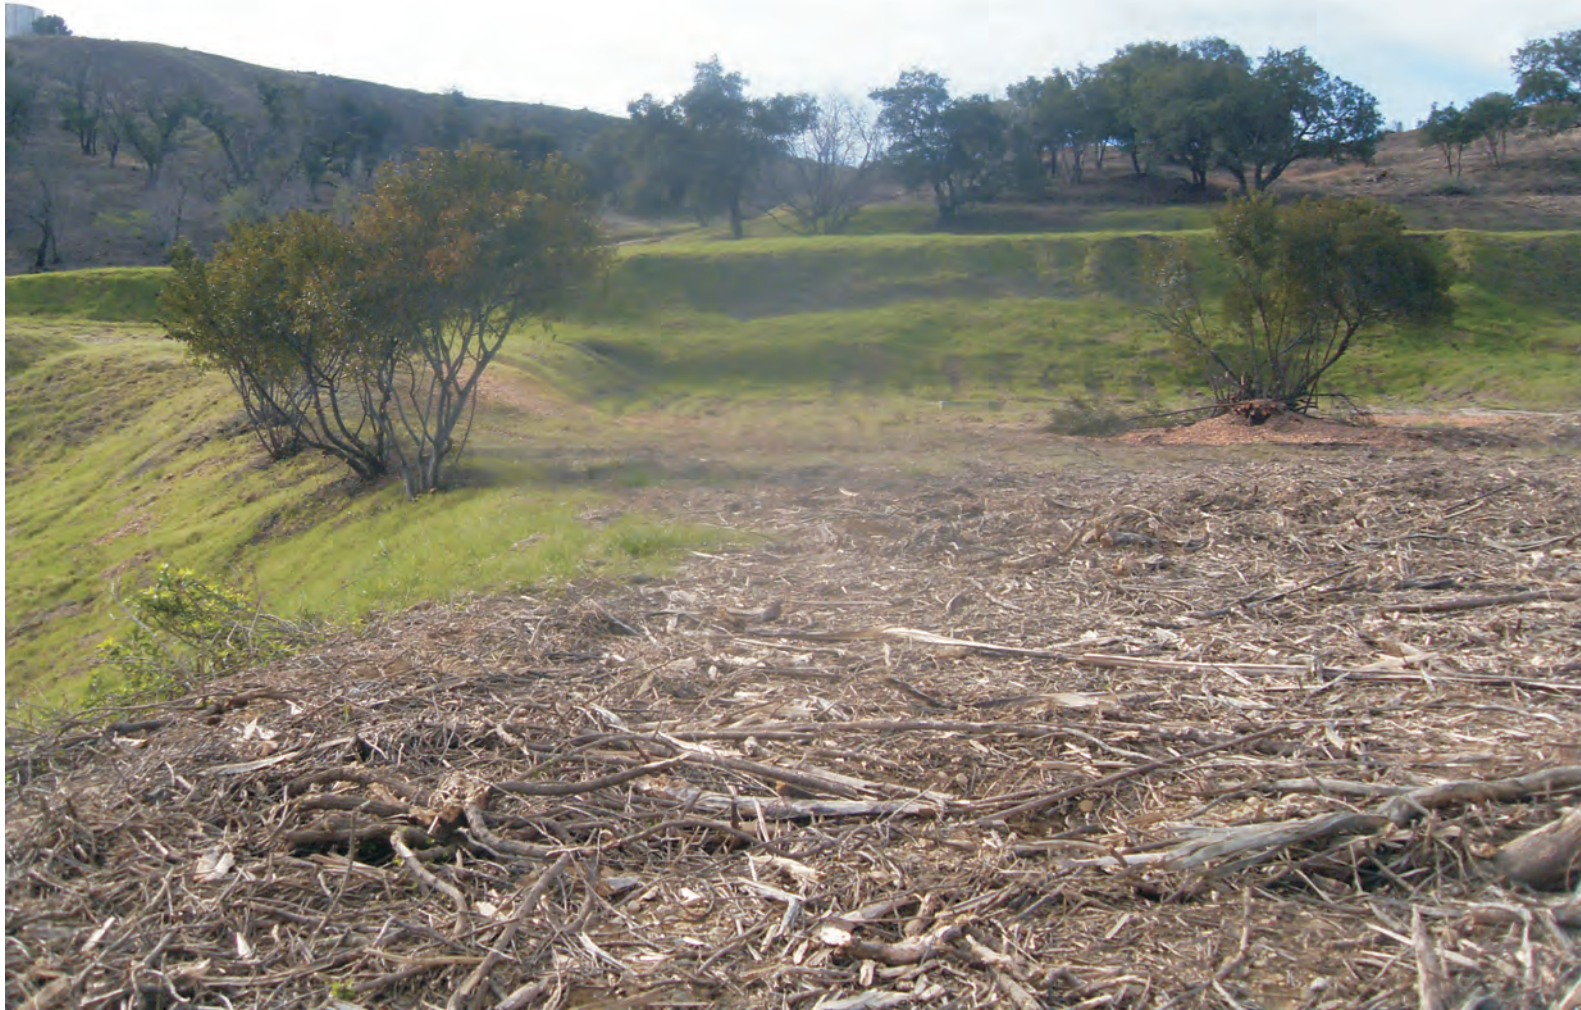
Figure 2.1.2a
Building 4318/4820
Site Photograph

Aerial Photographs: Aerial photographs show undeveloped land until the 1965 photograph when a small square building is observed that is identified as Building 4820. This is also seen in the 1967, 1972, and 1978 photographs. In the 1980 photograph, a new rectangular building is seen that is identified as Building 4318. This is also seen in the 1983 and 1988 photographs. Building 4318 appears to have been demolished in the 1995 photograph. Disturbed ground is seen in this area. In the 2005 and 2009 photographs, the site is mostly covered with vegetation although the footprint of Building 4318 can still be seen.¹

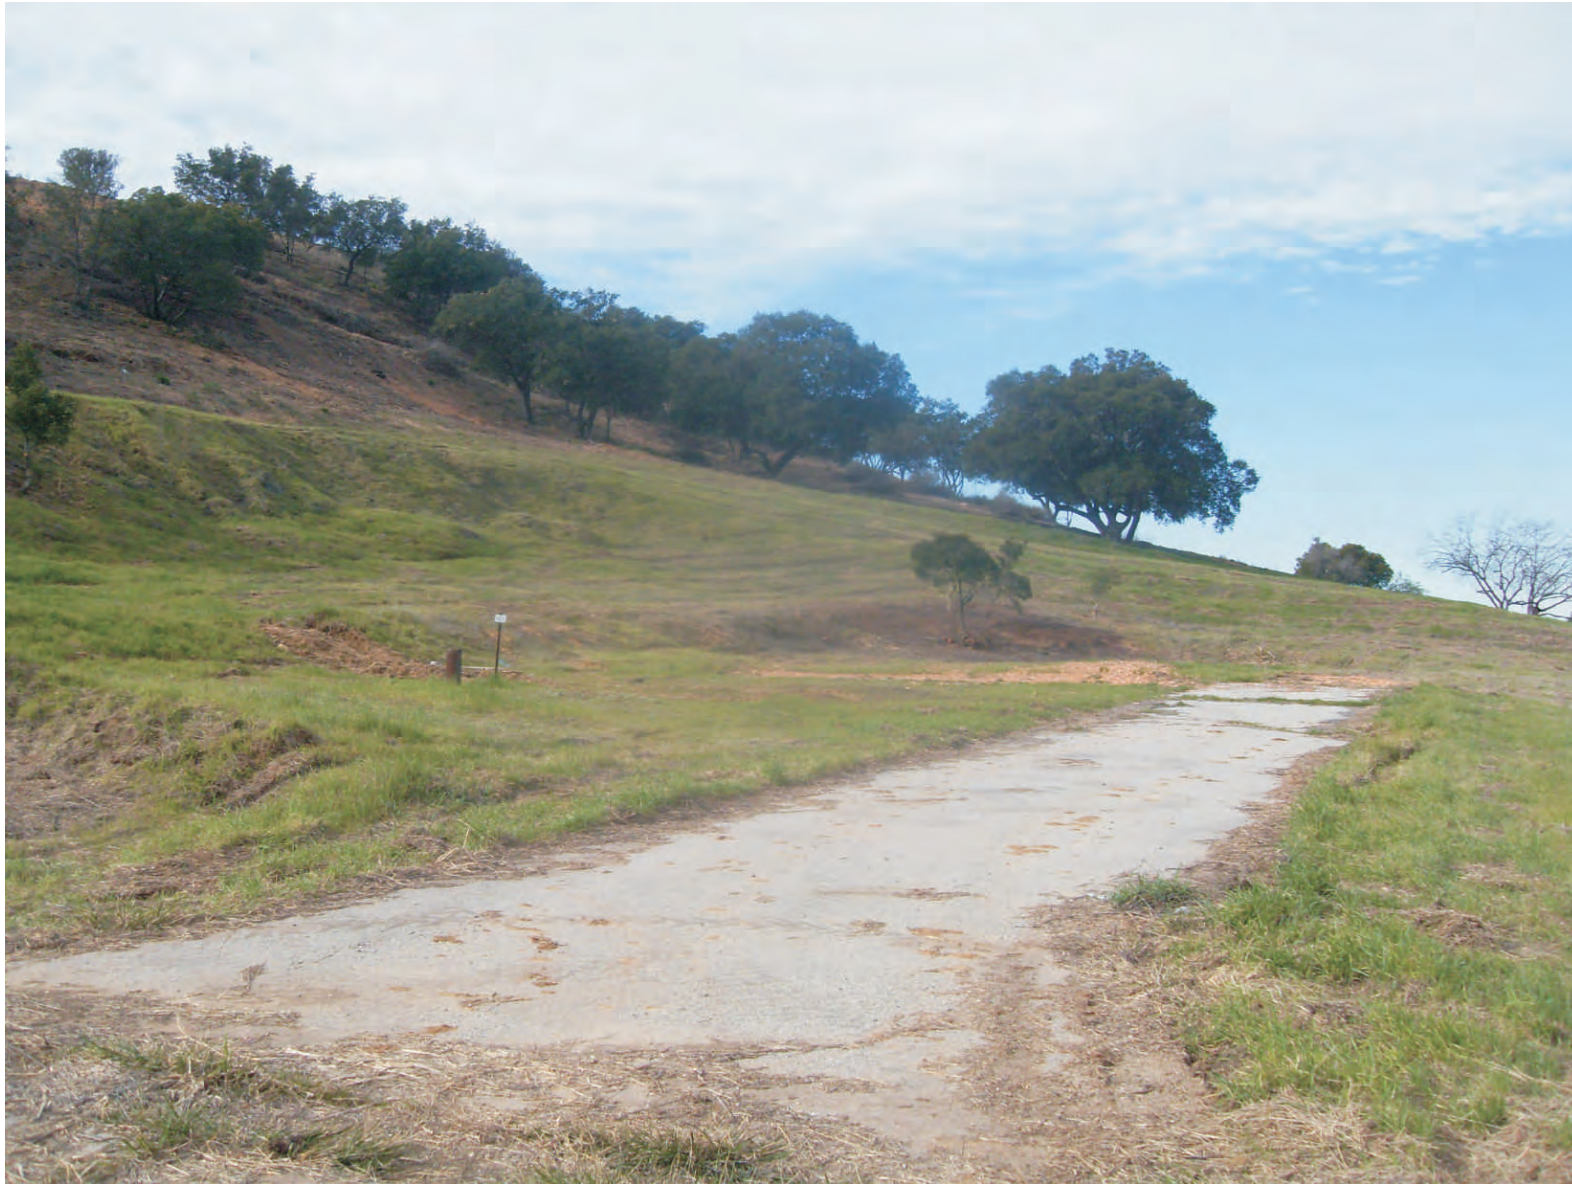
Figure 2.1.3a
Site 4814
Site Photograph

Current Use: Based on aerial photographs, Sites 4814, 4514 and Building 4314 appear to have been demolished between 1998 and 1995. Concrete building foundations and road pavement remain.

Site 4814 and Building 4314 look unchanged in the 1967, 1972, 1978 photographs, except for the open storage of items in drums and Baker tanks. In the 1980 photograph, Baker tanks and probable heavy equipment are observed as well as a possible horizontal tank and a stained area south of the tower. In the 1983 photograph, Baker tanks are visible between Site 4814 and Building 4314. The 1988 photograph shows that most of these tanks have been removed. The 1995 photograph shows that both Site 4814 and Building 4314 have been removed; no Baker tanks are observed, but a mound of uniform light-toned material is visible. The 2005 and 2009 photographs show that vegetation is growing back in the area.¹

- The flat and low-lying areas within and surrounding and between Site 4814 and Building 4314, particularly on the north side of the tower where Baker tanks were identified and west side of Building 4314 where the earth blast shield was identified on Figure 2.1.3d. Radionuclides originating from Site 4814 may have migrated to these areas via surface water flow or airborne releases.
- The site of the possible horizontal tank and stained area south of Site 4814, identified in the 1980 aerial photograph.
- The location of the underground piping that transported waste sodium from Site 4814 to Site 4886. Documentation regarding the removal of this piping could not be verified. .

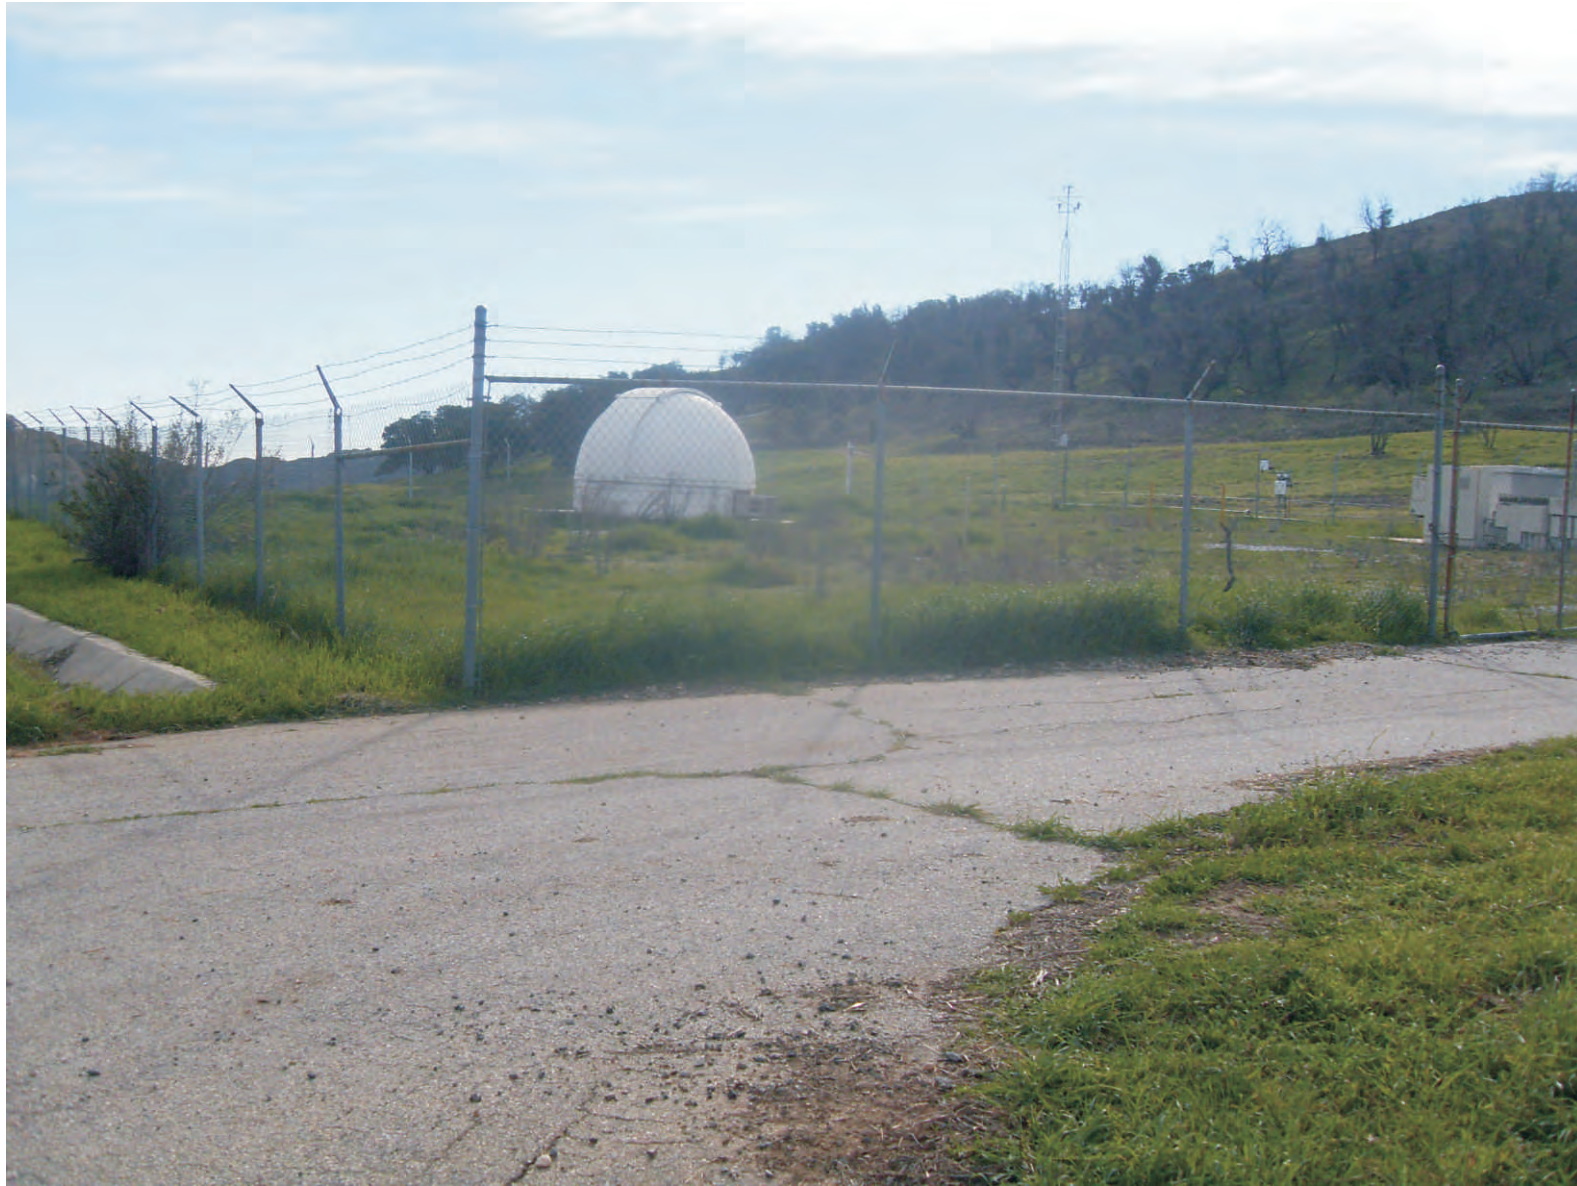
Figure 2.1.4a
Site 4425
Site Photograph

Building Features: Site 4425 was a mirrored parabolic dish concentrator with a 31-foot diameter swing area, a solar receiver, and a 25 kilowatt Sterling engine generator. A trailer, mounted on foundations, was also present at the site.^{2,3} A 1988 aerial photograph is presented in Figure 2.1.4b. This shows Site 4425 in the upper left side of the photograph. Figure 2.1.4c presents a plot plan with no sign of the site. Site 4425 later featured a weather station and a small astronomical observatory.

Aerial Photographs: Aerial photographs show undeveloped land until the 1988 photograph when a parabolic dish and trailer are observed that are identified as Site 4425. In the 1988 photograph, disturbed ground is seen associated with the construction of the dish, a probable stain is observed in the southeast corner of the site and two possible horizontal tanks are seen in the northeast corner of the site. The parabolic dish and trailer are also seen in the 1995 photograph. The parabolic dish and trailer are no longer seen in the 2005 photograph; the site is vegetated except for a small astronomical observatory and two small sheds. In the 2009 photograph, Site 4425 looks unchanged from 2005.³

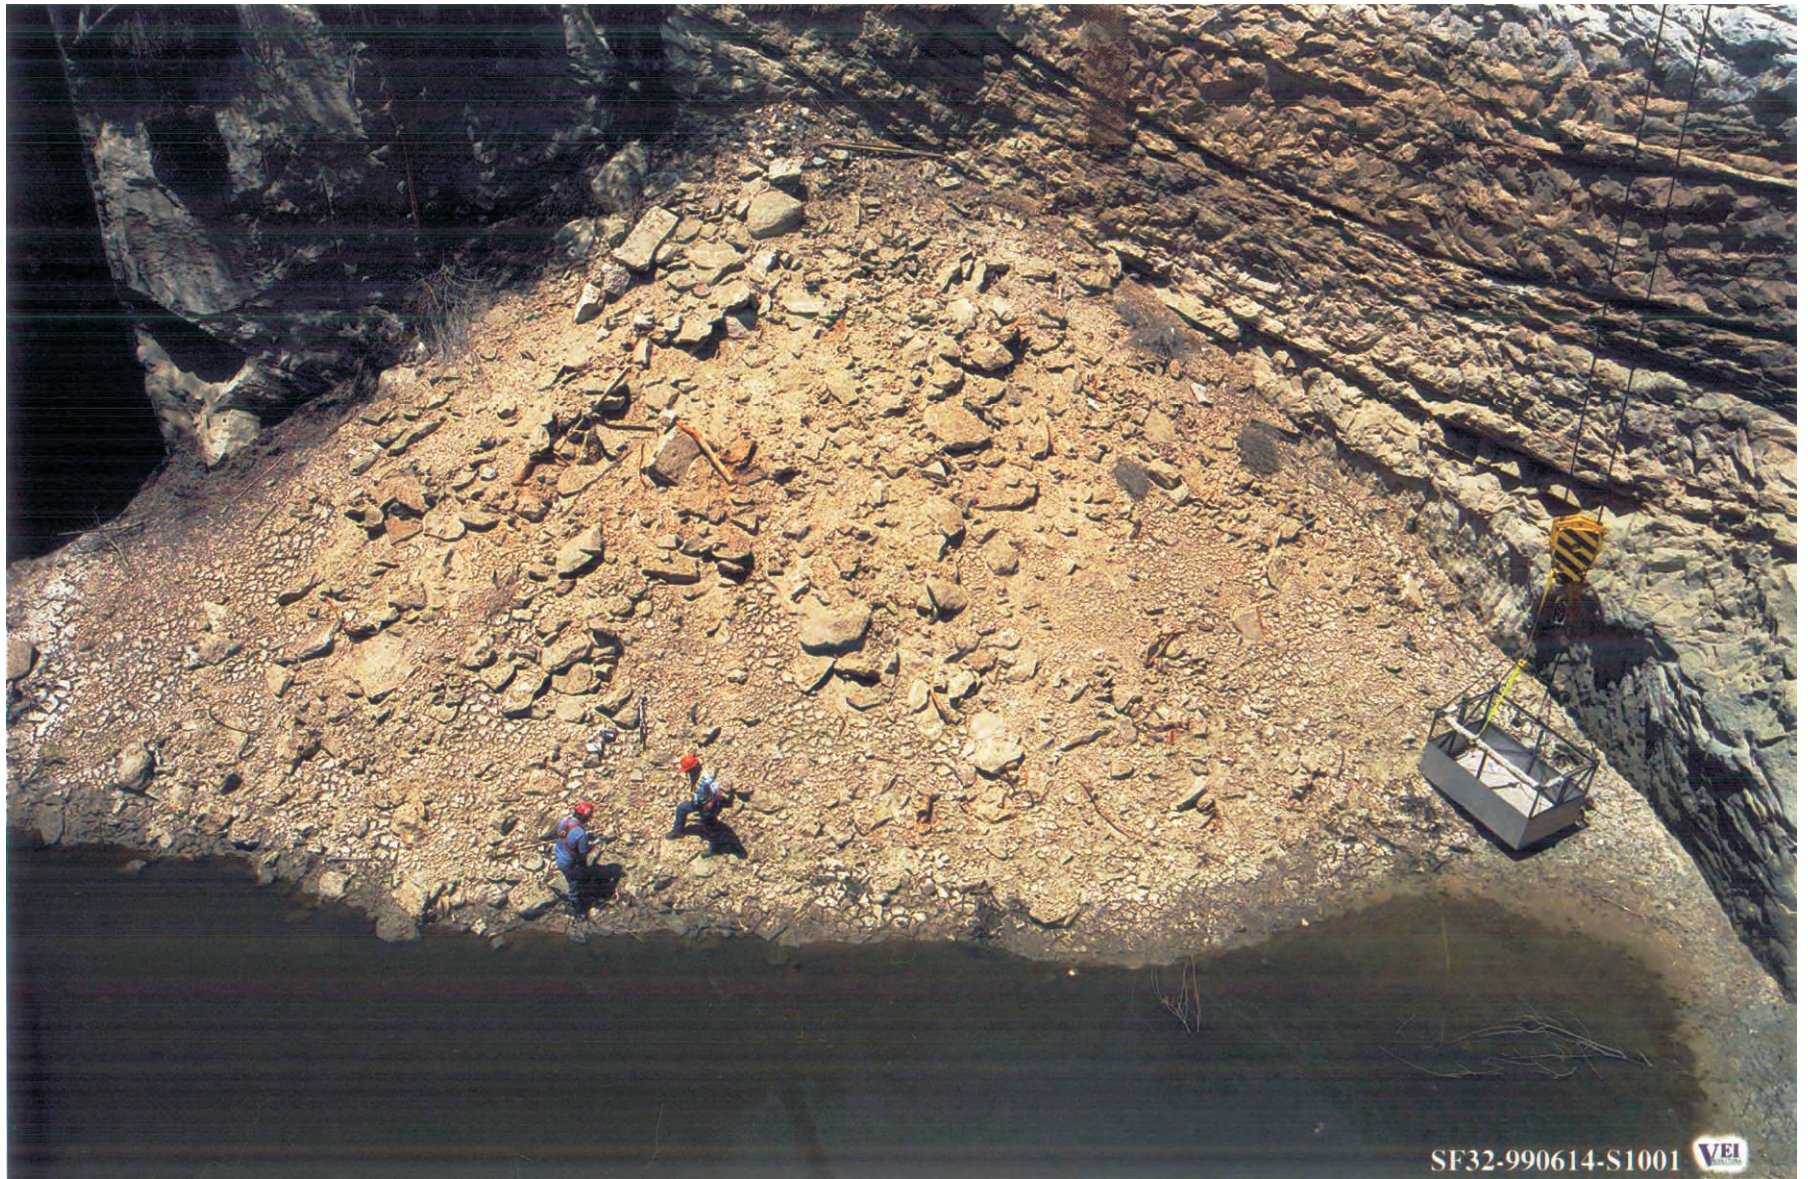
Figure 2.3.1g
Site 4056
Partially Drained Pit

Current Use: The Site 4056 landfill is not closed under RCRA. Reportedly, this site has not been used for the storage of hazardous and non-hazardous waste since 1981. The pit contains water and is fenced.
