## SITE CERTIFICATION SUMMARY

This Site Certification Summary provides information about the **Indian Orchard, Massachusetts, Site**. The U.S. Department of Energy Office of Legacy Management is responsible for long-term stewardship of the site under the **Formerly Utilized Sites Remedial Action Program**.

# Indian Orchard, Massachusetts, Site Certification Data Summary Worksheet

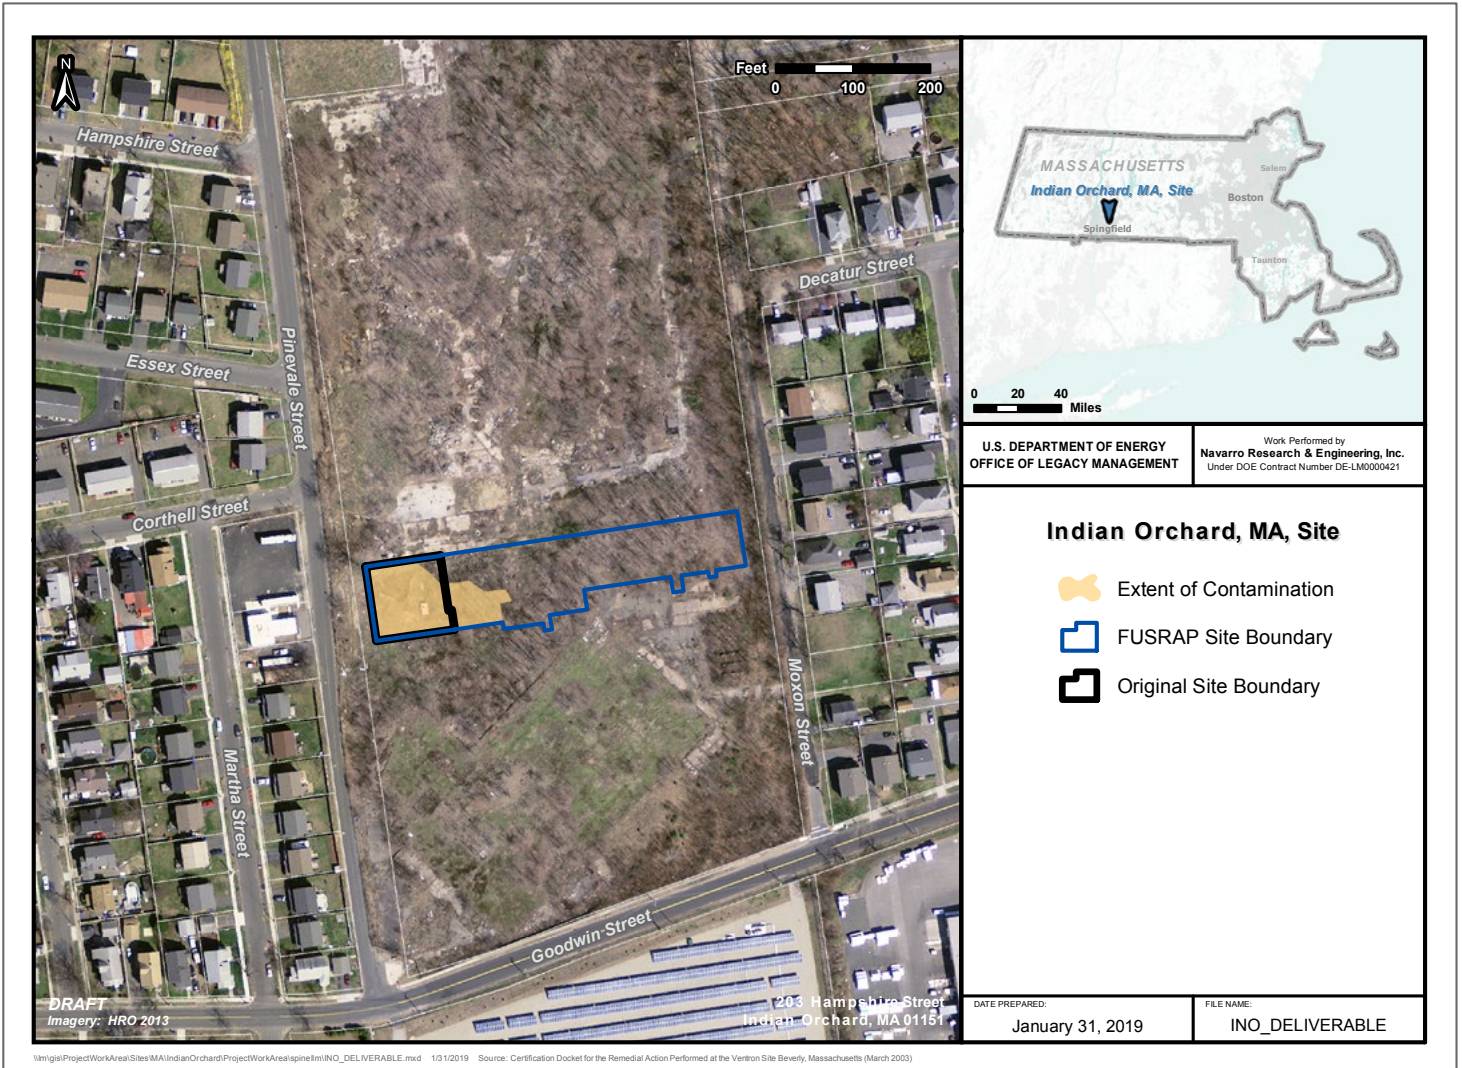
# Indian Orchard, Massachusetts, Site Map

For more detailed results of the post-remediation sampling, see the [Site Certification Data Summary Worksheet](#) on pages 4-7. For a detailed map of the site and sampling locations, see the [Site Overview Map](#) on page 8.
