SITE CERTIFICATION SUMMARY

This Site Certification Summary provides information about the **New York, New York, Site**. The U.S. Department of Energy Office of Legacy Management is responsible for long-term stewardship of the site under the **Formerly Utilized Sites Remedial Action Program**.

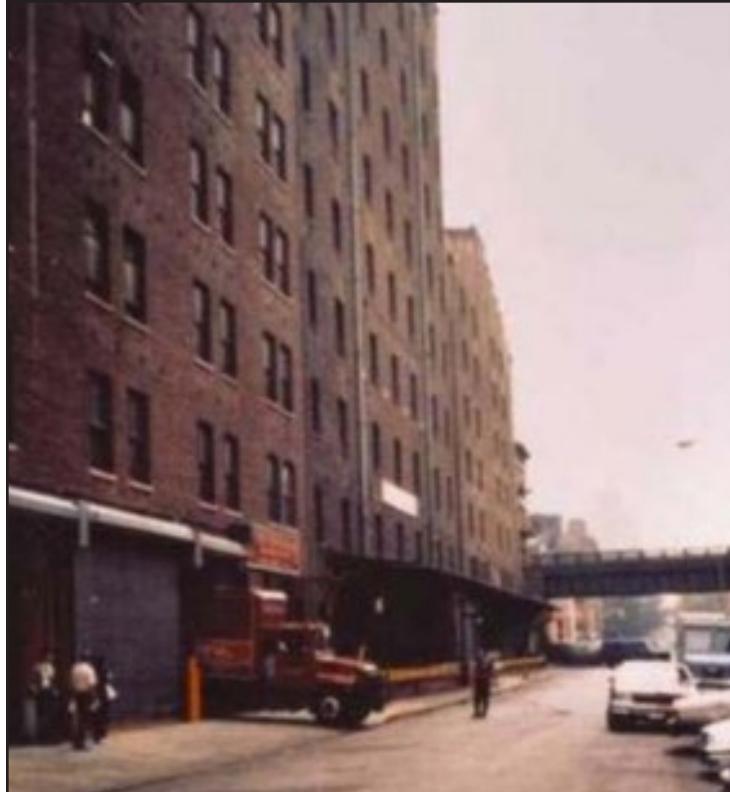
New York, New York, Site (Baker and Williams Warehouses), 1990.
