OE-3: 2024-02

## Prevention Of Injuries Using Portable Grinders

### PURPOSE

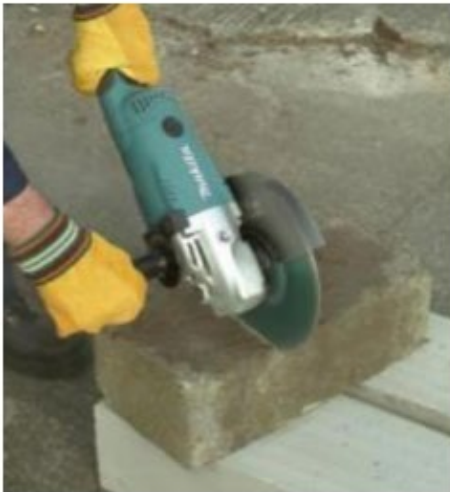
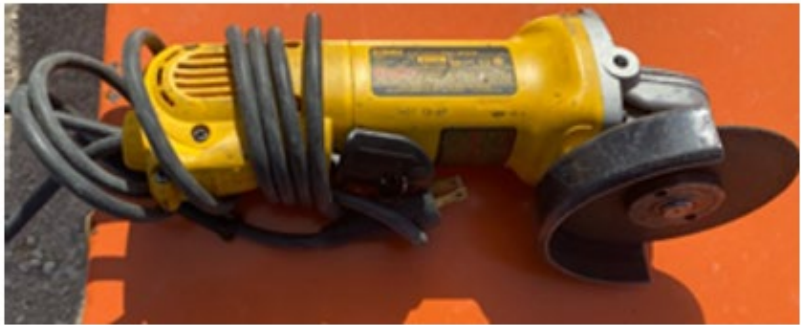
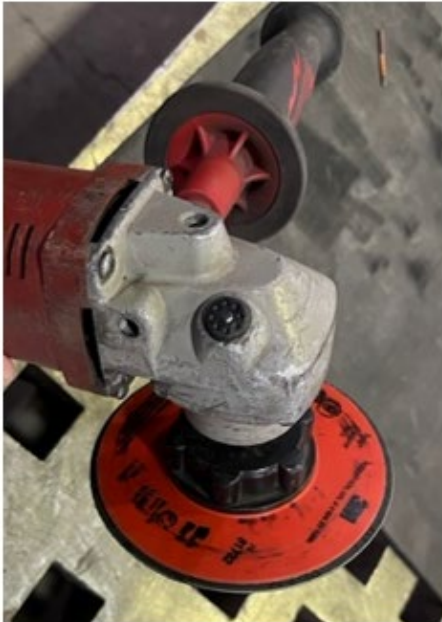
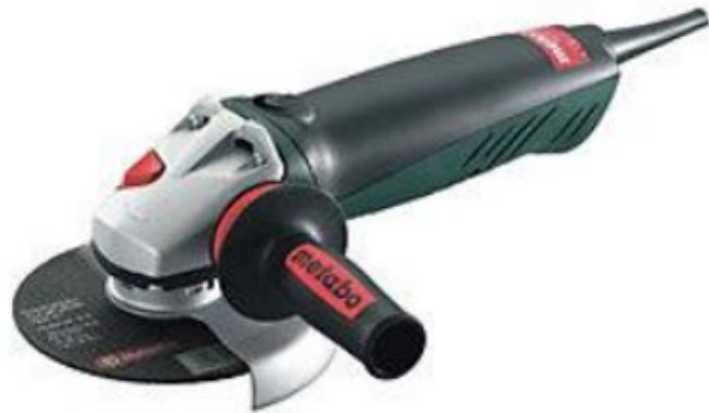
Examples of various types of portable hand-held grinders
