Appendix D – Biological Resources Report

July 1, 2022

Subject: Biological Resources Reconnaissance Assessment for the Vidal Solar Interconnection Project

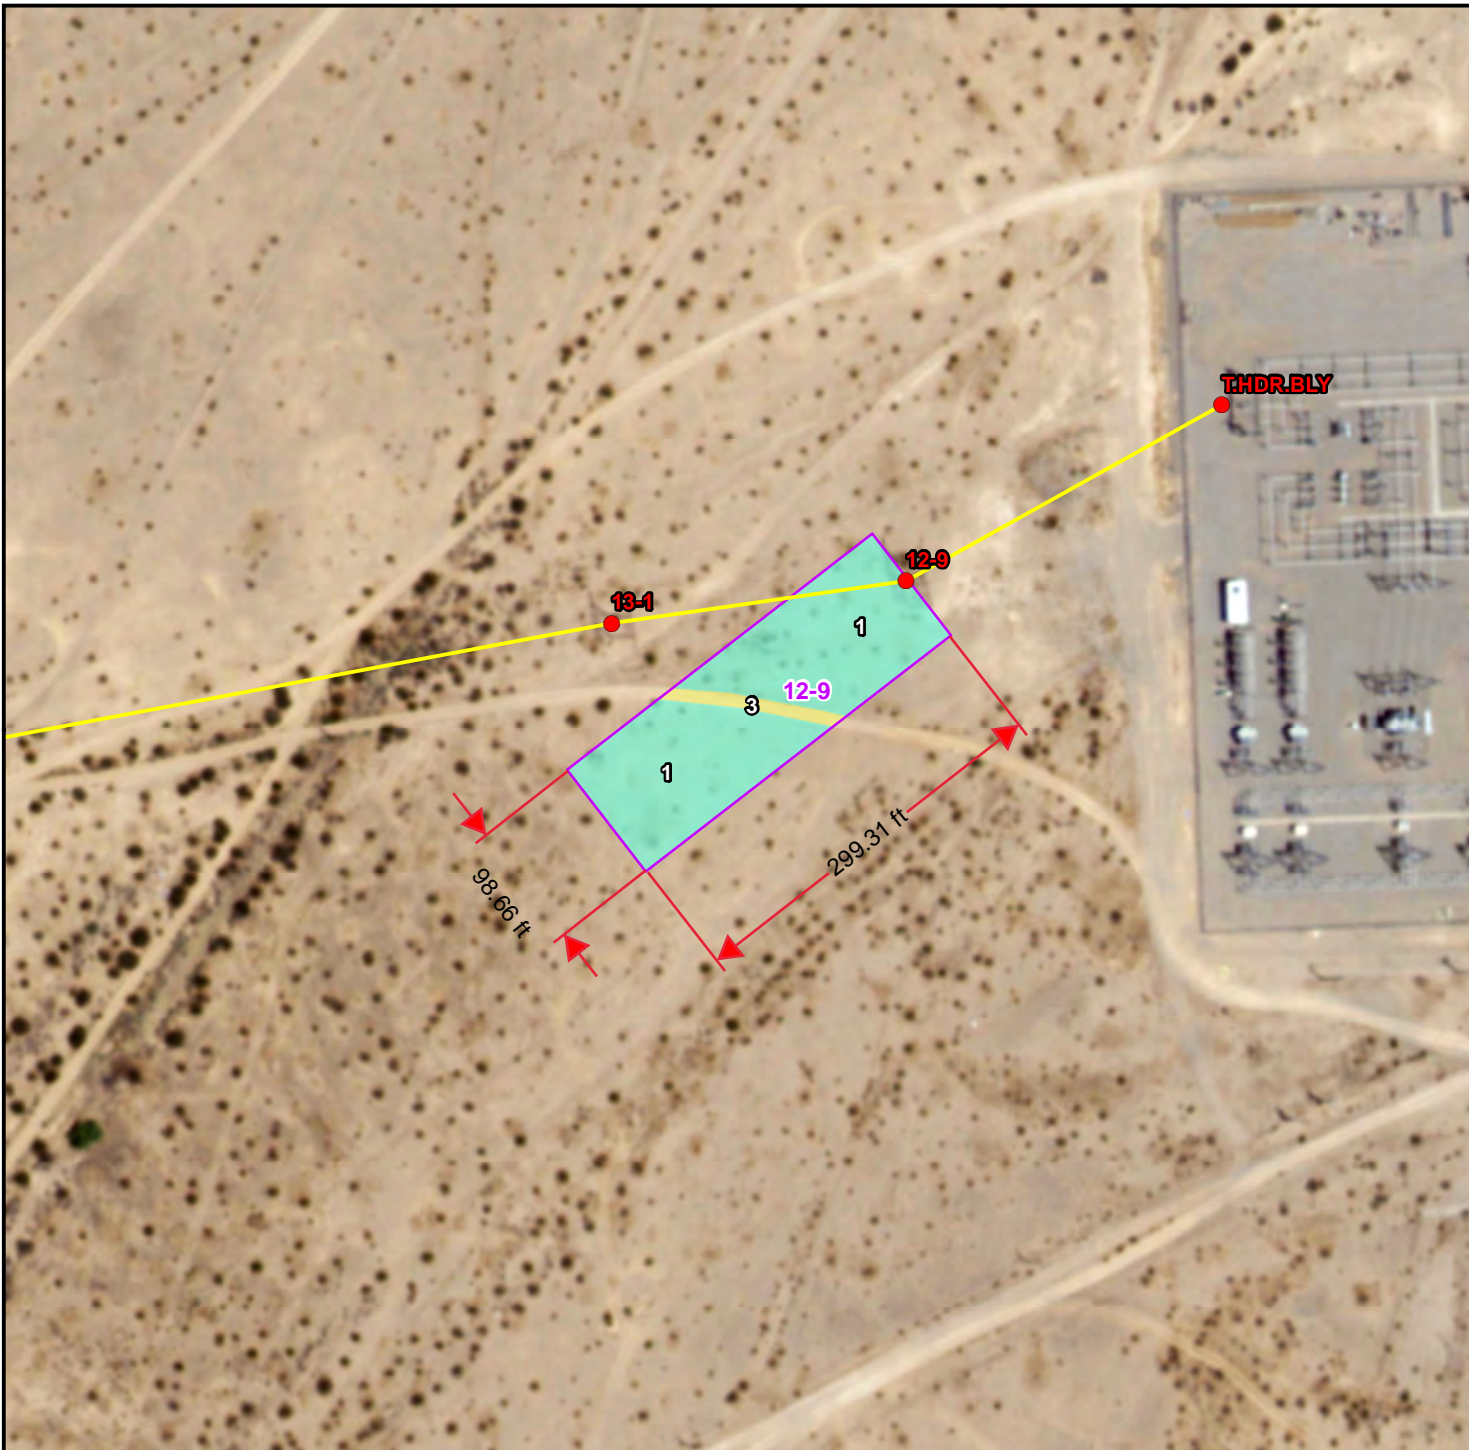
Figure 4
Vidal FOC
Vegetation Communities
Pull Site: 12-9

- Structures
 - Transmission Line
 - Pull Sites
- Vegetation Community Surveys**
- 1. Creosote Bush Scrub
 - 3. Bare Ground

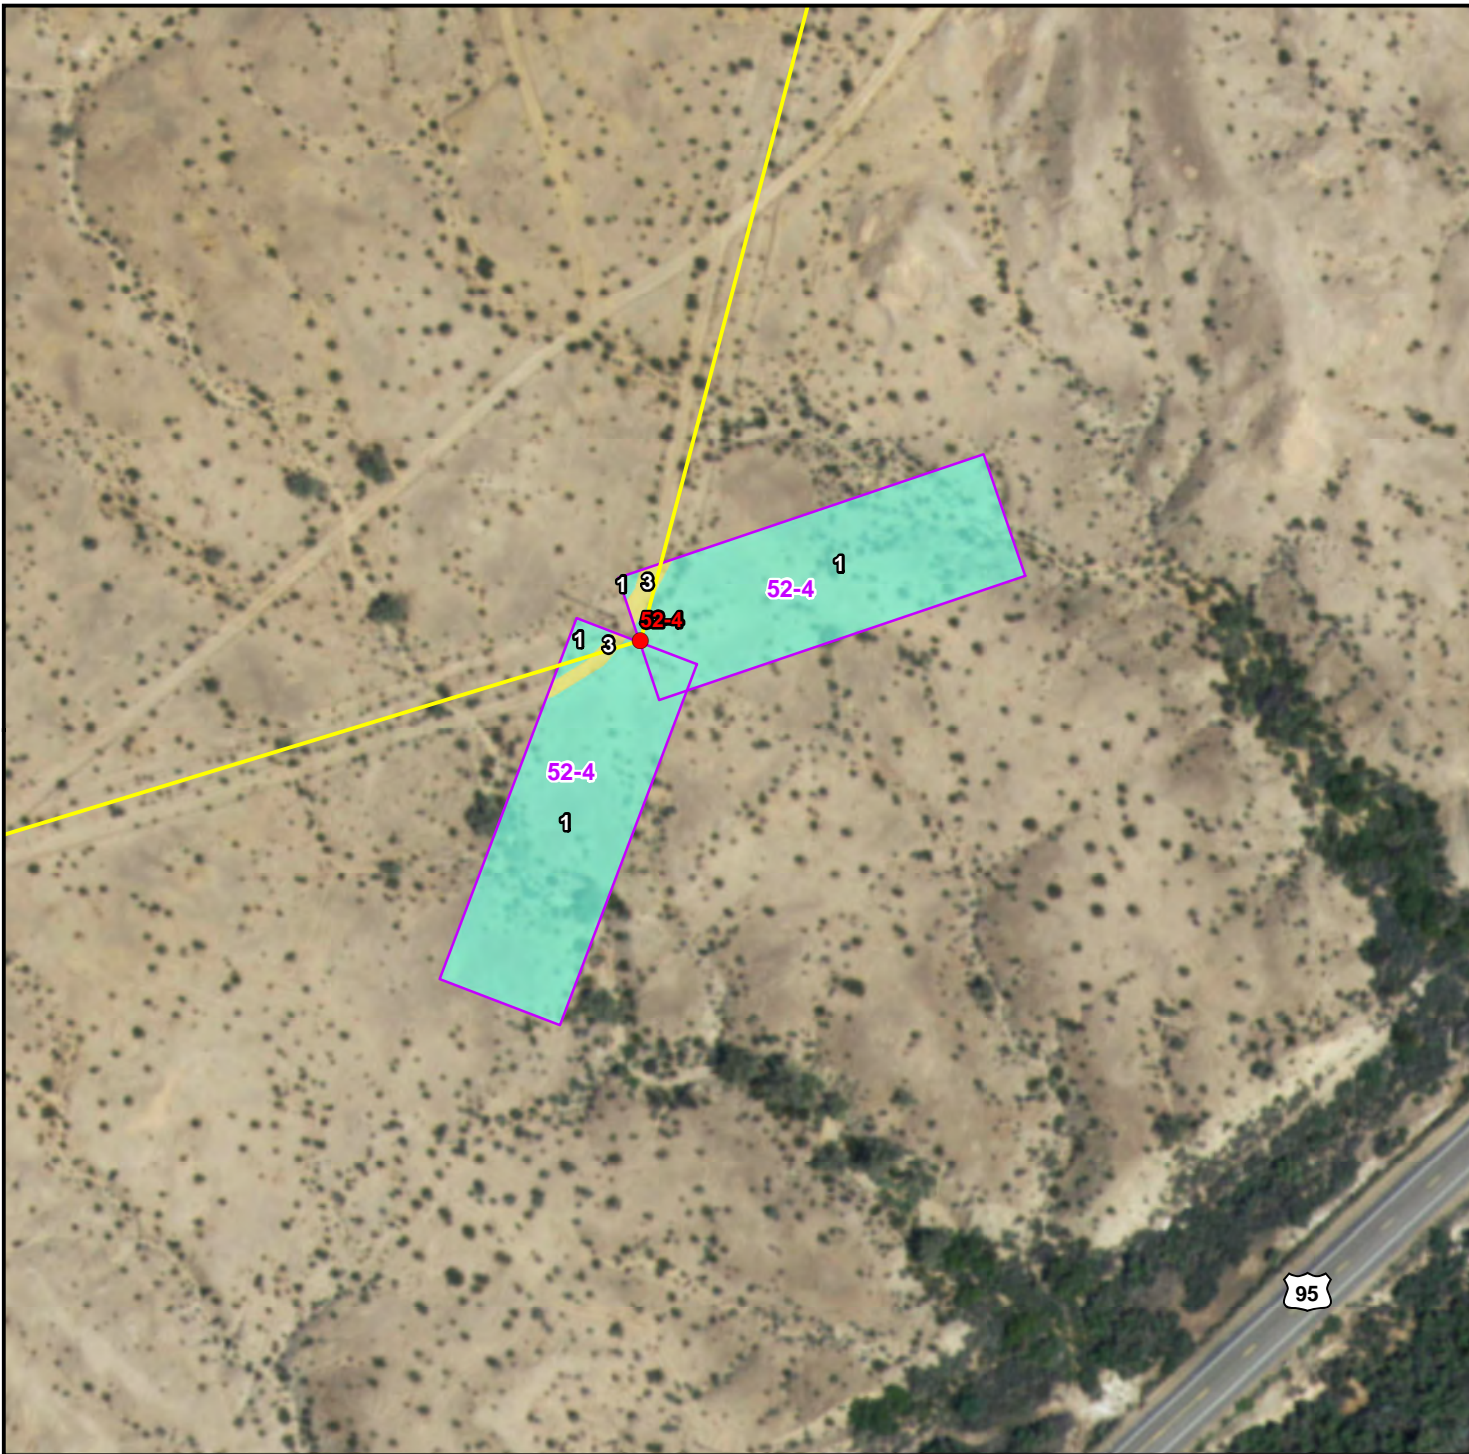
Figure 4
Vidal FOC
Vegetation Communities
Pull Site: 54-1

- Structures
 - Transmission Line
 - Pull Sites
- Vegetation Community Surveys**
- 1. Creosote Bush Scrub
 - 3. Bare Ground

Alverson's foxtail cactus is a CRPR 4.3 species that typically blooms between April and June. Alverson's foxtail cactus is not afforded special protection under CEQA as it is only on a State Watch List species but individuals present within the Survey Area (Figure 10) should be avoided or translocated if possible. Alverson's foxtail cactus was observed during the survey effort at the following pull sites: one location within 52-4 (southern area) and many locations within 54-1.

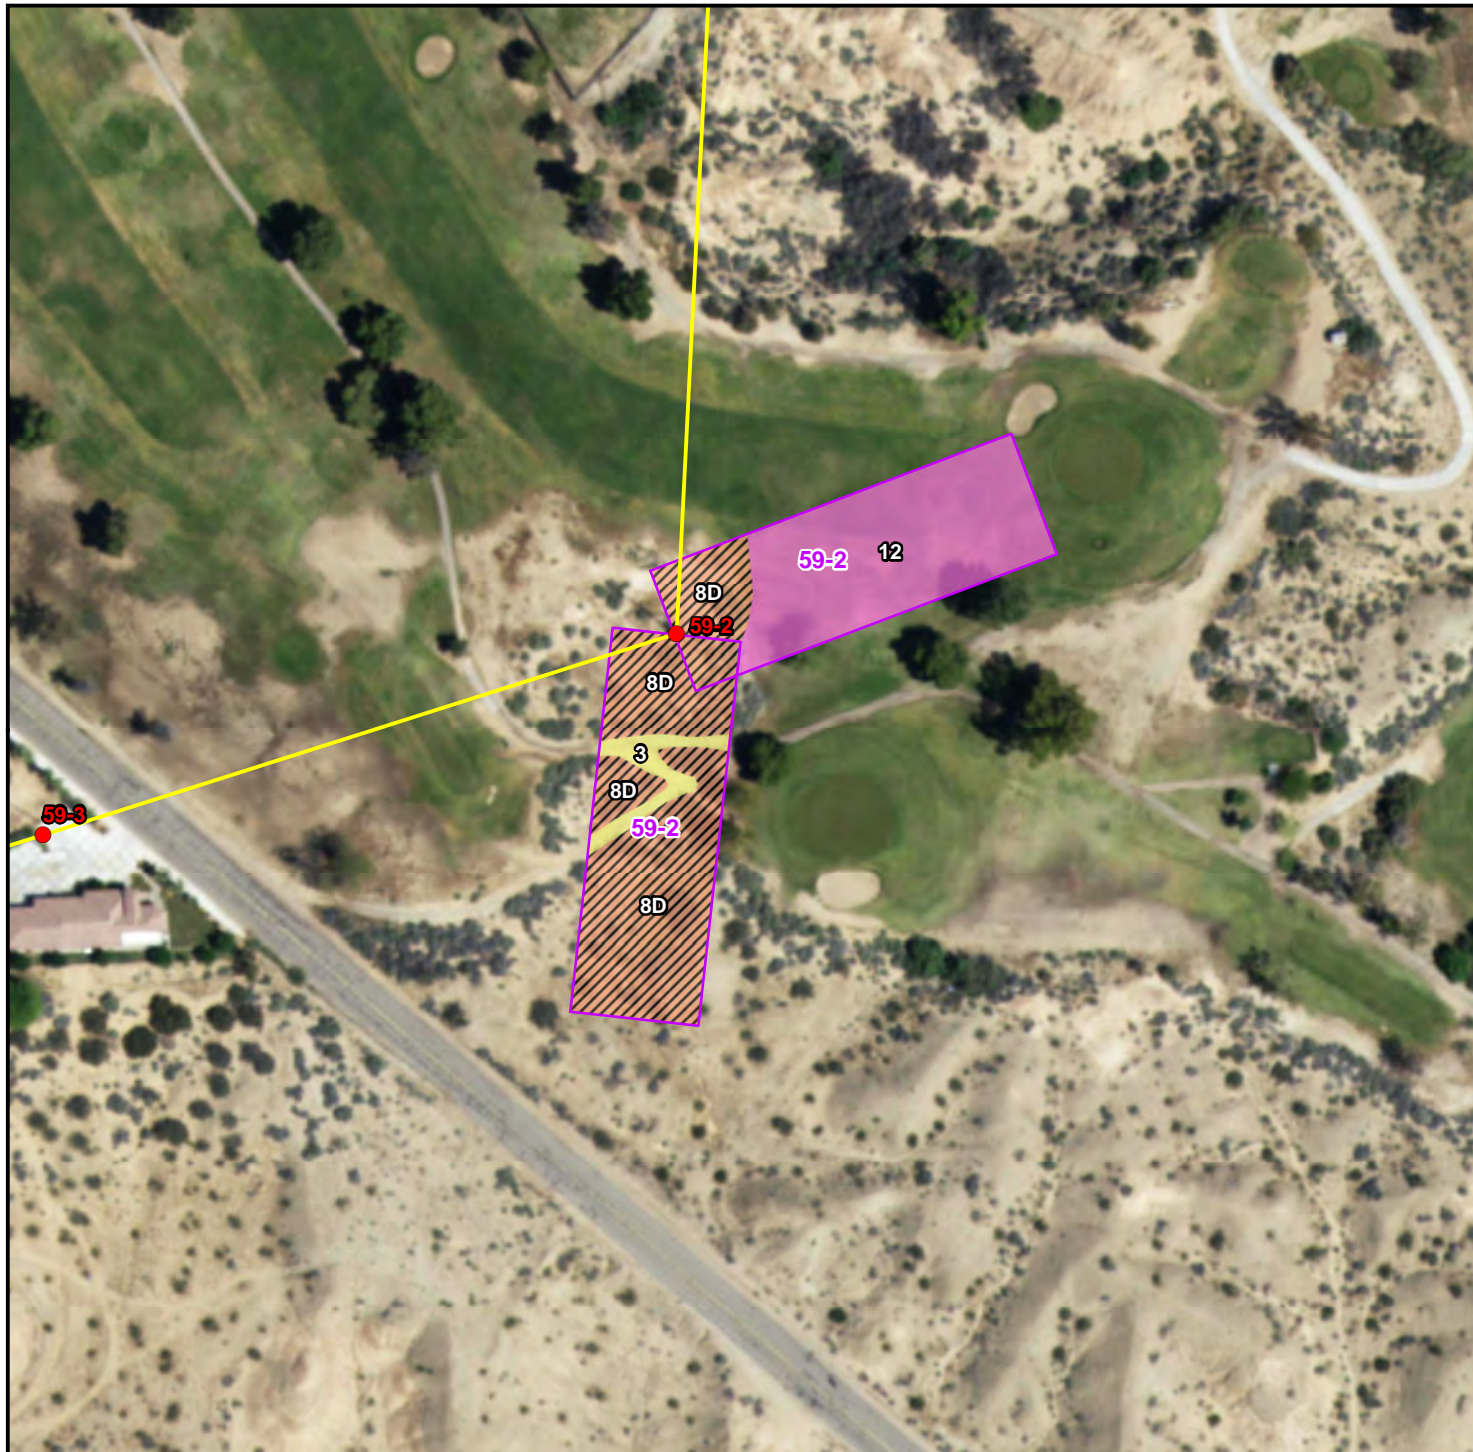
Figure 4
Vidal FOC
Vegetation Communities
Pull Site: 59-2

- Structures
- Transmission Line
- Pull Sites
- Vegetation Community Surveys**
- 3. Bare Ground
- ▨ 8D. Disturbed Allscale Scrub
- 12. Agriculture/Ornamental

The vermilion flycatcher (*Pyrocephalus rubinus*) is a California Species of Concern. It is a widespread tropical species whose range barely extends northward into the southwestern United States, where it breeds locally northward to southeastern California and southern Nevada. It may be found in wet oases in desert and semi-arid habitats and in diverse mixes of trees, brush, and grassy openings near open water. The male vermilion flycatcher has brilliant red underparts and a crown that contrast with the rest of its blackish coloration. Nests are open-cup and are usually 8-20 ft. above the ground in a horizontal fork of a large tree (Bent, 1942). Although the advent of various man-made habitat oases, such as parks, golf courses, and suburbs, in areas formerly supporting desert scrub have provided potential flycatcher nesting locations in the Mojave Desert of California, these areas also provide excellent foraging habitat for the brown-headed cowbird (*Molothrus ater*), a brood parasite known to use this flycatcher as a host (Hanna, 1936). This species was observed during the reconnaissance survey foraging in an ornamental tree near pull site 59-2 at the Blythe Golf Course and is considered present within the Survey Area.

The vermilion flycatcher is a California Species of Concern. This species was observed during the reconnaissance survey foraging in an ornamental tree near pull site 59-2 at the Blythe Golf Course and is considered present within the Survey Area.

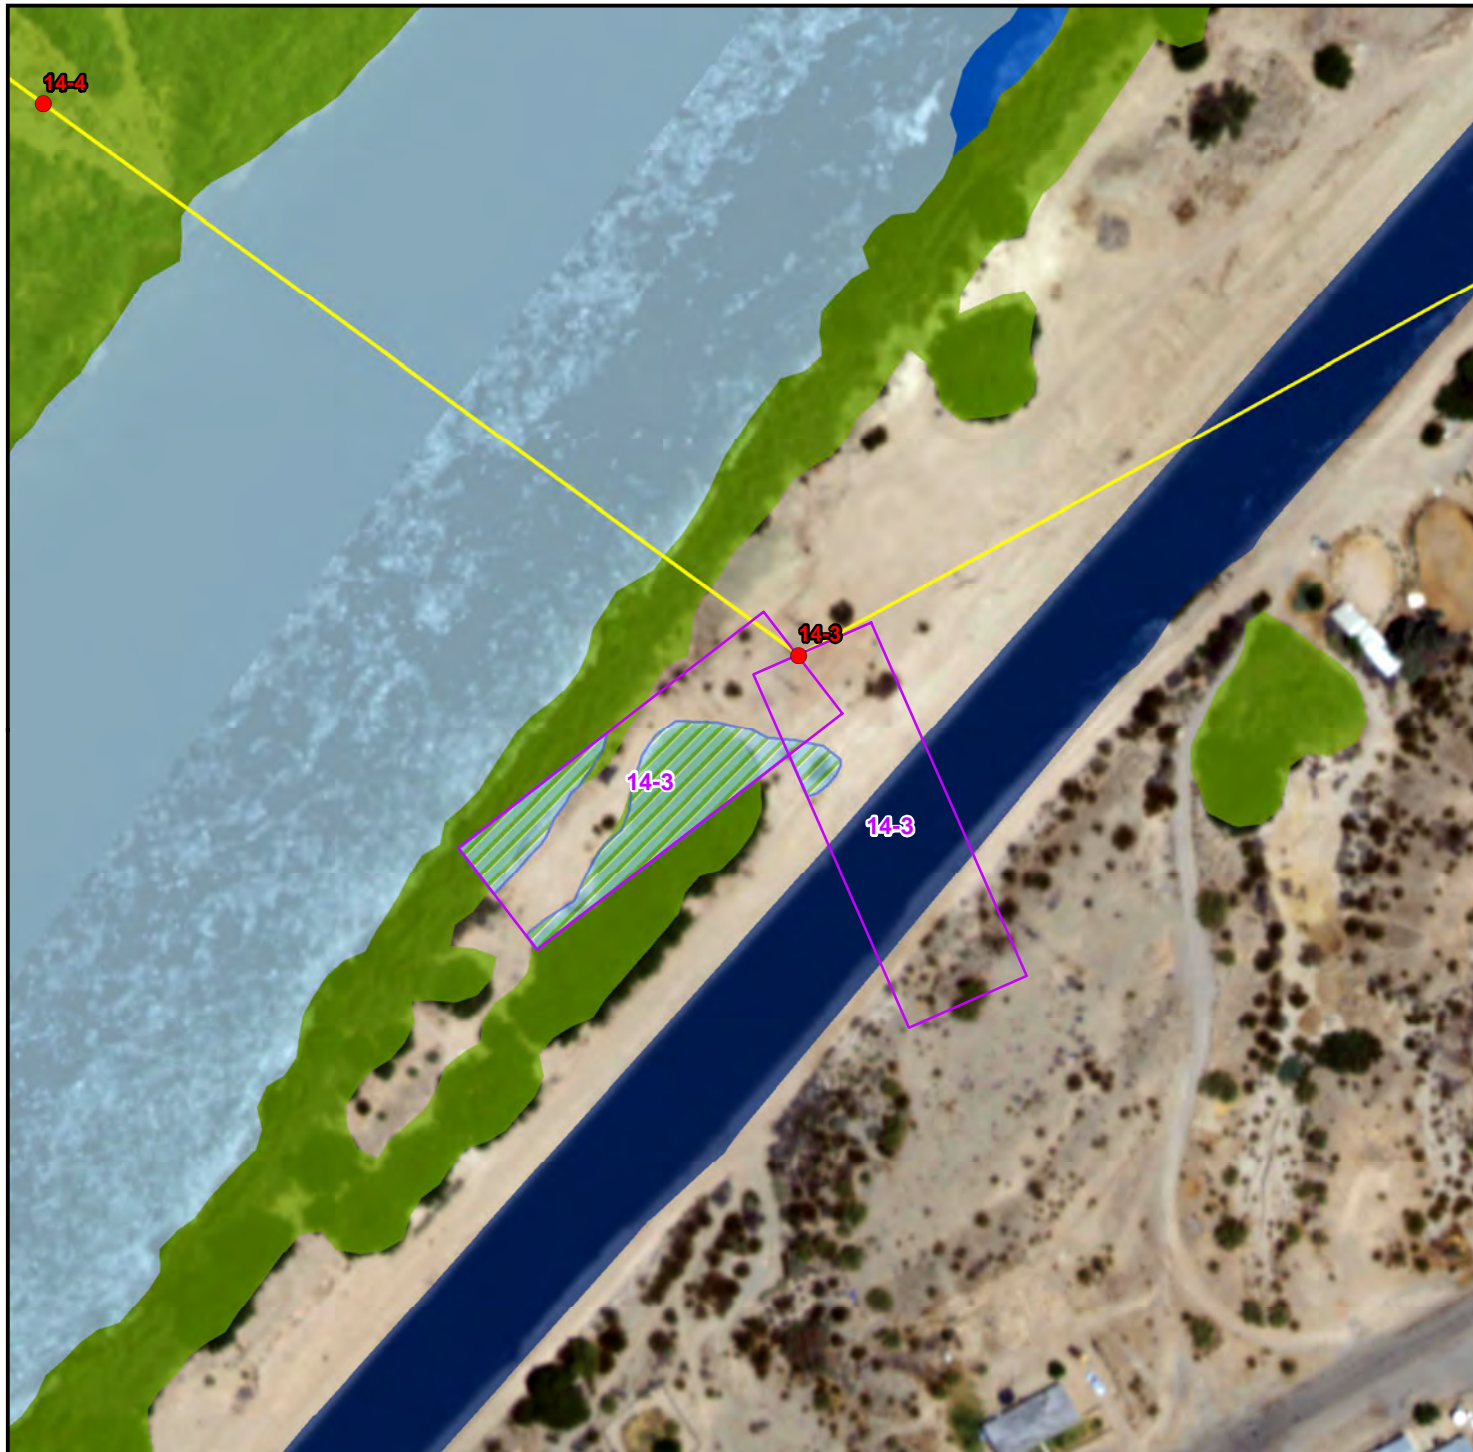
Pull Site: 14-3

- Structures
 - Pull Sites
 - Transmission Line
- NWI**
- Freshwater Emergent Wetland
 - Freshwater Forested/Shrub Wetland
 - Freshwater Pond
 - Lake
 - Riverine
- Jurisdictional Delineation Results**
- Bank to Bank
 - ▨ Wetland Results
- Non-Jurisdictional Features**
- Erosional Feature
 - Man-made Berm
 - ▲ Culvert
 - No Water Feature

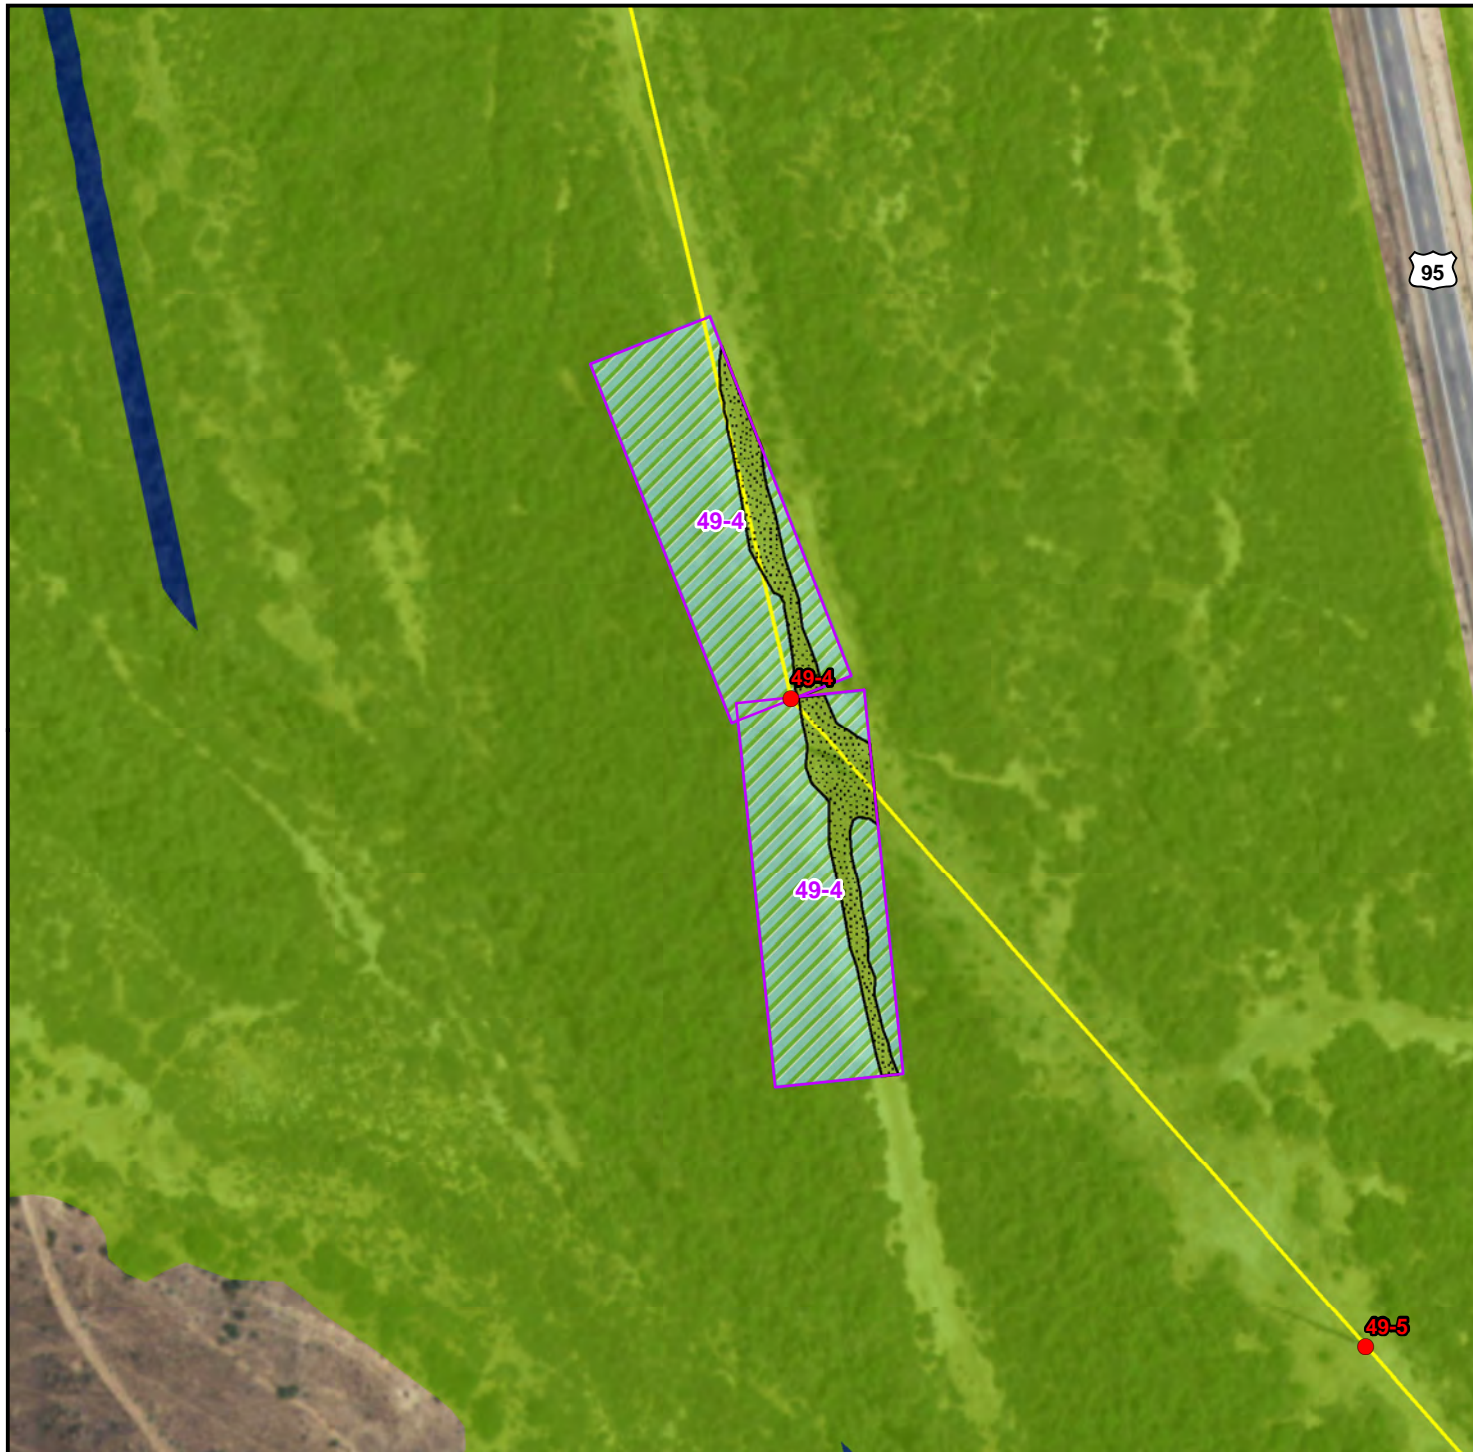
Pull Site: 49-4

- Structures
 - Pull Sites
 - Transmission Line
- NWI**
- Freshwater Emergent Wetland
 - Freshwater Forested/Shrub Wetland
 - Freshwater Pond
 - Lake
 - Riverine
- Jurisdictional Delineation Results**
- Bank to Bank
 - Wetland Results
- Non-Jurisdictional Features**
- Erosional Feature
 - Man-made Berm
 - ▲ Culvert
 - No Water Feature

- Pull site 49-4 is located approximately 4,200 feet west of the Colorado River, immediately east and adjacent to Interstate 95. Approximately 50 percent of this site contains Tamarisk Thickets and Arrow Weed Thickets; however, agriculture development in this area has separated the Colorado River from this riparian/wetland habitat. Water is currently received from ephemeral drainages from the west and vegetation in this area has become more arid and is not suitable for sensitive species that require wet/moist, riparian habitats. In addition, pull site operations can be contained within the access road and adjacent bare ground areas within the proposed pull sites. Therefore, impact to riparian habitat is not anticipated.

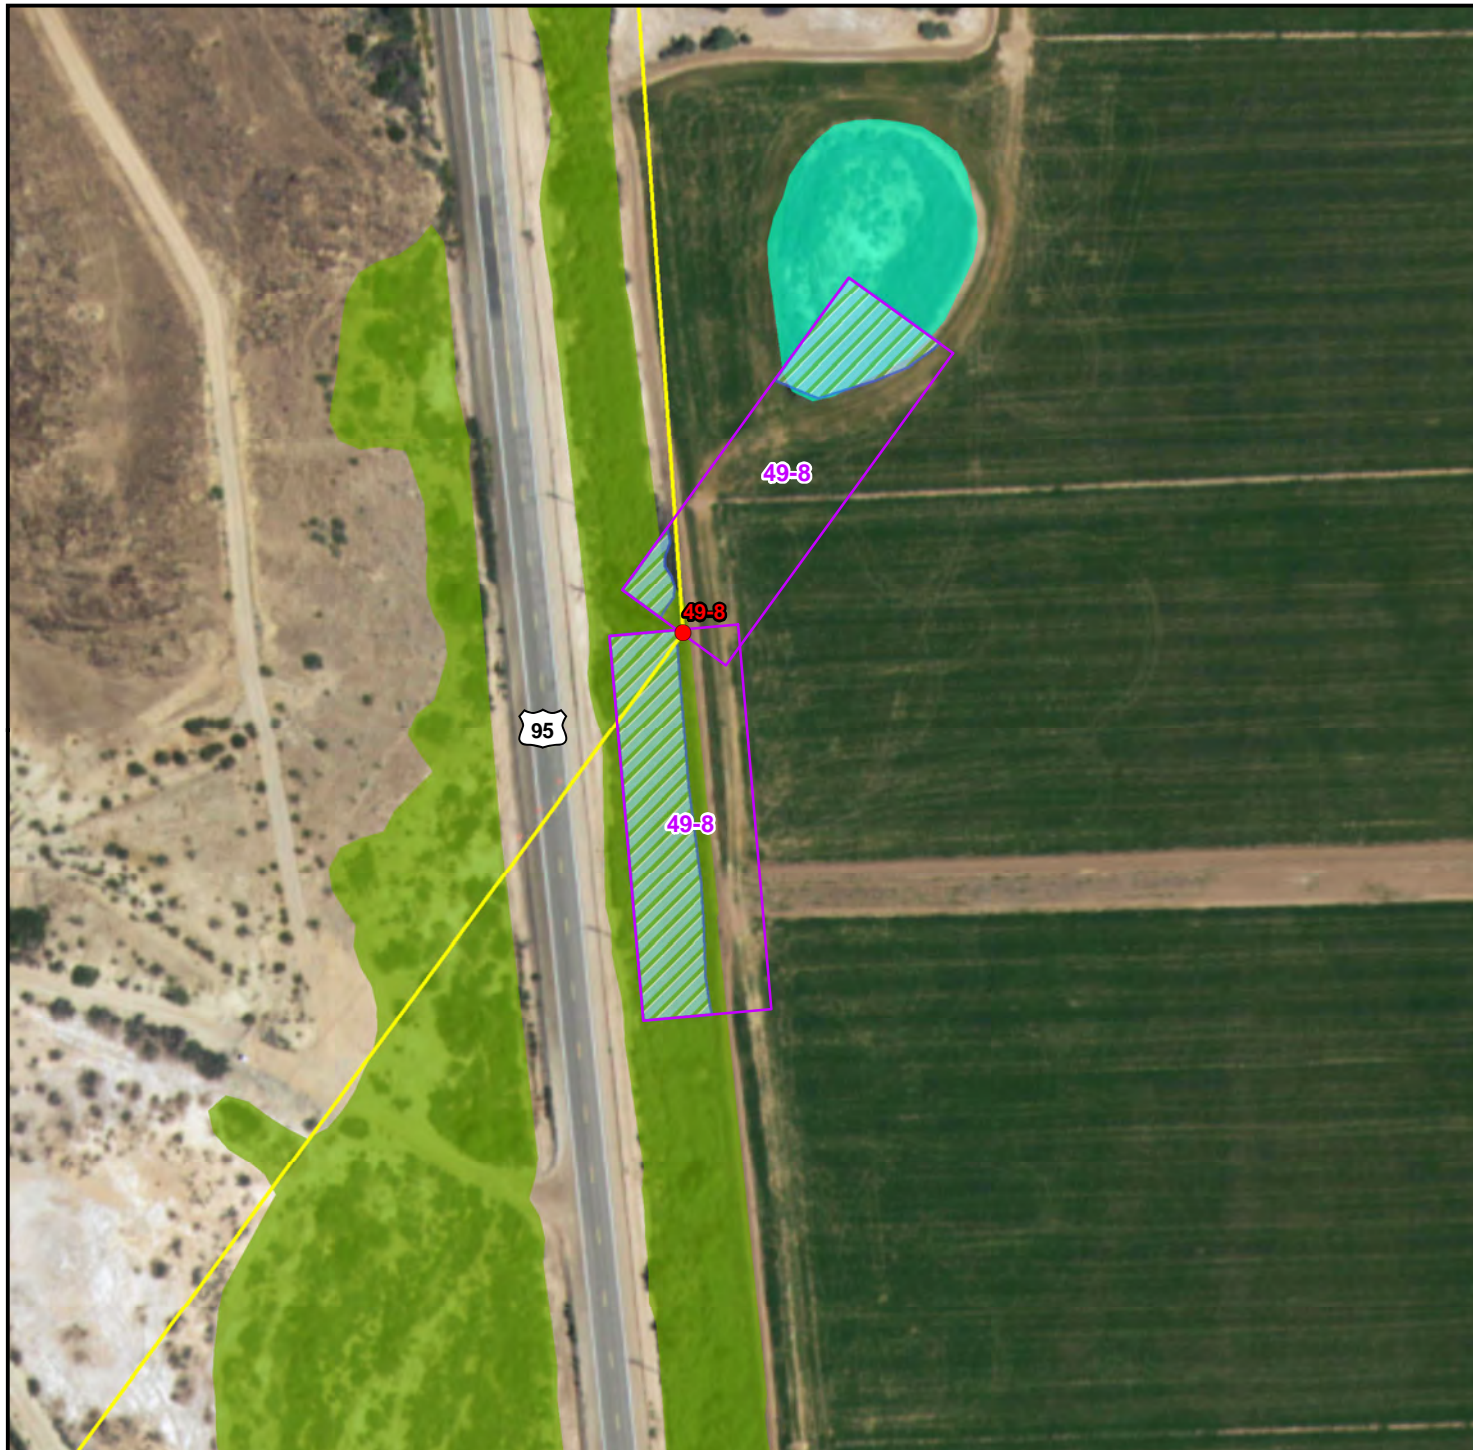
Figure 8
 Vidal FOC
 Jurisdictional Delineation Results
 Pull Site: 49-8

- Structures
- Pull Sites
- Transmission Line
- NWI**
- Freshwater Emergent Wetland
- Freshwater Forested/Shrub Wetland
- Freshwater Pond
- Lake
- Riverine
- Jurisdictional Delineation Results**
- Bank to Bank
- Wetland Results
- Non-Jurisdictional Features**
- Erosional Feature
- Man-made Berm
- ▲ Culvert
- No Water Feature

- Pull site 49-8 is located approximately 3,400 feet west of the Colorado River, immediately east and adjacent to Interstate 95. This area is highly disturbed. The majority of pull site 49-8 contains agriculture and bare ground. Two areas of scattered Tamarisk Thickets and Arrow Weed Thickets exist; however, agriculture development in this area has separated the Colorado River from this riparian/wetland habitat. Water is currently received from ephemeral drainages from the west and vegetation in this area has become more arid and is not suitable for sensitive species that require wet/moist, riparian habitats. In addition, pull site operations can be contained within the access road and adjacent bare ground areas within the proposed pull sites. Therefore, impact to riparian habitat is not anticipated.

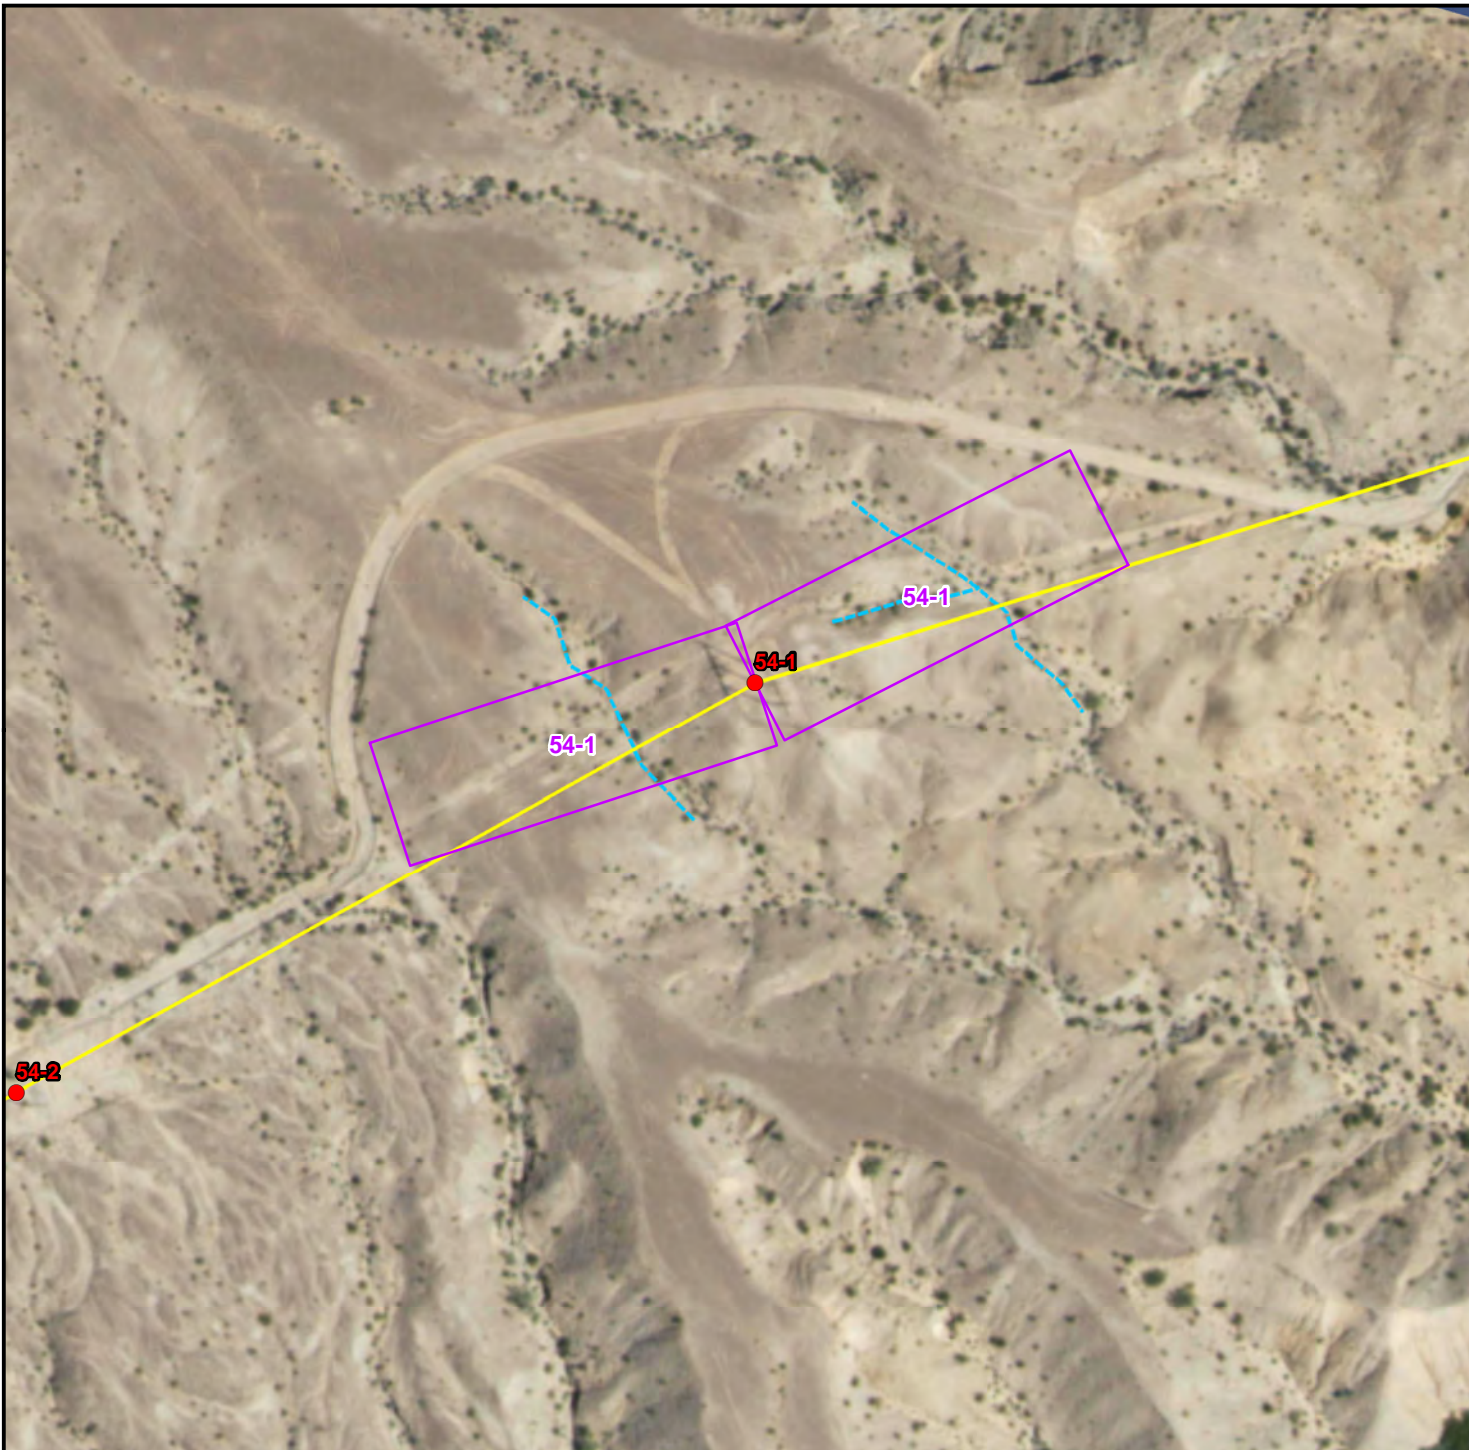
Pull Site: 54-1

- Structures
- Pull Sites
- Transmission Line
- NWI**
- Freshwater Emergent Wetland
- Freshwater Forested/Shrub Wetland
- Freshwater Pond
- Lake
- Riverine
- Jurisdictional Delineation Results**
- Bank to Bank
- Wetland Results
- Non-Jurisdictional Features**
- Erosional Feature
- Man-made Berm
- ▲ Culvert
- No Water Feature

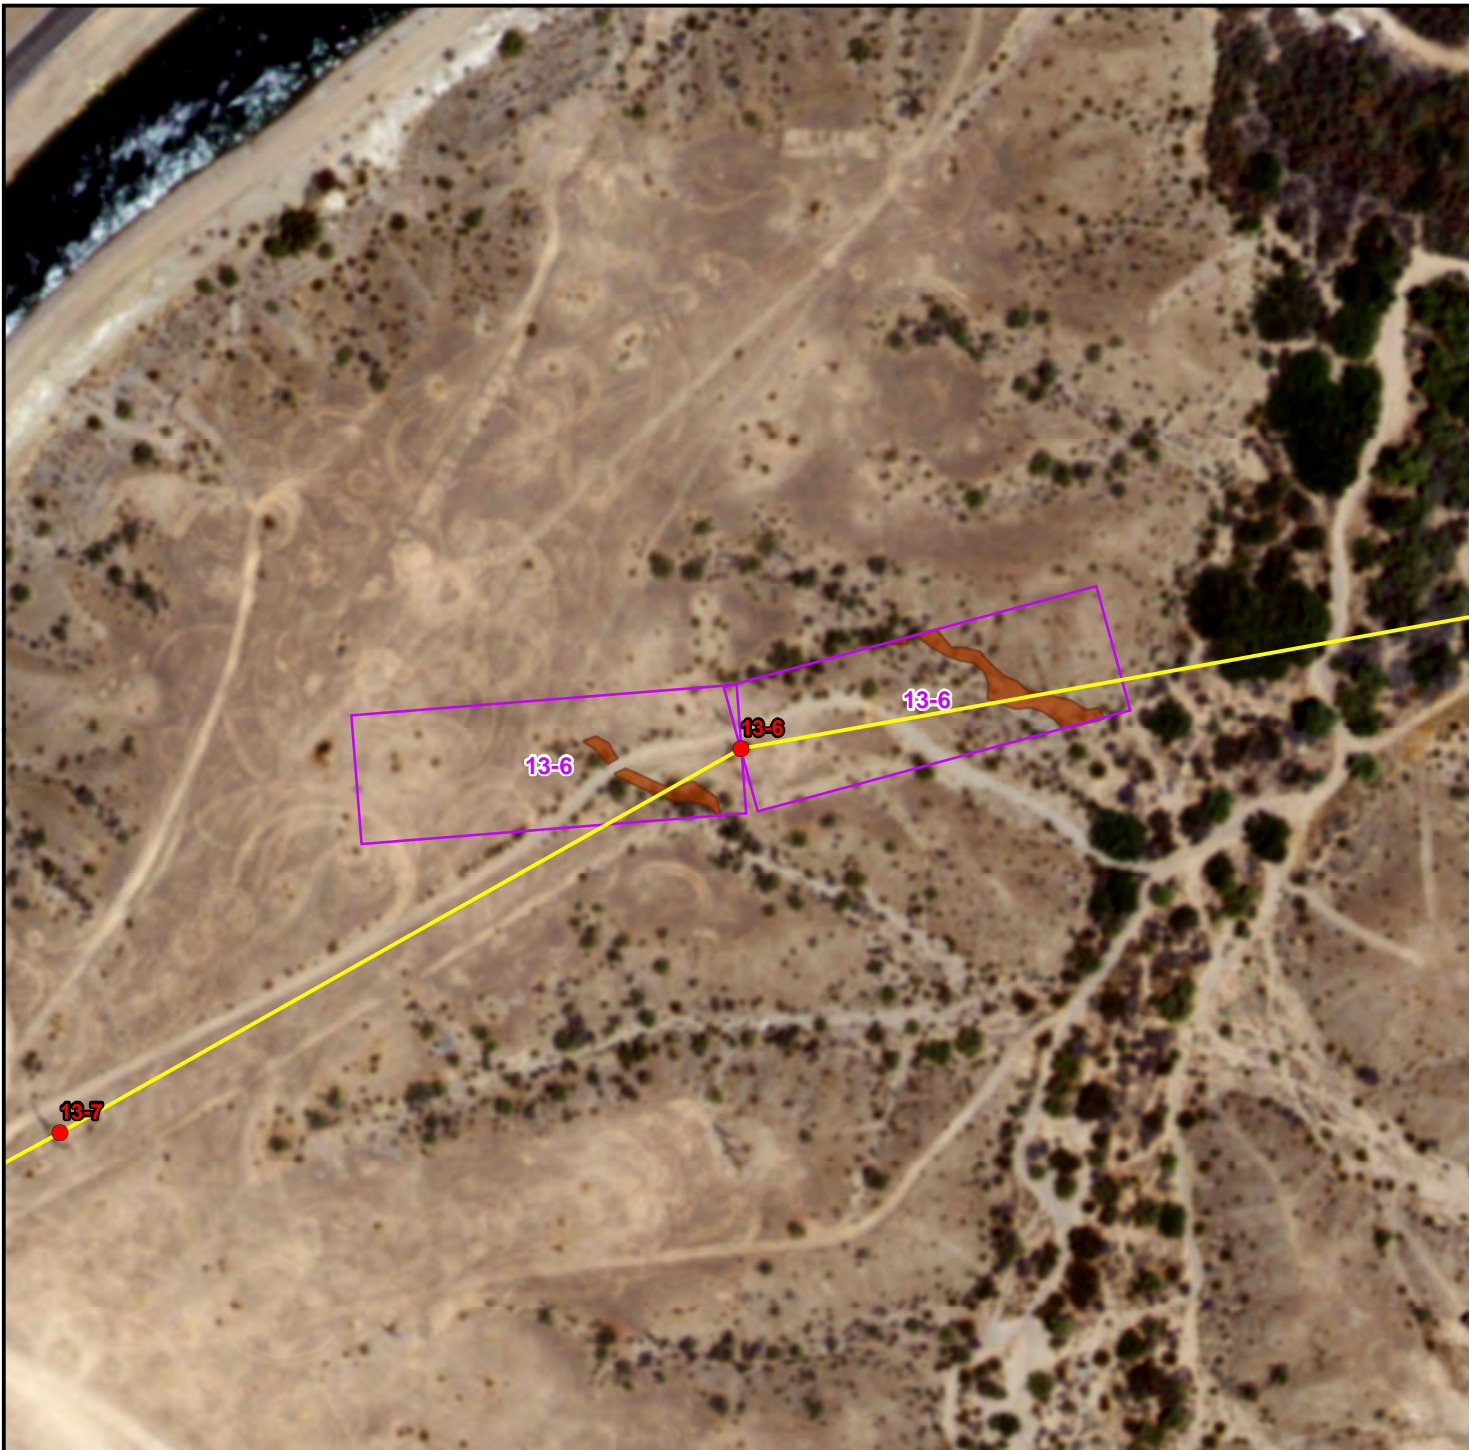
Figure 9
Vidal FOC
Impacts to Jurisdictional Waters
Pull Site: 13-6

- Structures
 - Transmission Line
 - Pull Sites
- Impacts to Jurisdictional Waters**
- Bank to Bank - 0.07 ac

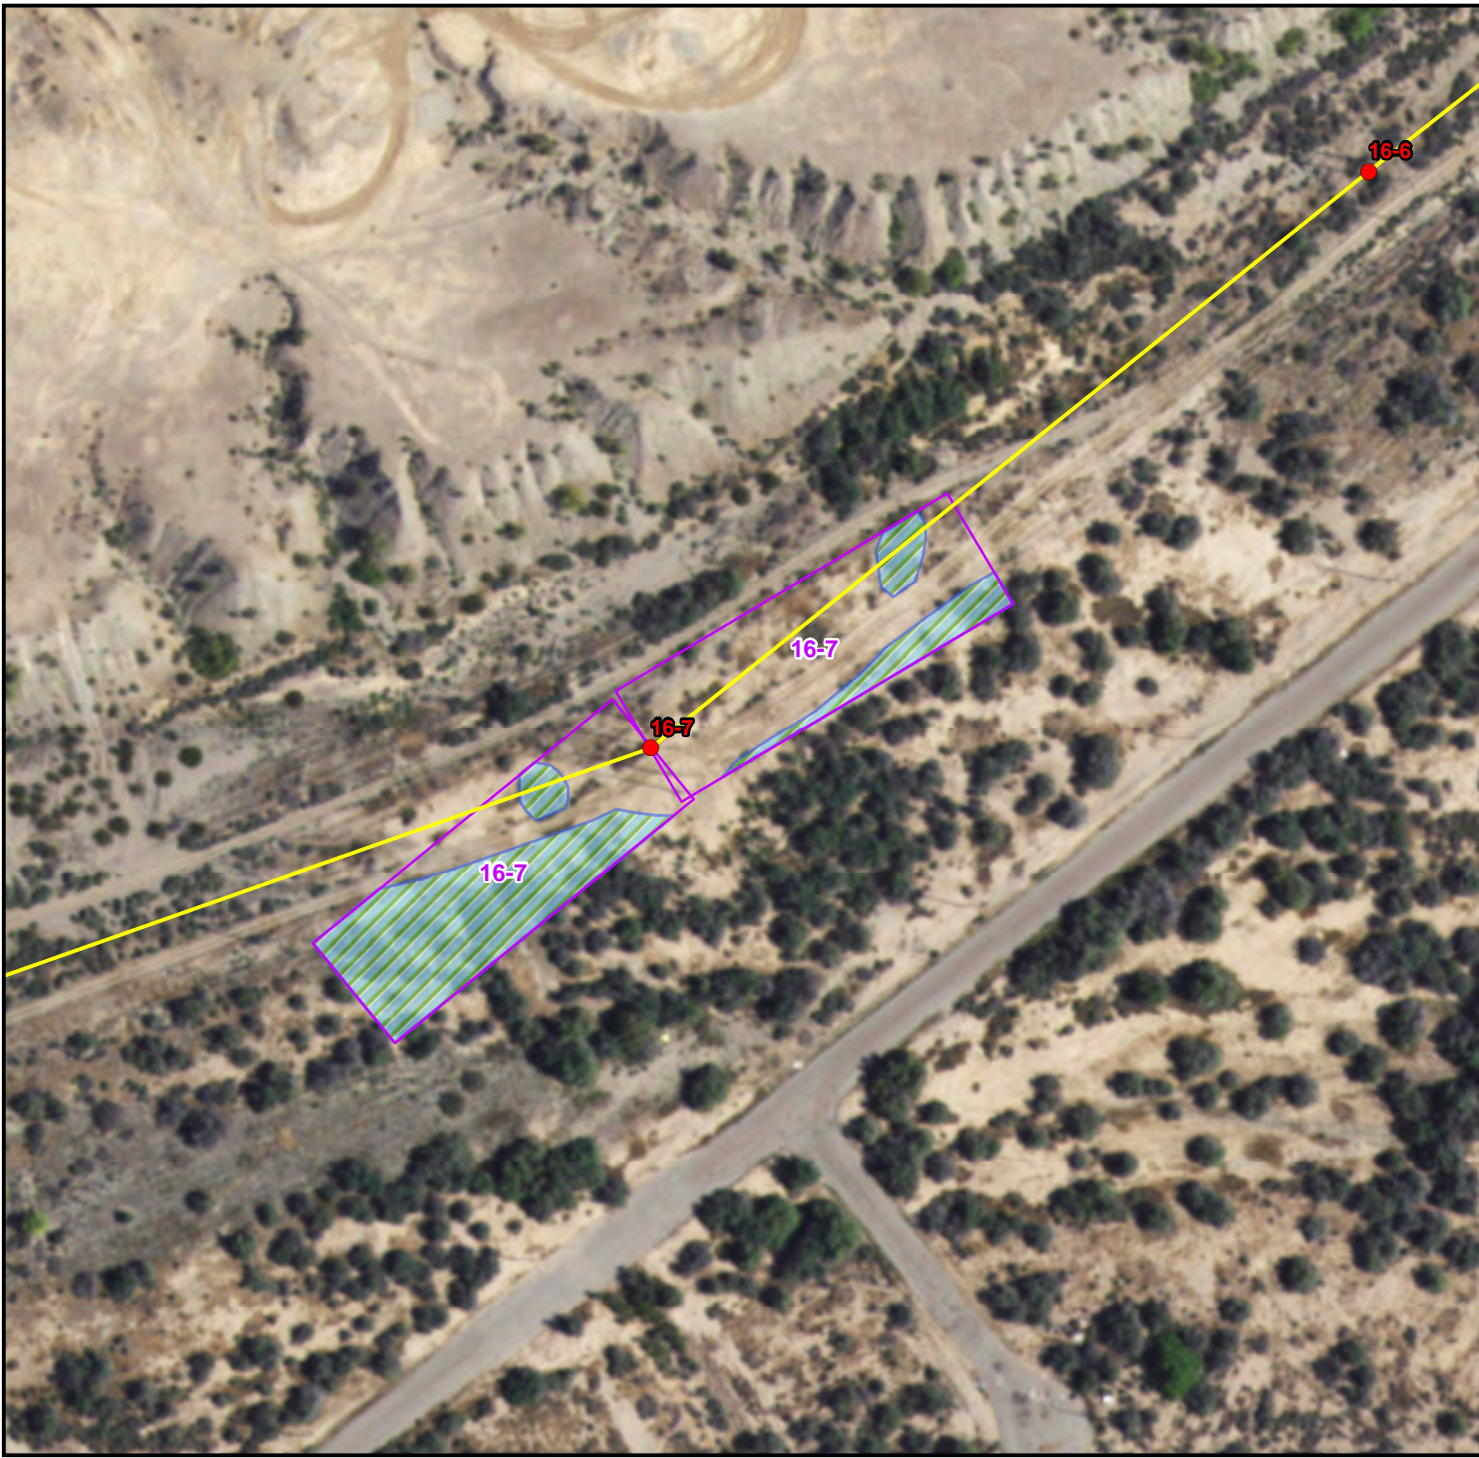
Figure 9
Vidal FOC
Impacts to Jurisdictional Waters
Pull Site: 16-7

- Structures
 - Transmission Line
 - Pull Sites
- Impacts to Jurisdictional Waters**
- ▨ Wetland Results - 0.60 ac

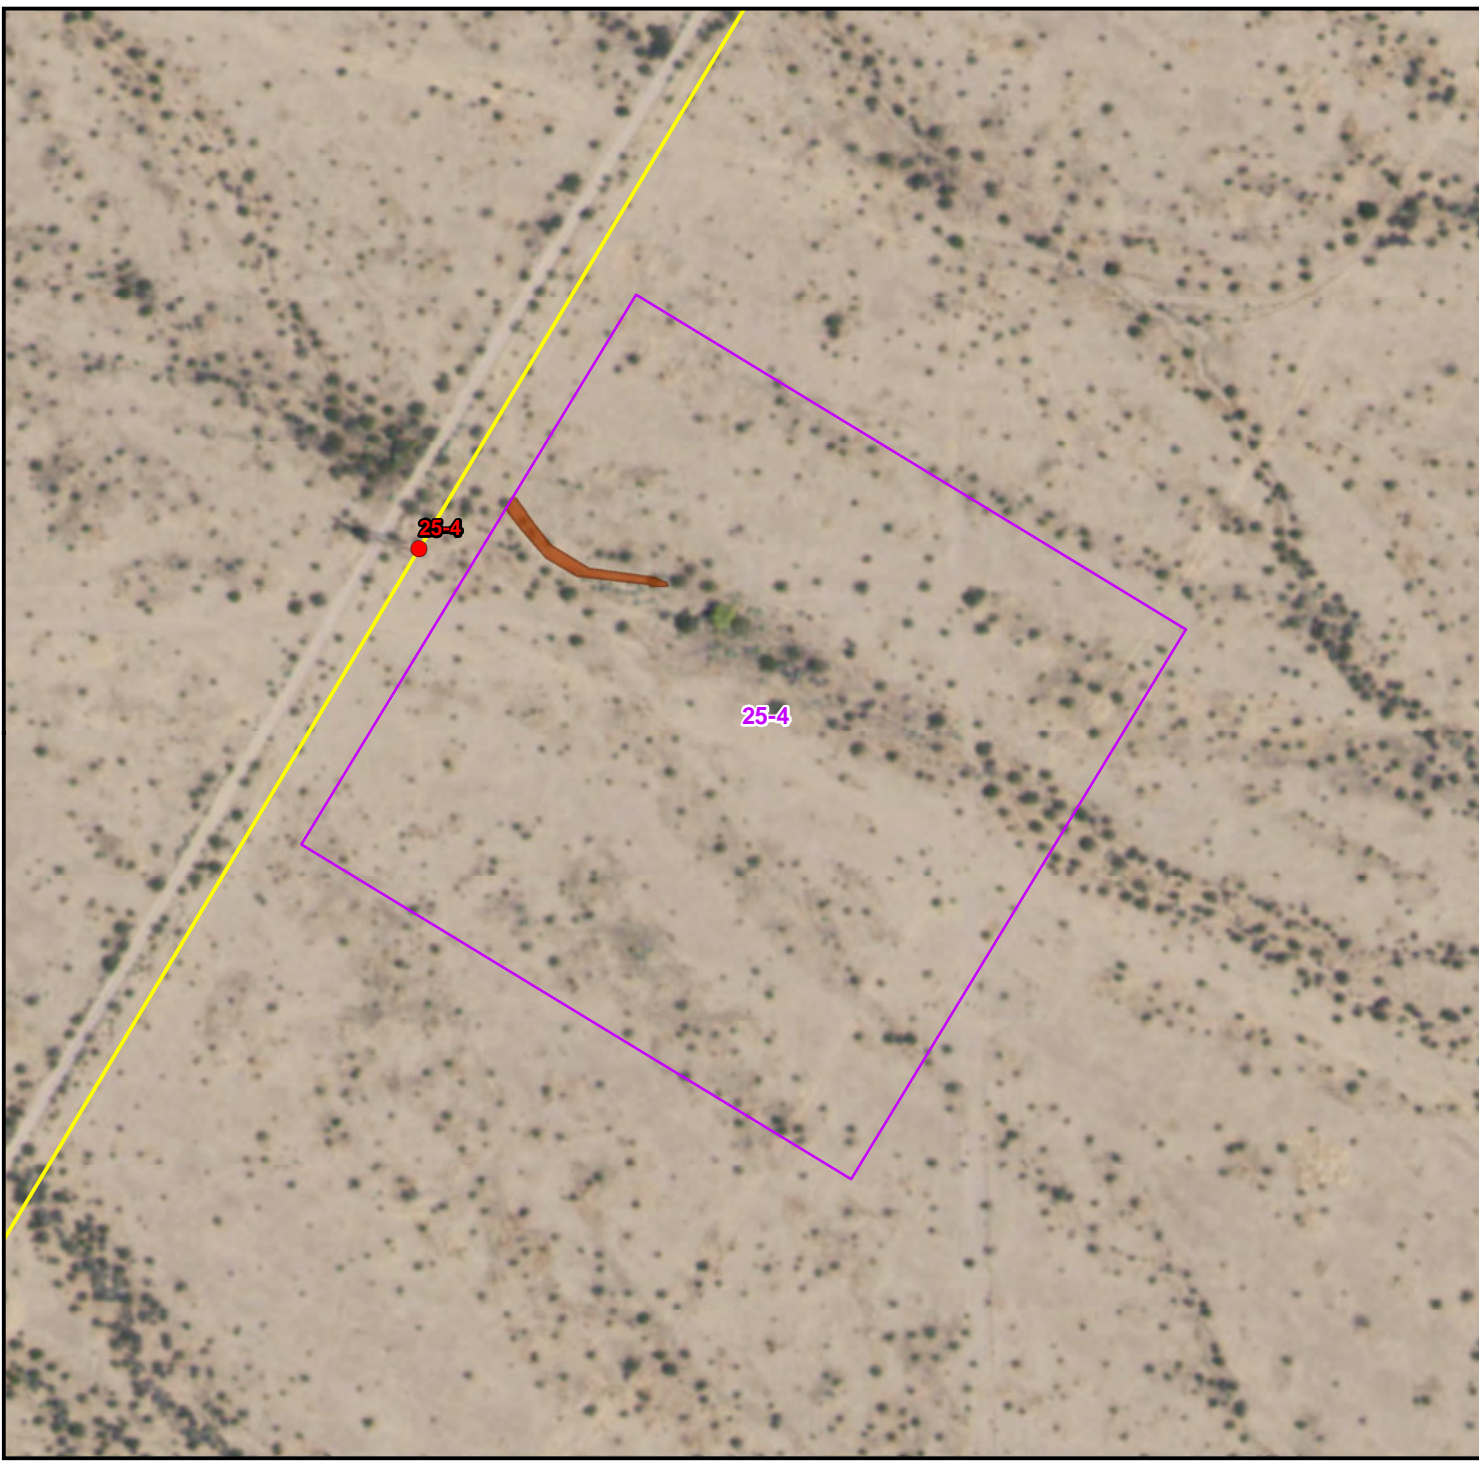
Figure 9
Vidal FOC
Impacts to Jurisdictional Waters
Pull Site: 25-4

- Structures
 - Transmission Line
 - Pull Sites
- Impacts to Jurisdictional Waters**
- Bank to Bank - 0.03 ac
