Appendix D – Biological Resources Report

July 1, 2022

Subject: Biological Resources Reconnaissance Assessment for the Vidal Solar Interconnection Project

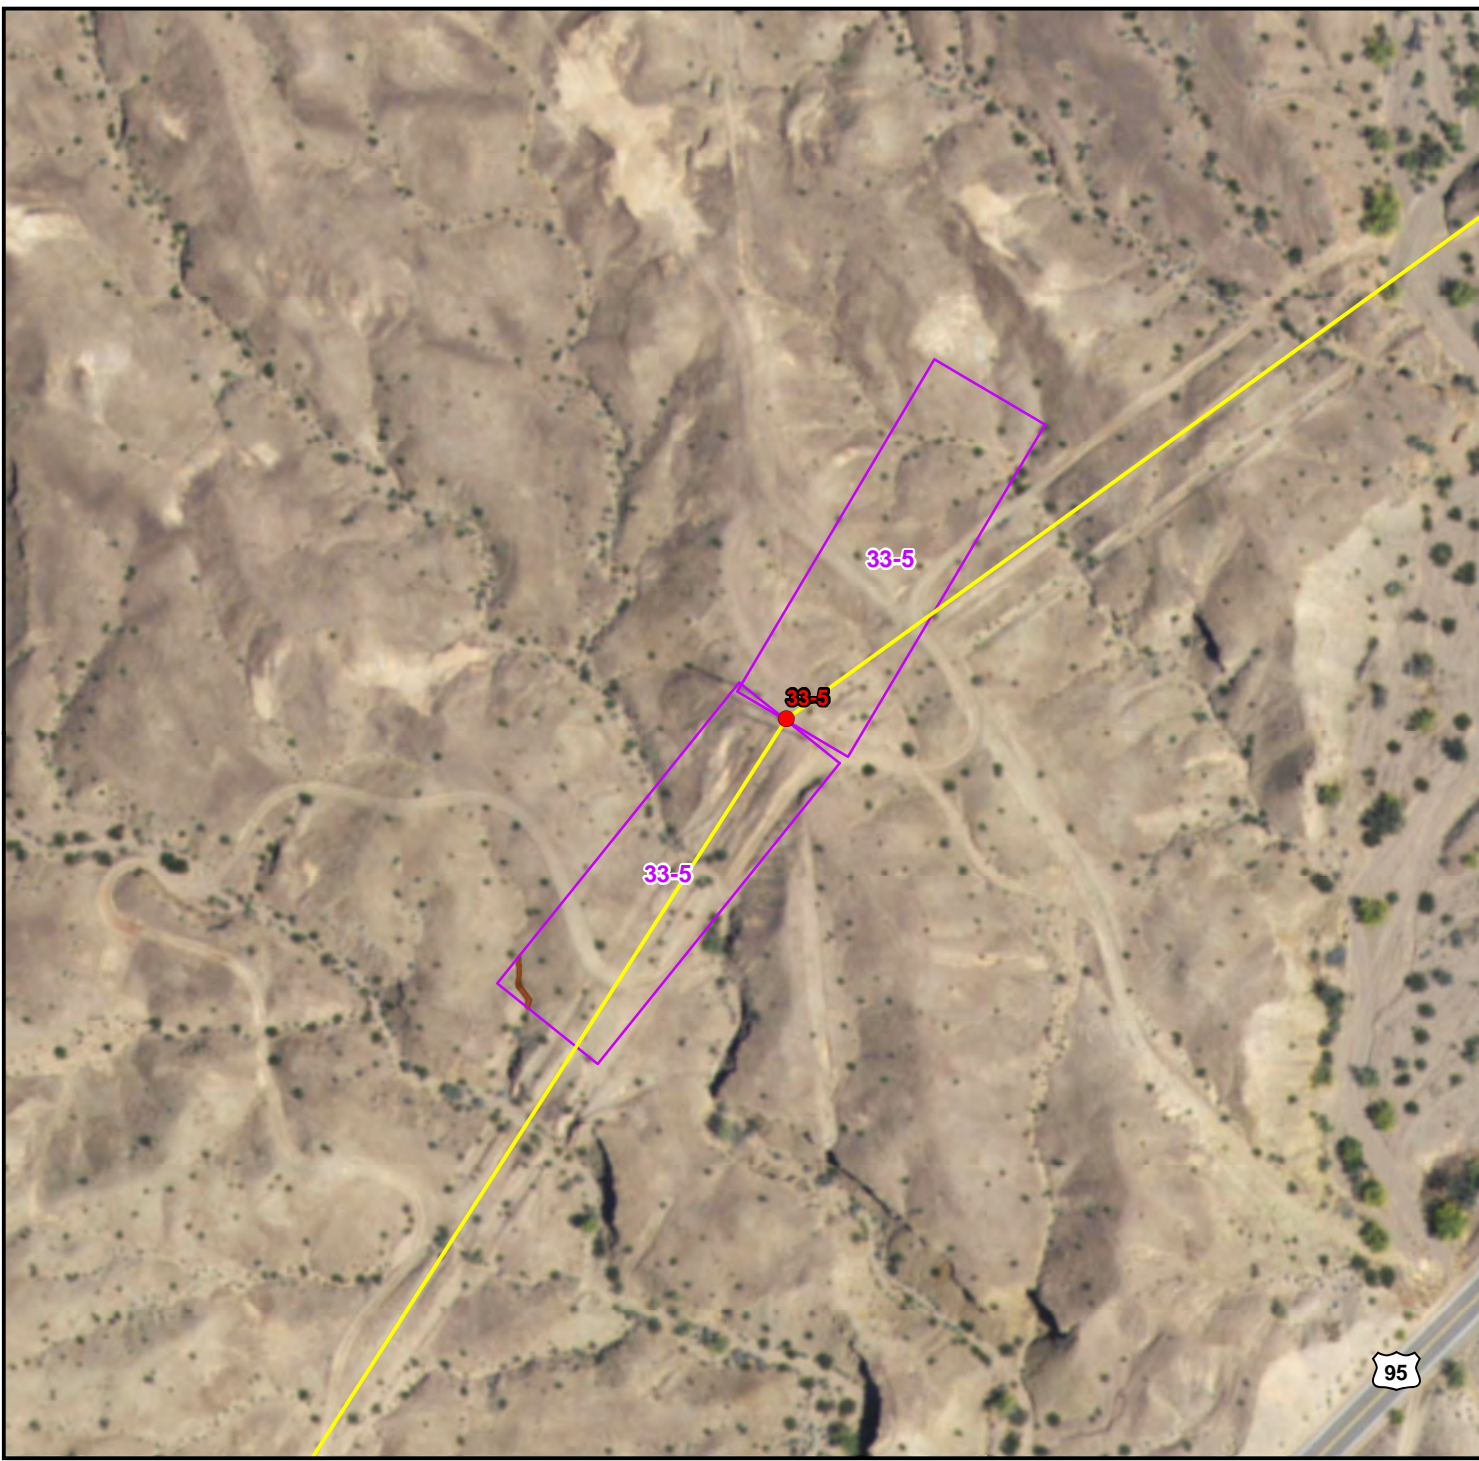
Figure 9
Vidal FOC
Impacts to Jurisdictional Waters
Pull Site: 33-5

- Structures
 - Transmission Line
 - Pull Sites
- Impacts to Jurisdictional Waters**
- Bank to Bank - 0.003 ac

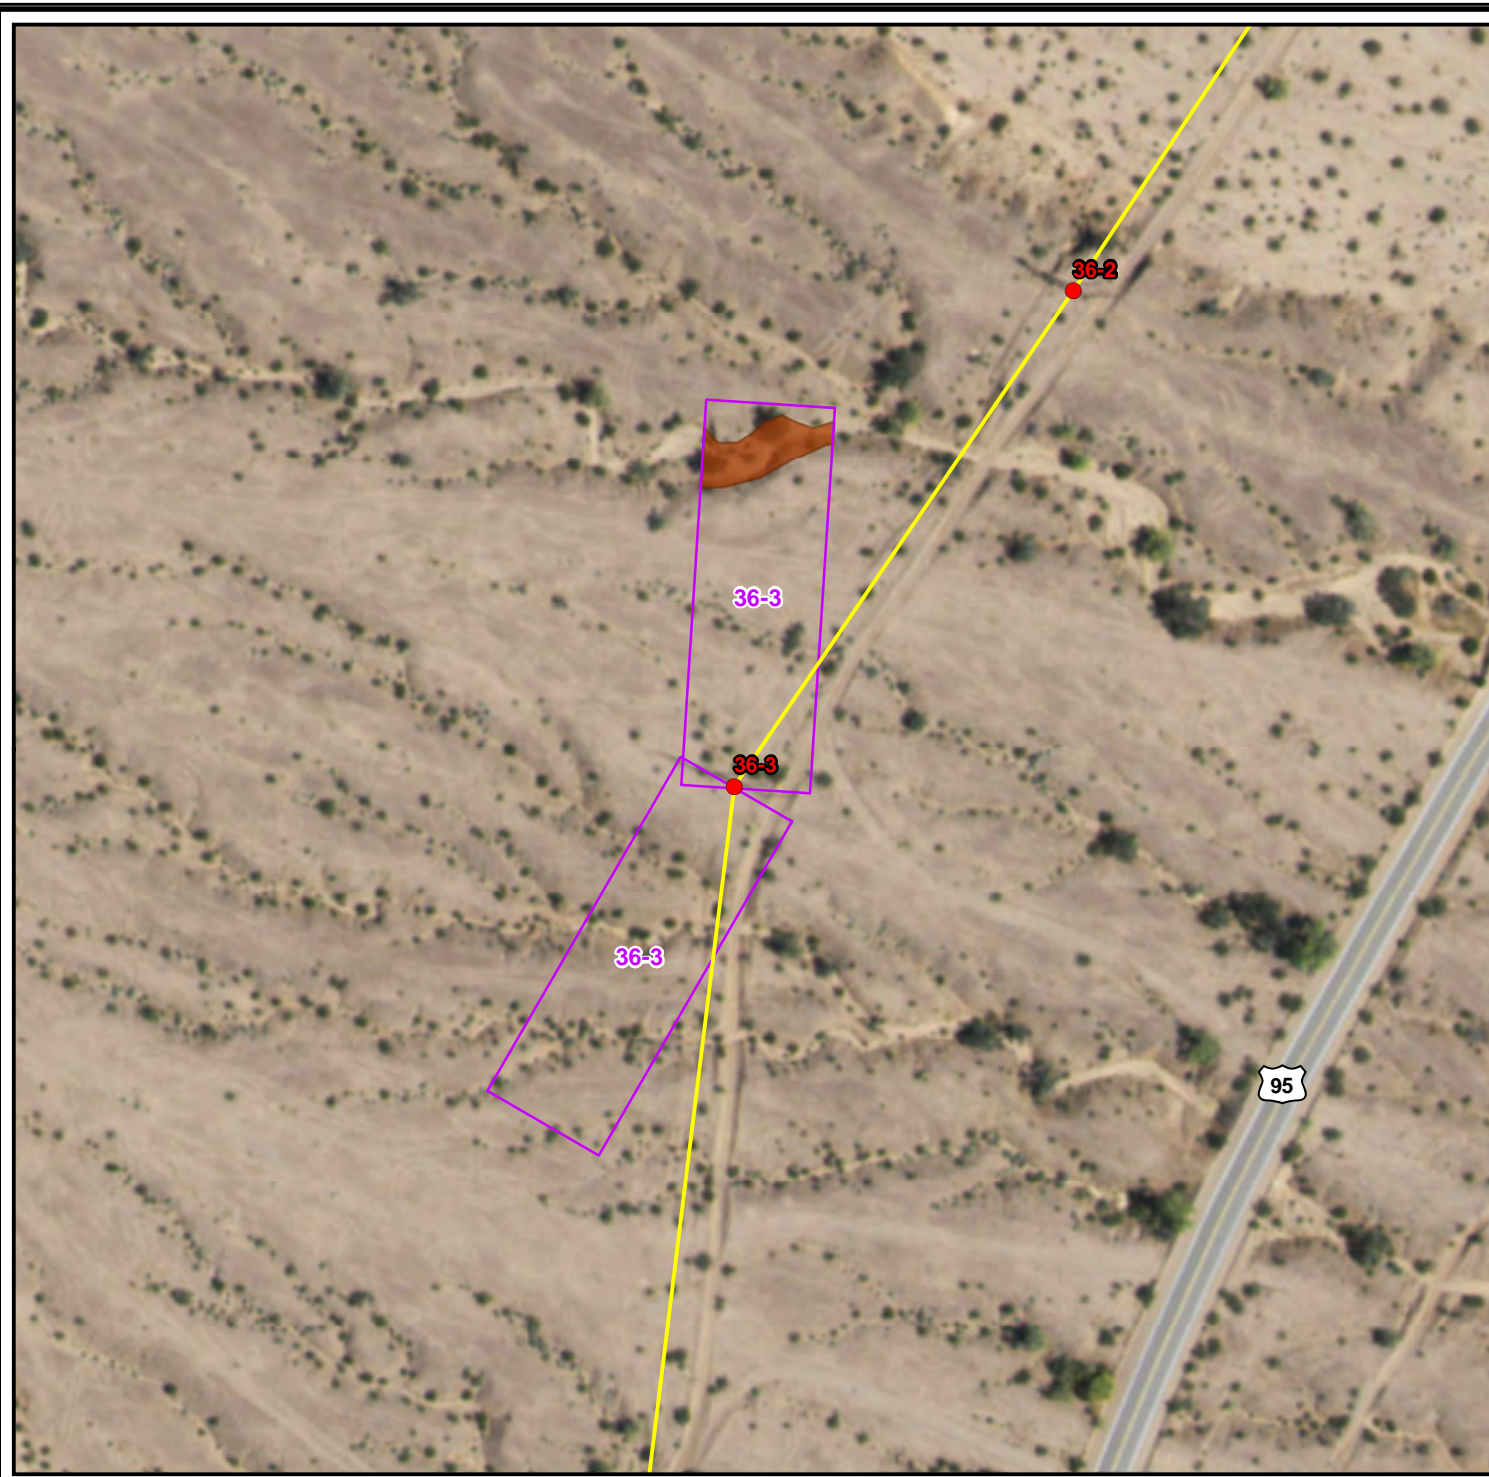
Figure 9
Vidal FOC
Impacts to Jurisdictional Waters
Pull Site: 36-3

- Structures
 - Transmission Line
 - Pull Sites
- Impacts to Jurisdictional Waters**
- Bank to Bank - 0.07 ac

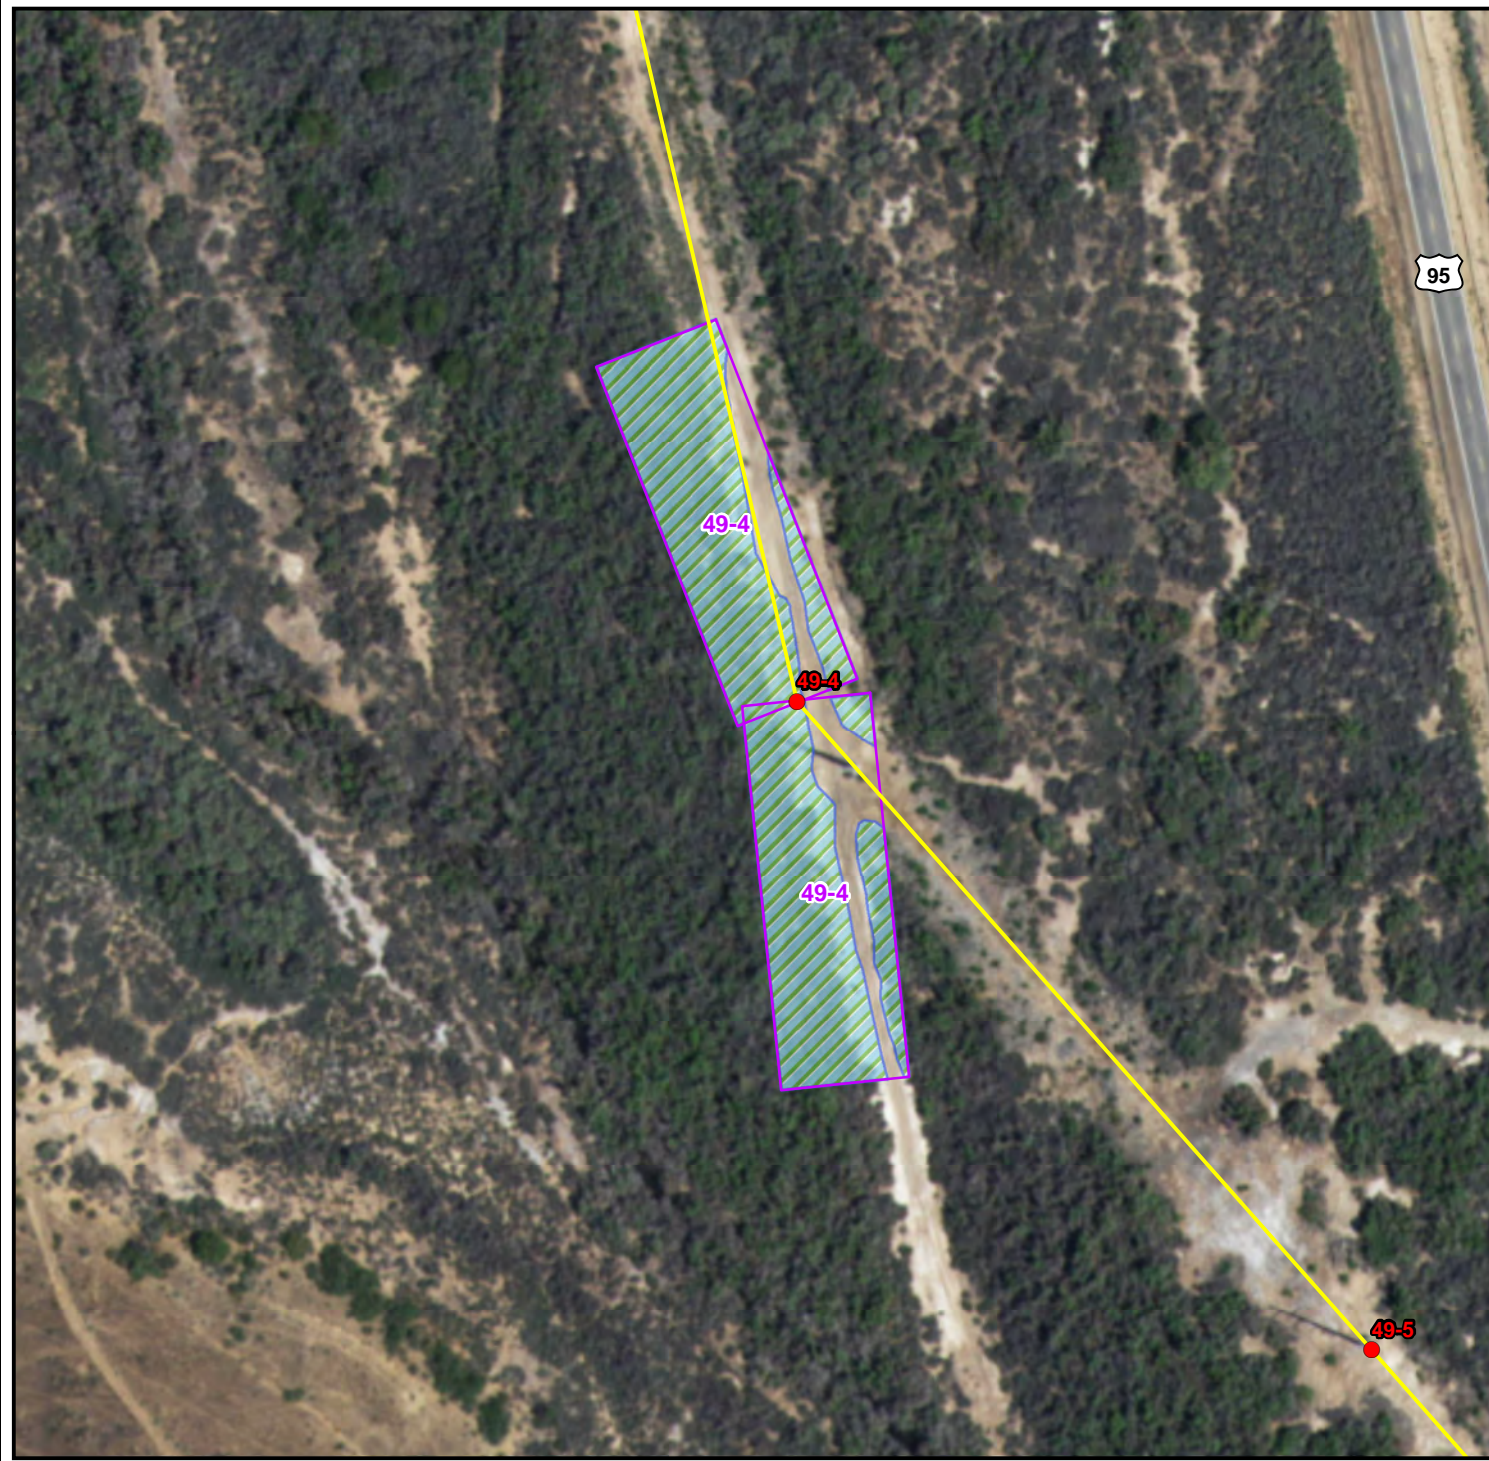
Figure 9
Vidal FOC
Impacts to Jurisdictional Waters
Pull Site: 49-4

- Structures
 - Transmission Line
 - Pull Sites
- Impacts to Jurisdictional Waters**
- ▨ Wetland Results - 1.11 ac

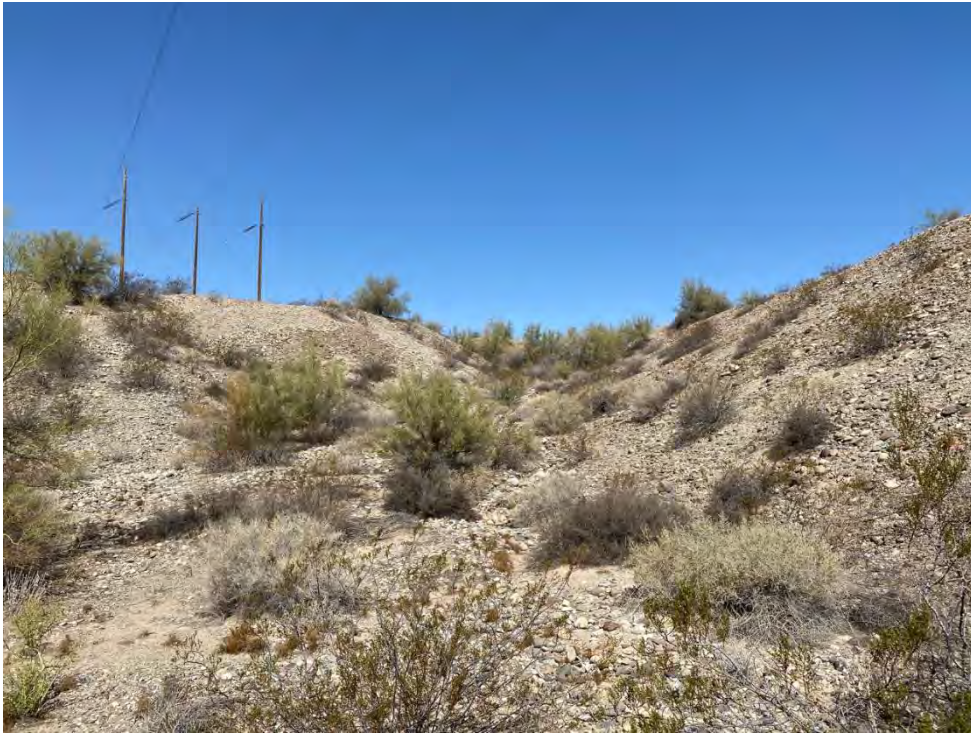
Photo 1

Pull site 13-6 looking at ephemeral drainage near the eastern end of the site. This area can be avoided.

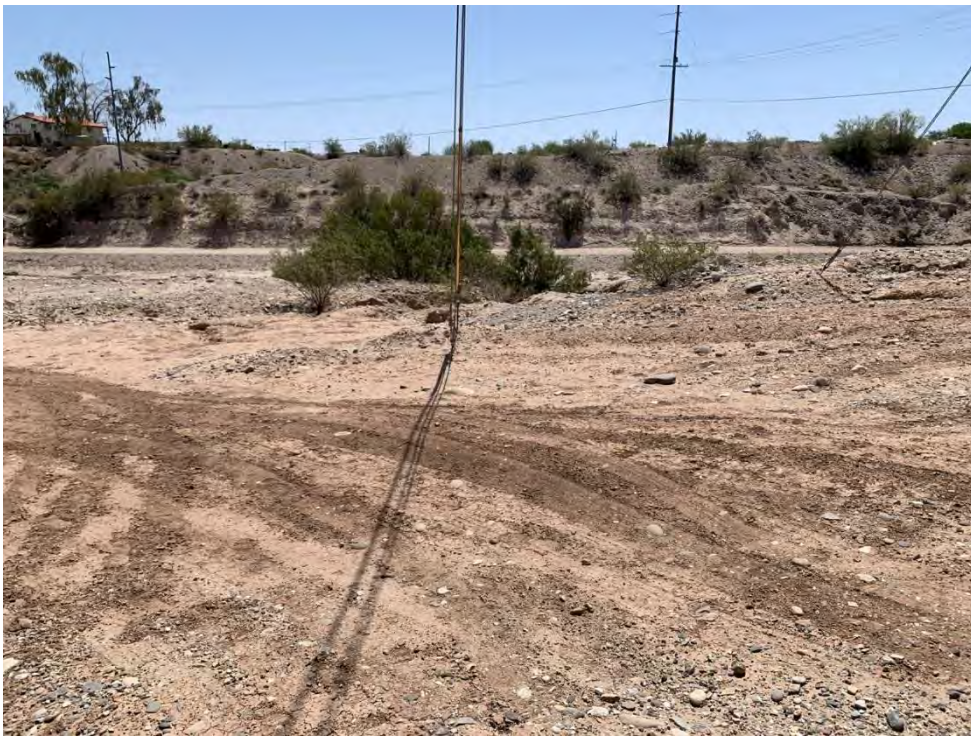
Photo 2

Pull site 14-3 bare ground area looking south. Wetland vegetation in area can be avoided.

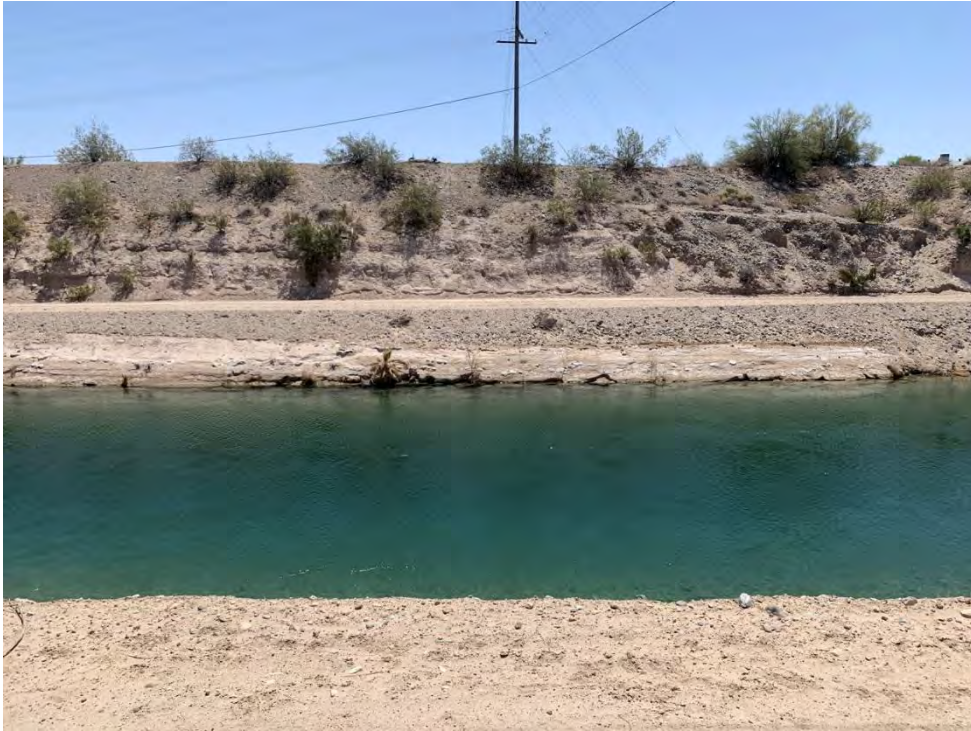
Photo 3

Pull site 14-3, looking at Main Canal that can be avoided during pull site operations.

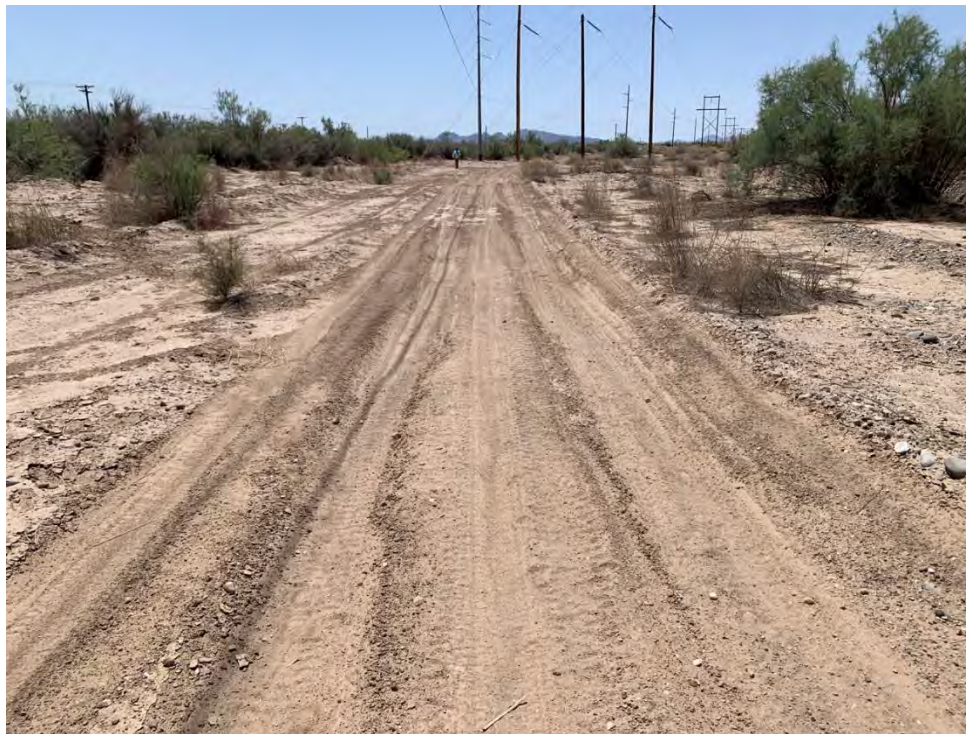
Photo 4

Pull site 16-7 looking southwest. Scattered Tamarisk Thickets and wetlands in area can be avoided.

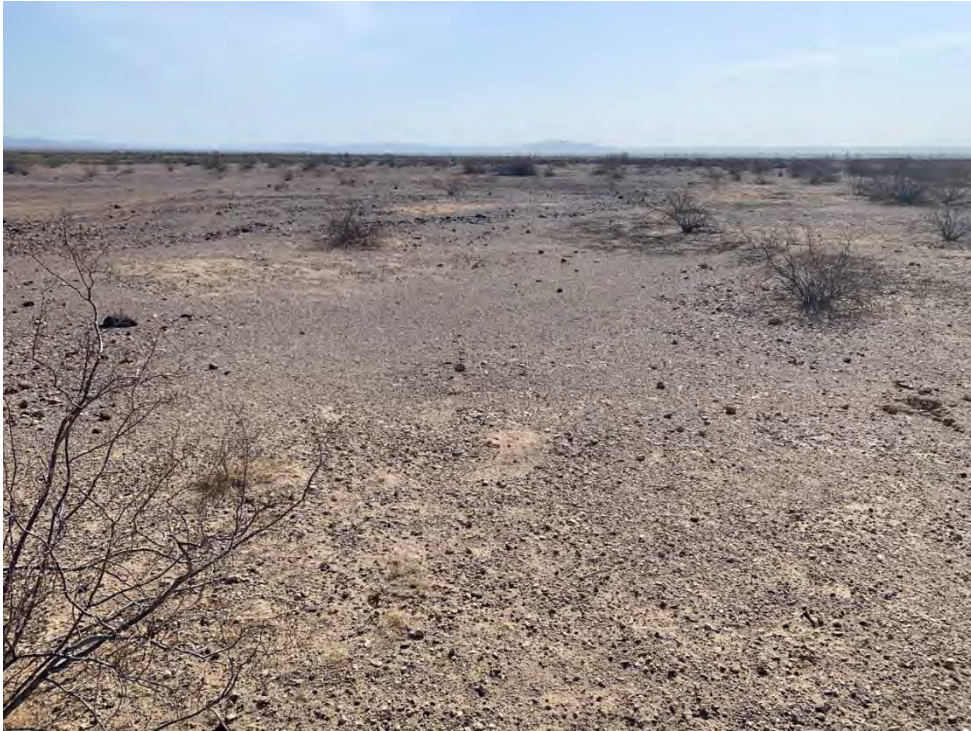
Photo 5

Pull site 25-1 (staging area) has scattered creosote bushes. A small area of Blue Palo Verde – Ironwood Woodland and Mesquite Thickets can be avoided in the northern area of the site.

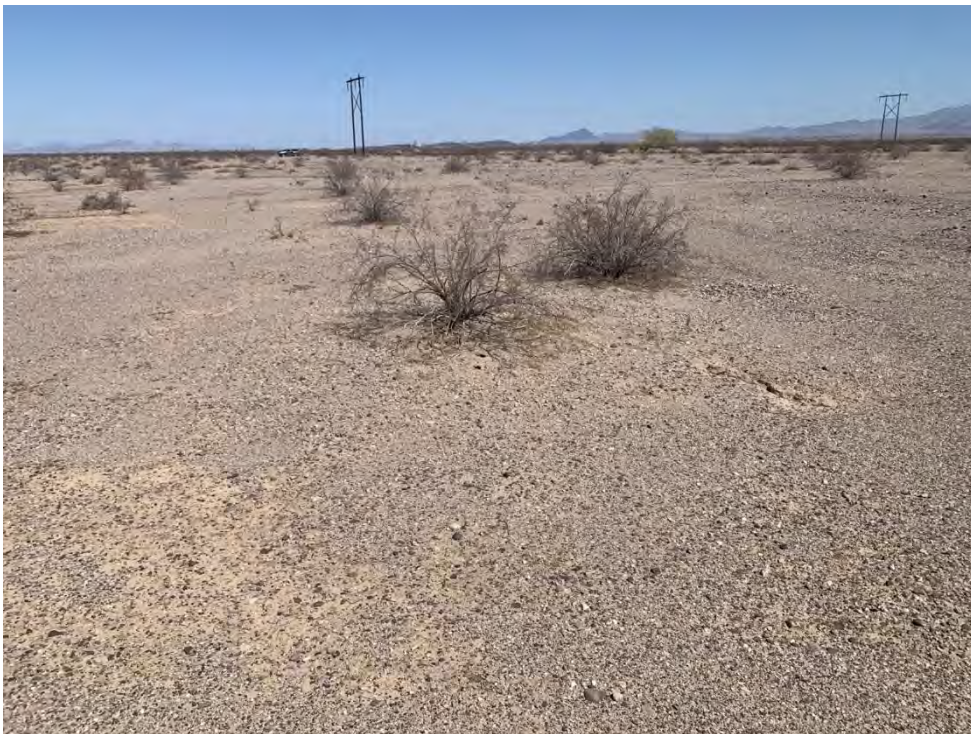
Photo 6

Pull site 25-4 (staging area) has scattered creosote bushes. A small area of Blue Palo Verde – Ironwood Woodland can be avoided in the central area of the site.

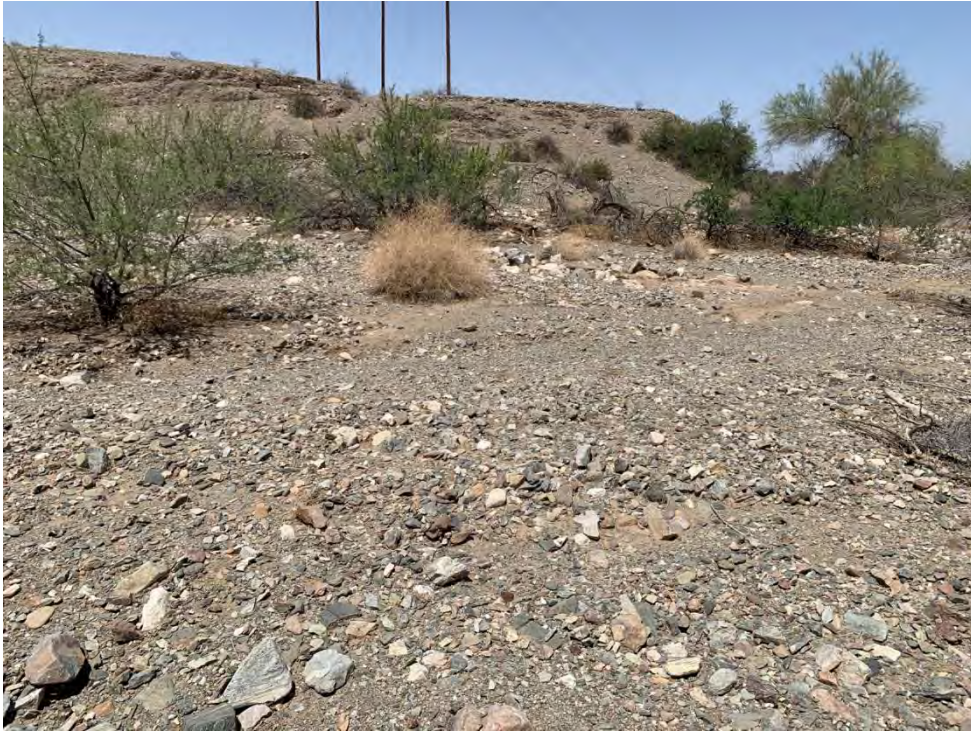
Photo 7

Pull site 31-3 looking at the ephemeral drainage with Blue Palo Verde – Ironwood Woodland vegetation that can be avoided.

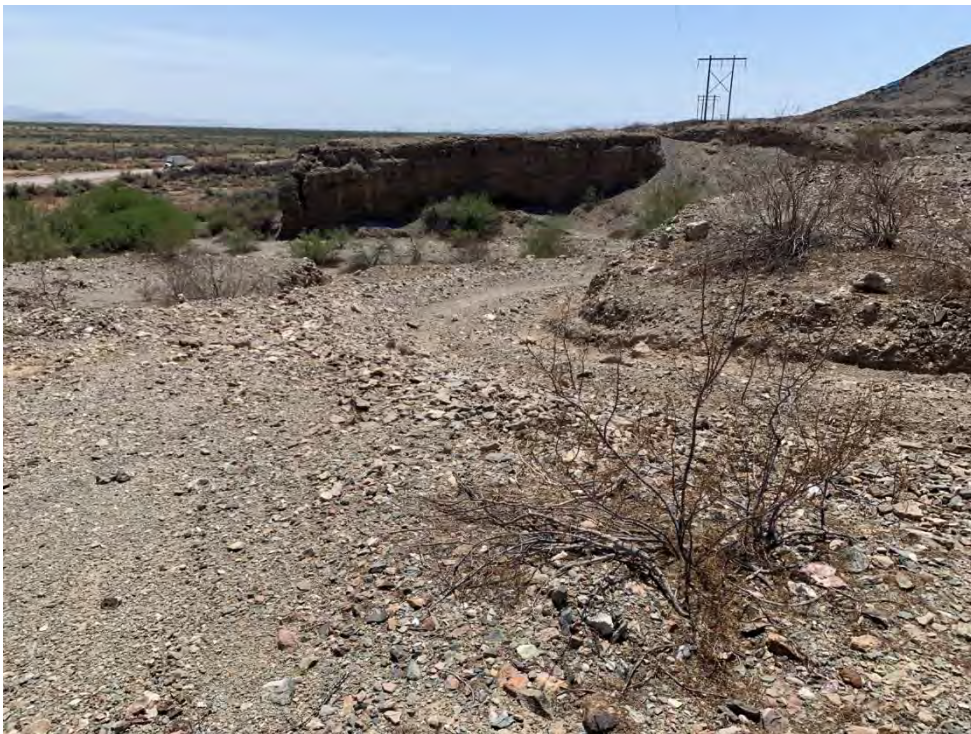
Photo 8

Pull site 31-3 looking south within pull site.

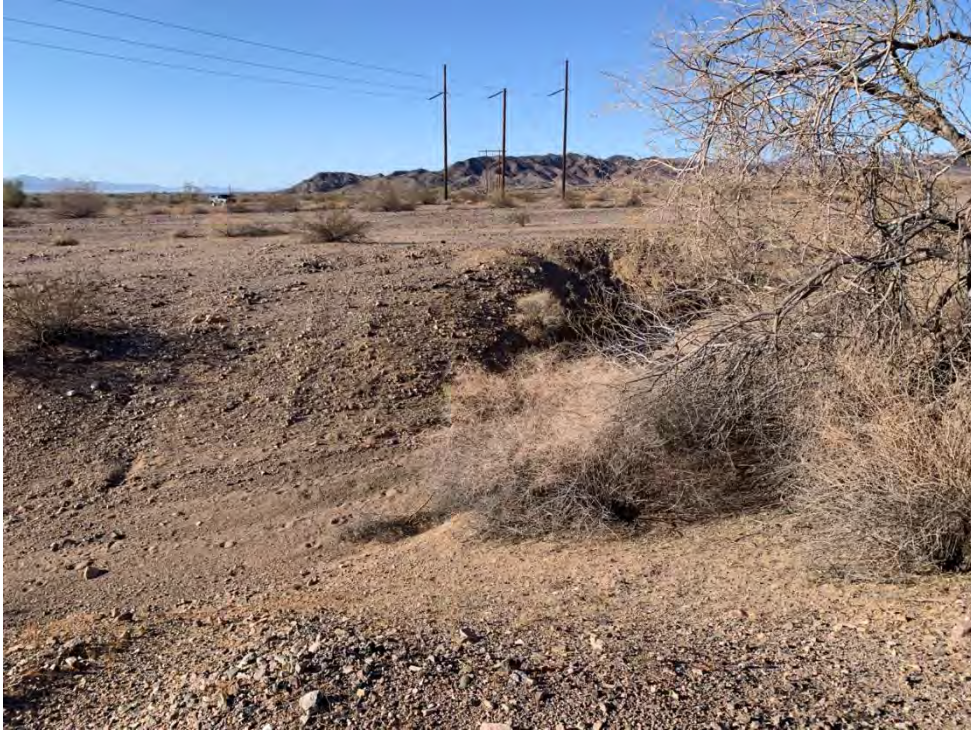
Photo 9

Pull site 36-3 looking from the Blue Palo Verde – Ironwood Woodland within a drainage from the northern portion of the site. This area can be avoided.

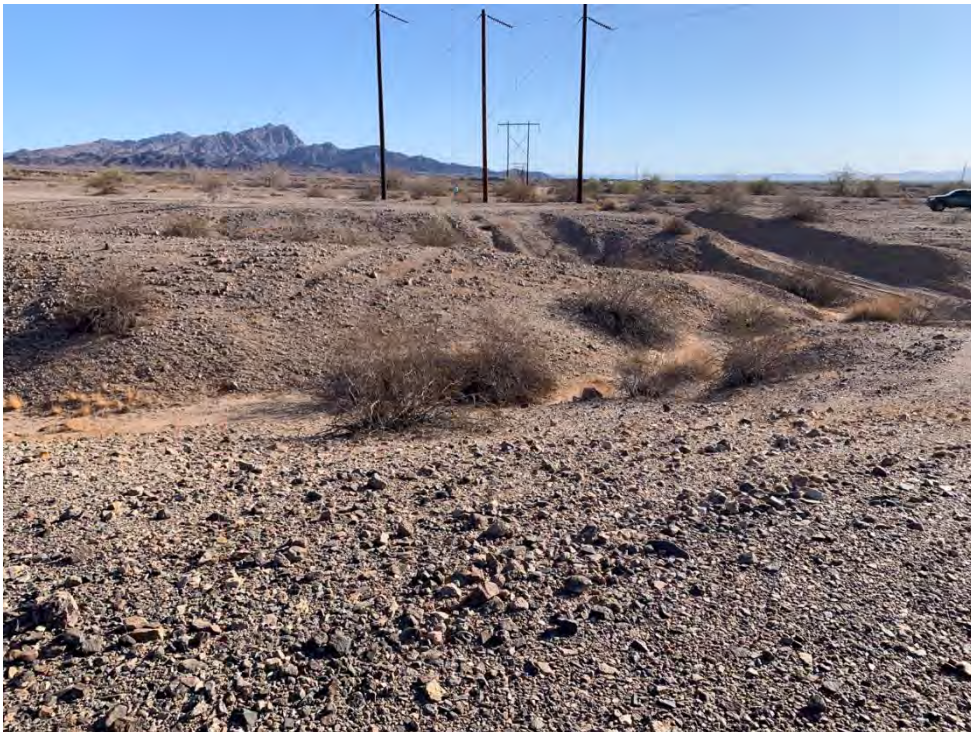
Photo 10

Pull site 36-3 looking at erosional areas due to topography in the area.

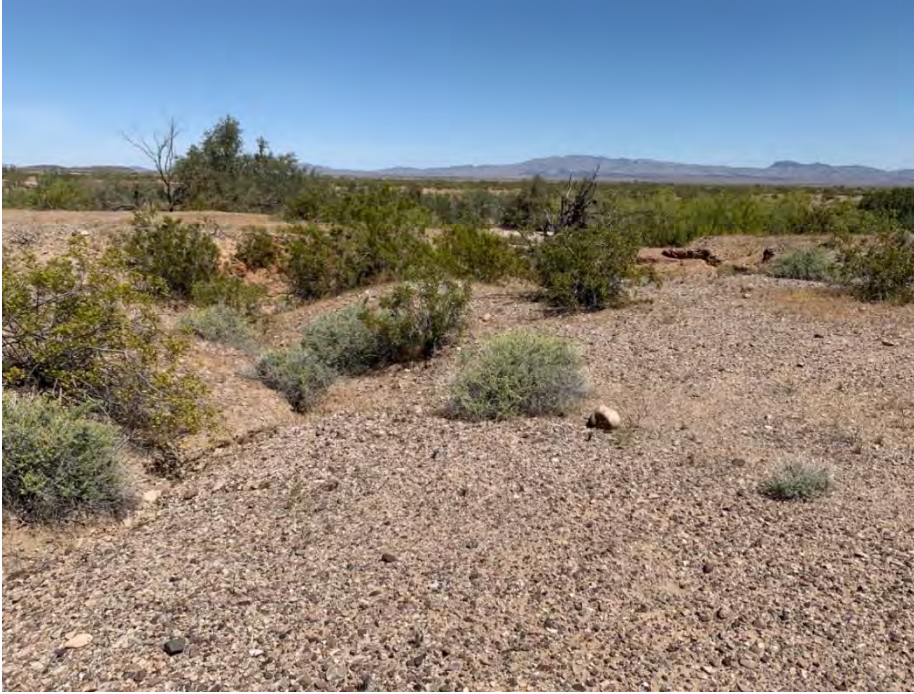
Photo 11

Pull site 44-1 looking at a portion of the braided wash that can be avoided.

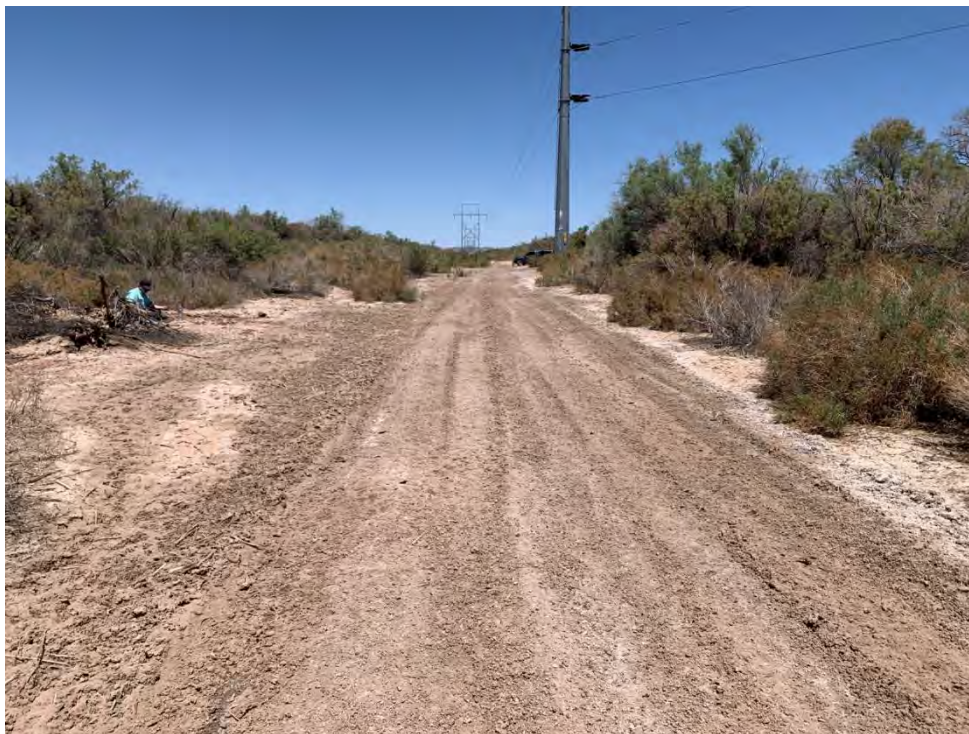
Photo 12

Pull site 49-4 showing access road and bare ground area through Tamarisk Thickets and Arrow Weed Thickets that can be avoided.

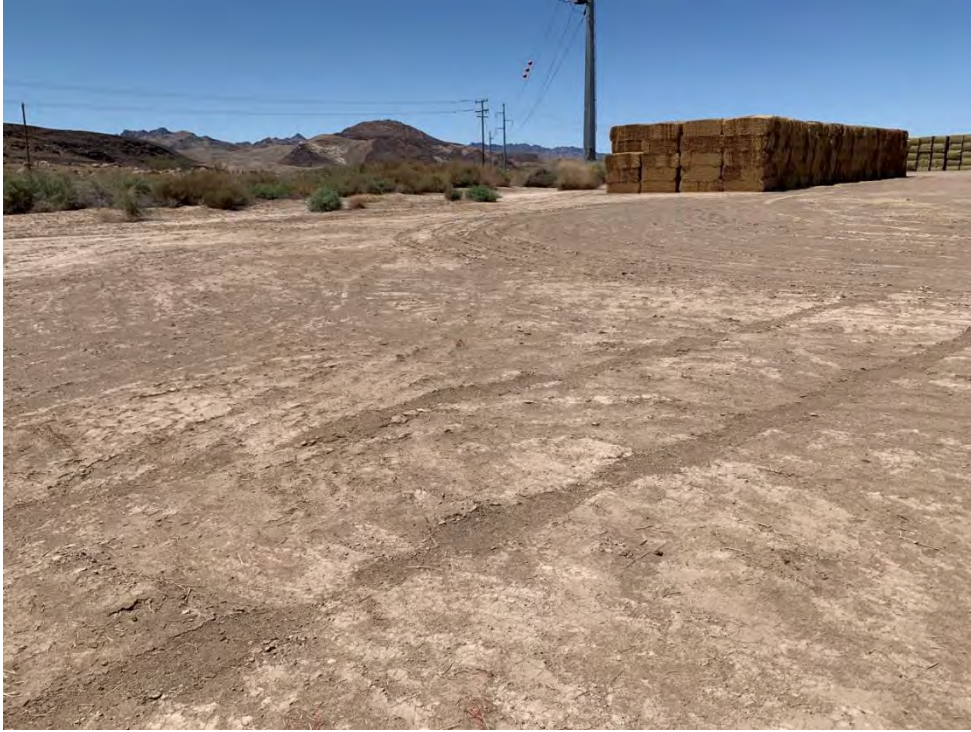
Photo 13

Pull site 49-6 looking at bare ground areas. Wetland areas can be avoided in this area.

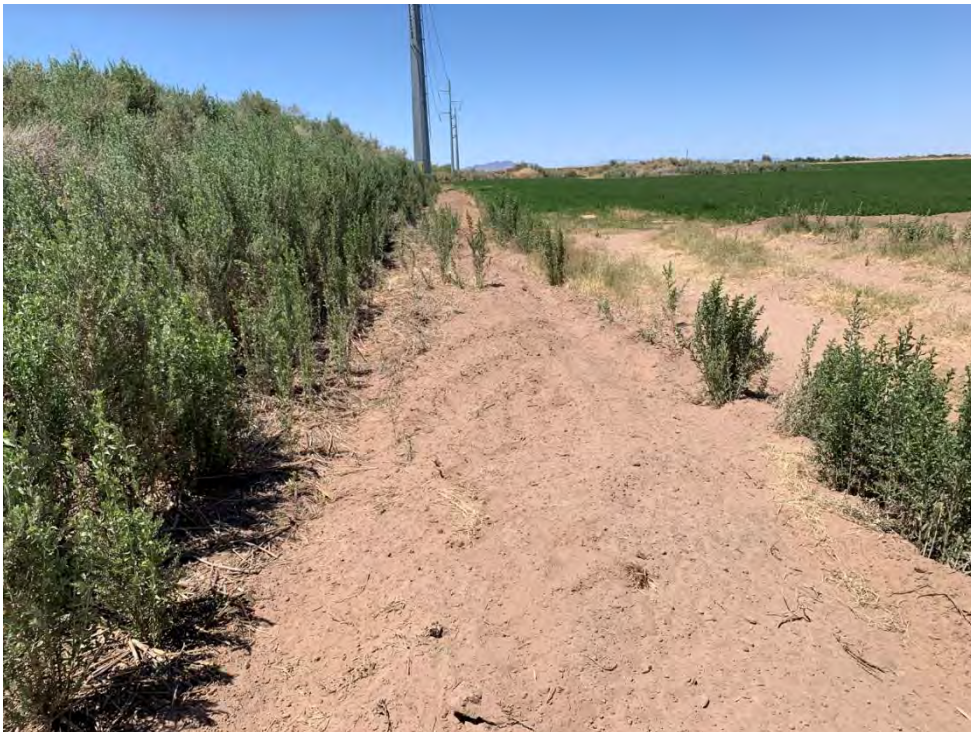
Photo 14

Pull site 49-8 showing bare ground areas near Arrow Weed Thickets that can be avoided.

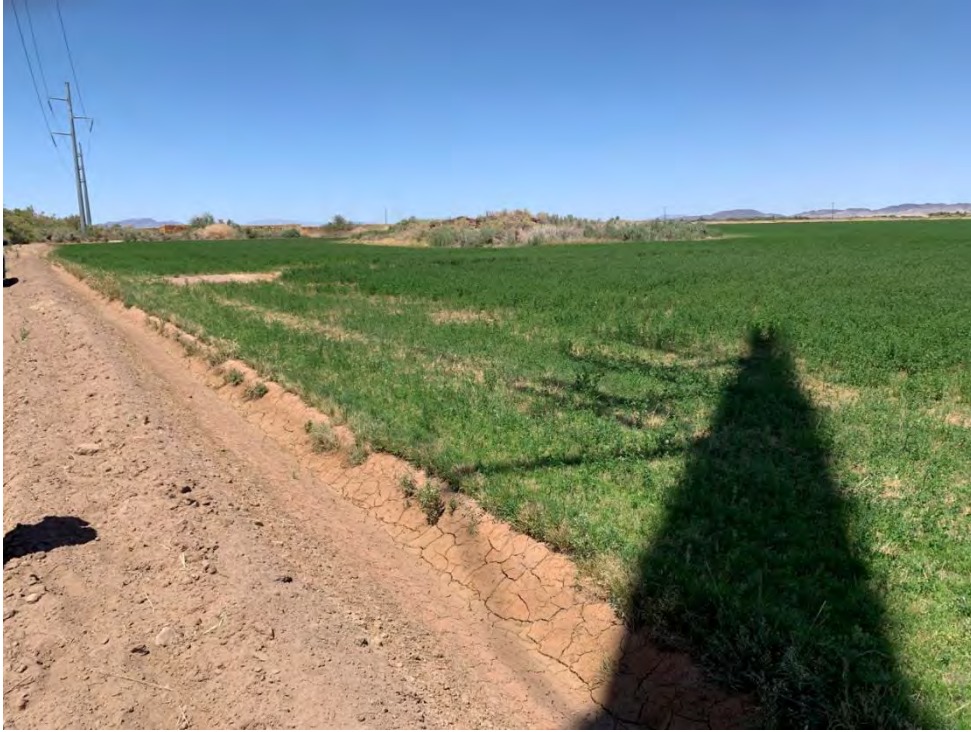
Photo 15

Pull site 49-8 looking at bare ground areas and agricultural areas that can be used during operations. The mound in the background is no longer a NWI Open Water area.

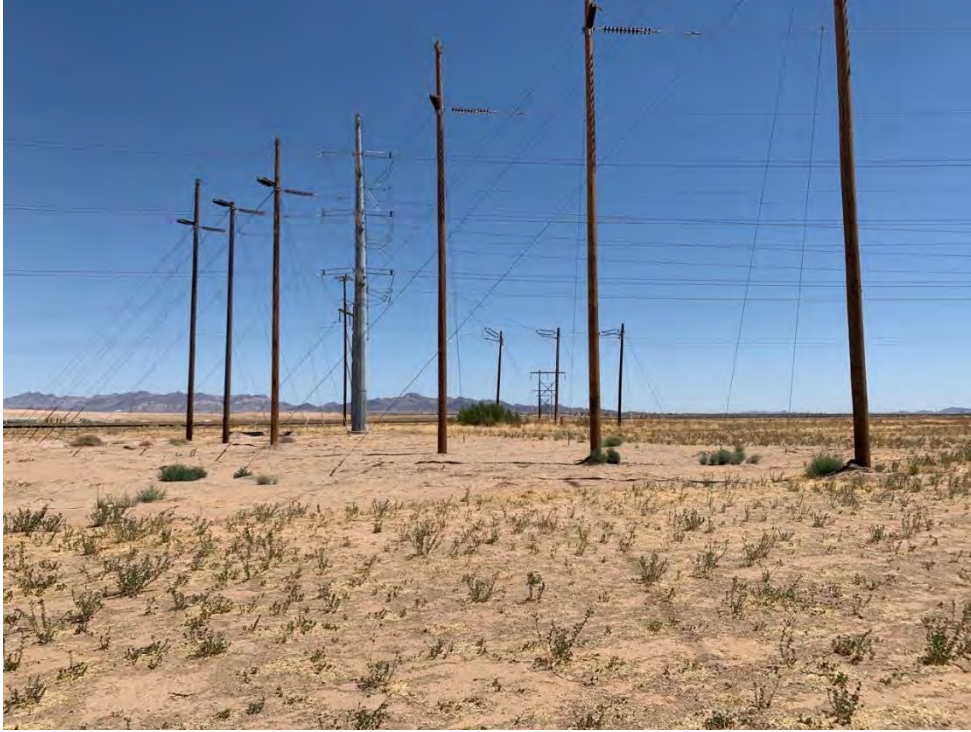
Photo 17

Pull site 64-2 looking at historic NWI freshwater pond that is no longer in area due to human disturbance and agriculture practices.

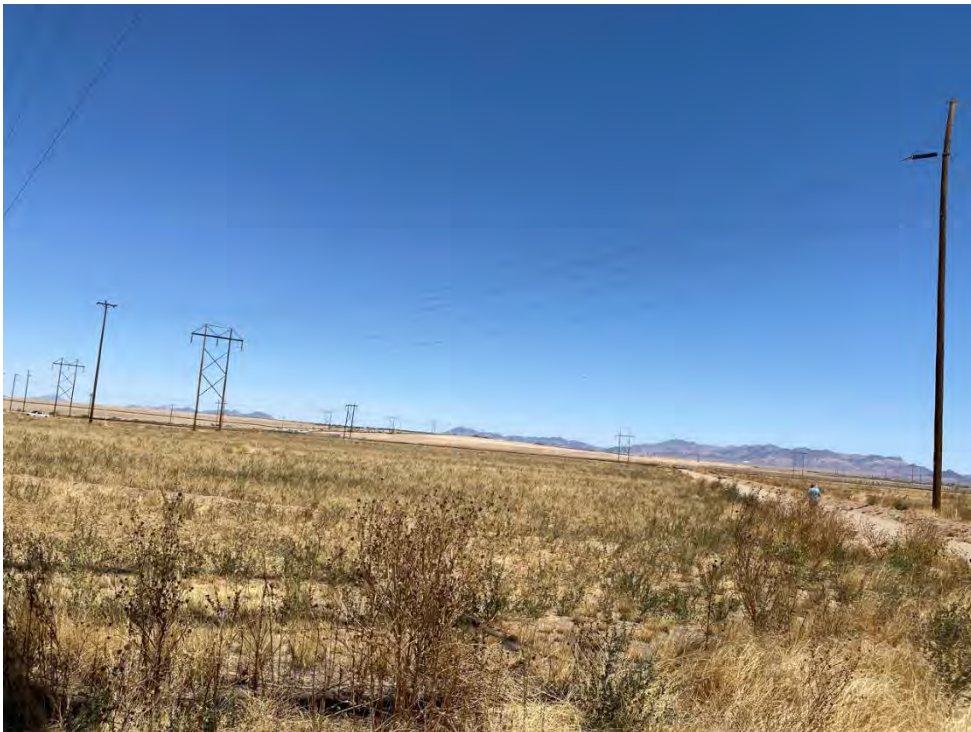
Photo 18

Pull site 64-4 looking at historical NWI on right side of photo that is no longer present. The NWI is an access road for agricultural practices.
