U.S. DEPARTMENT OF
ENERGY

Fernald
Preserve

Community Meeting

October 6, 2015

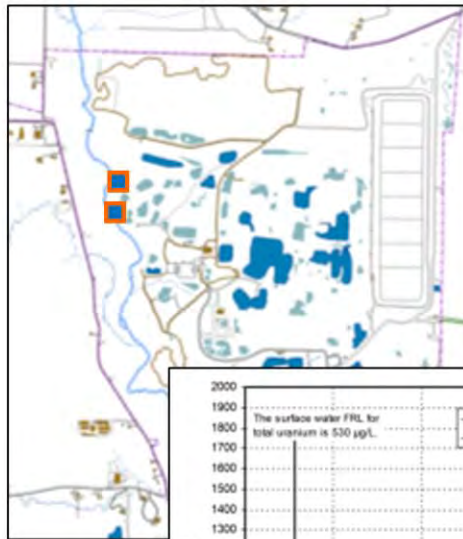
Surface Water and Treated Effluent Results

Surface water continues to be monitored at numerous locations onsite and offsite.

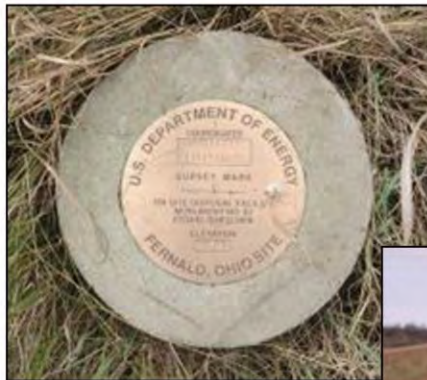
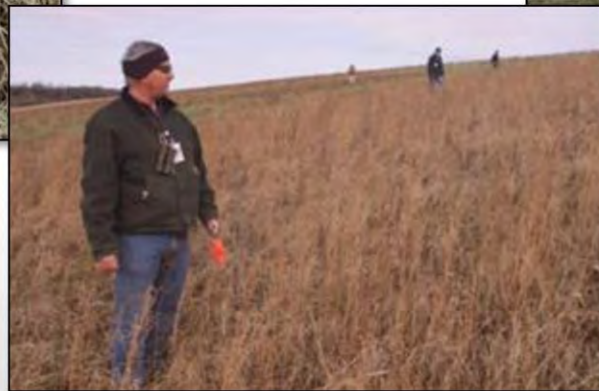
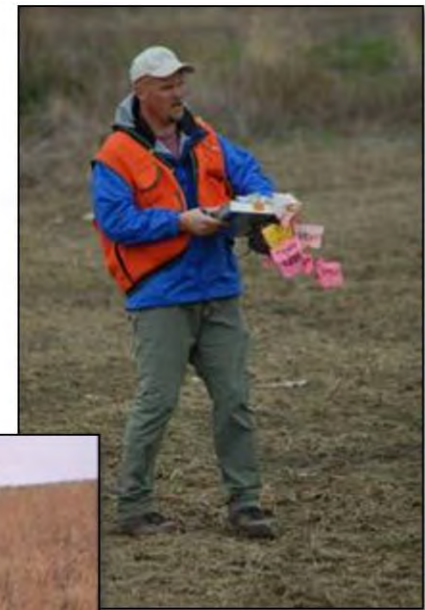
Inspections

The inspection process continues in compliance with the Fernald Preserve *Comprehensive Legacy Management and Institutional Controls Plan*.

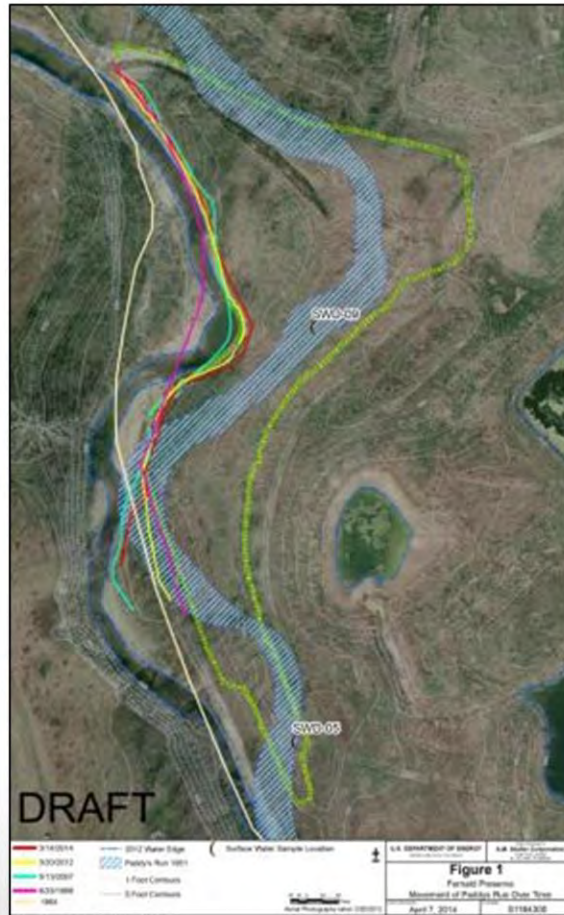
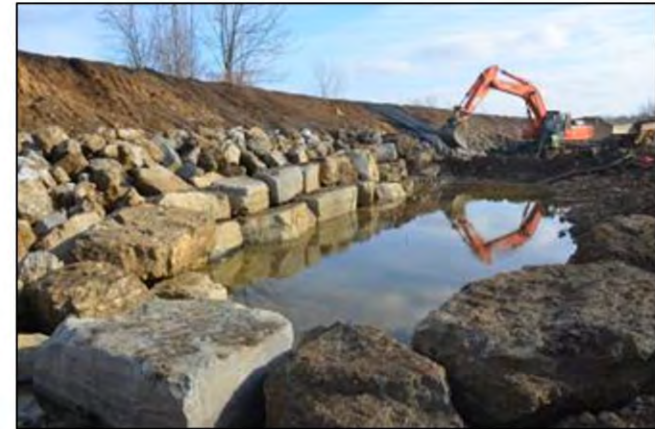
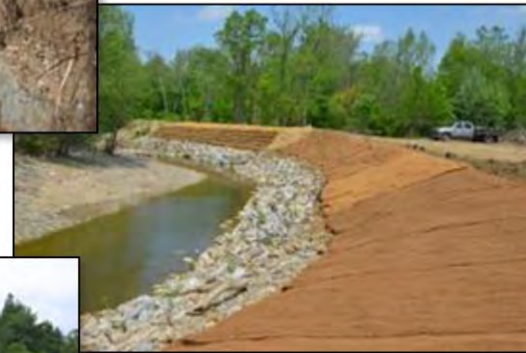
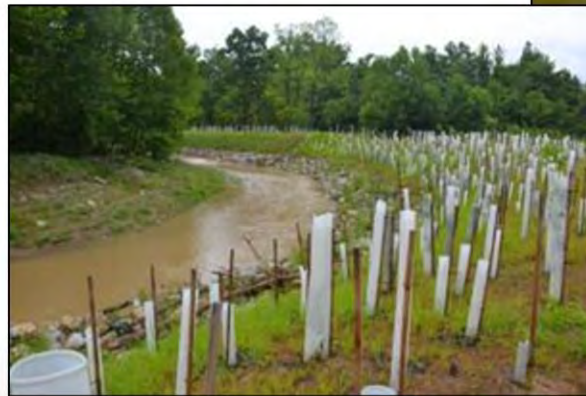
Construction of the Paddy's Run Streambank Stabilization Project began September 2014.

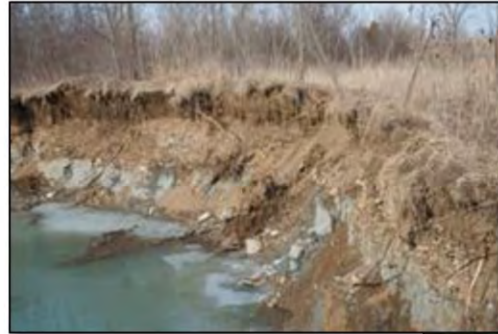
Construction of the Paddys Run Streambank Stabilization Project began September 2014.

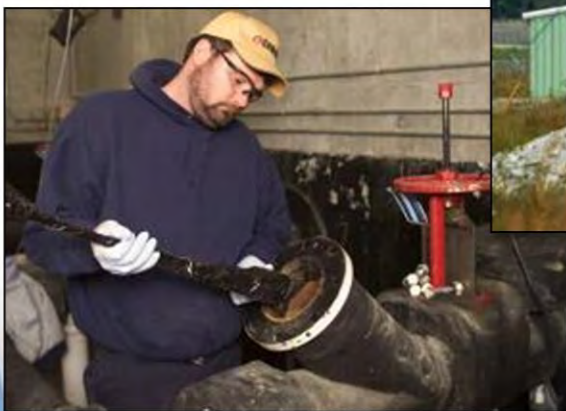
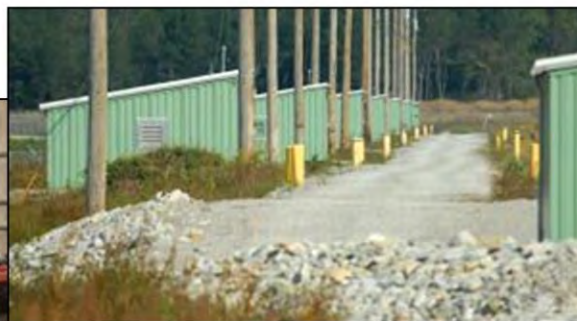
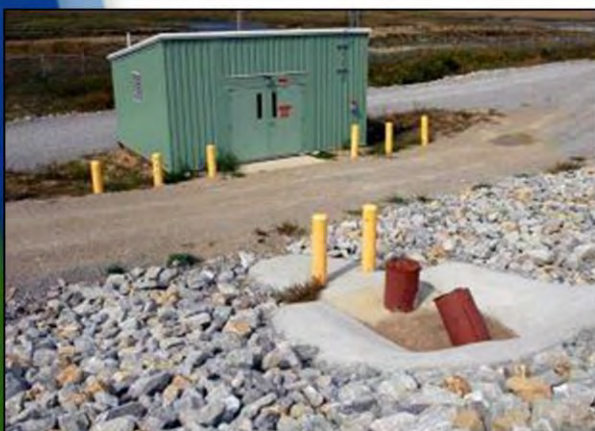
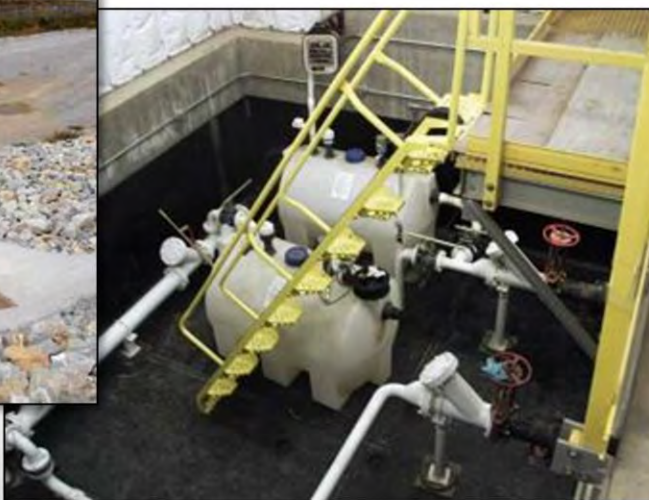
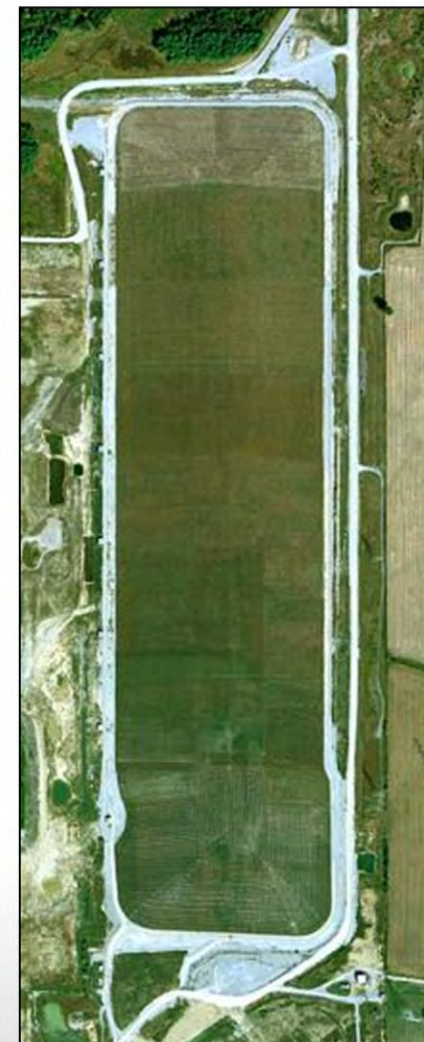
The On-Site Disposal Facility is an engineered waste-storage area that holds 2.95 million cubic yards of waste.

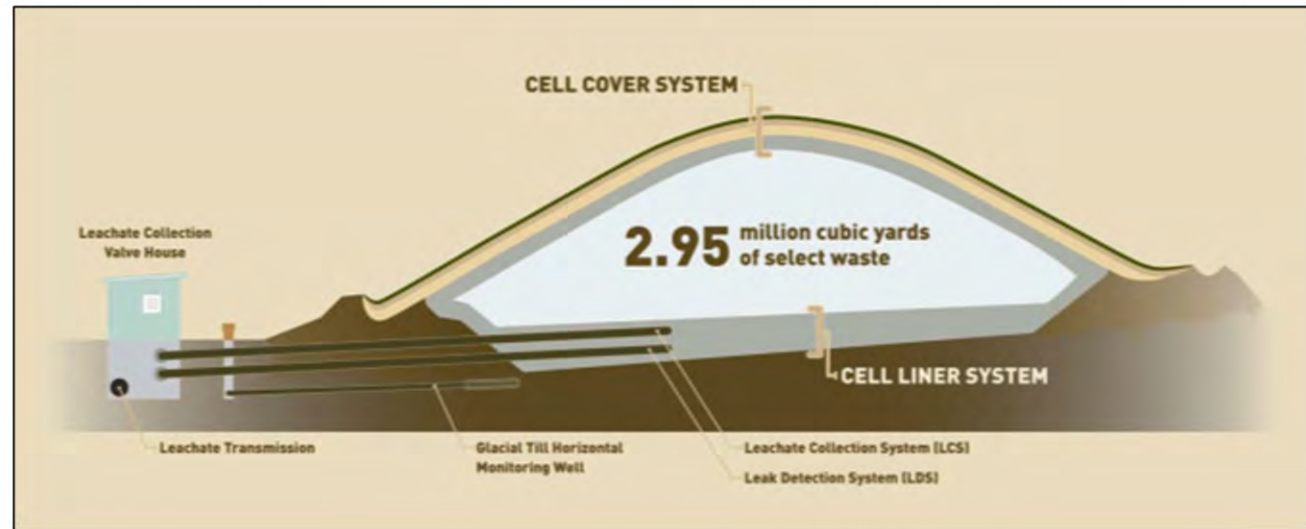
Leachate Collection System

The On-Site Disposal Facility was constructed with an engineered liner and cover system.

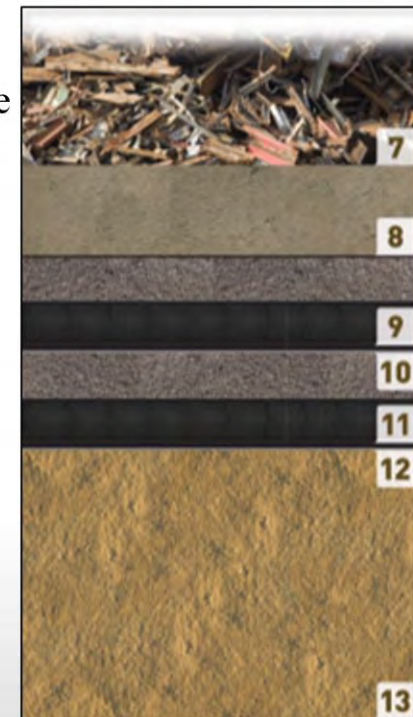
Waste is safely encapsulated between a 9-foot cap and a 6-foot liner within the On-Site Disposal Facility.

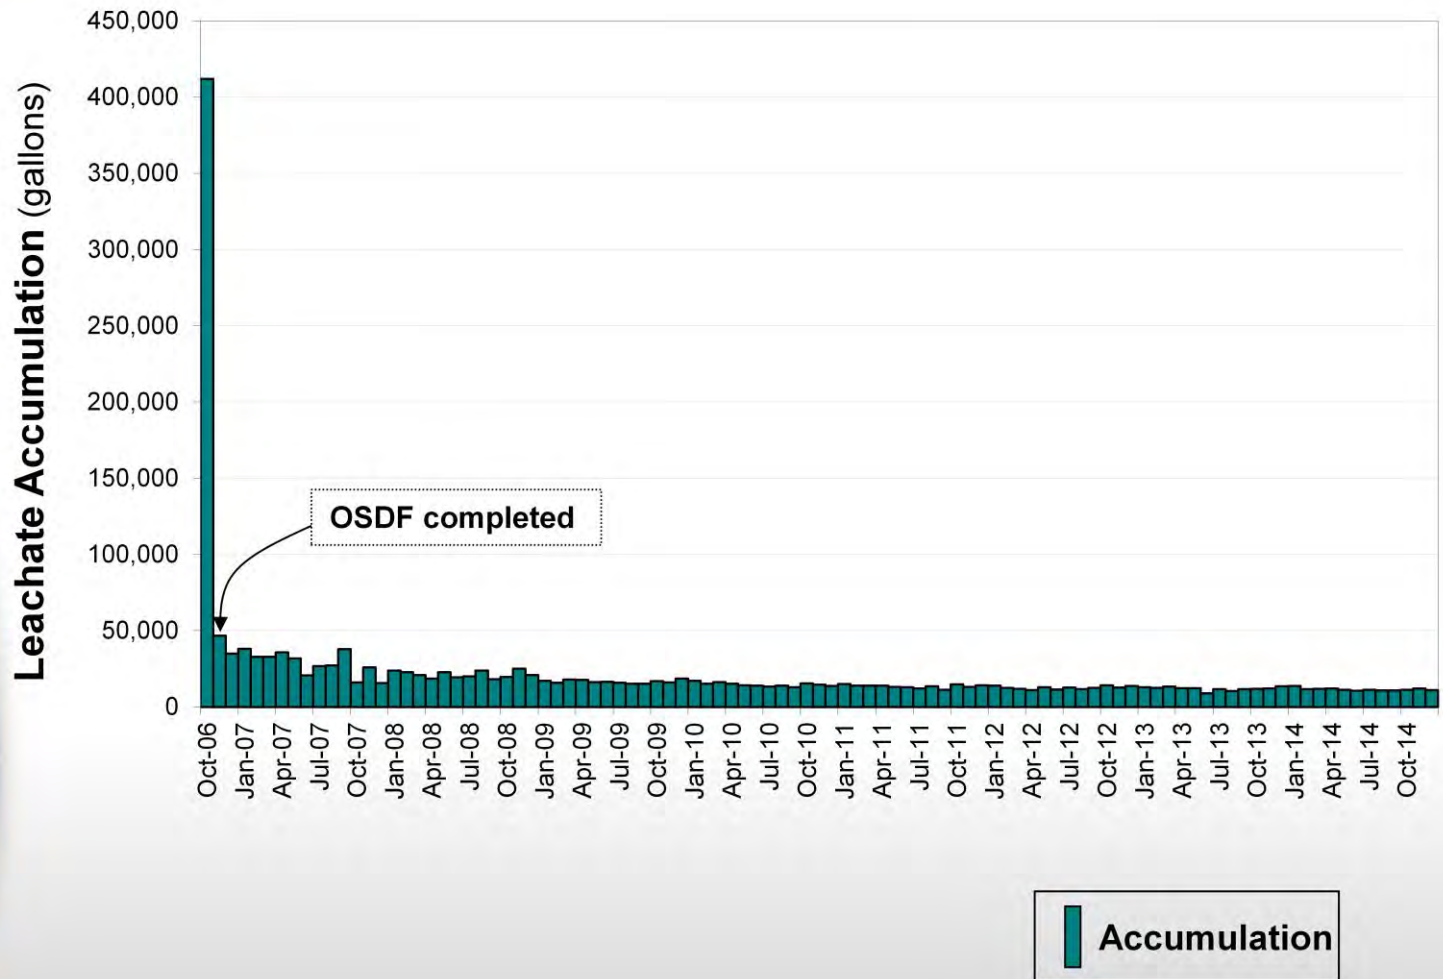
Leachate Collection System

Leachate is the moisture in the waste within the On-Site Disposal Facility. The leachate is collected and transferred to a treatment facility. Before the cover system was completed in October 2006, hundreds of thousands of gallons of leachate flowed each month. By 2014, leachate flows decreased to a monthly average of 11,579 gallons.

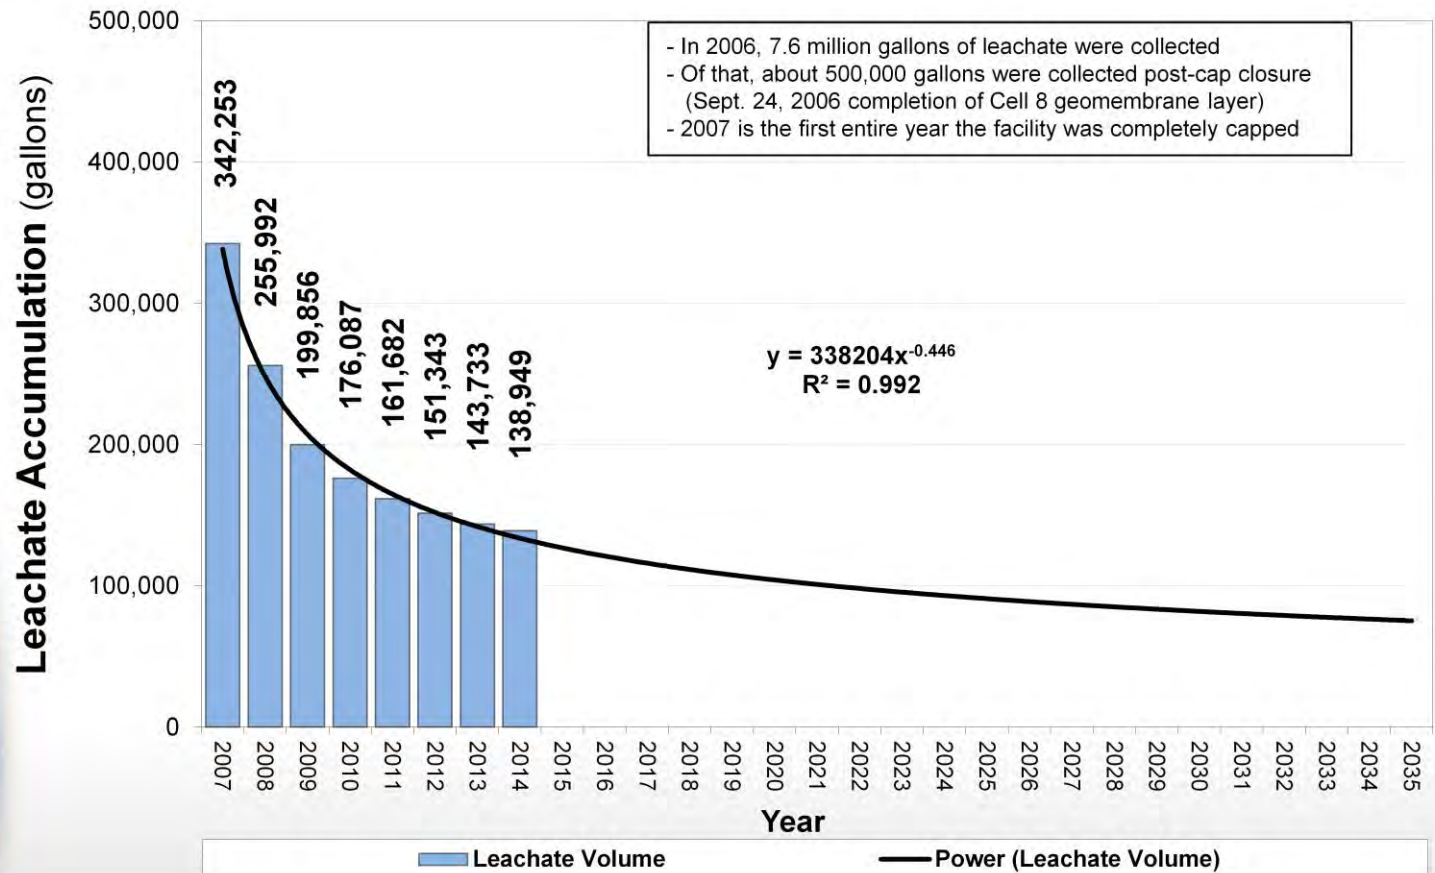
Leachate Collection System

Leachate is the moisture in the waste within the On-Site Disposal Facility. The leachate is collected and transferred to a treatment facility. Annual leachate flow continues to decline.

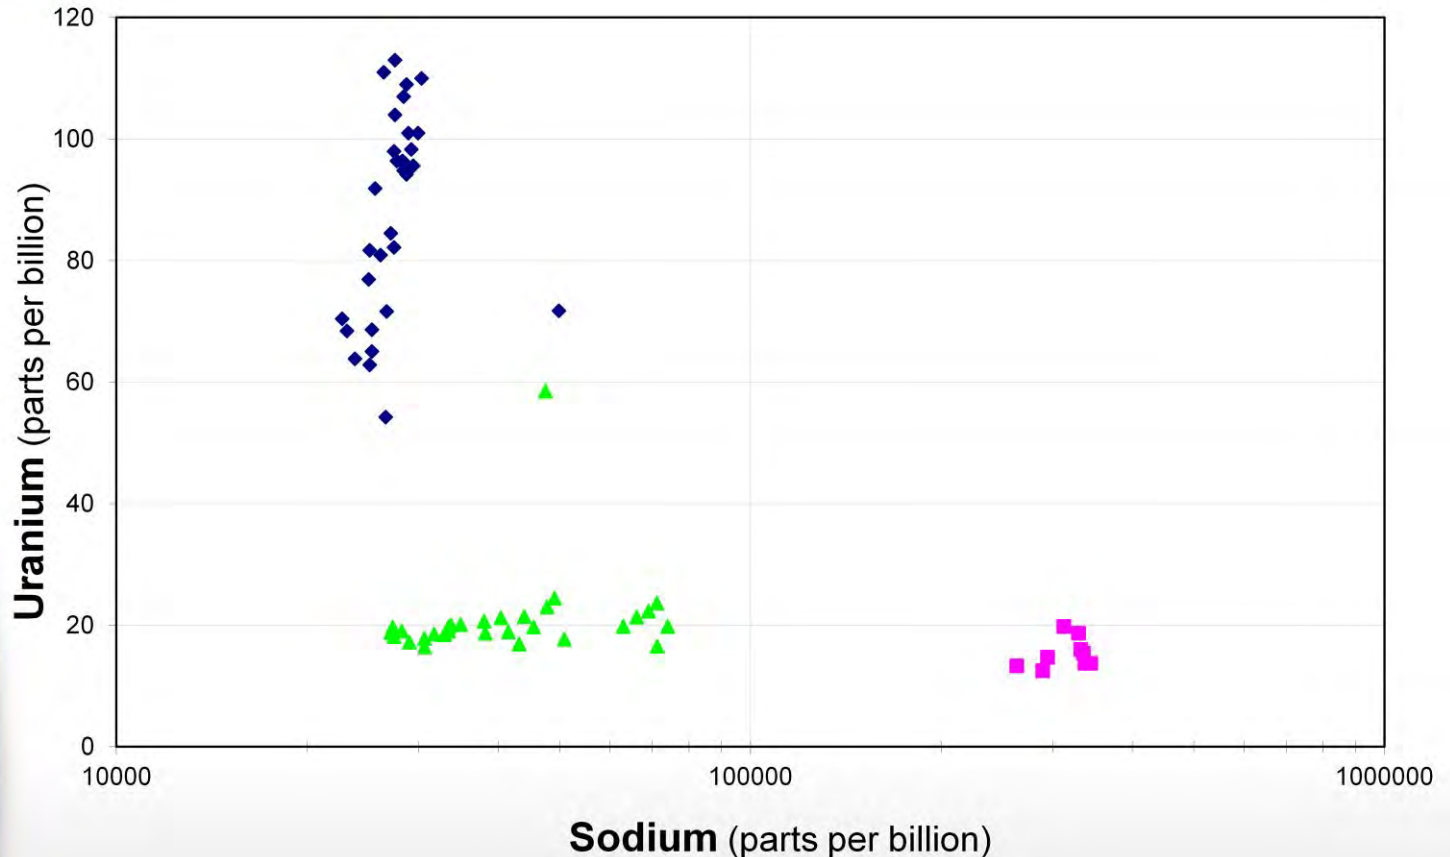
Uranium vs. Sodium Concentrations: Cell 3 (Bivariate Plot)

A comparison of uranium concentrations and sodium concentrations in and below Cell 3 of the On-Site Disposal Facility is an example of a method used to demonstrate that the liner system is working as designed.

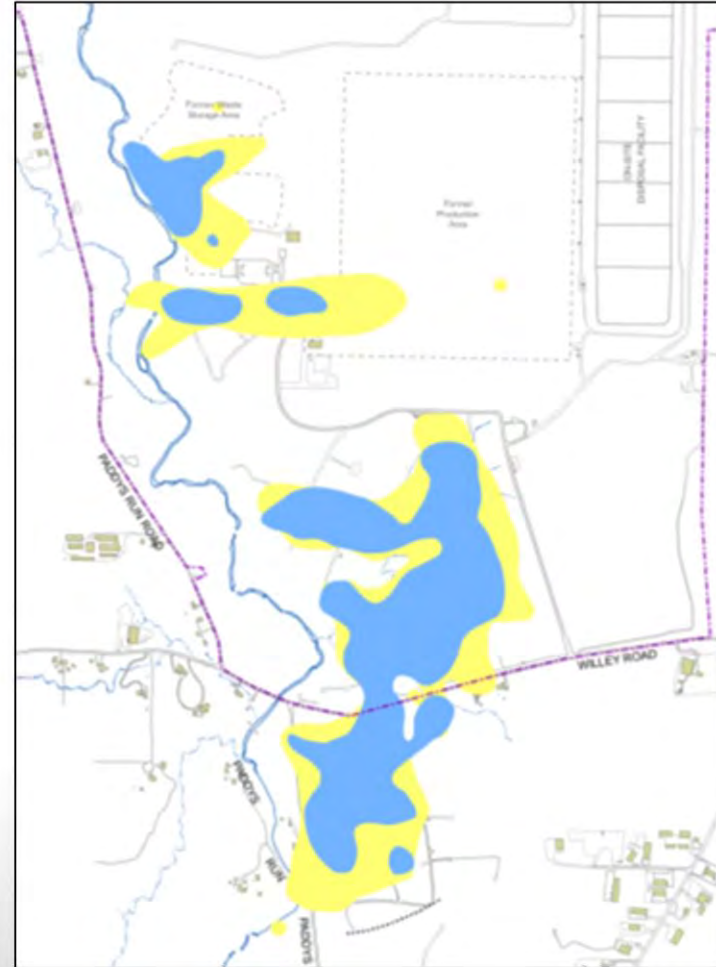
Maximum Plume: 2006 and 2014

Maximum size of uranium plume footprint was 189.3 acres in 2006.
Maximum size of uranium plume footprint was 110.9 acres in 2014.

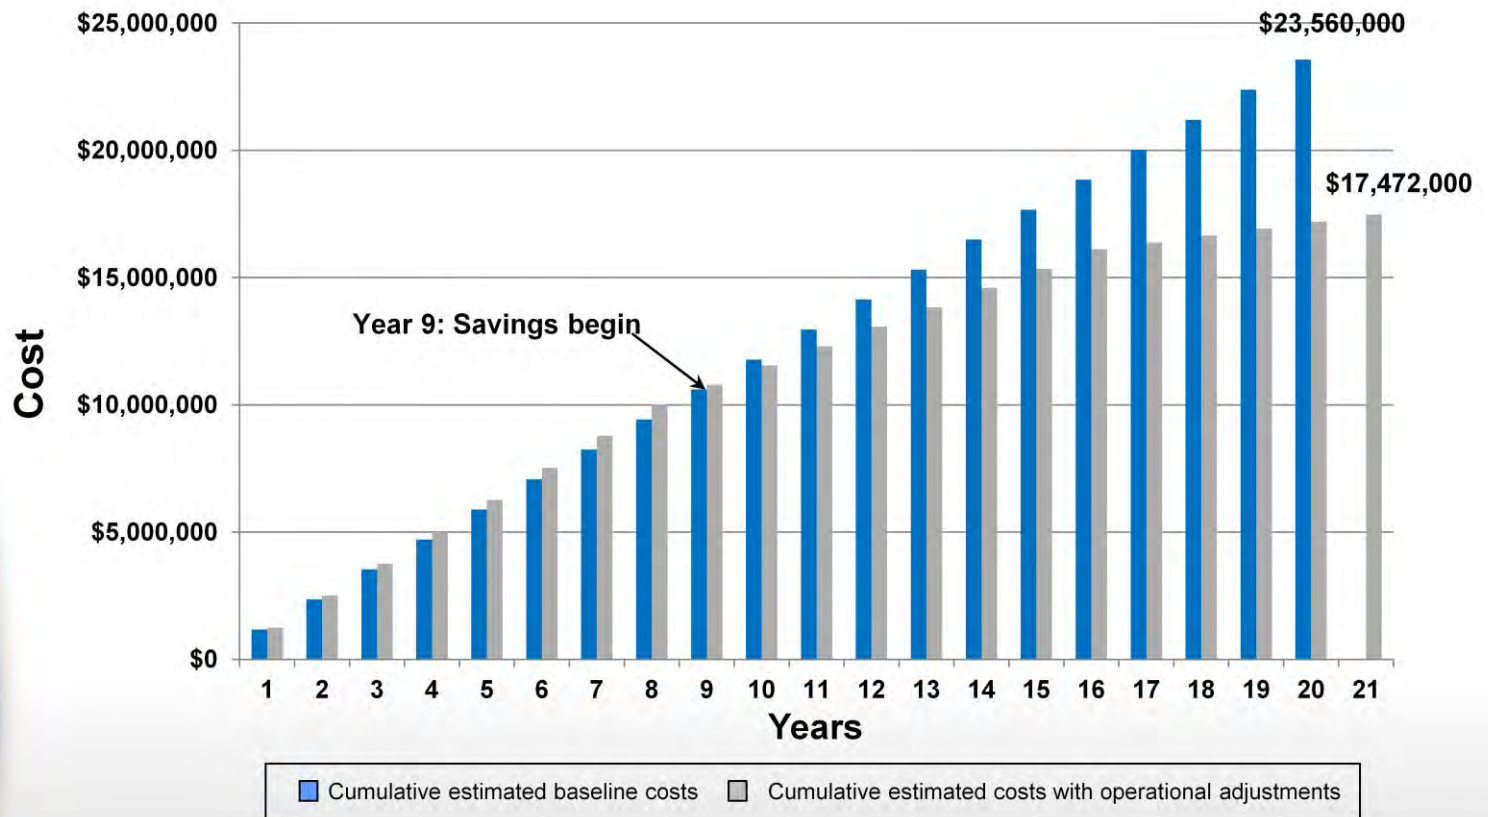
Operational Adjustments: Predicted Costs

The model predicts that amplified pumping will reduce future costs.

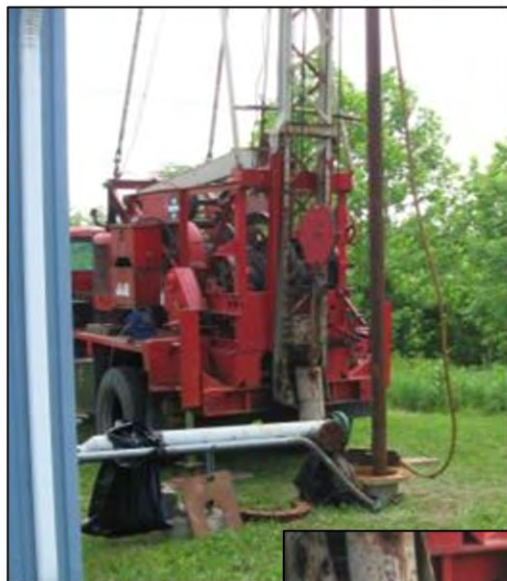
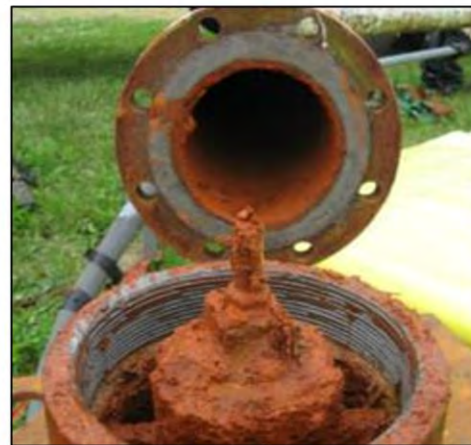
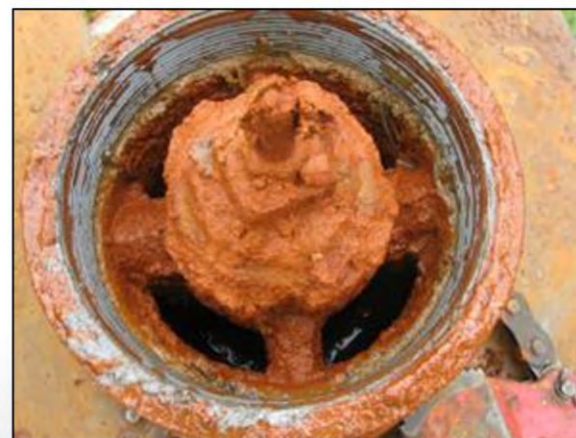
Six wells were rehabilitated this summer to address iron plugging. Iron plugging decreases the pumping efficiency of the well.

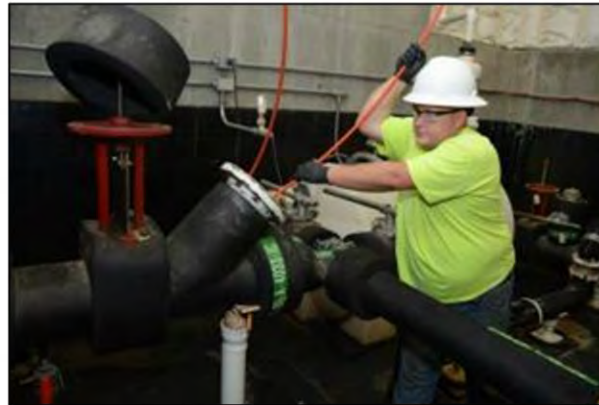
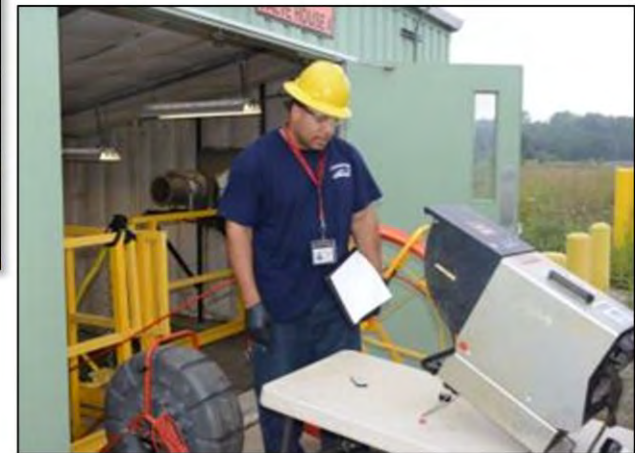
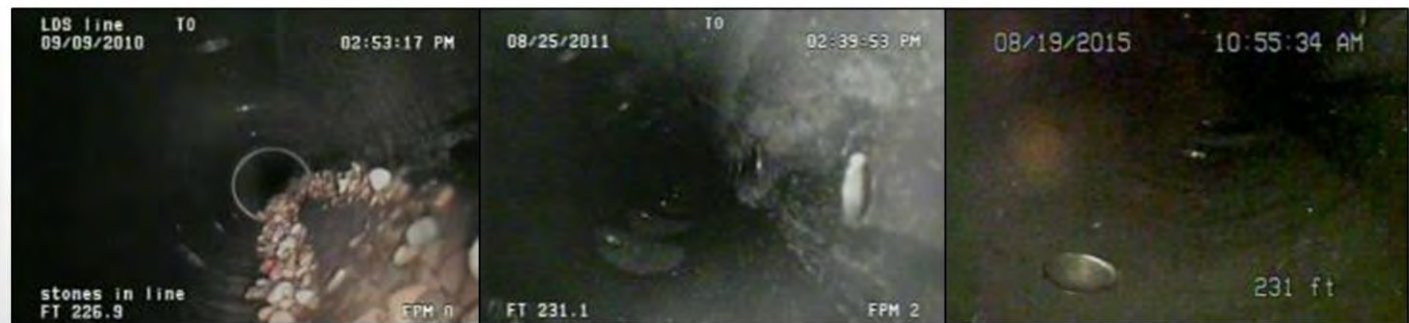
OSDF Piping Camera Survey

On-Site Disposal Facility leachate lines are routinely inspected using a camera.

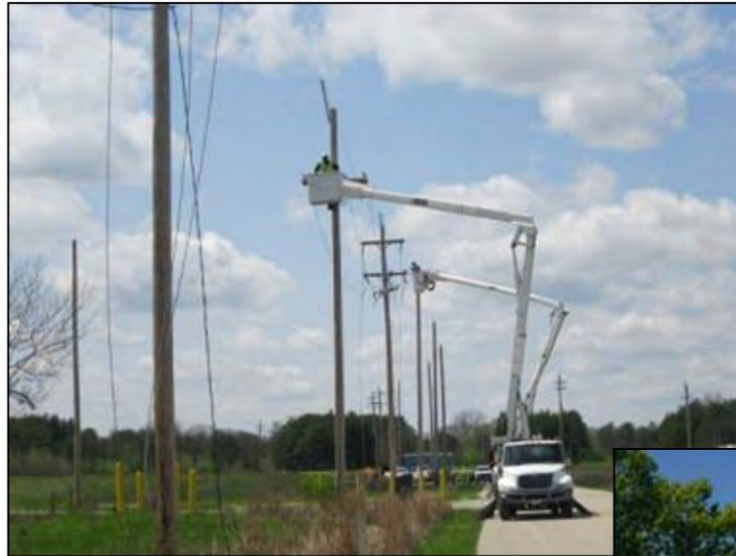
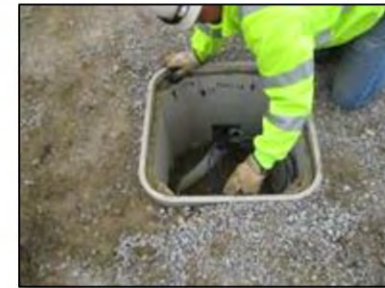
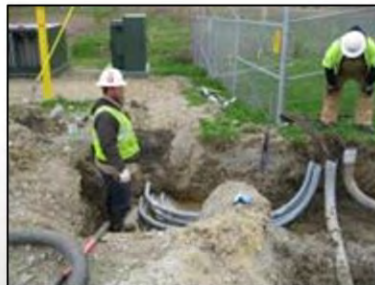
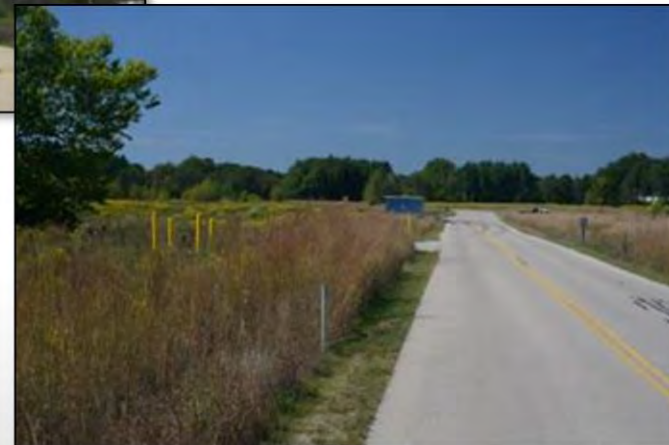
Electrical Upgrades Phase II

The electrical and communication lines from the On-Site Disposal Facility to the wastewater treatment facility have been installed underground.

The electrical and communication lines from the On-Site Disposal Facility to the wastewater treatment facility have been installed underground.

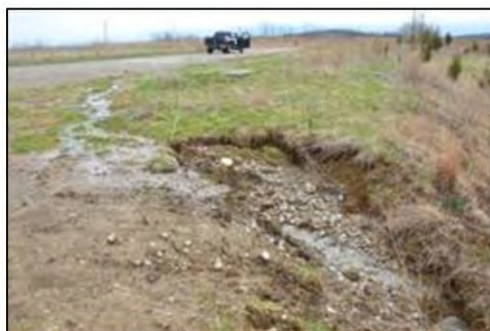
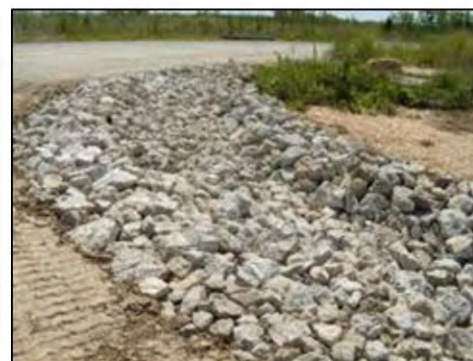
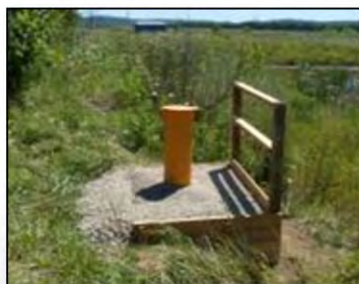
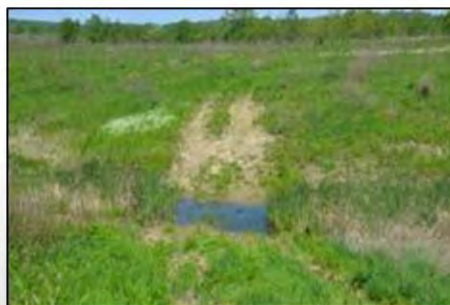
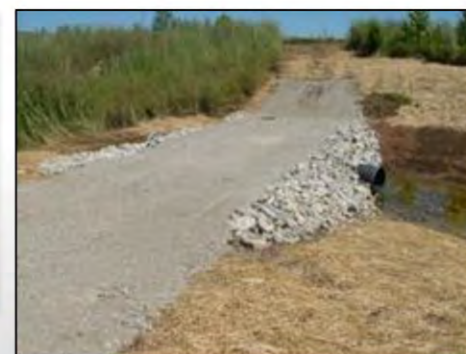
Erosion Repair and Well Access Improvements

- **Repaired erosion**
- **Improved vehicle access to monitoring wells**

Erosion repair and access improvements have been conducted at several locations onsite.

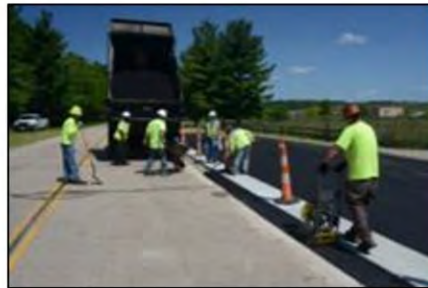
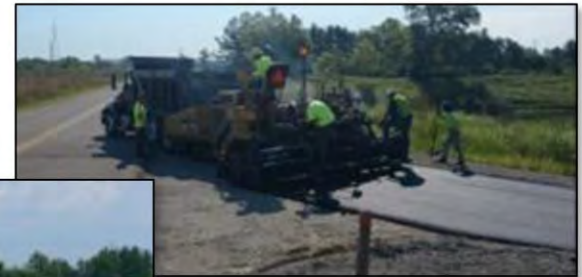
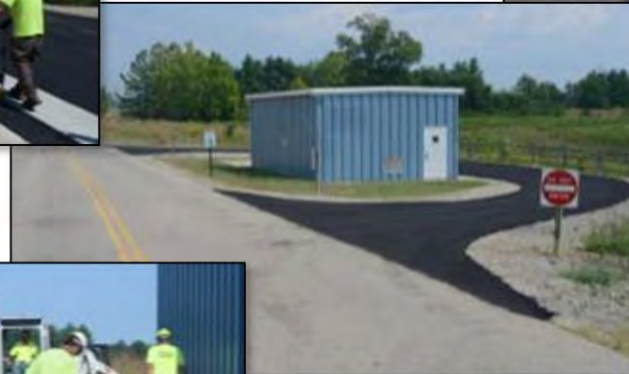
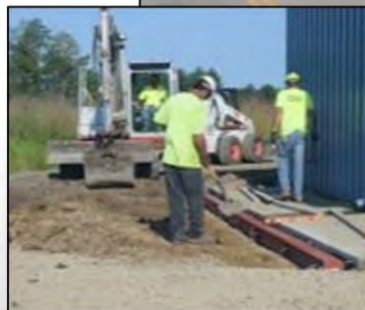
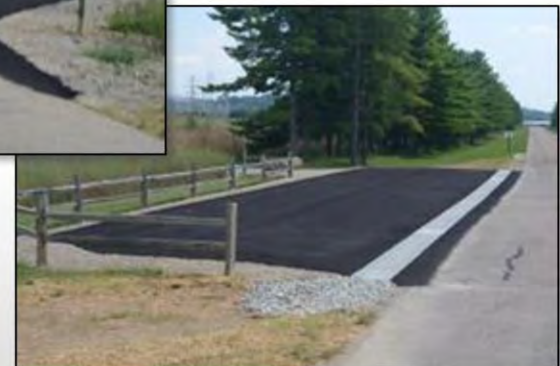
Asphalt Paving

- Lodge Pond trailhead parking lot
- Valve House turnout

The paving of several gravel areas onsite will make it easier for visitors to access the Lodge Pond trail and an observation area.

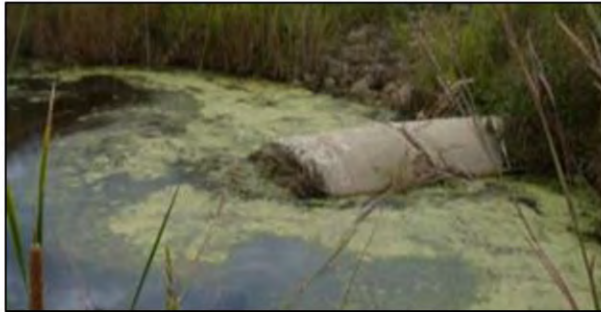
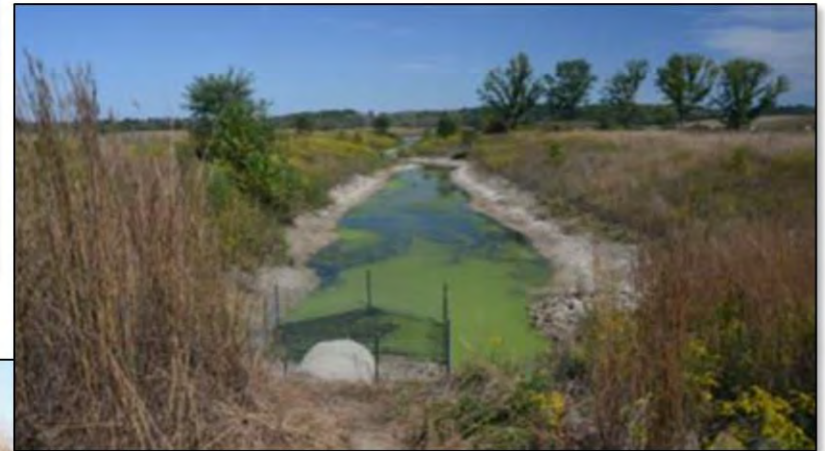
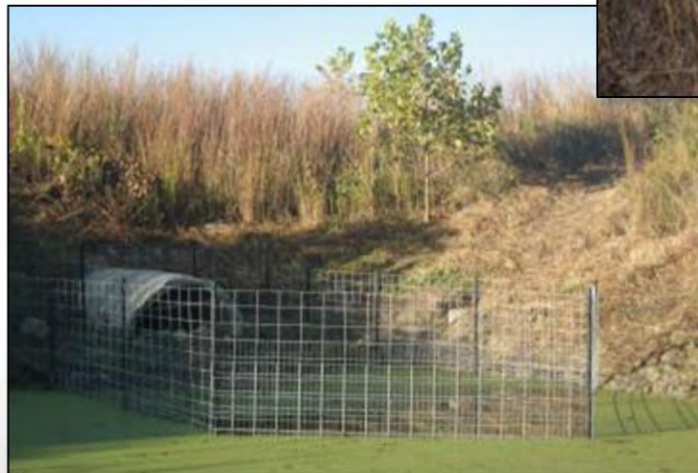
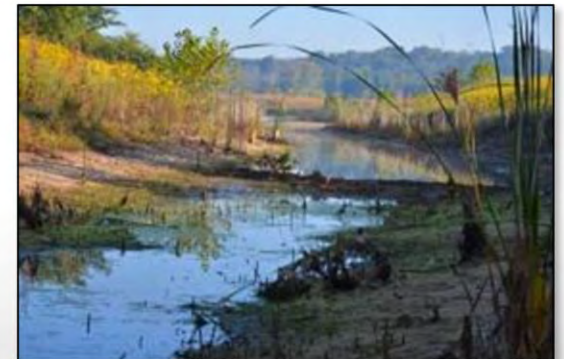
Main Drainage Corridor Culvert

Recent beaver activity at the MDC culvert required the installation of exclosure fencing.

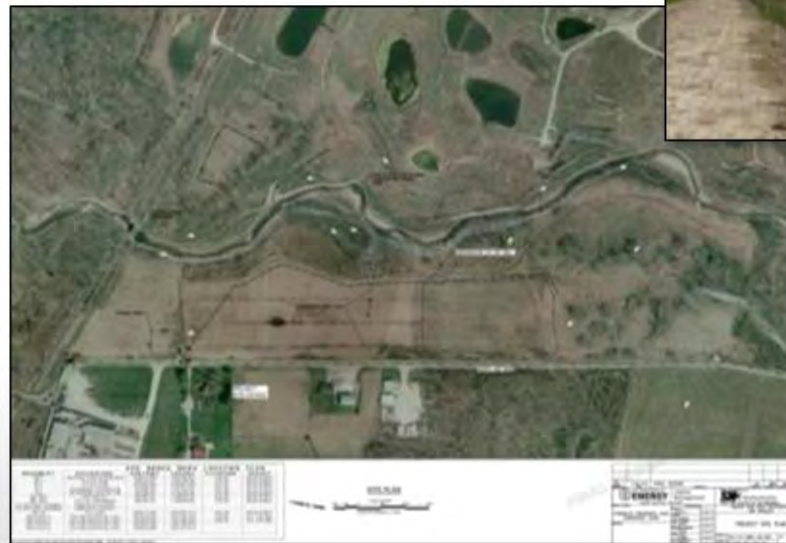
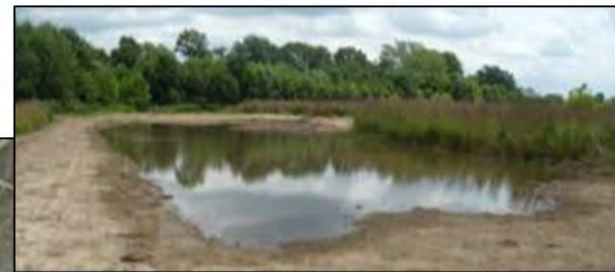
Restoration Projects

- **Paddys Run west restoration**
- **North woodlot enhancement**

The Paddys Run West restoration project involved wetland creation in a former pasture.
