Attachment 1.
Geologic Verifications of Phase 1 and Phase 2 Cell Excavation

"Geologic Characterization of Crescent Junction Cell Excavation Phase II," April 2012

Geologic Characterization for the Phase I Excavation of the Crescent Junction, Utah, UMTRA Disposal Cell

December 2008

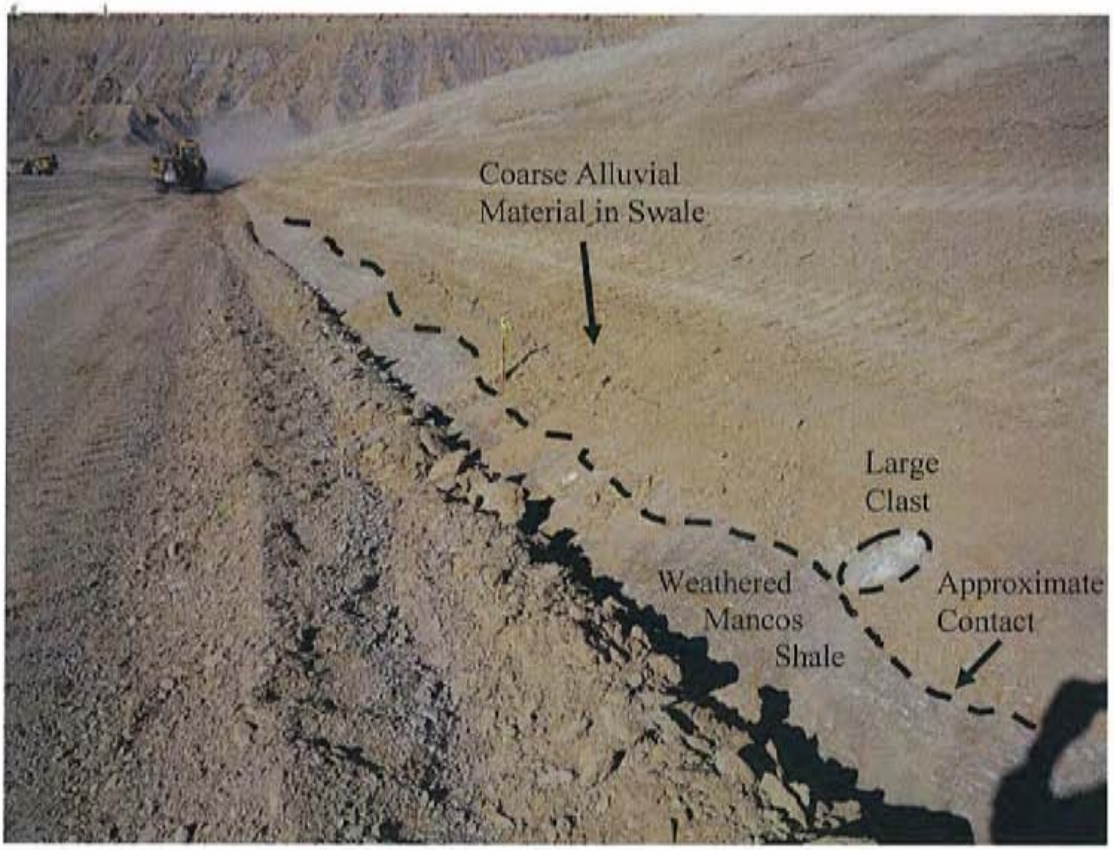
Figure 2. View North of Contact of Weathered Mancos Shale Bedrock and Coarse Clasts in Overlying Swale

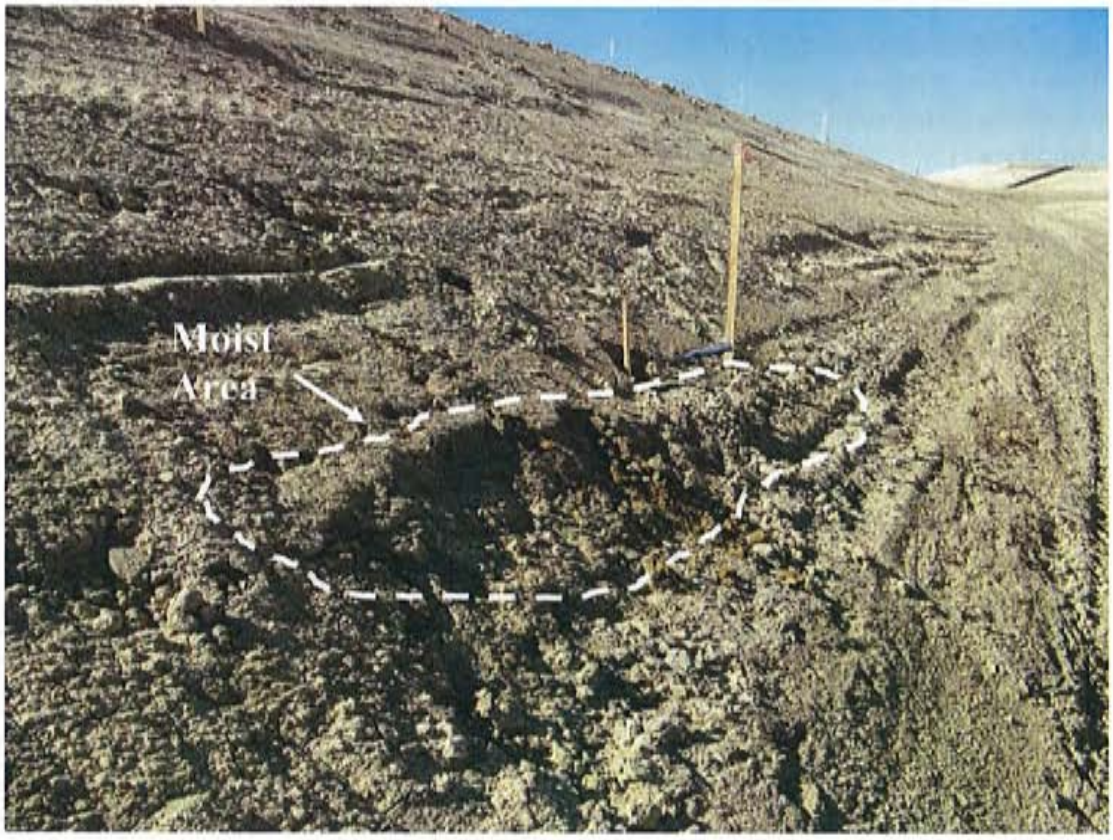
Swales that contained coarse alluvial material were checked for moisture where exposed on the side slopes of the excavation. All were dry except for one small swale near the center of the south side slope. Slight moisture associated with this swale, noticed in the September 3 visit (Location 8), extended laterally about 20 to 30 ft, was about 1 to 2 ft thick, and was near the contact of the top of weathered bedrock and alluvial material. This location appears to be in a minor bedrock swale off the main north-striking bedrock ridge described in the Bedrock Surface Section. This moist location was rechecked in successive visits – on October 9, it was noted to be slightly moist and was photographed (Figure 3). On October 28, the location had dried out, and it remained so in the succeeding visits on November 13 and 24. Apparently, a small amount of water that had accumulated in this minor swale was exposed during August by the excavation. The source of the moisture is not known, but could be from water used during the excavation or from a rainfall event when the excavation depth was near the level of the swale. This small amount of moisture dried up over the next two months.

Figure 3. Moist Area Around Location 8 (at the Short Stake) of September 3 on the South Side Slope

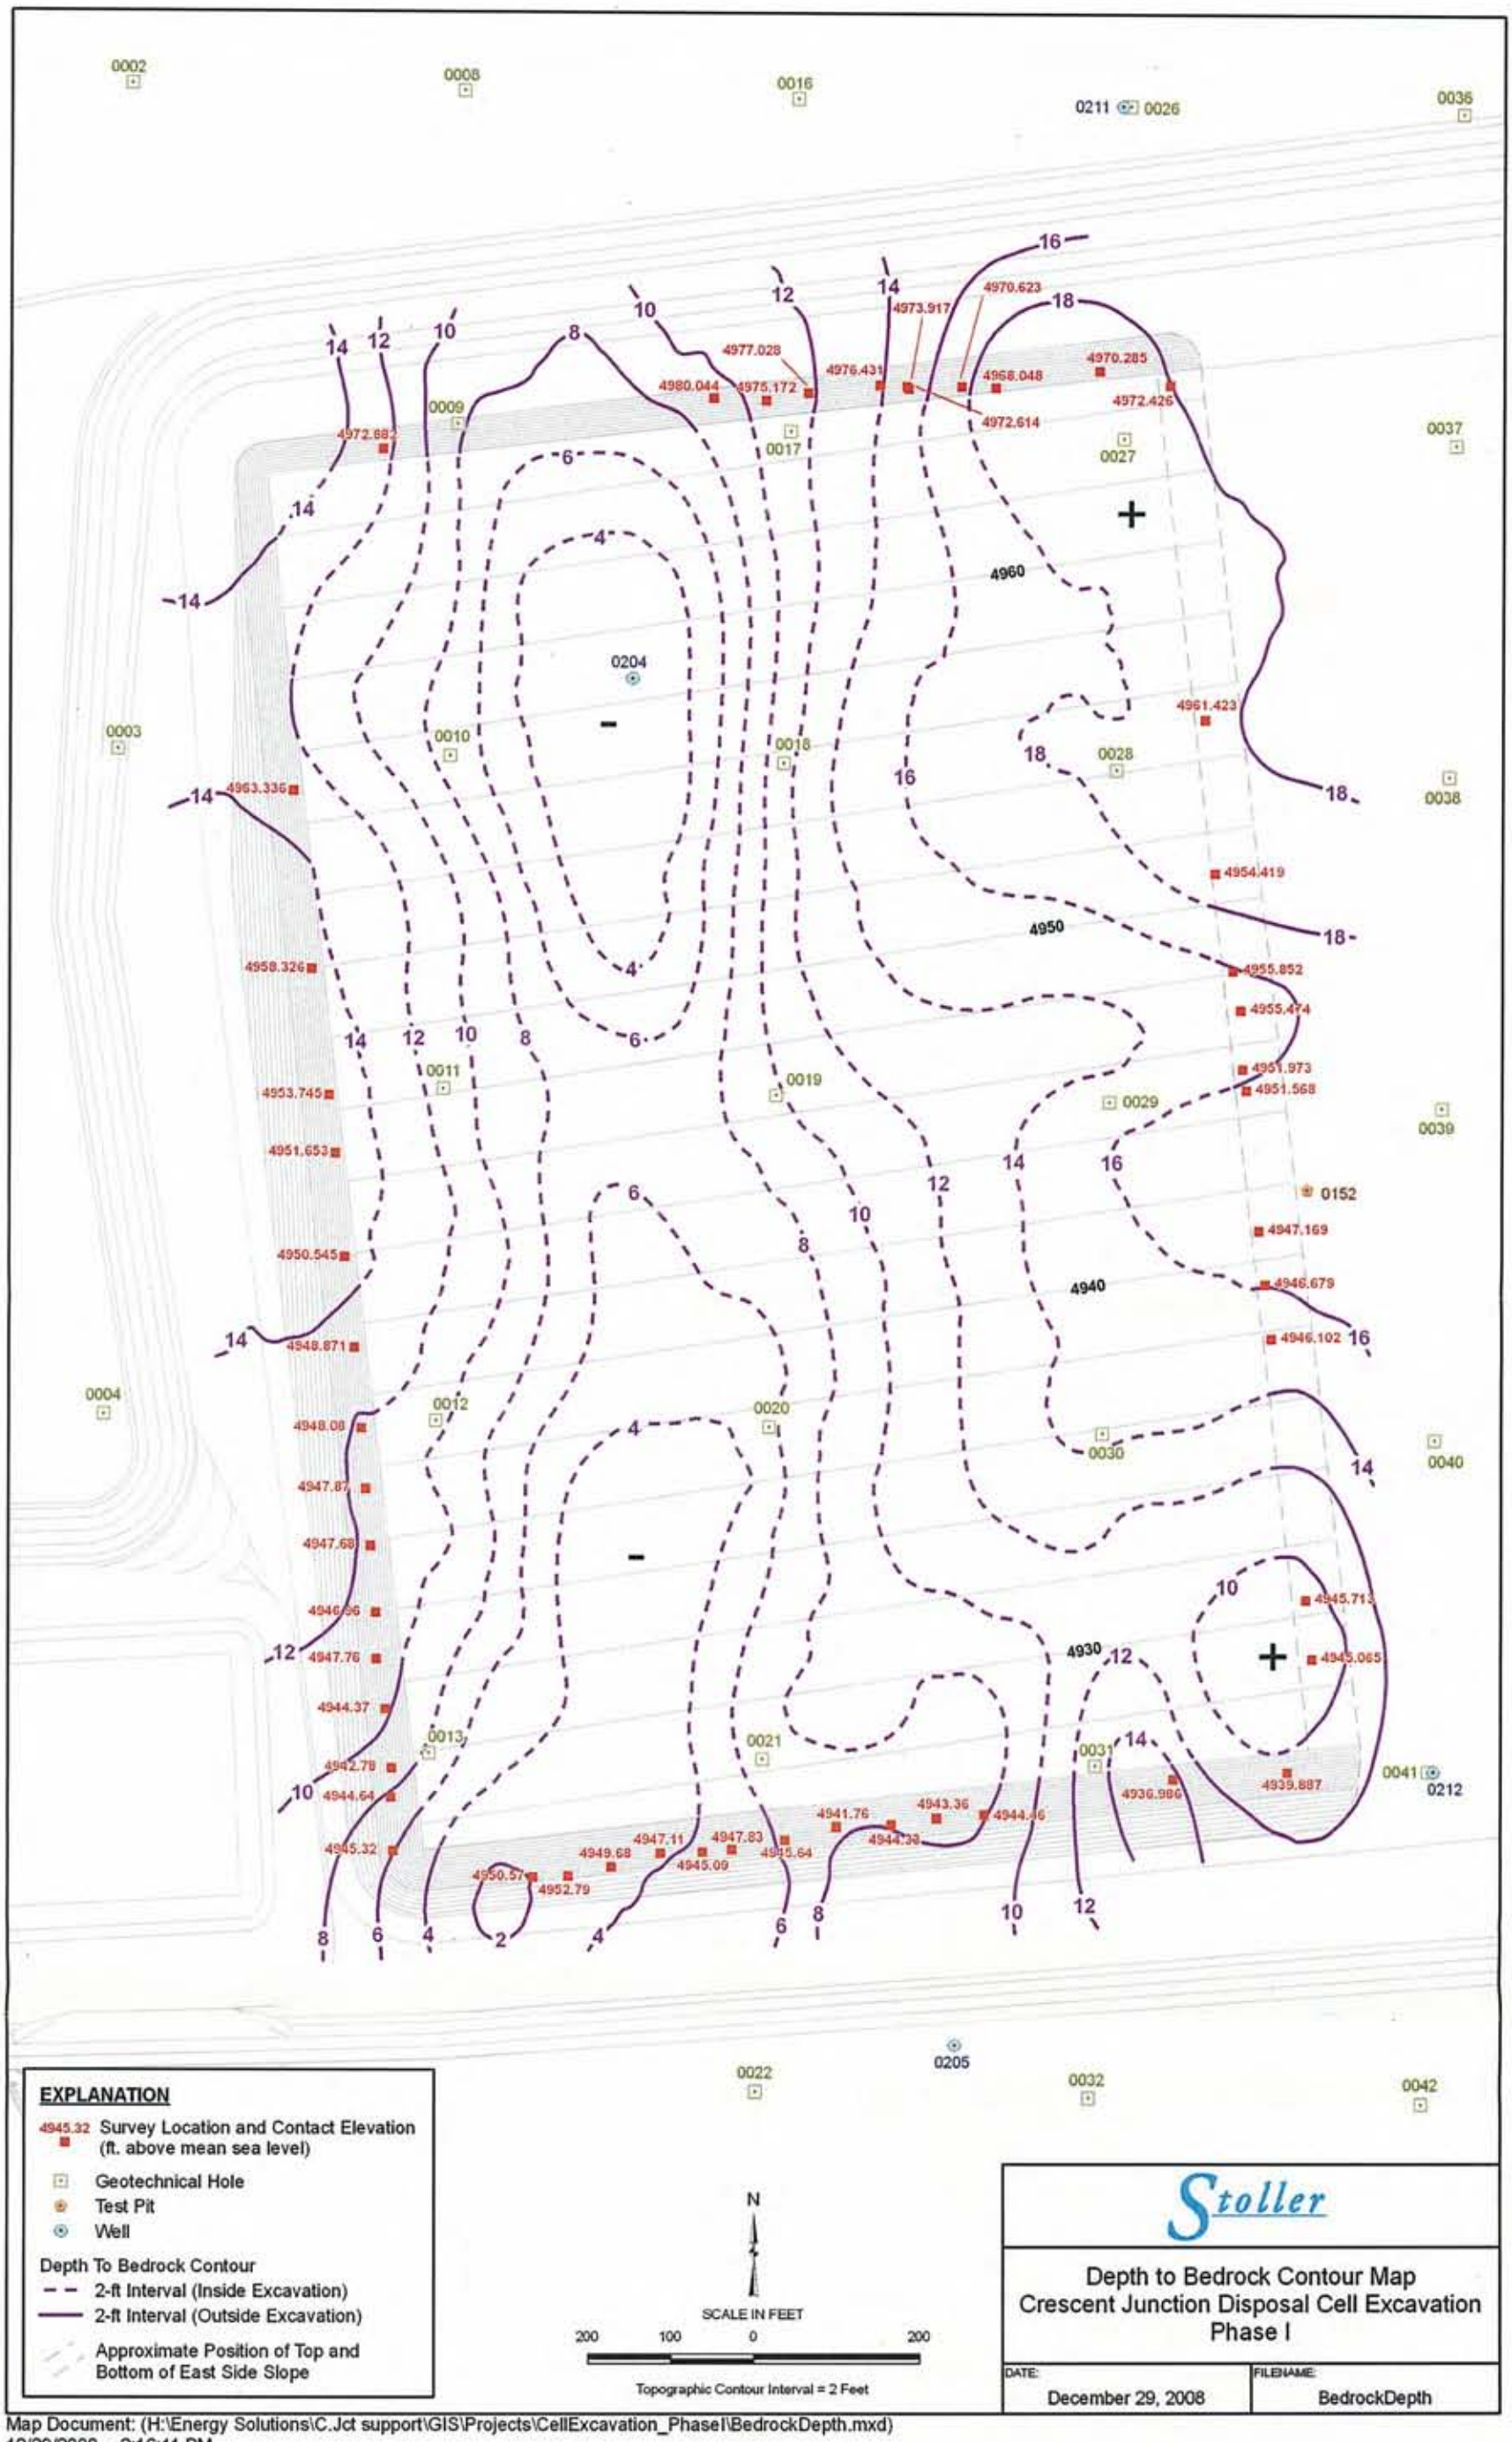
Figure 5. Depth to Bedrock

A Depth to Bedrock map was prepared by subtracting the elevations of the top of the bedrock from those of the original ground surface. This map, presented as Figure 5, essentially shows the thickness of the Quaternary material. Depth to bedrock is least in a north-striking area corresponding to the bedrock ridge in the west part of the excavation where depths are as little as 4 ft or less. Greatest depths to bedrock are as much as 18 ft or more along the east side of the excavation from the center of the east side to the northeast corner.

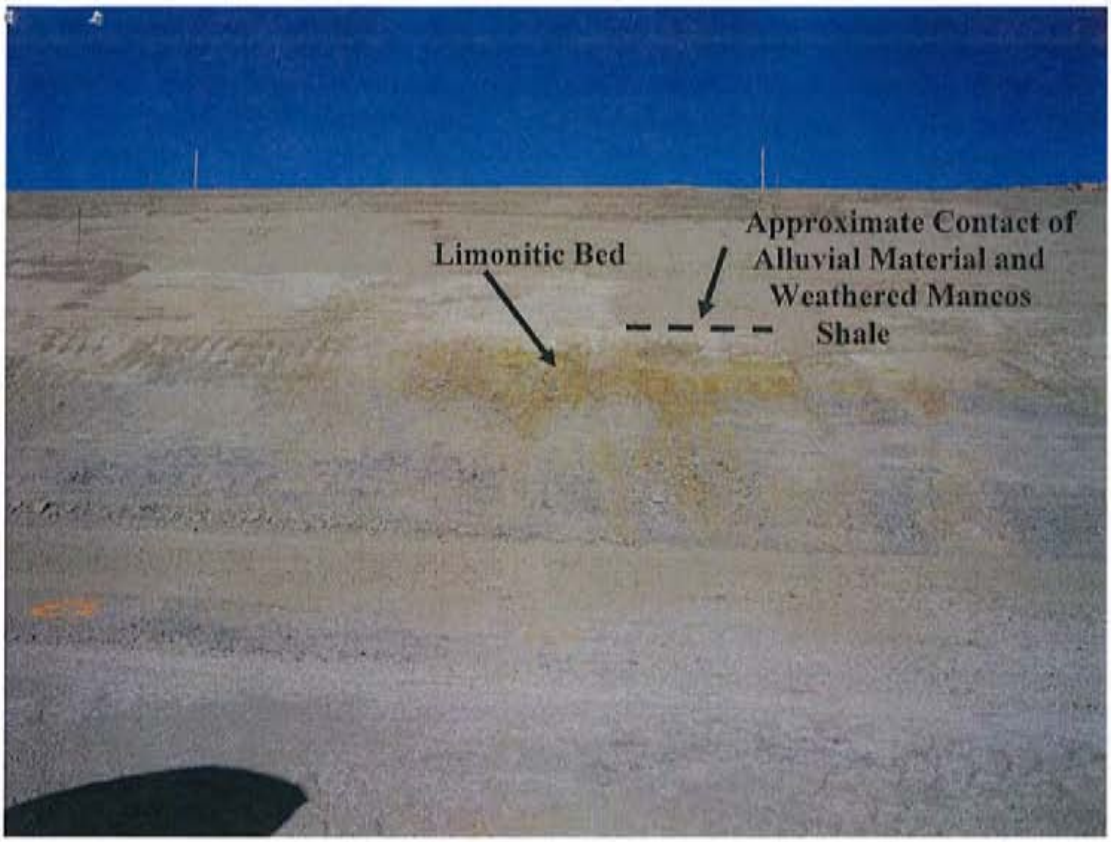
Figure 8. Limonitic Siltstone and Very Fine Grained Sandstone Bed on North Side Slope Near Northeast Corner of Excavation

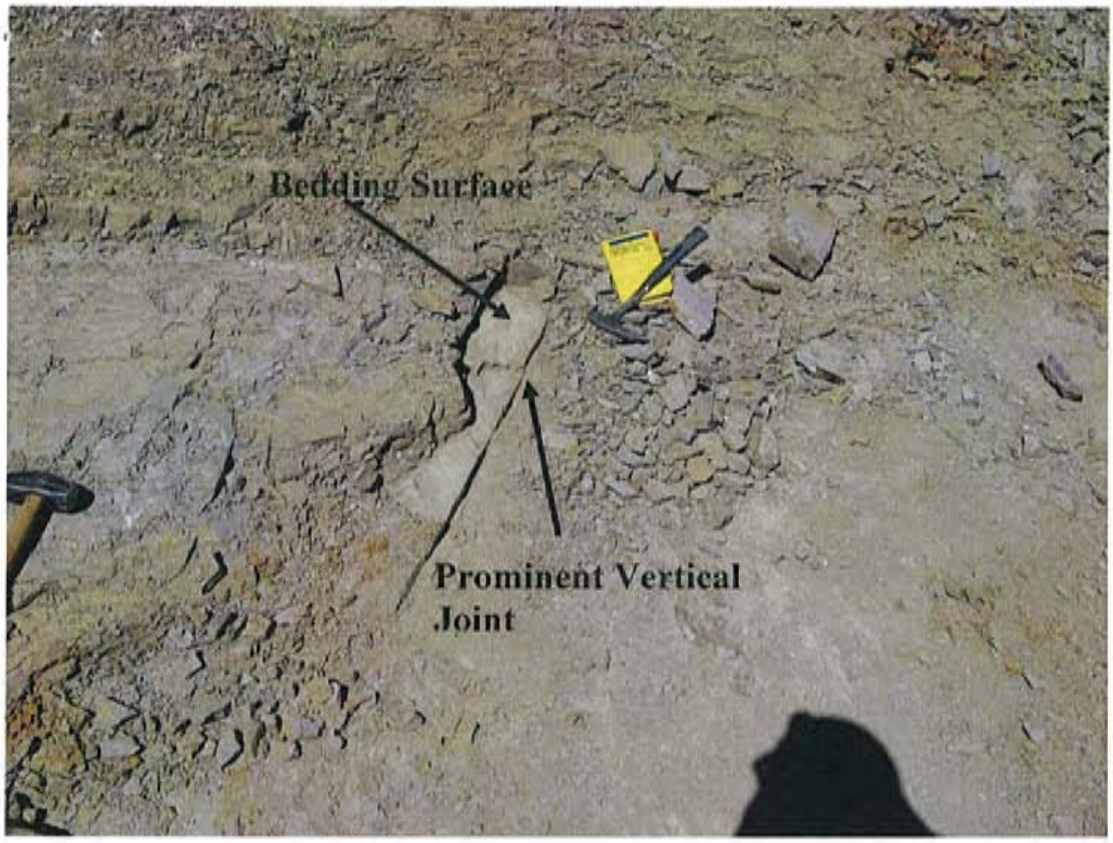
Figure 14. In the Southwest Corner of the Excavation, Bedding Surface Strikes N50W and Dips 6 Degrees Northeast and Prominent Vertical Joint Strikes N57W

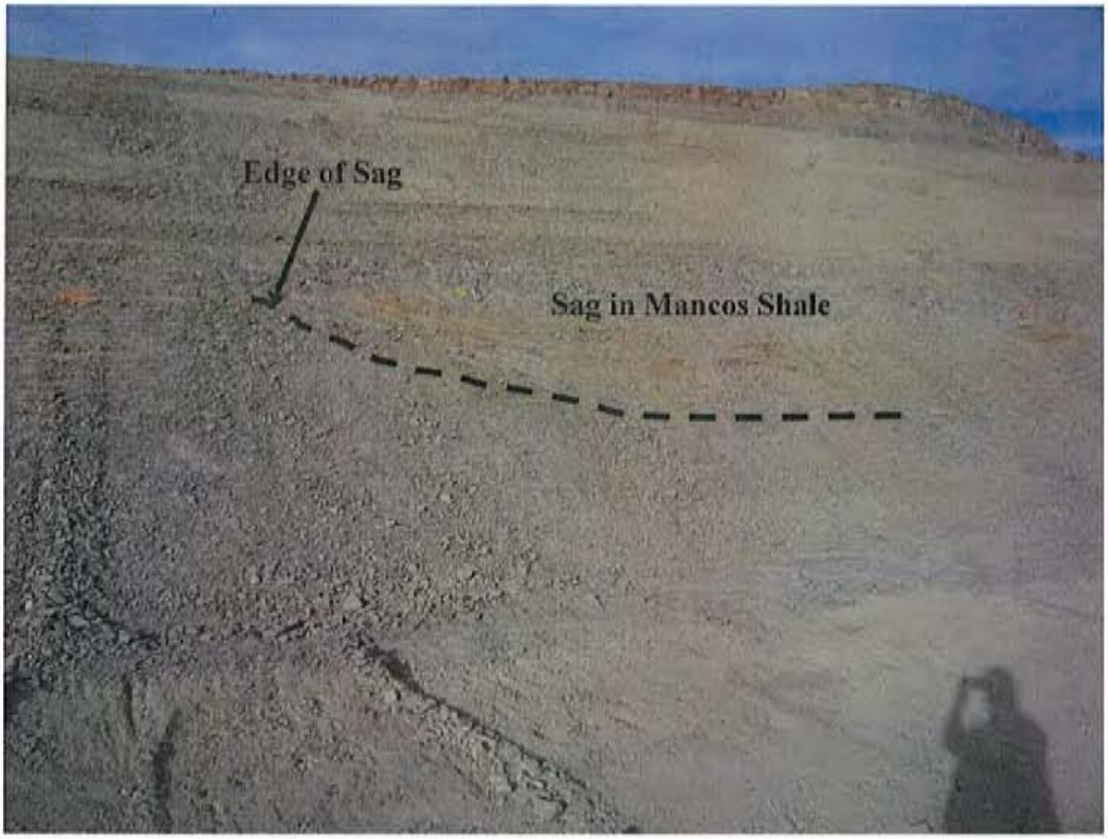
Minor structural sags in Mancos Shale bedding were noticed in several places in the excavation. One sag in the southwest part of the excavation (Figure 1) appeared to be a flexure expressed by steeper dip (15 degrees) of bedding and a strike of N20W. Two other sags are well exposed near the center of the north side slope of the excavation. The two sags are about 100 ft apart and each one is about 50 ft long and 3 to 4 ft deep, as expressed by bedding (Figure 16). Also, yellowish orange (limonitic) coloration is characteristic of the bedrock in the sags, and beds outside the sag are the normal yellowish gray color.

Figure 16. View Northeast of Sag in Mancos Shale About 50 Ft Long and 3 to 4 Ft Deep with Yellowish Orange Limonitic Siltstone Beds at Location 8 of November 13

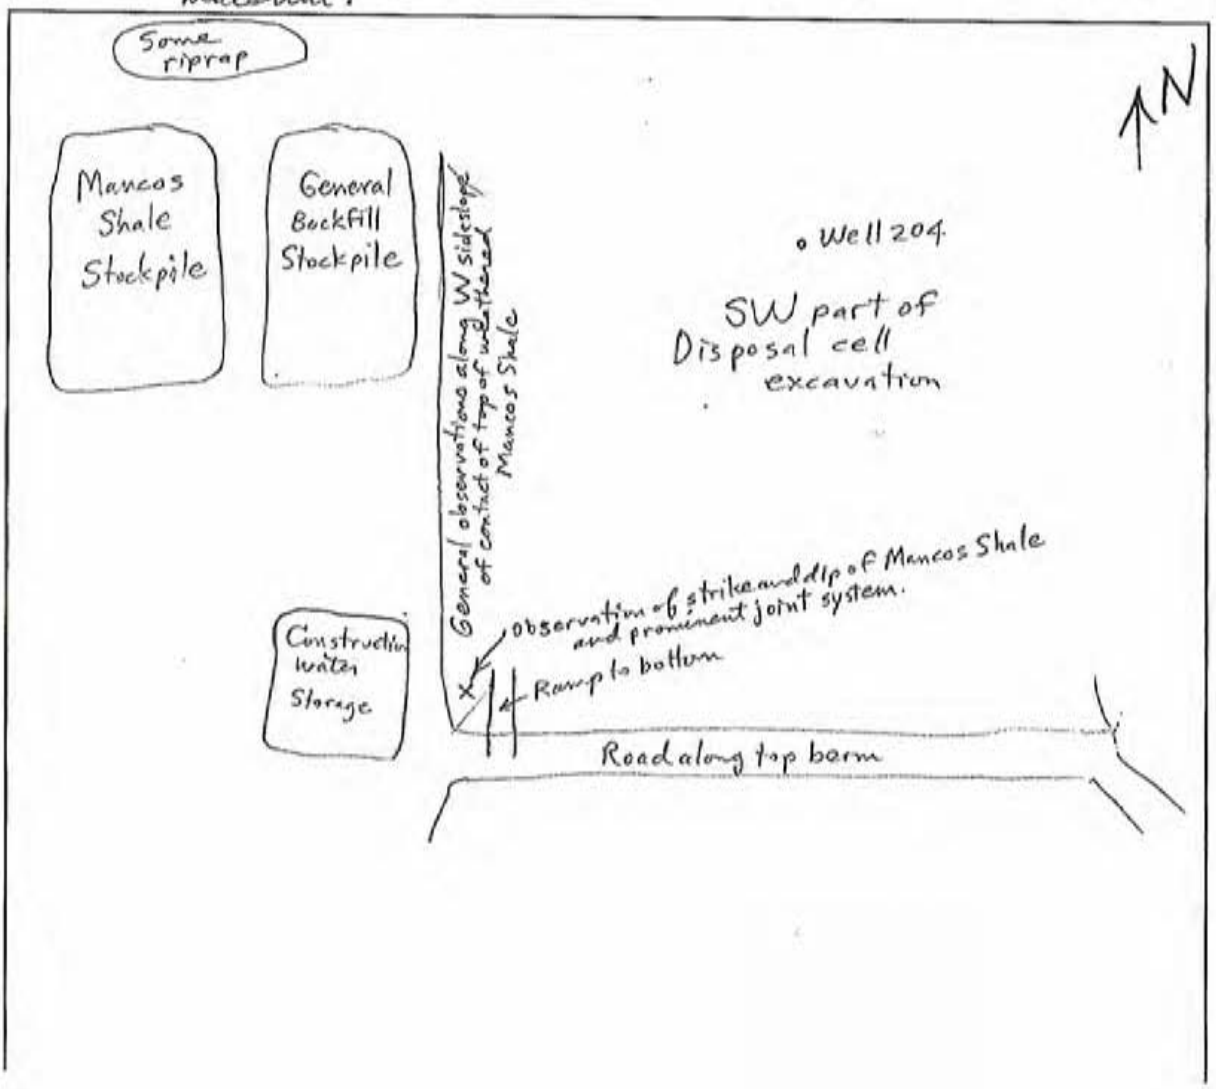
The contact of the top of weathered Mancos Shale and overlying Quaternary material is moderately well exposed along the West sideslope of the excavation. Reddish eolian material as much as 3 ft thick composes part of the Quaternary material.

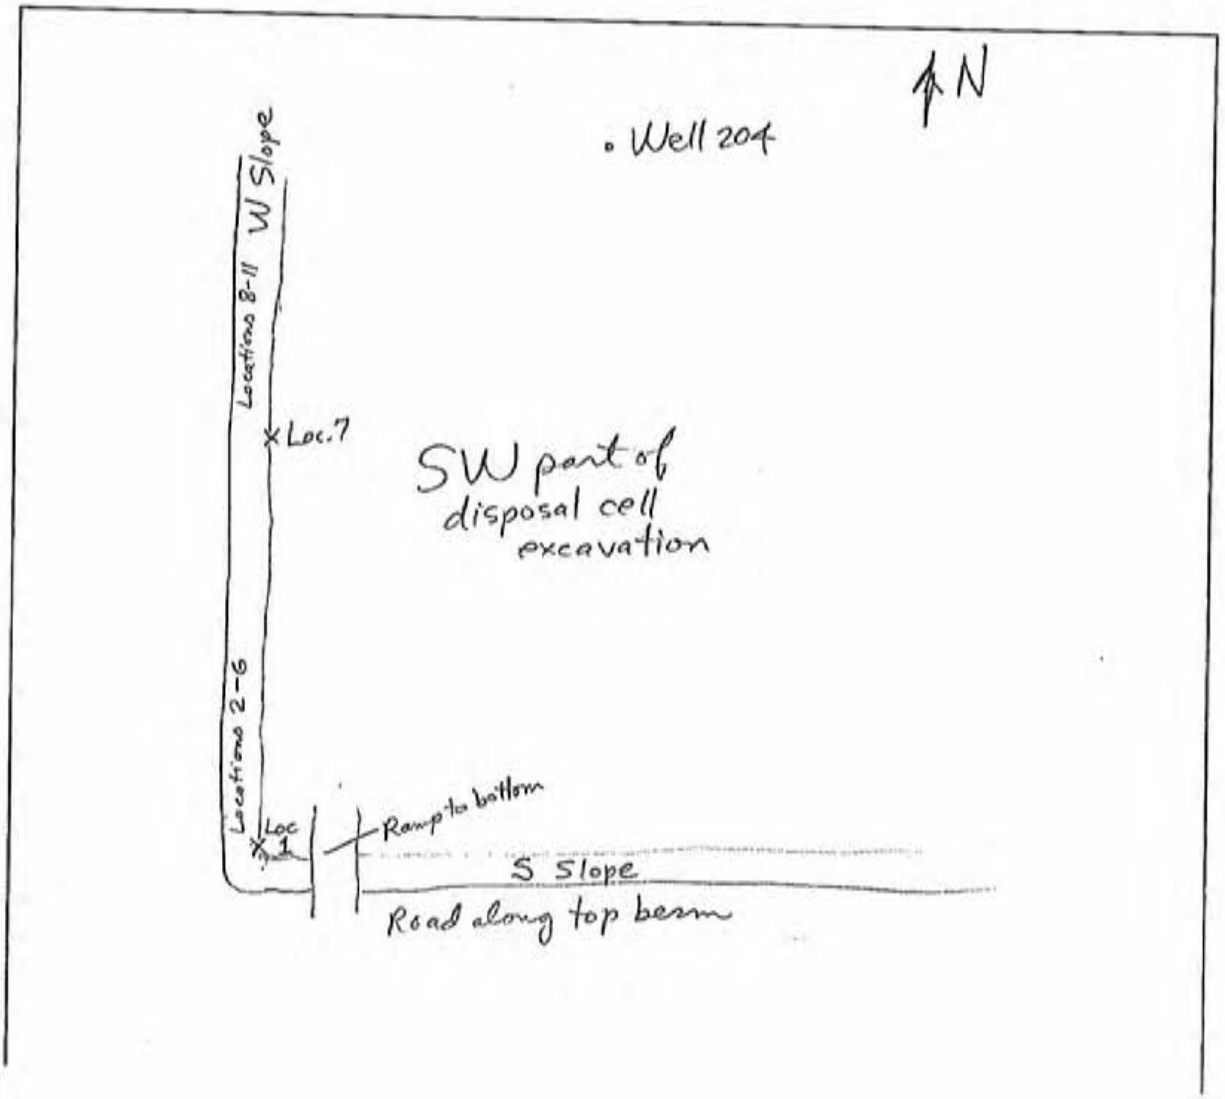
The contact of the top of Mancos Shale and overlying Quaternary material was staked and surveyed along the W side of the excavation. Little undulation of this contact surface was noted along this side of the excavation, probably because this slope is nearly parallel to the surface slope drainage direction. Weathered Mancos Shale is overlain by either alluvial material (mostly fine grained, but as large as 12-15" dia cobbles were noted) or eolian material (which was as much as 2ft thick).

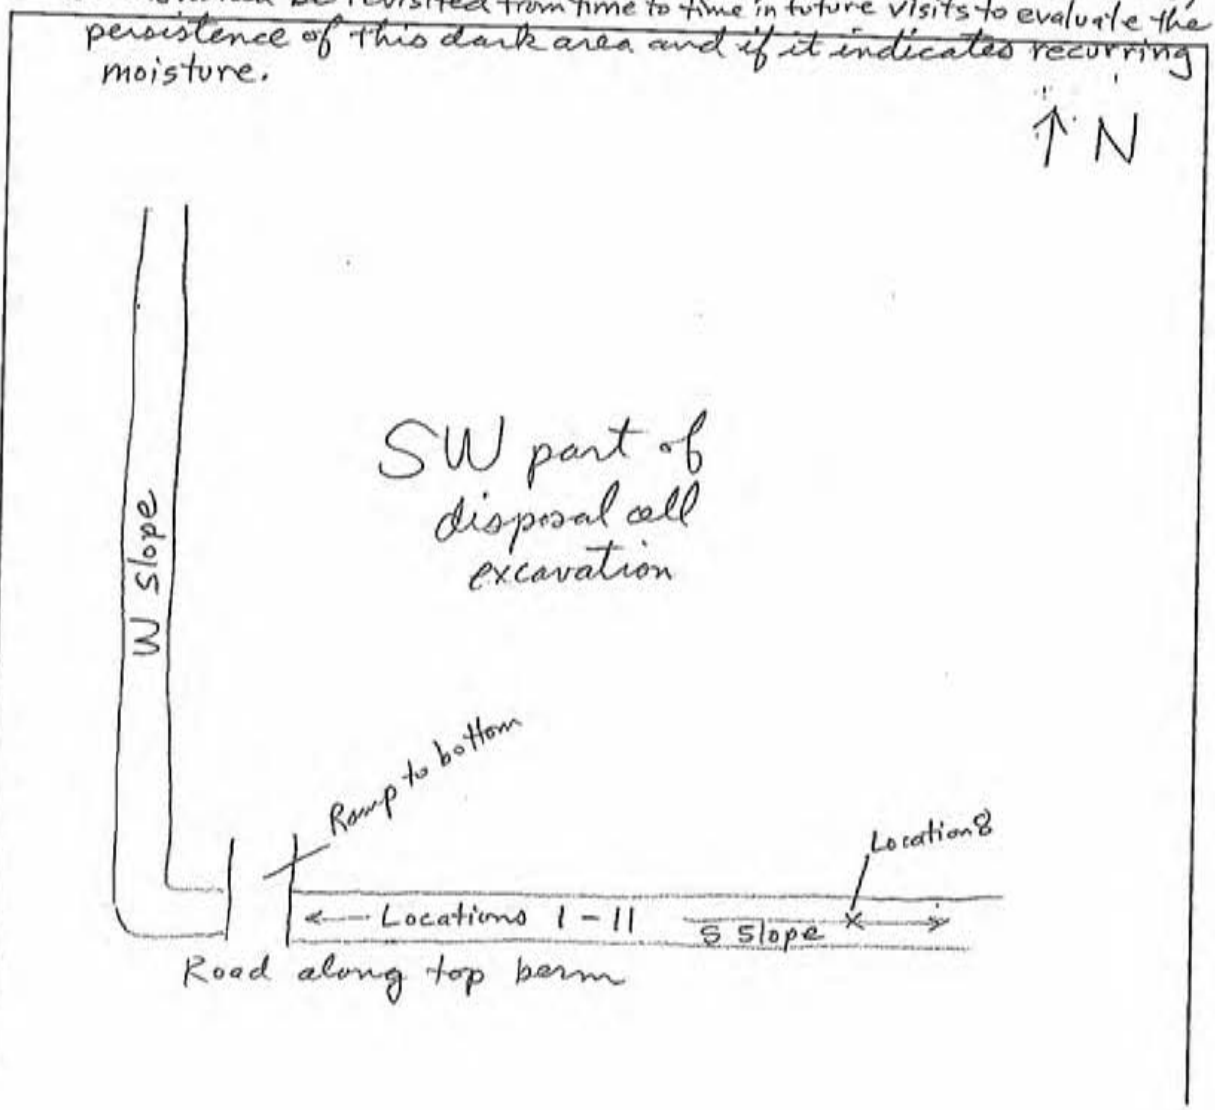
The contact of the top of Mancos Shale and overlying Quaternary material was staked and surveyed along the S side of the excavation. Moderate (5 to 6 ft) undulation of this contact surface was noted along this side of the excavation because this slope is nearly perpendicular to the surface slope drainage direction. Several channels in the basal alluvial material with clasts as large as 12 inches in diameter were seen. In a few locations, reddish eolian material 1-3 ft thick lied directly over the top of Mancos Shale. A condition of slightly moist (dark appearing soil) was noticed for about 10-15 ft both E and W of location 8. This narrow dark band was on or very near the bedrock contact; this area should be revisited from time to time in future visits to evaluate the persistence of this dark area and if it indicates recurring moisture.

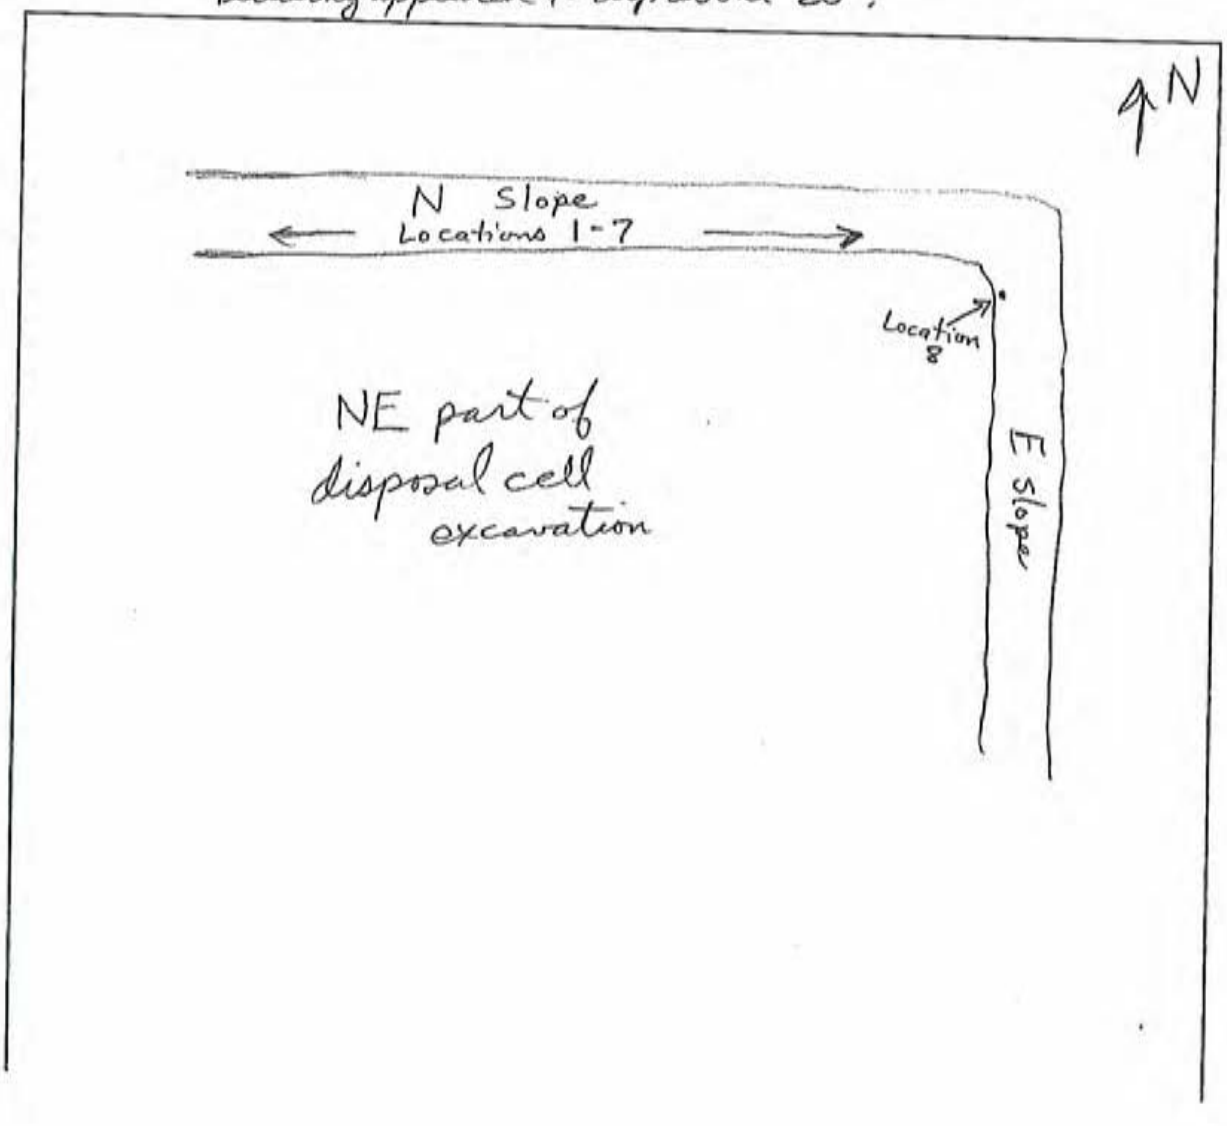
Description of significant geologic features (fractures, joints, weathering characteristics, lithologic variations, strike/dip, depth of overburden, Mancos Shale contract, etc):
The contact of the top of Mancos Shale and overlying Quaternary material was staked (to be surveyed in the next few days) along the N side of the excavation. Moderate undulation of this contact was noted along this side of the excavation because this slope is nearly perpendicular to the surface slope drainage direction. One channel in the basal alluvial material with clasts 2 inches in diameter and larger was noted at Location 7. A hard dolomitic limestone bed 1+ ft thick is near the base of the N side slope at Location 1. About 2-3 ft above this bed is a tan very fine grained sandstone bed about 6 in thick; strike and dip on this sandstone at Location 2 was N55W and 12° NE. A slight flexure of bedding was noted around Location 2 and just to the west where bedding appeared to dip about 20°.

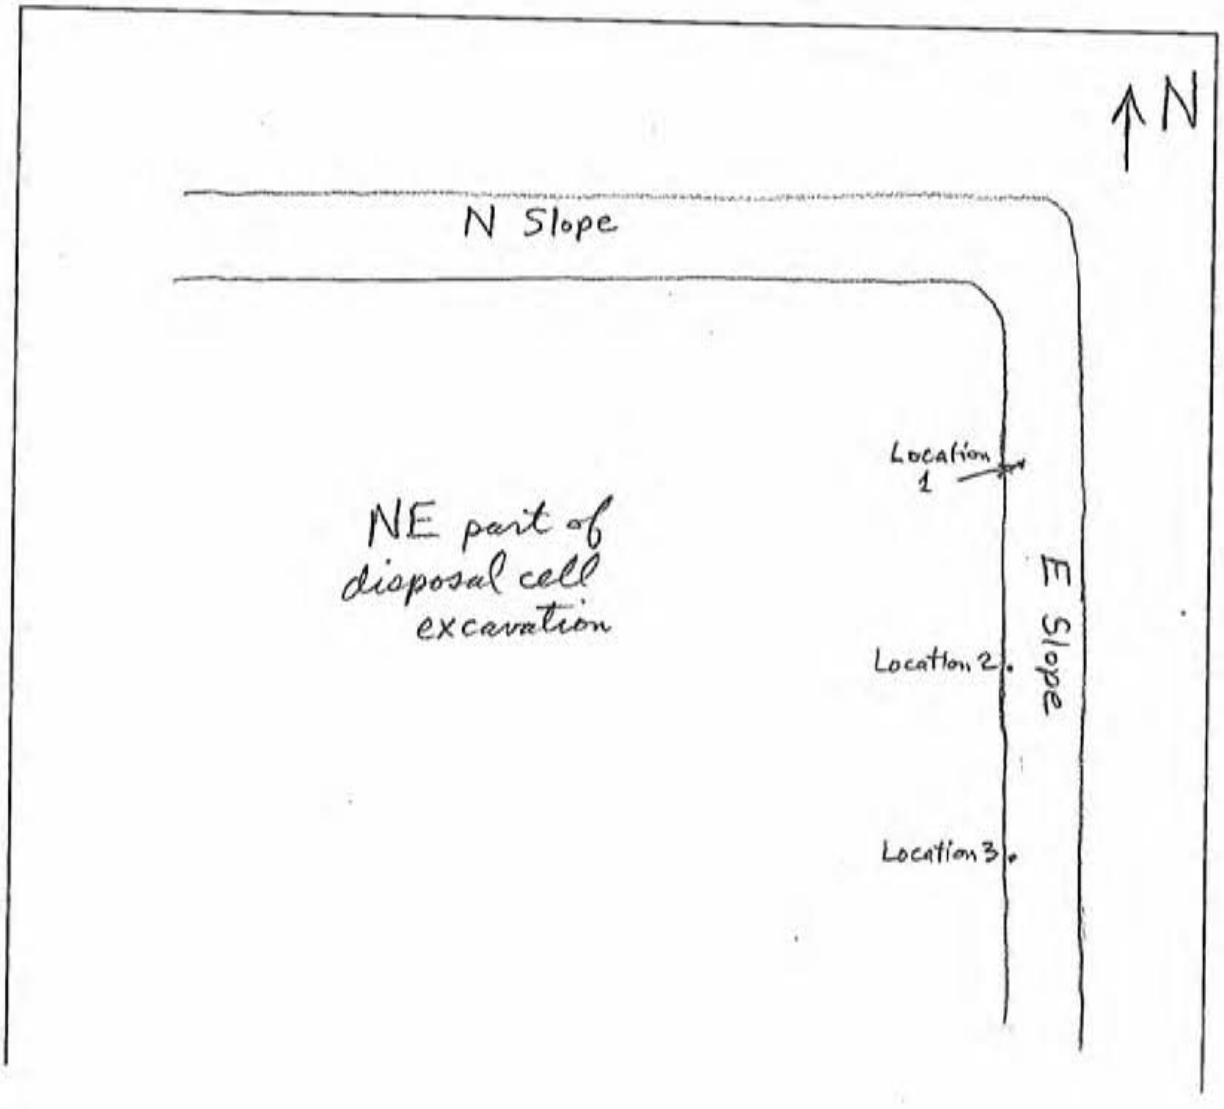
Image
1138 View of moist area along S Slope at Location 8 from 9/3/08.
1139 View N of stockpile of thick dolomitic siltstone at base of N Slope.
1140 View NNE of orthogonal joints in dolomitic siltstone about 20 ft S of Locations 1 and 2 from 9/22/08. Strikes of joints are N55W and N35E.
1141 Abundant gypsum along fracture in bottom of excavation
1142 View NNW from NE corner of bottom of excavation.
1143 View of Location 1 - Sandstone clast ~2 ft diameter in Quaternary paleochannel fill.

Description of significant geologic features (fractures, joints, weathering characteristics, lithologic variations, strike/dip, depth of overburden, Mancos Shale contract, etc):
Moist area on S Slope of excavation persists at Location 8 (from 9/8/08). About 100 yds W of Location 1 (from 9/23/08) is stockpile of gray resistant dolomitic siltstone (blocks from bed as thick as 3 ft). Stockpile of unweathered gray shale is just E of the dolomitic siltstone stockpile. Orthogonal joints striking N55W and N35E are in dolomitic siltstone 20 ft S of Locations 1 and 2 (from 9/23/08). Carbonized wood fragments in very fine grained sandstone was seen 20 ft S of Location 2 (from 9/23/08) as evidence of brief shoaling of the Mancos Sea. Prominent joint in bottom of excavation was N65W and an open fracture oriented N80W was noticed.
Location 1 was staked at large sandstone clasts (as large as 2 ft diameter) in paleochannel in Quaternary fill on the E Slope.

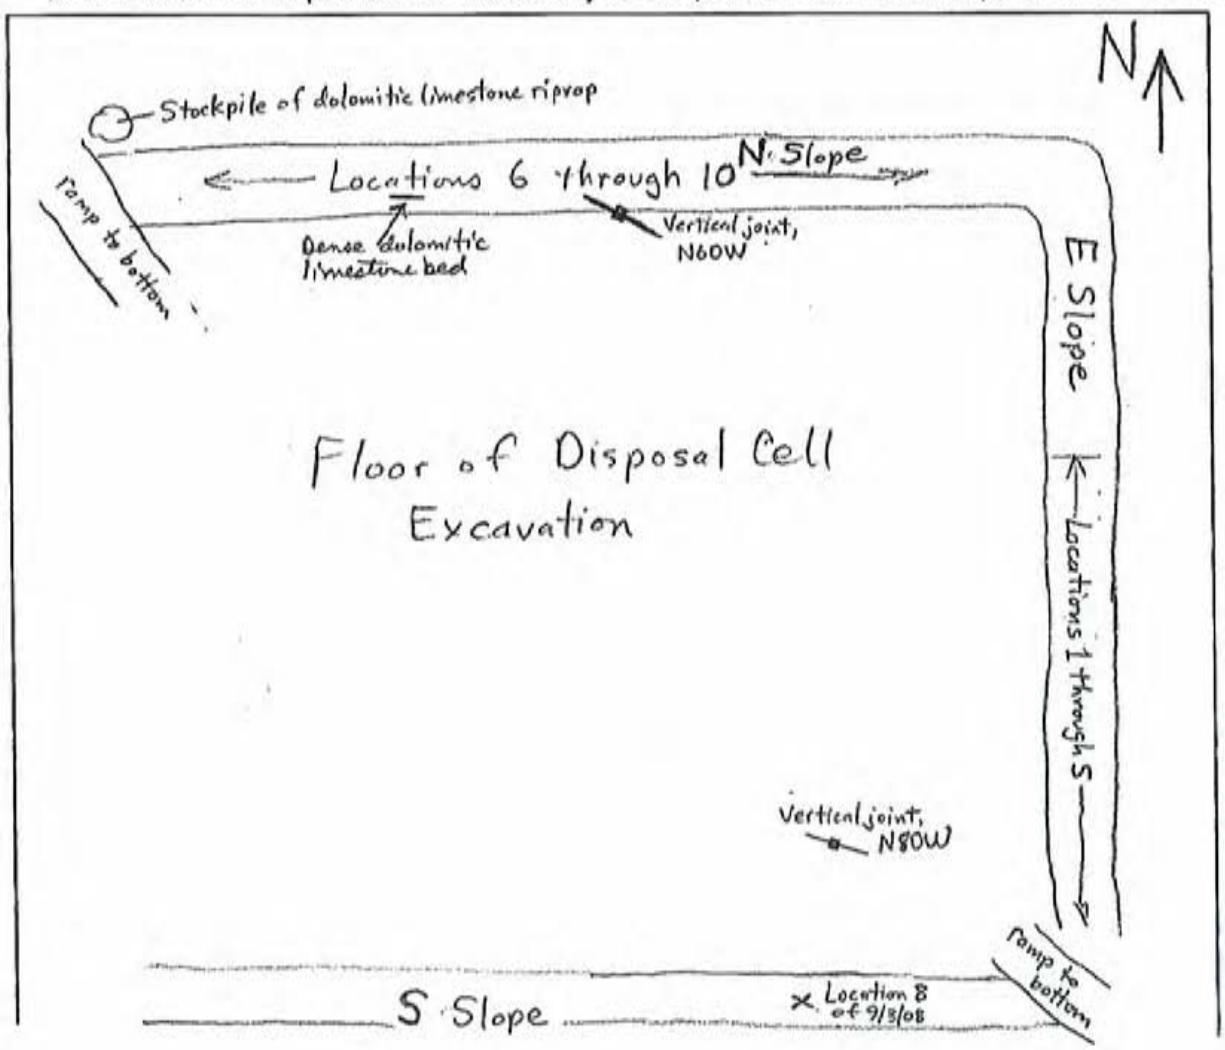
The contact of top of weathered Mancos Shale and overlying alluvial material was noted in 4 locations along the N slope of the excavation. One location (9) on the N slope was for a yellowish gray to grayish brown, very fine grained sandstone bed about 1 ft thick. A dense dolomitic limestone bed about 1 ft thick is on the N slope about 30 ft SW of

Sketch: Location 3 of 9/23/08. Material removed during excavation of a thicker part of this same bed is stockpiled at the NW end of the disposal cell excavation, just above the N slope.

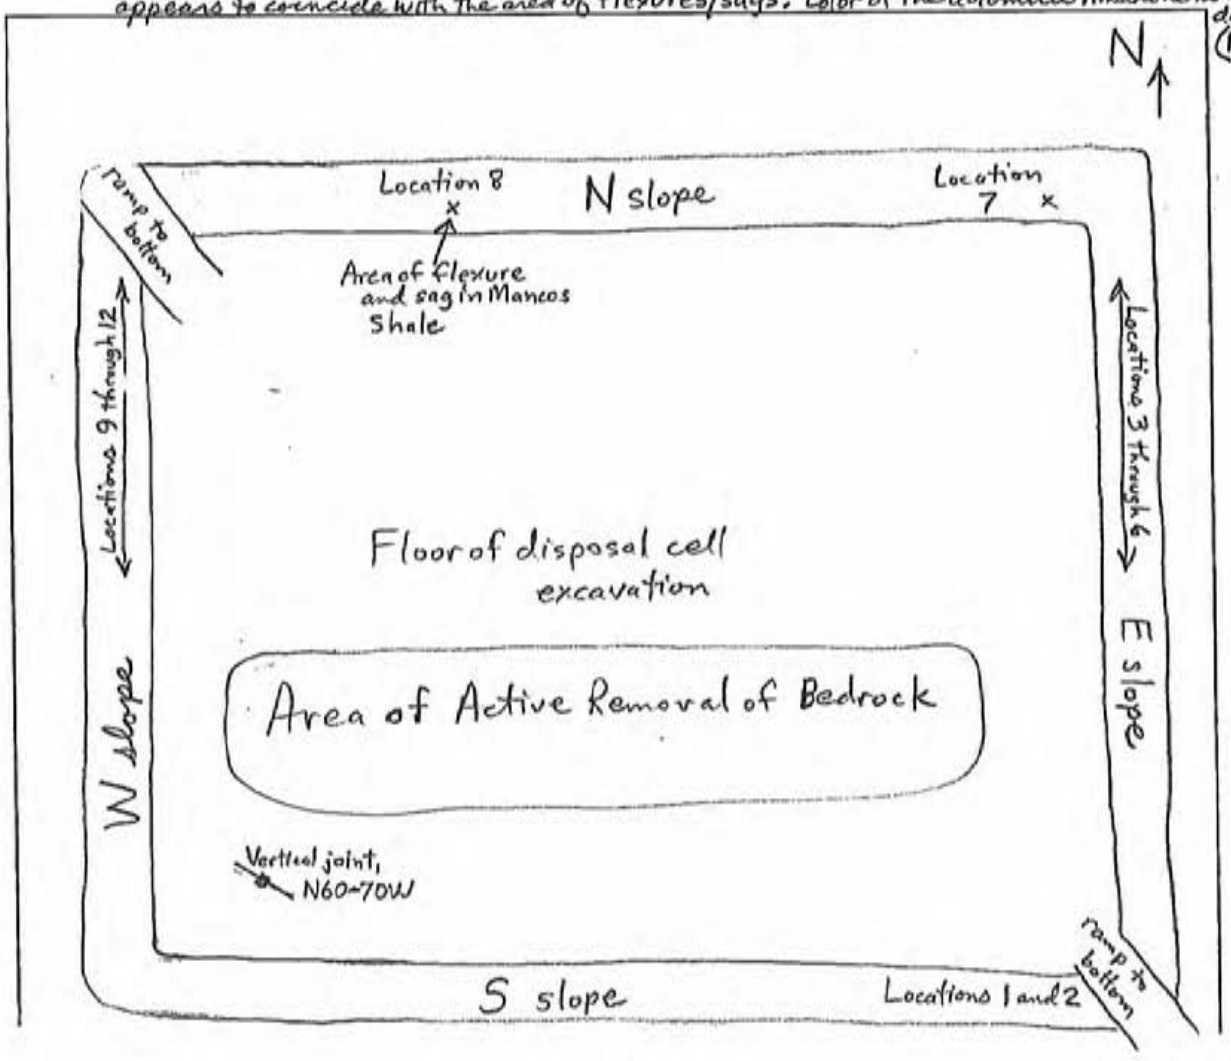
In the area of the N slope near where a bed of dolomitic limestone is exposed (in area of Locations 1 and 2 from 9/23/08), an apparent flexure or sag about 50 ft long and 3-4 ft deep was noted in Mancos Shale. Limonitic (tan-orange) siltstone and very fine grained sandstone occur in the sag and do not appear to continue beyond it. The center of the sag is marked at Location 8 and the sag is just W of another flexure noted in Mancos Shale and the thin bed of dolomitic limestone. The dolomitic limestone bed outcrop can only be followed for about 30 ft and it appears to coincide with the area of flexures/sags. Color of the dolomitic limestone is medium dark gray (N4).

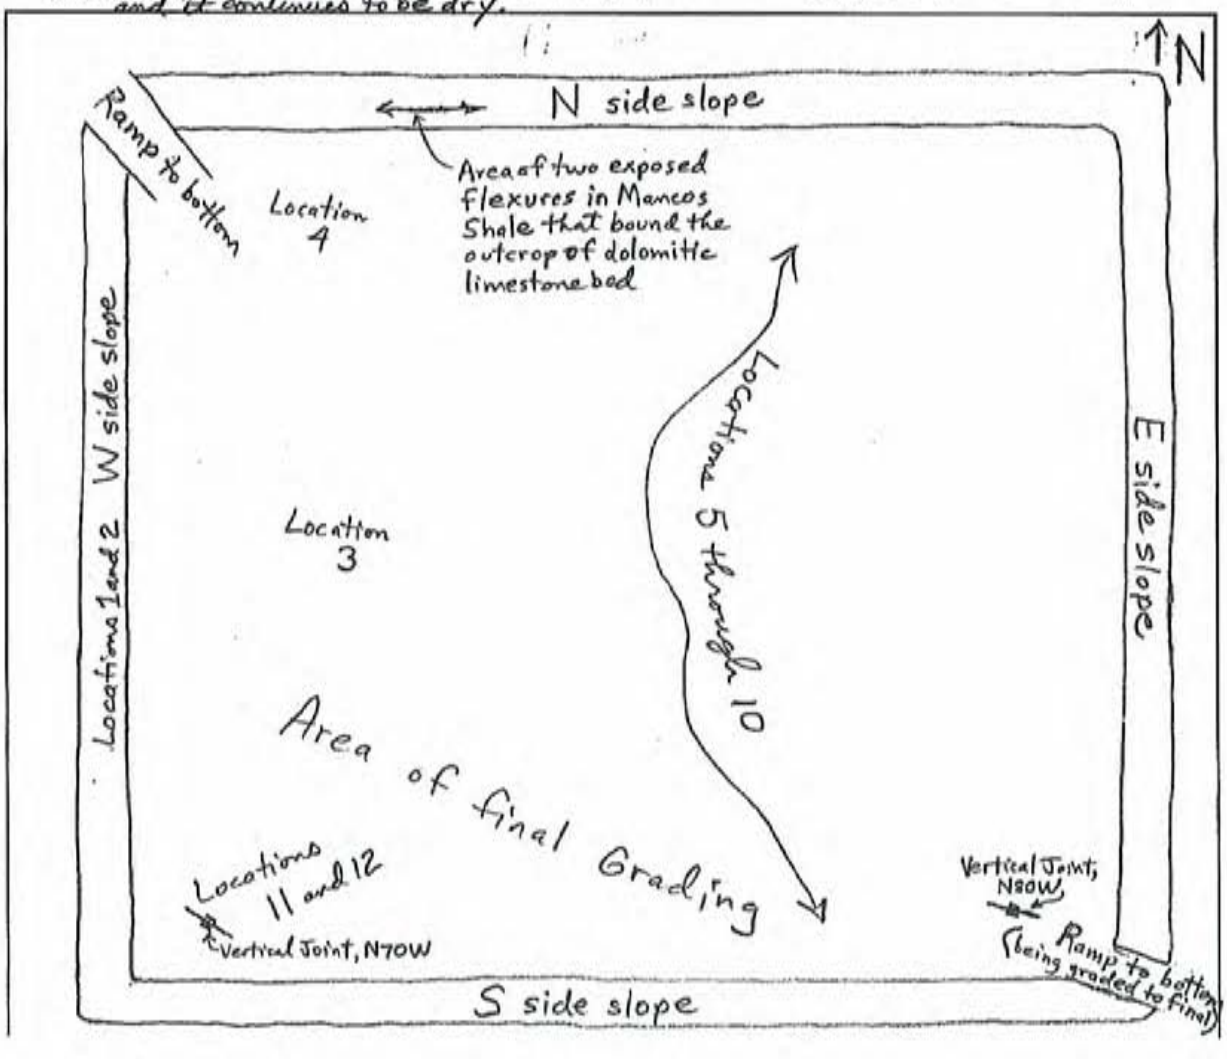
Better exposure of the original flexure noted in Location 2 of 9/23/08 showed it to also be a sag in the Mancos Shale similar to the sag noted in Location 8 of 11/13/08. The thin bed of dolomitic limestone is exposed in the N side slope between the two sags, apparently in a slightly higher structural area.

Sketch: The area of forage moisture in the vicinity of Location 8 of 9/3/08 on the S side slope was checked and it continues to be dry.
