National Nuclear Security Administration

Federal Accident Investigation

**Accident Investigation into Contamination at the
Los Alamos Neutron Science Center on or about
August 21, 2012**

September 2012

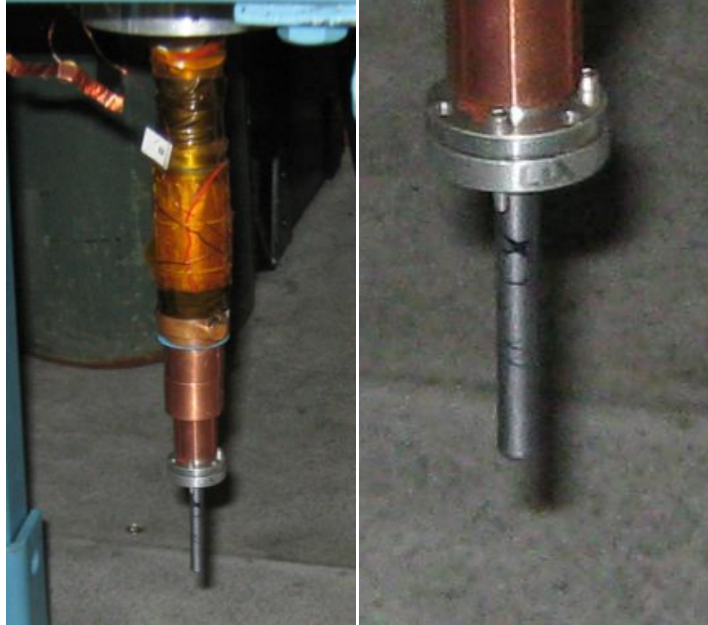
Subsequent analysis showed that this canister was contaminated with Lutetium Technetate, and the collar and perhaps other parts were the same used in January 2012 on the sample canister for PI-1's Lutetium Technetate sample from UNLV.

Figure 2.1.7. Displex Cold Finger and Close Up of Tungsten Sample
