**Type A Accident
Investigation Board Report
July 11, 1996
Electrical Shock
at
Technical Area 53,
Building MPF-14
Los Alamos National Laboratory**

August 1996

Albuquerque Operations Office

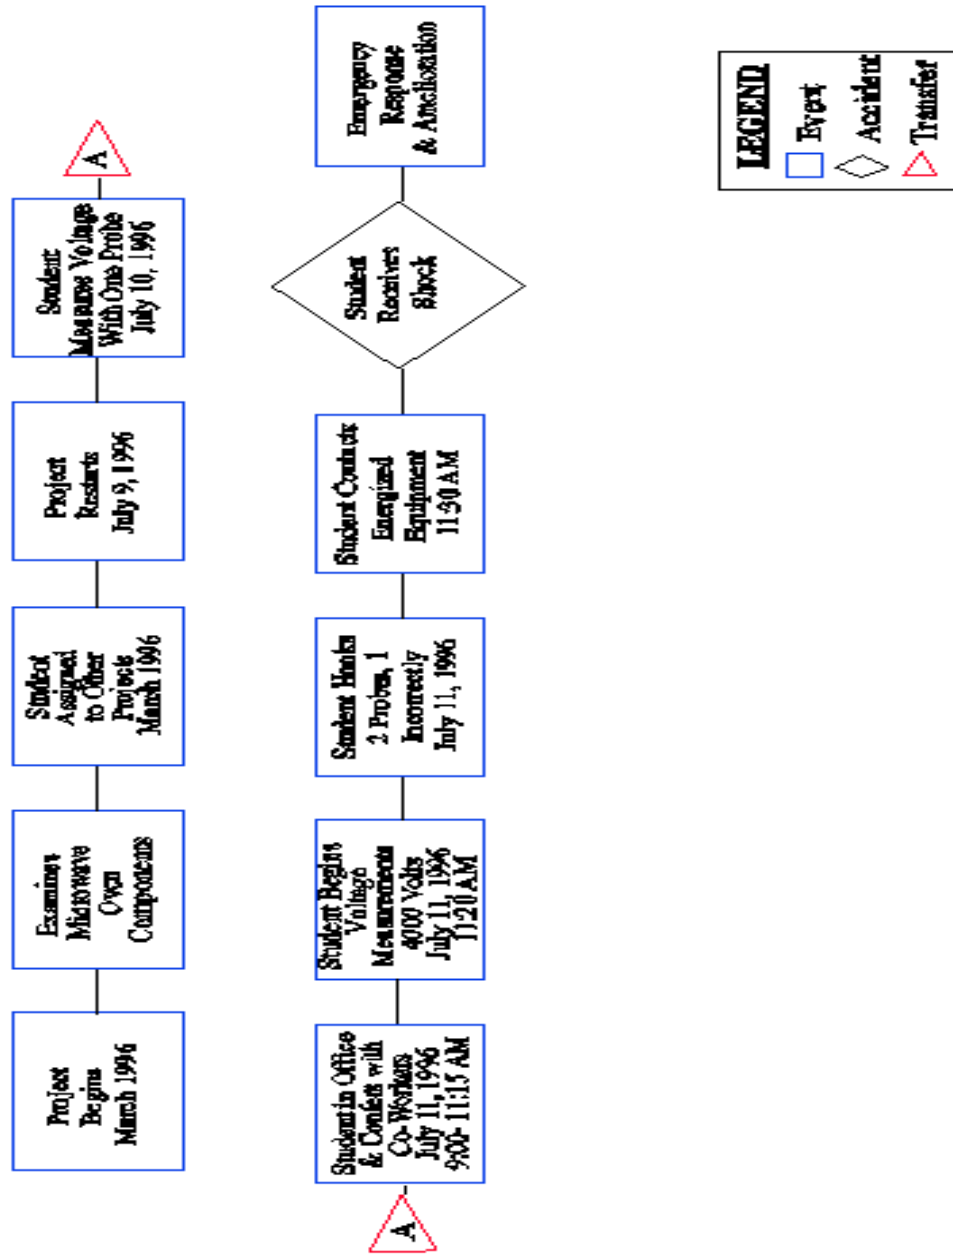
immediately by a coworker who was passing near the scene. The coworker summoned additional assistance from other staff members working in the building. First aid was given to the student employee by a nearby coworker and a call placed to 911. Section 2.3, Accident Analysis, contains a more detailed discussion of specifically how the shock was probably received, based on reconstruction of the accident from the physical evidence, interviews, and the results of equipment testing requested by the Board. Figure 2-4 summarizes the chronology of the accident.

Figure 2-4: Summary Events Chart and Accident Chronology

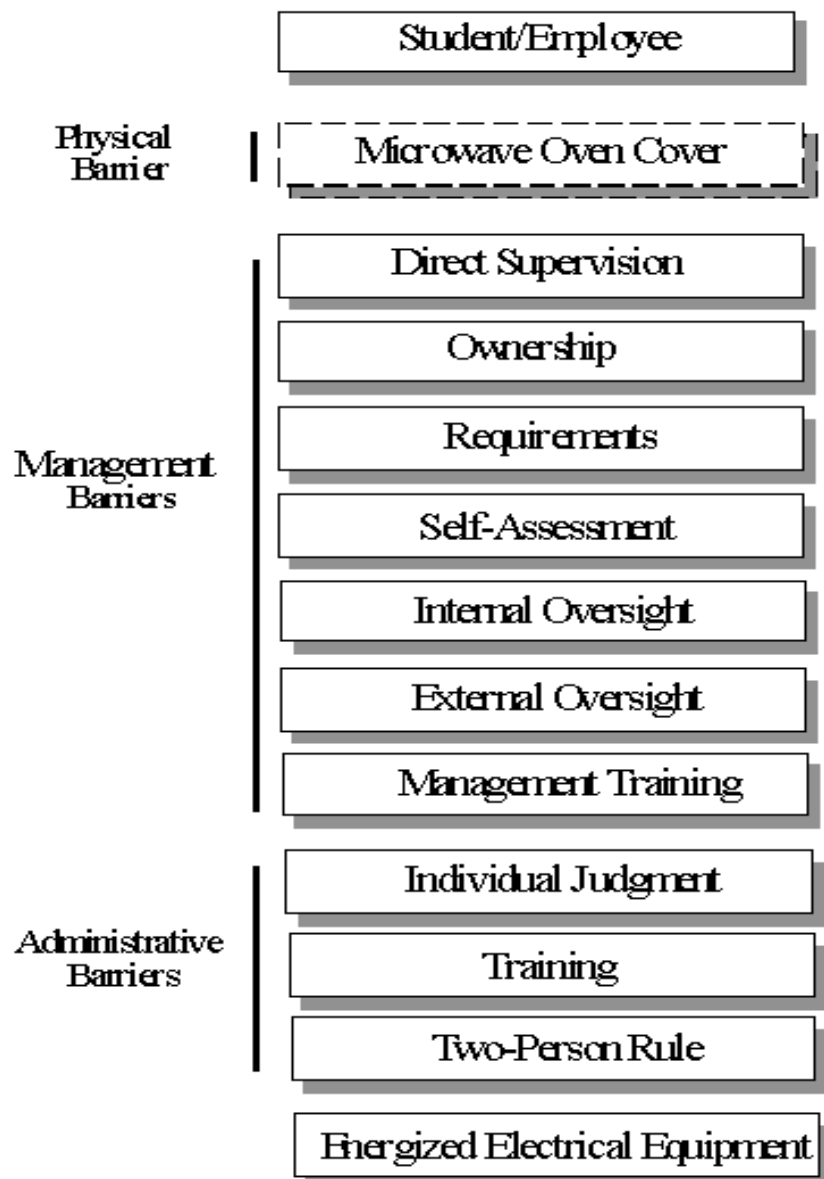
Figure 2-8 Barrier Analysis Summary

The safety barriers between the accident victim and the high voltage hazard of the microwave oven included physical barriers, management barriers, and administrative barriers. The barriers are presented in summary form in Figure 2-8 and are discussed in more detail below.

The Group Leader failed to clearly define responsibility for supervision of the student employee.
