Final Report

July 1997

**Type B Accident
Investigation Board Report
of the Plutonium Intake,
Between August 4, 1996–February 10, 1997,
By a Crane Operator
At the Savannah River Site F-Canyon**

Savannah River Operations Office

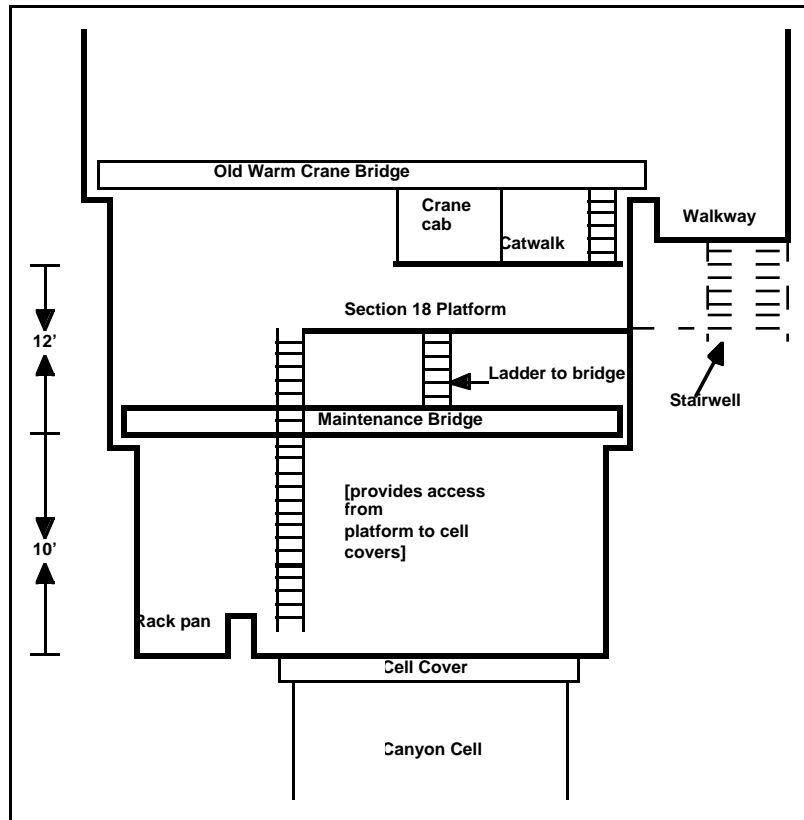
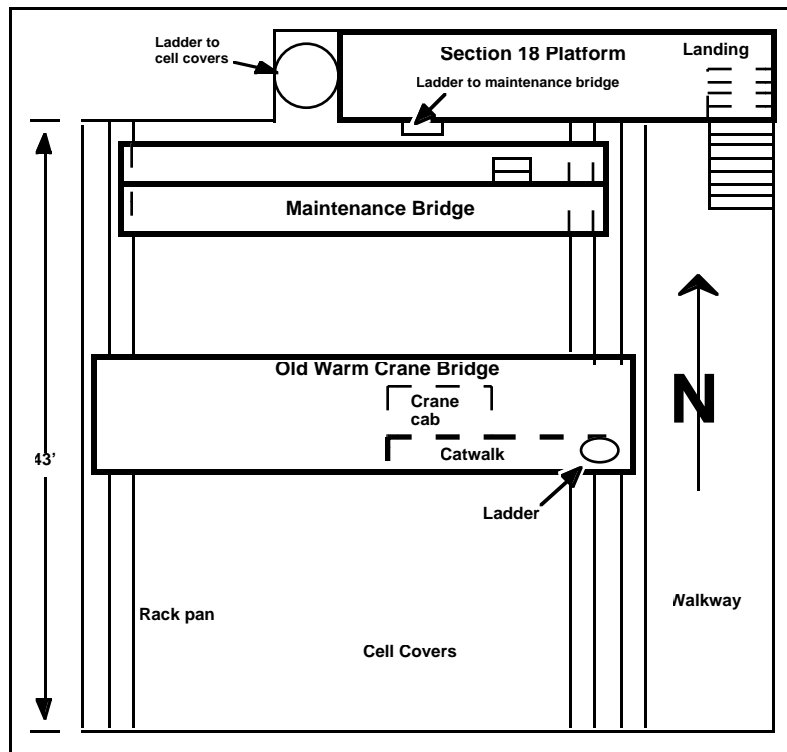
Figure 2-1 Typical Warm Canyon Section 18 (Cross Section Looking North)

On May 13, 1997, while performing a walkdown of the Warm Canyon, the Board discovered tools and protective clothing on top of the section 18 cell covers, section 18 stairwell landing, section 18 platform, and the maintenance bridge in the Warm Canyon (Figures 2-1, 2-2). Because of the worker safety implications of these discoveries, WSRC management was notified. Subsequently, WSRC conducted a separate investigation to determine when, how, and why the tools and protective clothing were located in these areas of the Warm Canyon. The results of the WSRC investigation are discussed in Appendix D.

On May 22, 1997, the cell covers and the material found on the cell covers were surveyed. Gloves and shoe covers were found in close proximity to tools and equipment, which included a ball peen hammer, thin blade screwdriver, and pliers. Some of the plastic shoes covers were manufactured by FABOHIO Inc., a type not used in F-Canyon prior to April 1996 (Exhibit 2-1). The maximum transferable contamination found on the cell covers was 300,000 dpm/100 cm² alpha and the maximum transferable on any item was 200,000 dpm/100 cm² alpha, which was found on a snap ring, a screw driver and a plastic shoe cover.
