# Status Of Integrated Waste Treatment Unit

**Kevin O'Neill**  
Idaho Cleanup Project

**June 22, 2017**

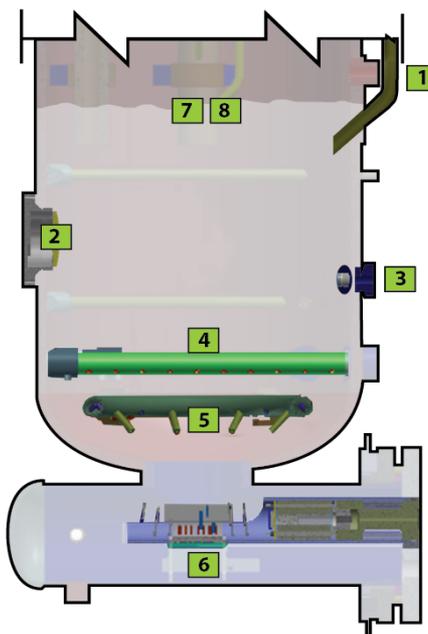
Auger Grinder Failure	
Observation	Auger-Grinder Locked Up
Impact	Inability to Transfer Product Results in Plant Shutdown
Root Cause	Build-up on Rotating Parts Insufficient Mechanical Design Lack of Adequate Purge
Solution	Auger Grinder Root Cause Analysis Industry Expert Consultant Extensive Prototype Testing Improved Purge Gas Strategy Improve Mechanical Design Recovery Capability
<b>6</b>

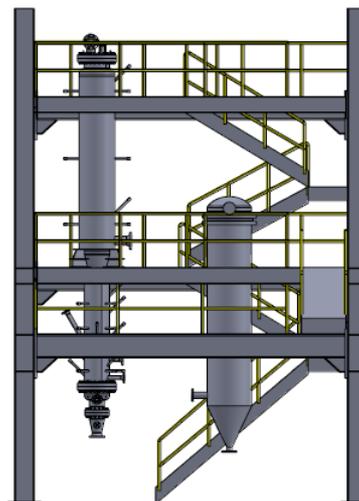
(Above) 18-in diameter DMR vessel (left) and Process Gas Filter (right)
