# *Groundwater Level Trends on the Idaho Site*

*Nicole Hernandez (DOE-ID)*

*July 11, 2012*

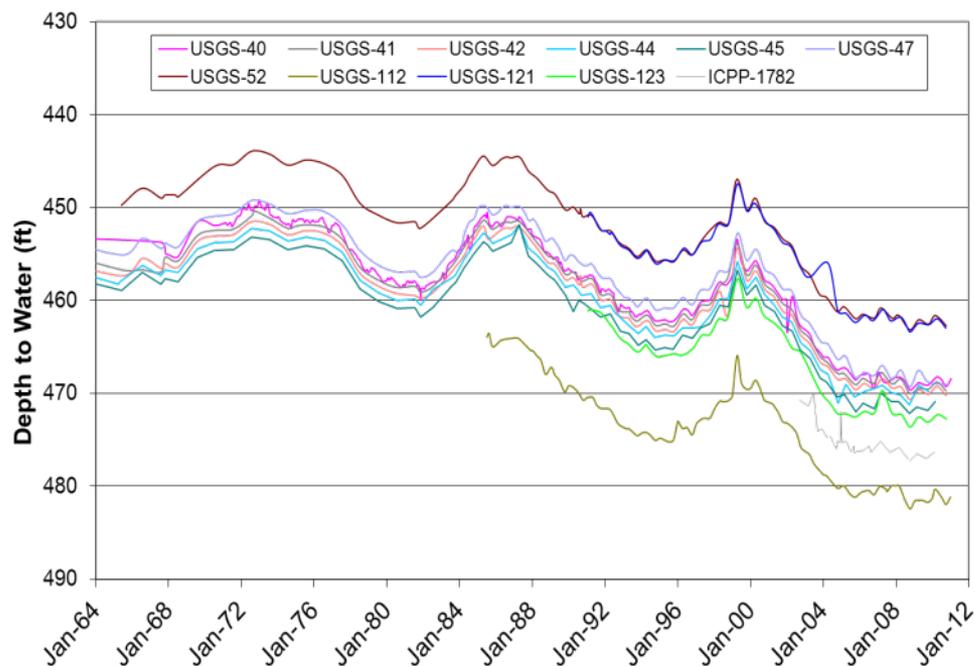
# SRPA Groundwater Level Trends

- SRPAquifer shows decade-long cycles of rising and falling water levels (wet and dry cycles).
- Long-term declining trend, with partial recovery during wetter years.

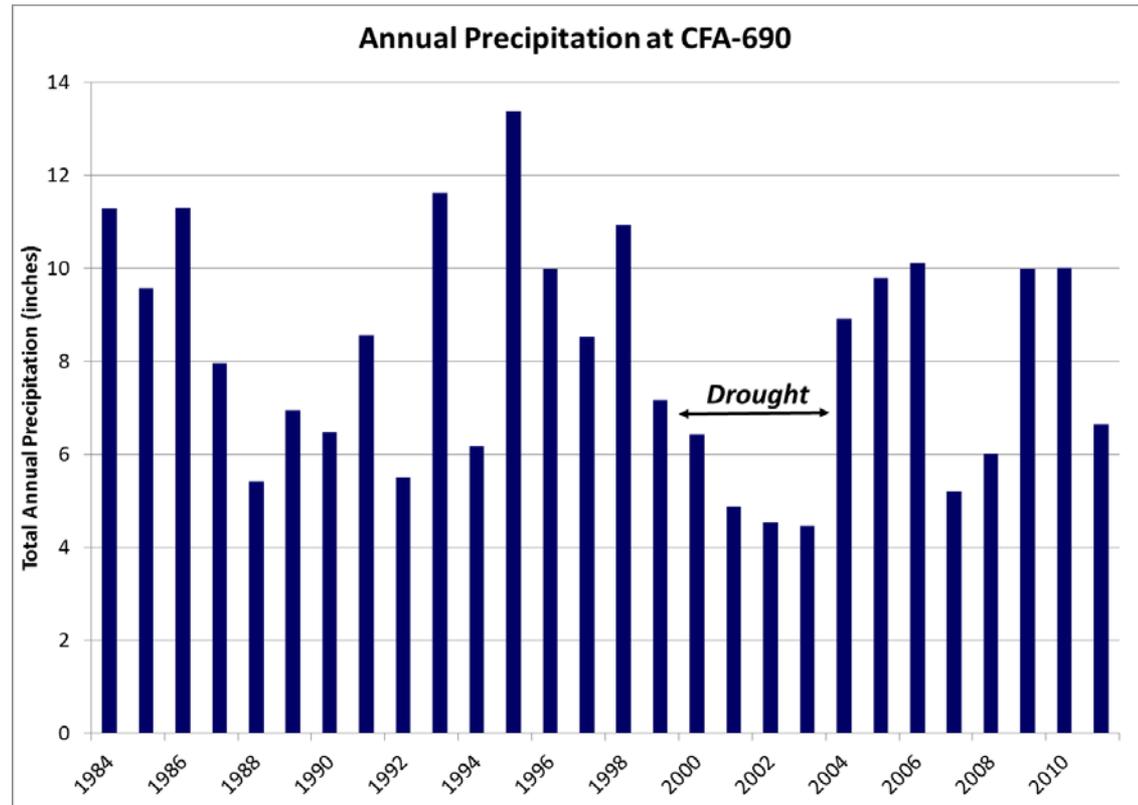
# Causes of Groundwater Level Changes

- Regional droughts result in reduced recharge from Yellowstone Plateau, Birch Creek, etc.
- Changing irrigation practices (flood to sprinkler) has resulted in reduced groundwater recharge throughout the Snake River Plain.

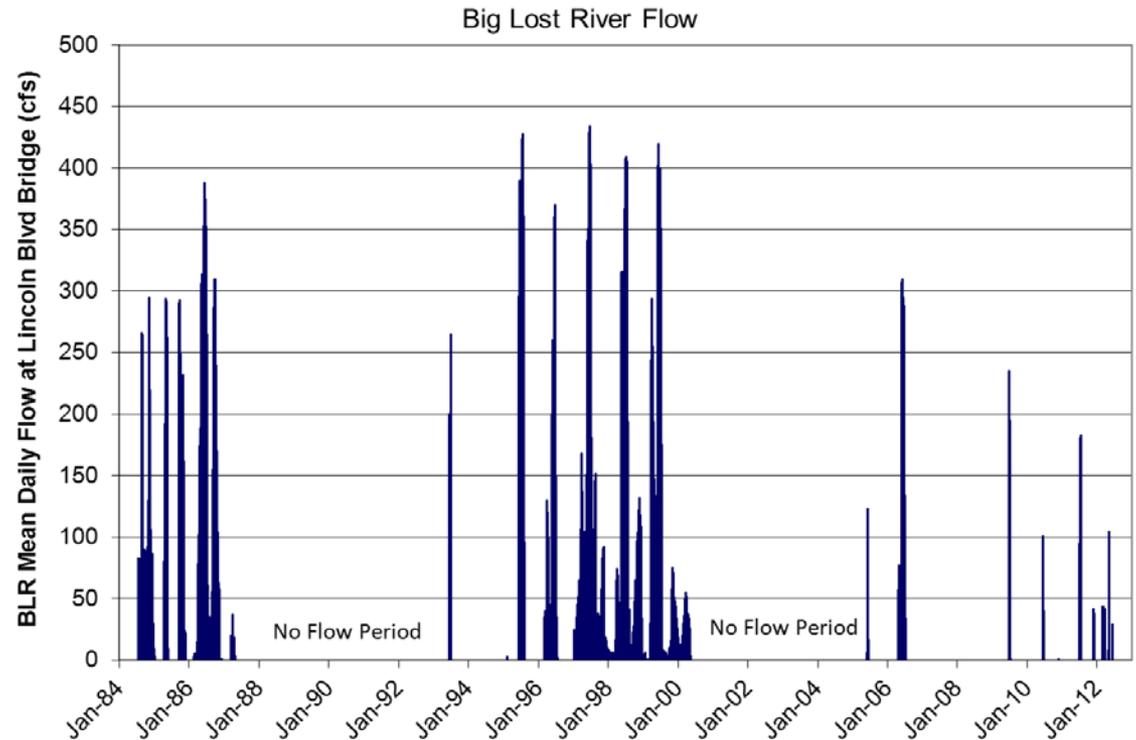
# Causes of Groundwater Level Changes

- Controlled discharges from Mackey Reservoir result in variable periods of flow and no flow in the Big Lost River (BLR).
- Diversion of Birch Creek surface water flow to Reno Ditch for irrigation purposes (1991) reduced groundwater recharge;
- Decreasing BLR flows onto the Site since 2005 as a result of diversion of flow to recharge basins (upstream of Site)
