# Joint Accident Investigation Report

**Construction Lifting Accident  
at the Los Alamos National Laboratory  
Results in Serious Injuries  
to a Subcontract Employee  
on December 19, 2018**

February 1, 2019

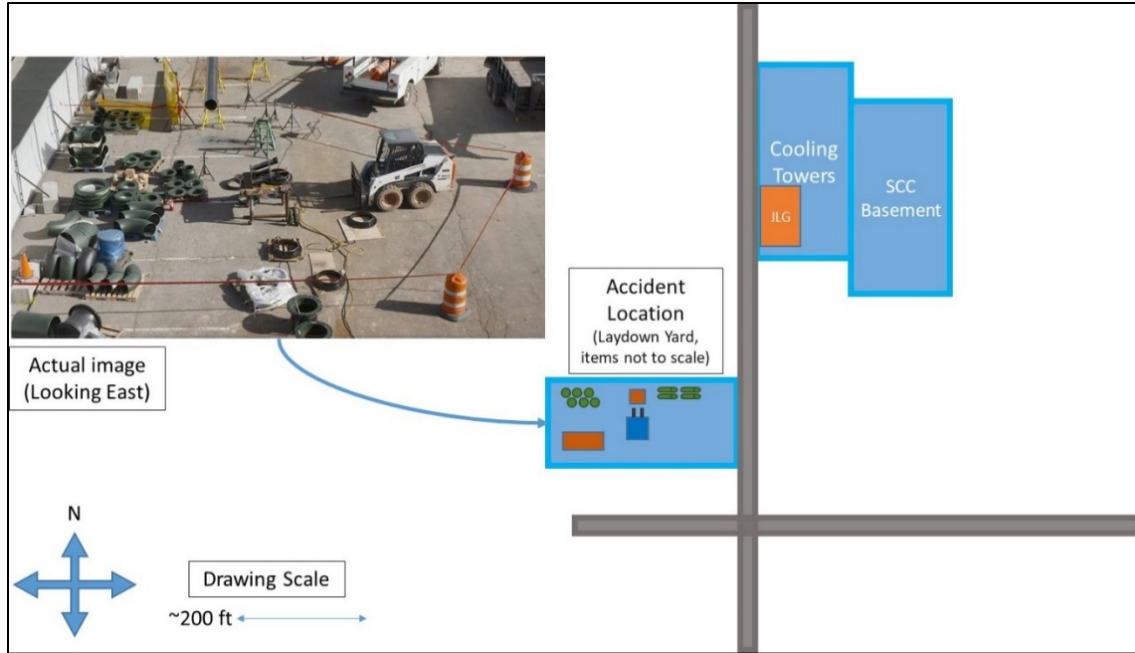
Figure 1: ECCCE Project site diagram with view of the laydown yard.

In April 2018, the ECCCE project team awarded CCI a subcontract for this project that involved the construction of five cooling towers, four heat exchangers, seven pumps, and associated piping and electrical upgrades. The project involves installing piping at both the cooling tower near TA-3 and in the basement of the SCC. The piping is fabricated in a fenced parking lot nearby, which is the project's "laydown yard" (Fig. 1) where the accident occurred.

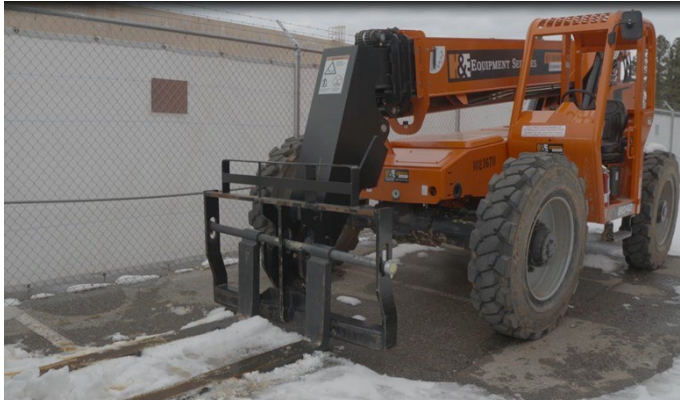
Figure 3: JLG Telehandler Forklift.

The primary machine used to stage the flanges was a JLG Forklift Telehandler (or simply, the JLG forklift) that had been rented by CCI to conduct precision material handling activities (Fig. 3).

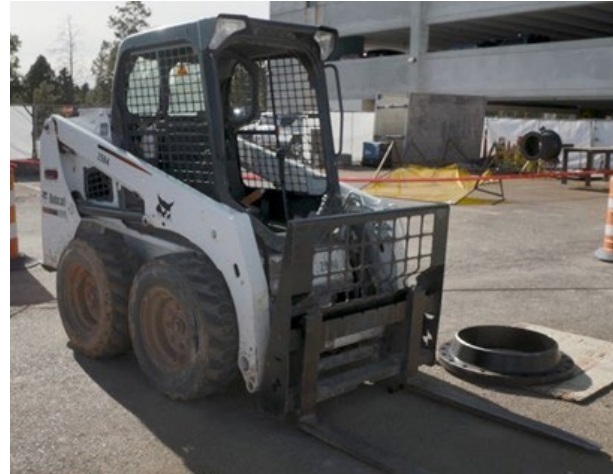
Figure 5: Bobcat S450 Skid Steer Loader used on day of the accident.

CCI had also rented a Bobcat S450 Skid Steer Loader (or simply, “Bobcat”) (Fig. 5), which they used to move materials and equipment for the project. The Bobcat had interchangeable forks and a bucket that CCI used as needed. Generally, the Bobcat with forks attached was used to move pallets loaded with materials or equipment, and the bucket was used to move earth. Multiple accounts from CCI employees and other personnel who were present in the laydown yard indicated that the Bobcat with forks attached had previously been used to perform material handling and hoisting and rigging.

Although not designed or intended to be used with the Bobcat, the JLG forklift attachment fit over the Bobcat’s forklift tines.

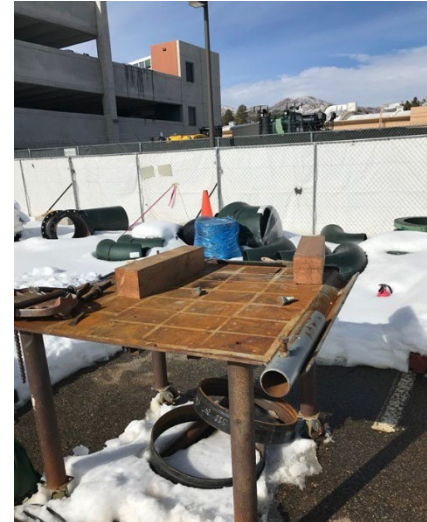
Figure 7: J1's Welding Table and 4-in. piping connections.

with composite castors to allow it to be moved around the laydown yard (Fig. 7). The castors could be locked to prevent incidental movement.
