National Nuclear Security Administration

Accident Investigation Report

**Office of Secure Transportation
Vehicle Accident Resulting in a Fatality and
Serious Injuries to Four Additional Federal
Agents near Okemah, Oklahoma
on October 5, 2018**

January 2019

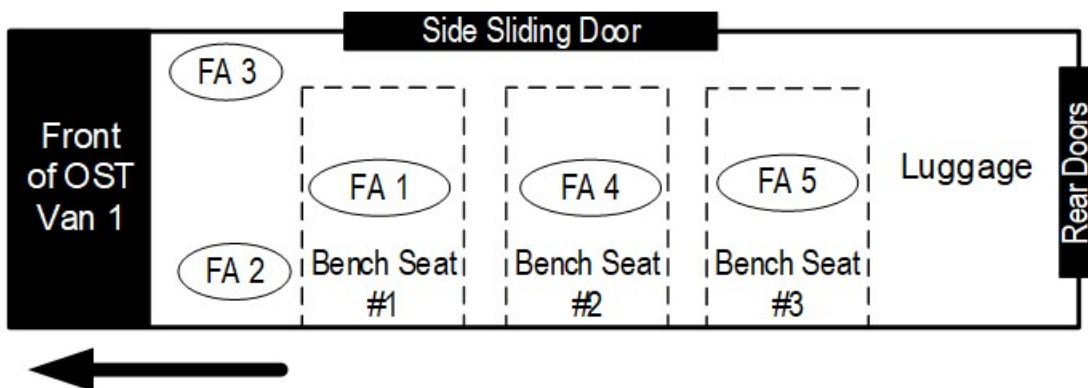
Figure 2-1. Location of Federal Agents in Van 1 at the Time of the Accident

At the time of the accident, the Federal Agents in Van 1 are believed to have been seated in the following locations (Figure 2-1): FA 2 - driver; FA 3 was seated in the front passenger seat, to the right of FA 2; FA 1 was seated immediately behind FA 2, on the left side; FA 4 was seated immediately behind FA 1, on the left side; and FA 5 was seated immediately behind FA 4, on the left side.

Definitive locations of the Federal Agents in the bench seats were not determinable as all occupants were removed before arrival of police.

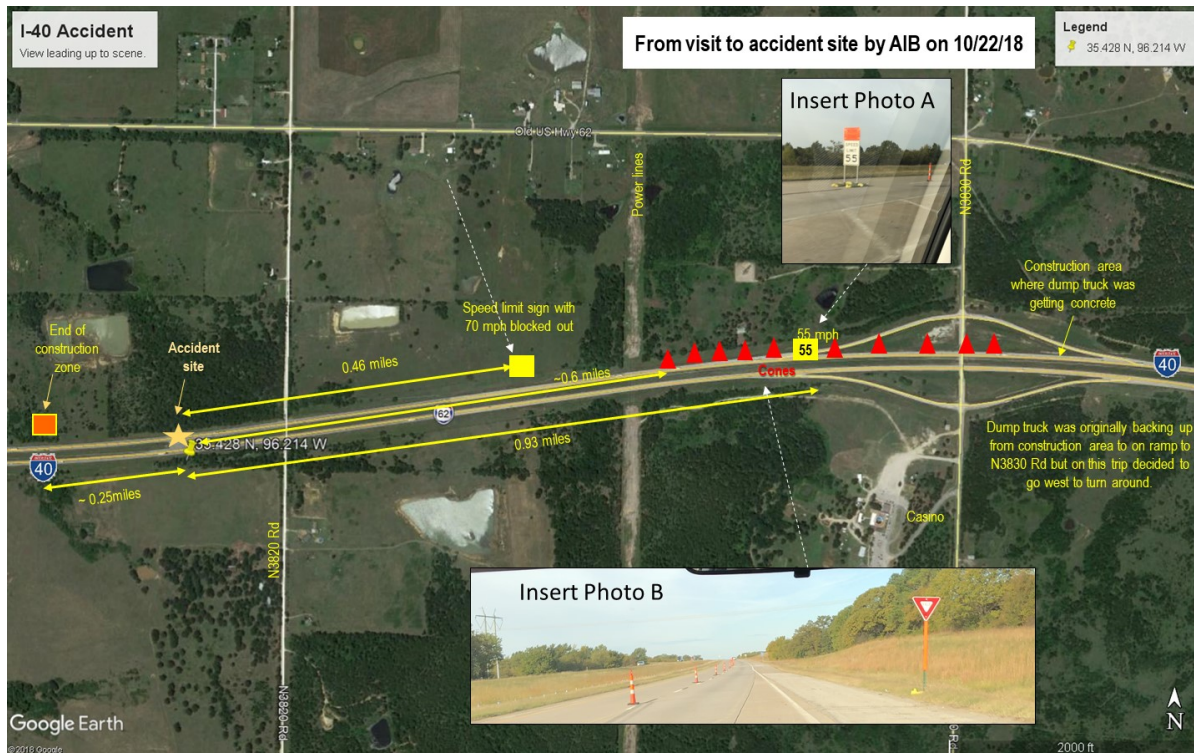
Figure 2-2. Annotated Aerial View of Accident Location

At the site of the accident, I-40 is a divided highway, two lanes eastbound and two lanes westbound, with shoulders and a grass median dividing eastbound from westbound traffic. The accident site is near Okemah, OK. The construction work consisted of the removal and replacement of a portion of the right-hand, westbound lane. Weather conditions were clear; it was daylight; visibility was not obscured by objects, fog, or smoke; and the roadway was dry asphalt (Figure 2-2, Insert Photo B).

The accident occurred in the termination area of an active work zone where the lane closure had ended and both lanes were open (about 0.6 miles from the end of the lane closure noted by cones in Figure 2-2, Insert Photo B),² and approximately 1,272 feet east of the end work zone signs where the speed limit returned to 70 mph (noted by orange rectangle in Figure 2-2). The posted speed limit was 55 mph in the work zone.

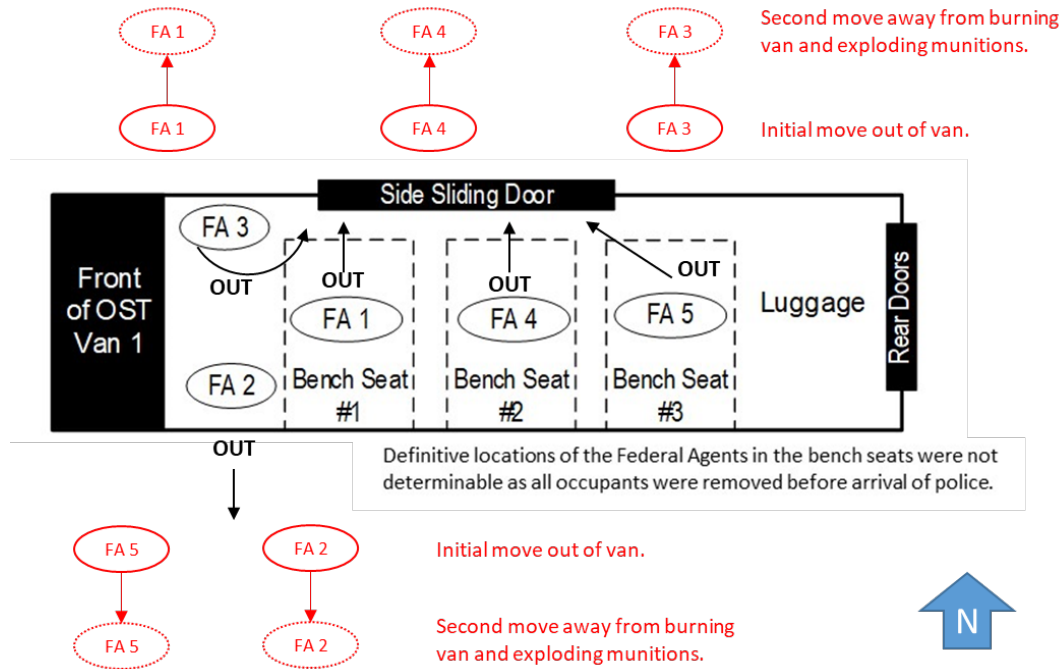
Figure 2-3. Extrication of Occupants of Van 1 after the Accident

The fire had progressed, and while the Airman was extracting FA 3, flames had begun to appear at FA 2's feet. Once FA 3 was successfully extracted, the Airman ran to secure a fire extinguisher. When he returned to Van 1 with a fire extinguisher, the Airman discovered that FA 2 had been successfully extracted and immediately went to the aid of FA 3 and FA 4 (Figure 2-3).

At approximately 0855, Van 1 was fully engulfed in flames; because of this, and munitions going off in Van 1, FA 2, and FA 5 were moved further to the left of Van 1, while FA 1, FA 3, and FA 4 were moved further to the right of the van (Figure 2-3).

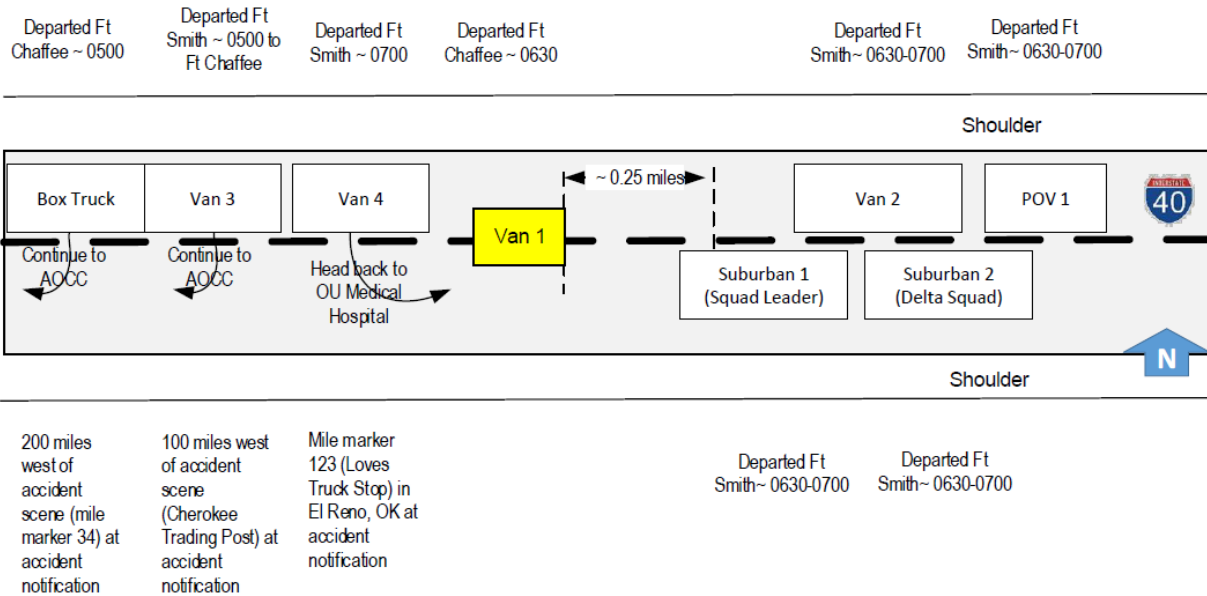
Figure 2-4. Location of OST Vehicles at the Time of Notification/Recognition of the Accident

OST Van 2 (FA 6, FA 7, and FA 8), OST Suburban 1 (Unit 3 Squad Commander 1, Squad Commander 2, and Squad Commander 3), OST Suburban 2 (DELTA Team), and POV 1 (two Federal Agents) were 0.25 miles east and several vehicles behind Van 1, in stopped traffic (Figure 2-4).

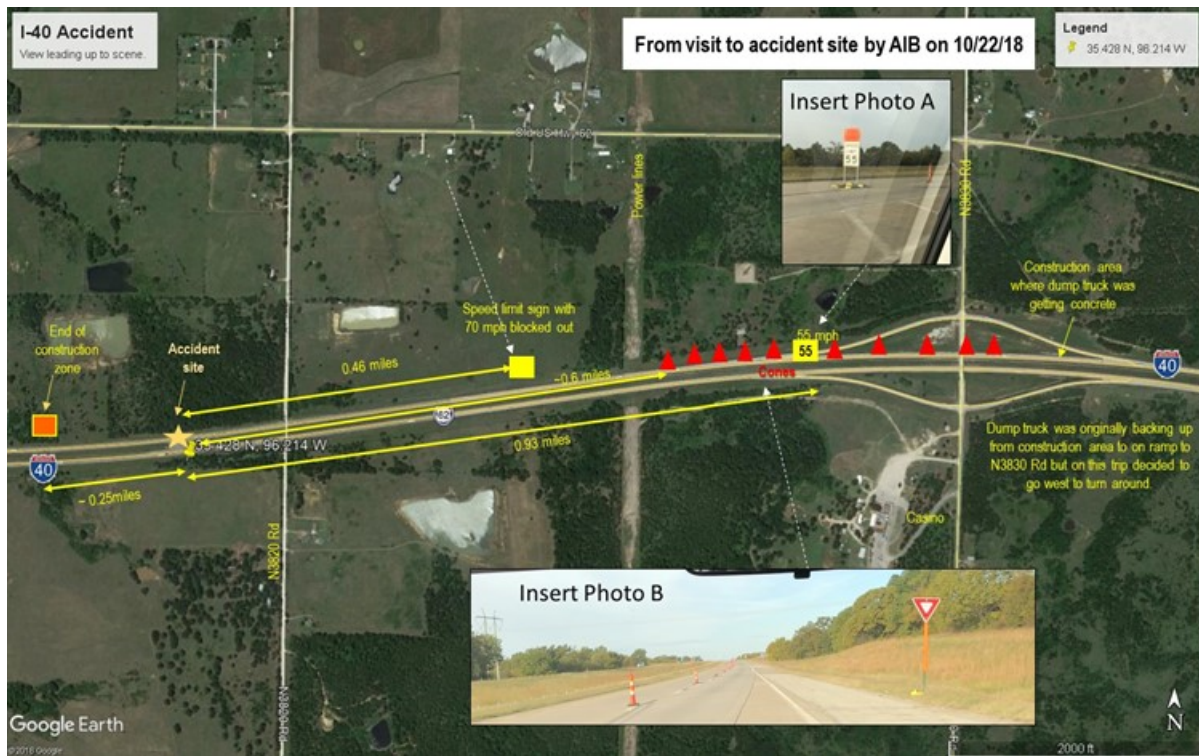
Figure 2-12. Annotated Aerial View of Accident Location

Figure 2-12 provides an overview of the accident site to provide context for the accident that occurred along I-40 west-bound at mile marker 225.4 Okfuskee County (noted by gold star in Figure 2-12 west of N3820 Road).

The accident occurred in the termination area of an active work zone where the lane closure had ended and both lanes were open (about 0.6 miles from the end of the lane closure noted by cones in Figure 2-12 and Insert Photo B)⁷ and approximately 1,272 feet east of the end work zone signs where the speed limit returned to 70 mph (noted by orange rectangle in Figure 2-12). The posted speed limit was 55 mph in the work zone.

According to the OHP Report, the road conditions at the time of the accident were dry, the asphalt road was level, weather was clear, it was daylight, and there were no visibility obscurations [straight road in a locality that was not built up (Insert Photos B and C in Figure 2-12)]. The road conditions were used to determine the speed of the Dump Truck at the time of impact and the speed of Van 1.

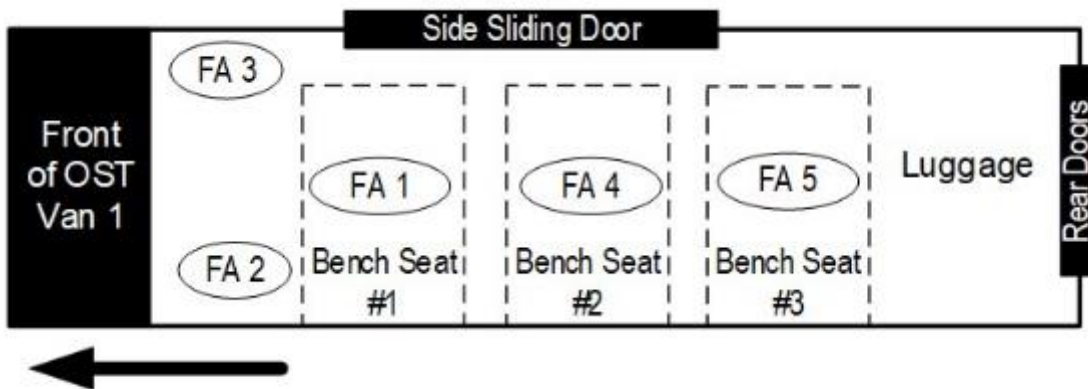
Figure 2-14. Location of Occupants at the Time of the Collision

Van 1 was a 2013 Chevrolet Express passenger van described in Section 2.4.2., “The Vehicle.” The last bench seat was removed allowing room for storage of luggage (Figure 2-14). The van was occupied by five Federal Agents who were returning to Amarillo after completing training at Fort Chaffee, AR. The seating location of the five Federal Agents at the time of impact is shown in Figure 2-14. The definitive locations of the Federal Agents in the bench seats were not directly determinable by the Troopers because all occupants had been removed from the vehicle before their arrival.

Definitive locations of the Federal Agents in the bench seats were not determinable as all occupants were removed before arrival of police.
