OES: 2020-01

February 2020

ORPS Data Indicates Work Process Deficiencies at Active Deactivation and Decommissioning Projects

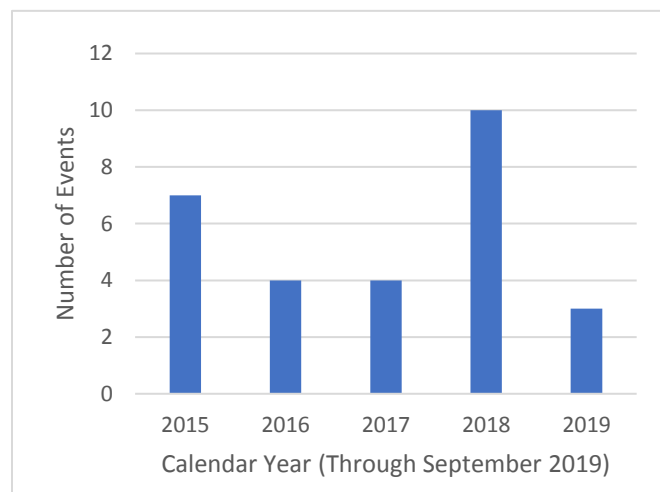
Figure 1- Number of Radiological Events that Included Work Process Deficiencies at D&D Projects

Figure 1 shows the number of radiological events with work process deficiencies at active D&D sites during the 2015 – 2019 time period.

These radiological events included: (1) loss of control of radioactive material, (2) spread of radioactive
