### **Asbestos Abatement Project Closeout Report**

# **Asbestos Abatement Project Closeout Report for the Piqua, Ohio, Decommissioned Reactor Site**

**September 2019**

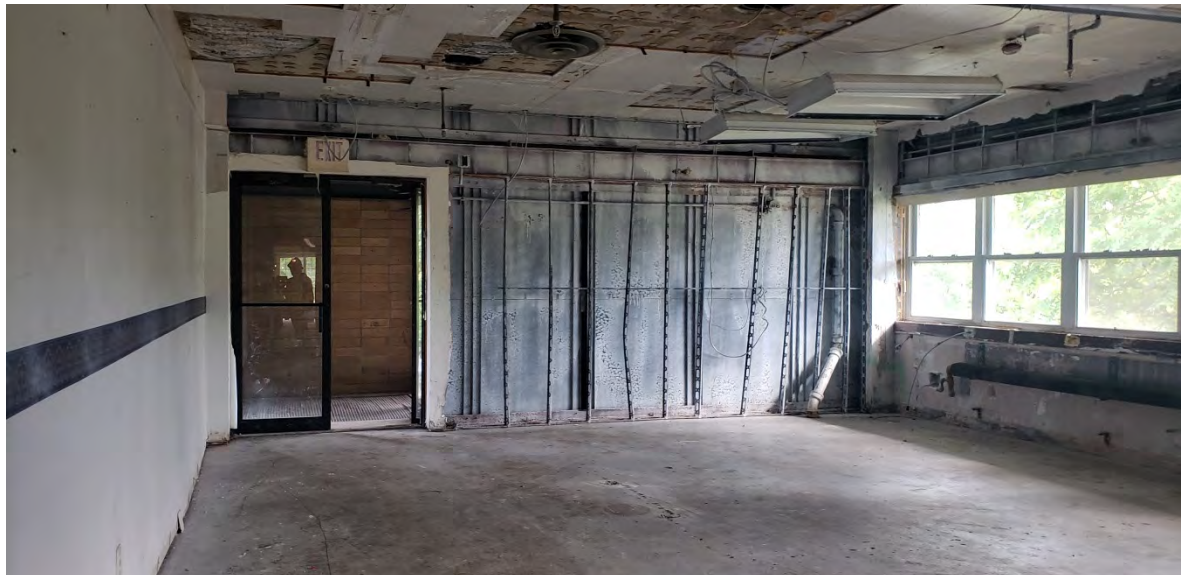
The Administration Building consists of three stories above grade and a full basement, and the floor space ranges from 5332 ft<sup>2</sup> at the basement level to 355 ft<sup>2</sup> at the third level, for a total of 11,718 ft<sup>2</sup> including stairways. The first and third floors required selective demolition of interior wall construction, and it took place after the decommissioning of the Reactor Building. In particular, new construction occurred on the first floor to include three new front offices, a redesigned conference room, and redesigned laundry area and locker room accommodations, all with dropped ceiling installed. Similarly, an office area was established on the third floor. Photo 9 shows the first floor front office area with walls marked for selective demolition, ACM floor tiles in hallway, and laminate flooring in an office. Photo 10 shows the same area after removal of vermiculite, selective demolition of walls, removal of ceiling tiles, and abatement of ACM floor tiles. Photo 10 also shows the removal of ACM piping that was tied to the wall-mounted radiator.

*Photo 10. Piqua Administration Building, First Floor Office Area, After Abatement*

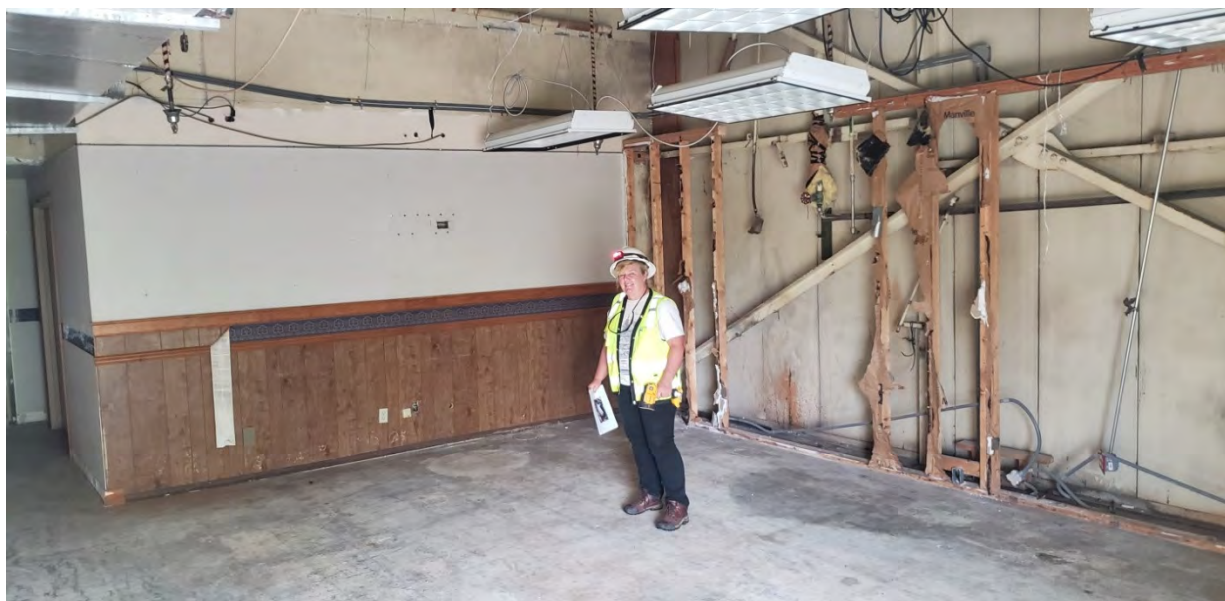
Photo 11 shows the first-floor Administration Building conference room before abatement. The area included false rear walls, a dropped ceiling, and carpeting. The room required selective demolition since the room had concealed ACM pipes, ACM floor tiles, and ACM mastic. Photo 12 shows the same room after selective demolition and abatement of those ACM materials.

*Photo 12. Piqua Administration Building, Conference Room, After Abatement*

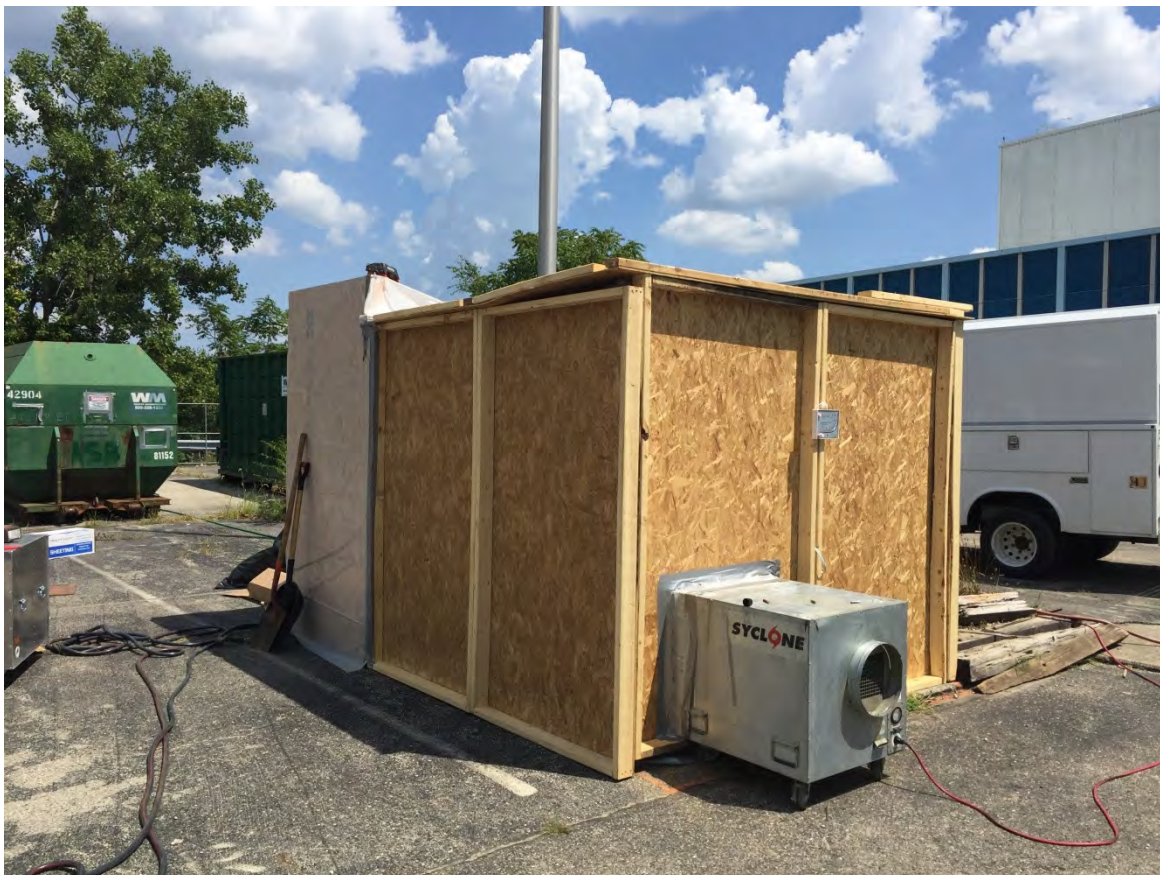
The abatement of the utility vaults below grade was a challenging endeavor. Air monitoring was required prior to entry into the confined space each day. As shown in Photo 21, a wooden containment area was constructed to be use as the entry point. This structure provided asbestos containment and served as a barrier to entry to prevent falls into the confined space opening.

*Photo 21. Entry to the Below-Grade Utility Vaults*

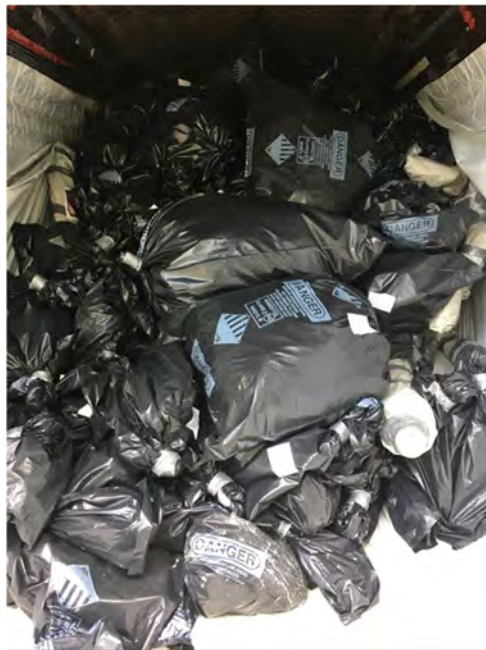
Photos 25–28 illustrate different aspects of the placement of ACM into the waste container. Photo 25 shows ACM-labeled double bagged-units. Photo 26 shows glove-bagged ACM pipes wrapped and candystriped. Note that the sharp edges of cut pipe are taped to prevent injury in transport and avoid tearing adjacent ACM bags. Photo 27 shows a laydown area of abated ACM pipe lifted from the lower levels of the Reactor Building. Photo 28 illustrates the innovation of using a waste box for safe handling and transport of waste material.

*Photo 25. ACM Bags*

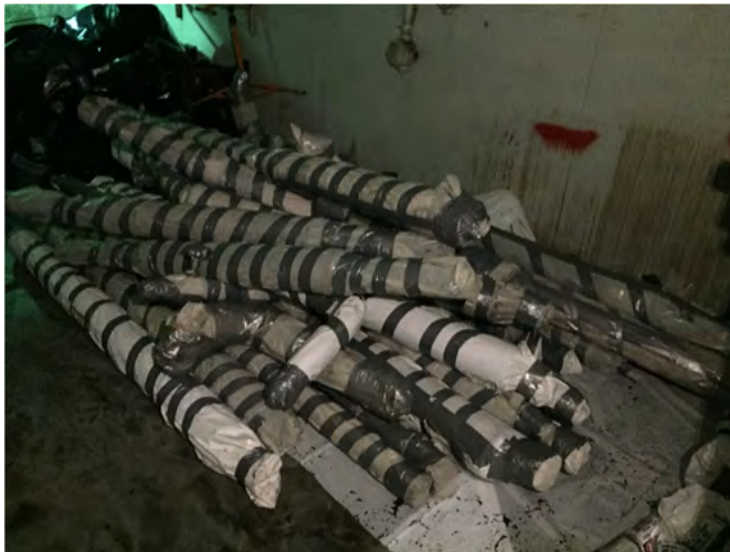
*Photo 26. ACM Pipes*

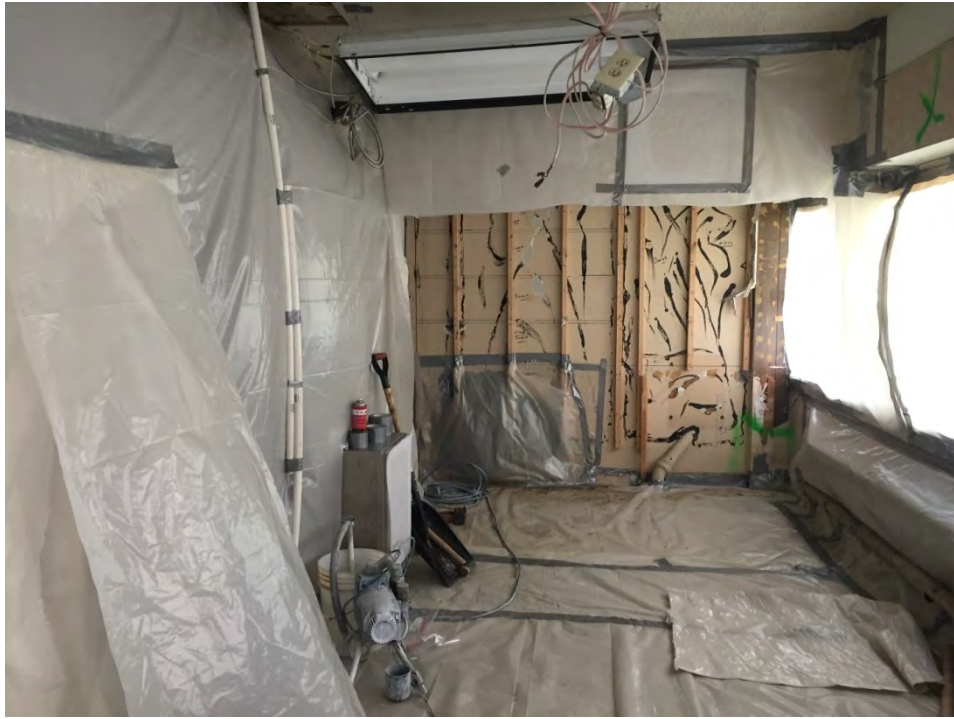
*Photo 30. Administration Building, First Floor: Inside Full Containment*

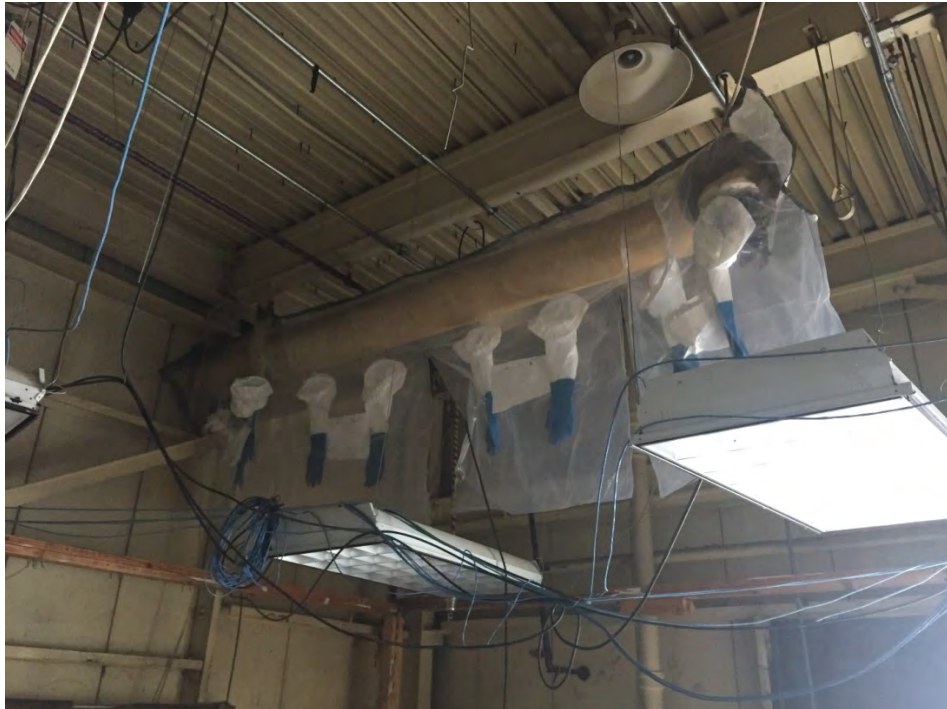
*Photo 31. Administration Building, First Floor: Glove-Bag Abatement in Conference Area*

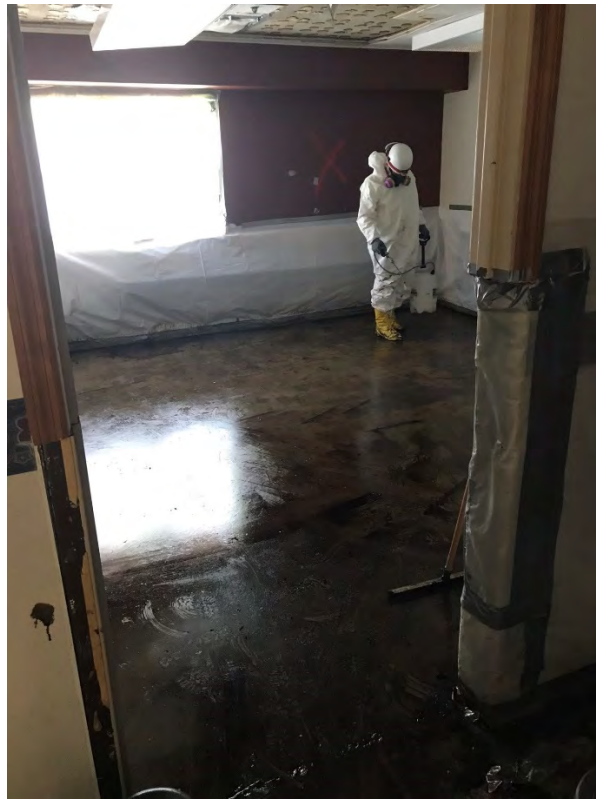
*Photo 32. Administration Building, Third Floor: Floor Tile/Mastic Removal in Full Containment*

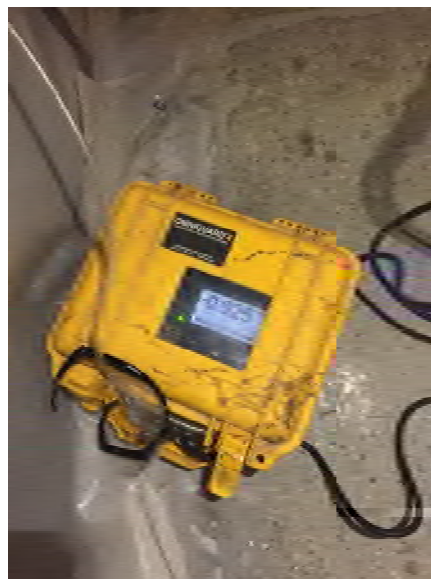
Throughout each working day, Neuber and Rii personnel frequently monitored the negative pressure differential in the full containment with a manometer (Photo 34). A pressure differential of 0.02 inch of water or above was required. When the pressure differential dropped less than 0.02 inch of water, the work practices and containment setup were evaluated to determine the root cause. Corrective measures included adding additional air filtration devices to lower the inside containment negative pressure, reducing the number of times workers went in and out of containment, and reinforcing to the workers the proper closure of the containment poly door flaps.

*Photo 34. Manometer*

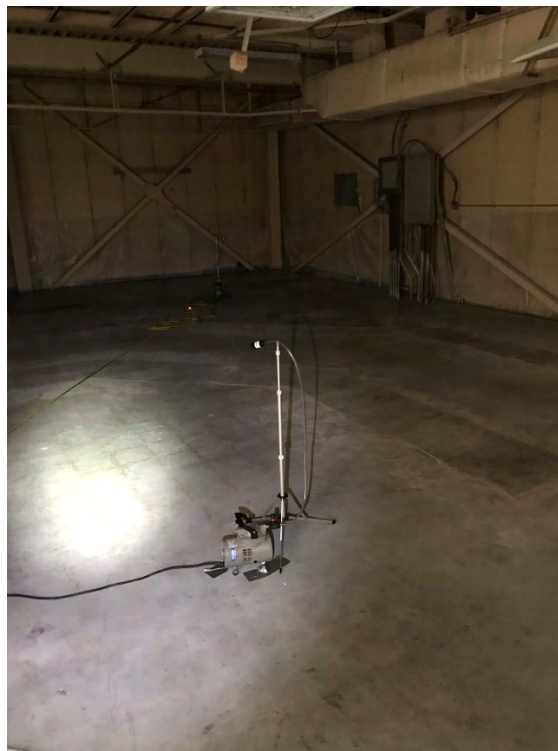
Rii, as the abatement oversight contractor and the asbestos abatement SME for this project, performed air monitoring during abatement, and for final air clearance testing (Photo 35). Rii also was responsible for approving the continuation of Neuber work practices (daily practices, enclosure construction, modification and removal, and permits for unrestricted entry). In addition, after Neuber provided notification that the abatement was complete (Attachment 11), Rii was responsible for visually inspecting the abatement area and performing final air clearance testing within each containment. Prior to the performance of final air clearance monitoring, Rii completed a visual inspection of each containment for the potential presence of asbestos dust or residue (Attachment 12). If residue is found, the entire abatement work area was given another vacuuming or wipe down.

*Photo 35. Air Clearance Testing*
