Moab UMTRA Project Hillside Geology Assessment

May 2009

U.S. Department
of Energy

Office of Environmental Management

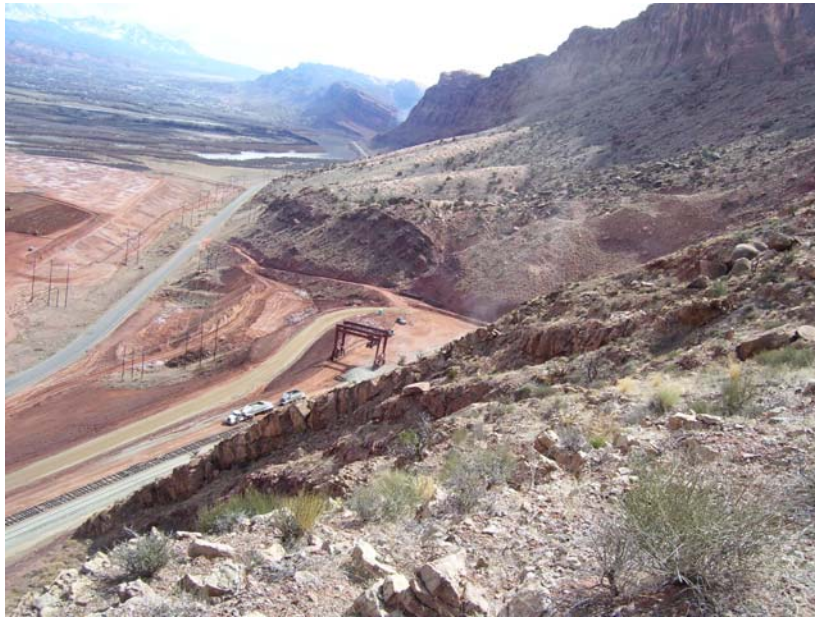
Photo 3. Looking South from Slope A Towards Honaker Trail Cap Rock

Differences exist between each of the five slopes, mainly due to lithology and slope aspect. Slope A (Photo 3) is the slope farthest to the southeast that was mapped during this project. It was deemed unsafe to continue further, past the gully and to the Honaker Trail cap rock. This slope consists of many stepped outcrops of Honaker Trail fossiliferous limestone, sandstone, and siltstone (Photo 4). The contact of the Honaker Trail and Cutler Formations is located on this slope face at an elevation of approximately 4,700 ft (Photo 5). Abundant vegetation, including

yucca, Mormon tea, sage, rice grass, and juniper, cover the gravelly surface of Slope A. The lower portion of this slope is covered with a section of the Honaker Trail cap rock (Figure 1).

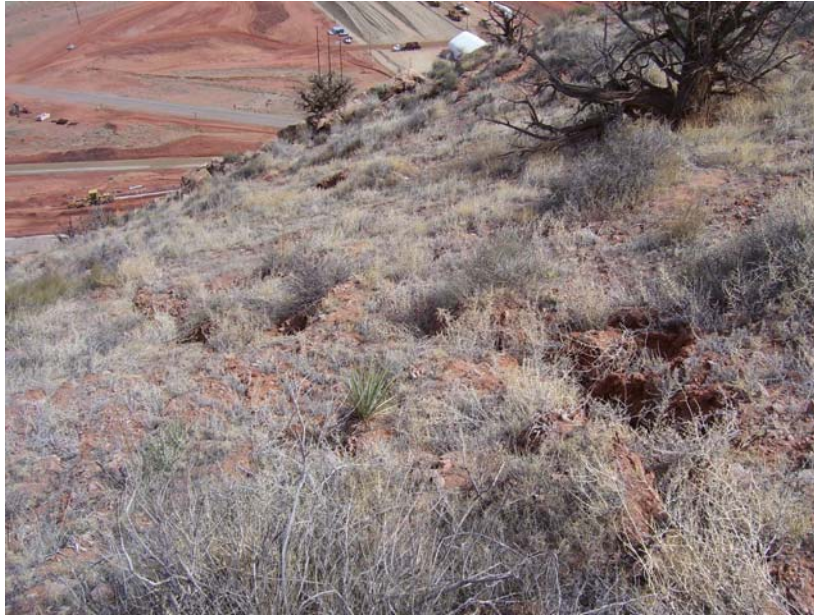
Photo 6. Slope B Mini-drainage Channel

The surface of Slope B (Figure 2 and Photos 6, 7, and 8) also consists of an angular gravel surface with many stepped outcrops of the Honaker Trail and Cutler Formations (Photo 8). This slope also contains two small drainage channels that originate at the base of one of the Honaker Trail outcrops. These channels are approximately 1 to 4 ft deep and 1 to 6 ft wide (Photo 6); they join together immediately above the Honaker Trail cap rock (Figure 1), above the recent excavation in the Moenkopi Formation.

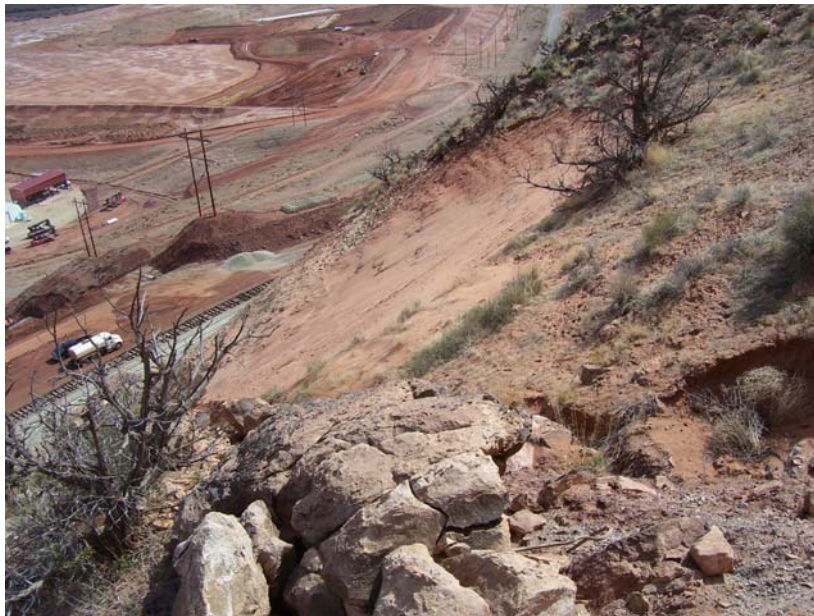
Photo 9. Location of Honaker Trail Outcrop in Relation to February 2009 Excavation

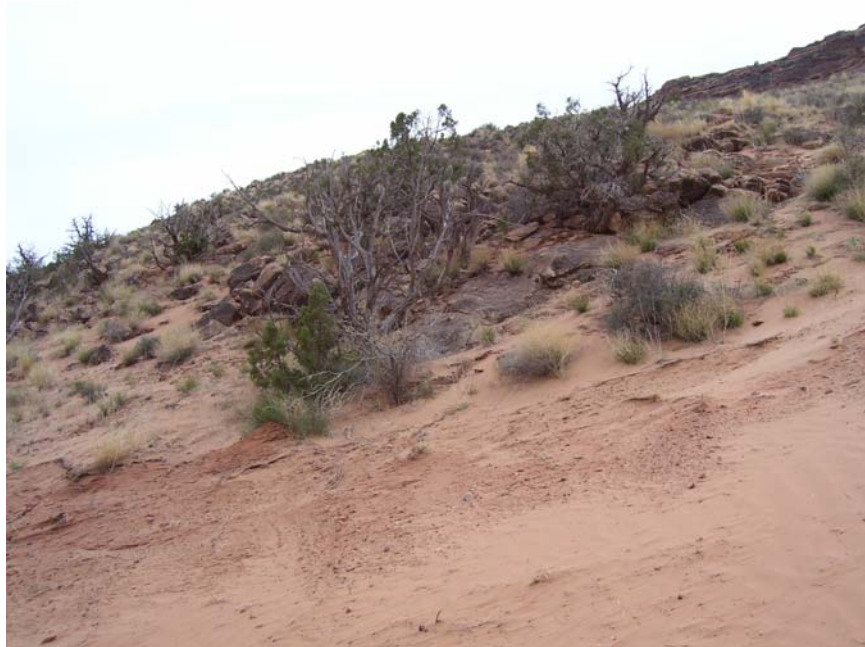
*Photo 10. Looking Up Towards Honaker Trail Outcrop
from February 2009 Excavation*

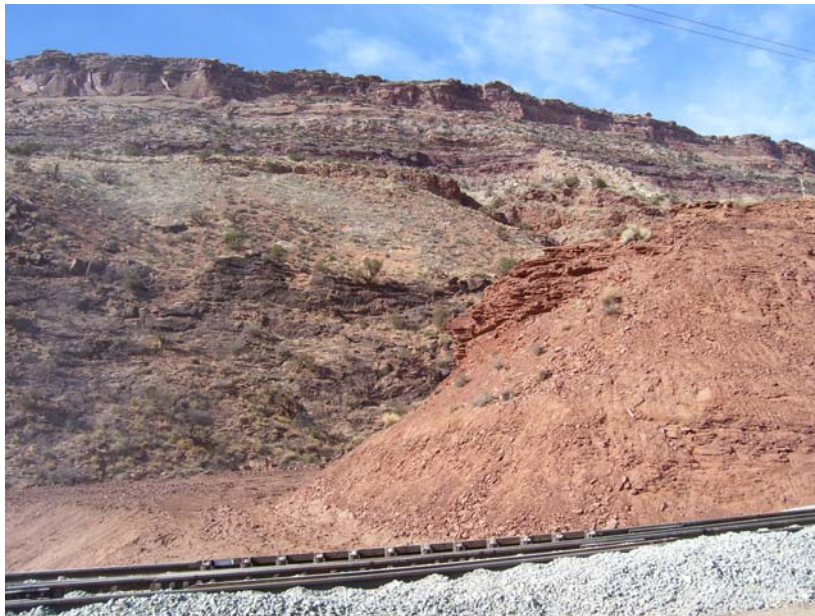
Photo 11. Base of Slope D

The lower half of Slope D (Figure 1) consists of a slab of the Honaker Trail sandstone cap rock above the new cul-de-sac. Above the cap rock, the slope contains abundant shrubs and grasses and highly developed cryptobiotic soil. Sand has filled in some of the low-lying areas. The sides of the slope are flanked by the Moenkopi Formation (Photo 11). During the construction, the cul-de-sac was filled in with backfill material up to the rail grade (Figure 2).

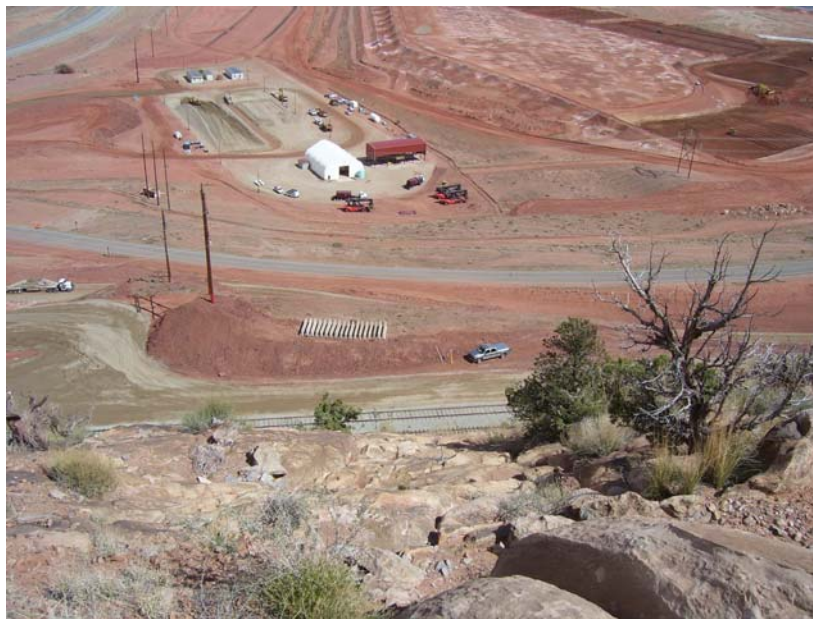
Photo 12. Looking Downslope from Drainage 1

Drainage Channel 1 (Figure 2 and Photo 12) extends from the top of the talus field, downslope to the area where the rilled Moenkopi Formation meets the rail line. The area immediately above the Moenkopi Formation is composed of Honaker Trail sandstone dipping at 25 to 35 degrees. The drainage is characterized by numerous sandstone boulders and cobbles, and a natural dam of the Honaker Trail Formation is present approximately 400 ft upslope (Figure 1 and Photo 13).

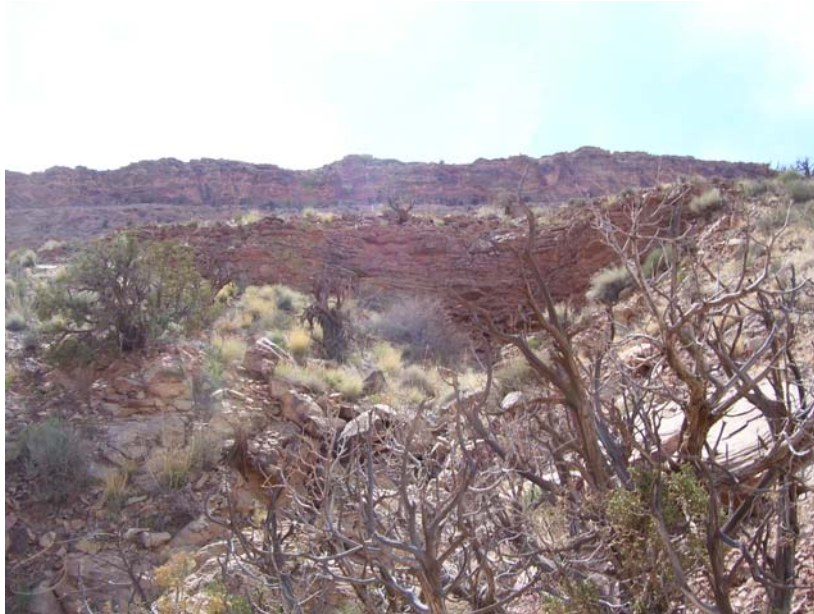
Photo 13. Natural Dam of Honaker Trail in Drainage 1

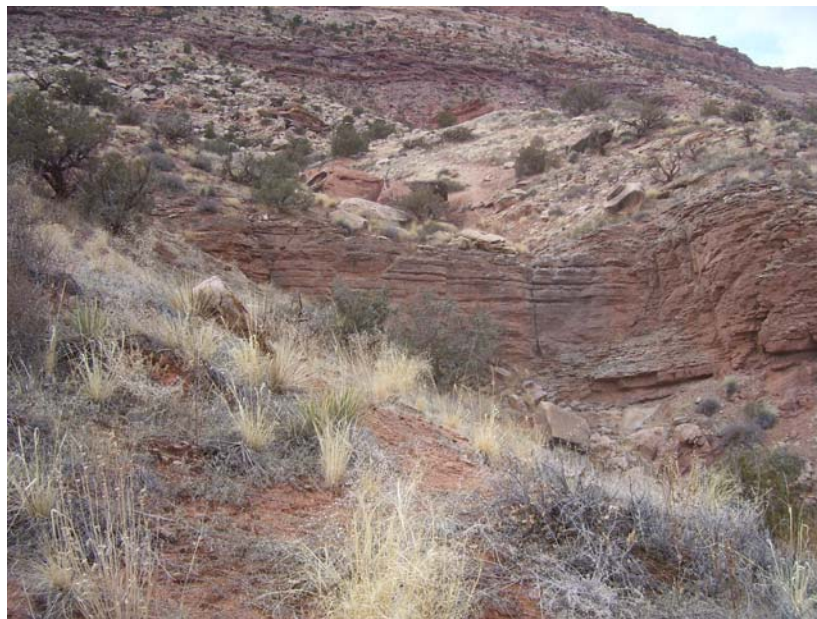
Photo 16. Looking Upslope at Honaker Trail Formation in Drainage 3

Drainage Channels 3 and 4 (Photos 16, 17, and 18) are characterized by large stepped natural dams of the Honaker Trail Formation and large boulders (up to 30 ft in height). These drainage channels empty downslope into the cul-de-sac area (Figures 1 and 2). It appears that most of the large boulders are upslope, near the talus; the lower section of the drainage contains mostly sand and cobbles.

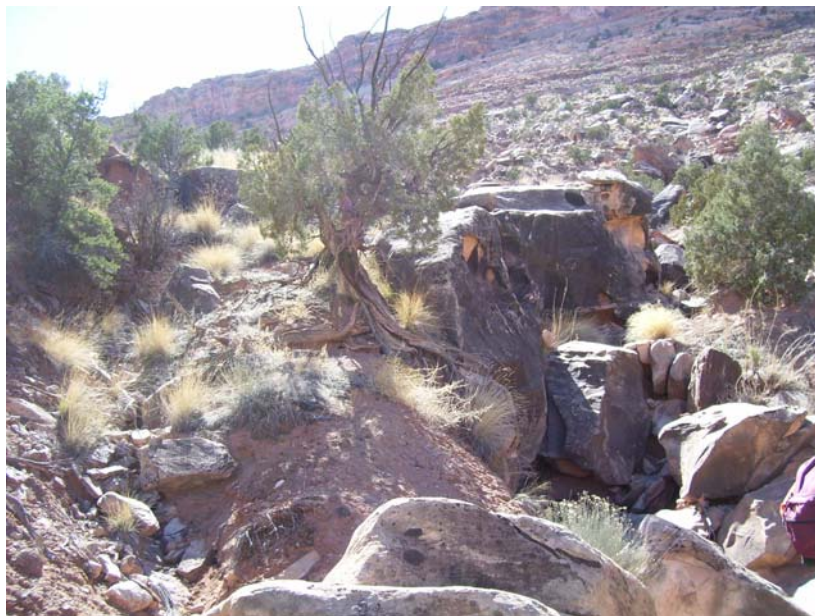
Photo 18. Boulders Located Upslope from Drainage 4
