Savannah River Site

SRNS Independent Investigation Team Report:  
Tritium Unloading Puncture Event (U)

SRNS-RP-2015-00071

February 26, 2015

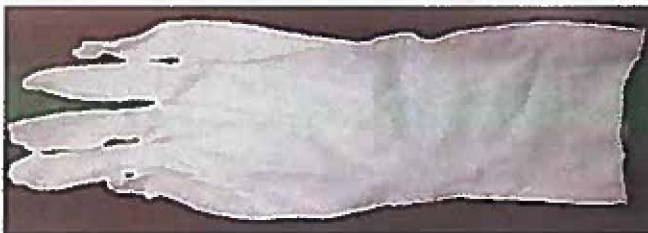
Figure H. Cotton liner

Operator A (injured operator) dressed out, entered the contamination area (CA), opened the glovebox airlock sash hood, and passed in new o-rings and the 2 o-ring extraction tools contained in the o-ring extraction kit. Operator B retrieved the o-rings and one of the tools and proceeded to work on an o-ring at position 8 while Operator A was exiting the CA. Operator B did not wear over gloves during the evolution because he did not consider the tool he was working with to be a sharp. The particular o-ring extraction tool he was using for work was blunt on one end. Operator B was able to remove the o-rings at his station using the second tool with blunt and forked ends. Operator A proceeded to enter position 5 and evaluated o-rings at this position. Operator A determined that the o-ring on the adapter plate was degraded and needed replacement. He proceeded to remove the o-ring from the underside of the adapter plate with the pointed end of the second tool while holding the adapter plate in his left hand and the tool in his right hand. After some difficulty and multiple pushing motions, the tool slipped and penetrated through the 30 mil butyl glove-port glove (Figure F), the nitrile glove (Figure G), and the cotton liner (Figure H) with a glancing blow, breaking the skin on his left palm near the thumb (Figure I).
