U.S. DEPARTMENT OF
ENERGY

Accident Investigation Report

**Tree Felling Fatality at the Oak Ridge Reservation on
August 11, 2023**

November 6, 2023

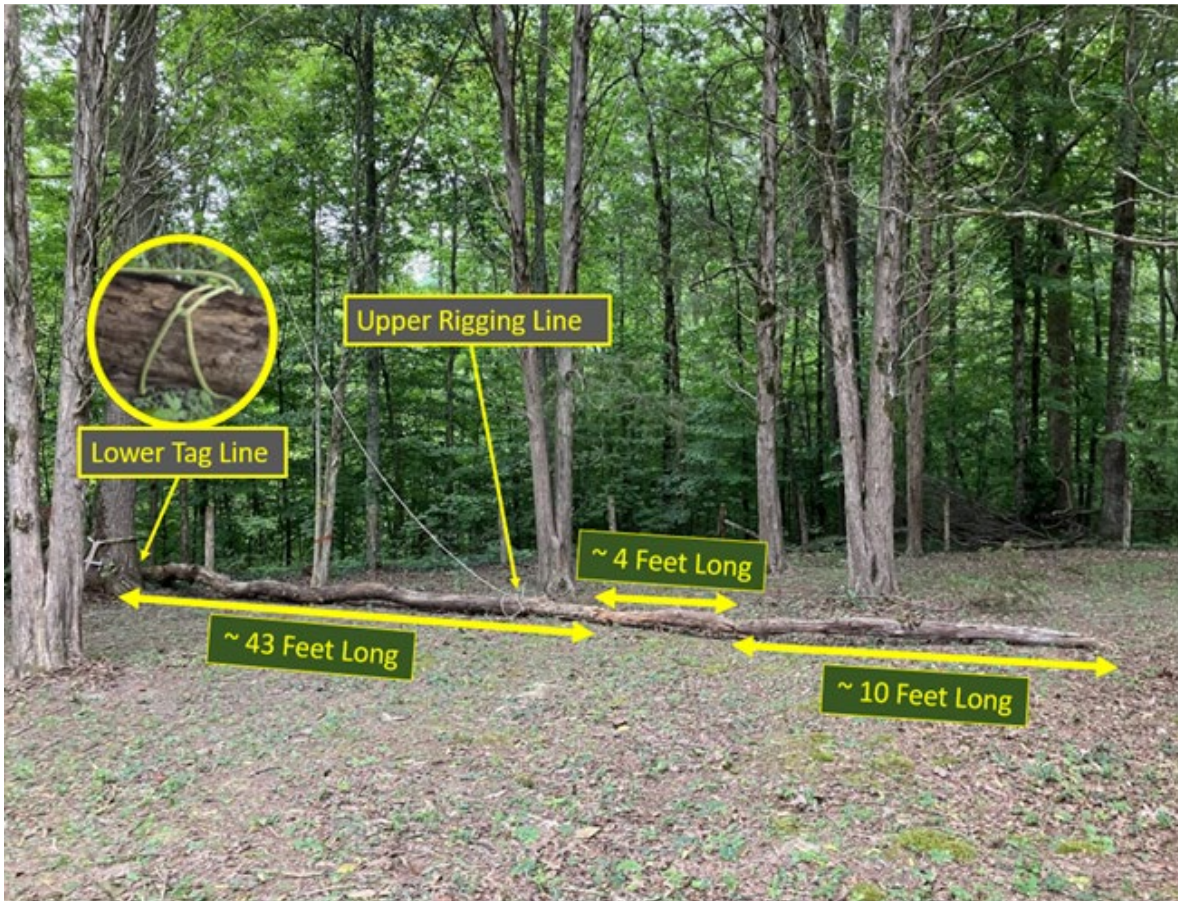
Figure 2-5. Upper Rigging Line and Lower Tag Line

Work then transitioned to the dead limb on QUCO2. Information as to why the bucket truck was not used for removing the dead limb never became available to the Board. However, it was assumed, given the sacred nature of the cemetery and the limited, physical space in which to position and operate the bucket truck, prevented use of the bucket truck, resorting in CoTW-1 and CoTW-2 electing to manually remove the dead limb. The dead tree limb to be cut was approximately 57 feet long with a circumference at the base of approximately 36 inches (See Figure 2-5). CoTW-1 and CoTW-2 tied ropes to the bottom and approximately 14 feet from the top of the dead limb. The upper rigging line had been rigged over a branch of an apparently healthy tree and tied to the dead limb to support the limb after the base was cut so it could be lowered in a controlled manner between a White Oak and a Hickory tree. The bottom rope (tag line) was tied to the bottom of the dead limb above the cut location (See Figure 2-5).

Note: after the accident, approximately 43 feet of the remaining dead tree limb was still in a generally upright position with the base resting on the ground and the top supported by the upper rigging line and leaning against other trees. Davey employees came to the site to lower the dead limb to a safe configuration on August 24, 2023, with the concurrence and oversight by the AIB. The image in Figure 2-5 was taken after the dead limb was safely lowered and the pieces aligned.

When the final cut was made, the dead limb base struck the ground and the top portion made contact with other trees resulting in the top 14 foot section, as shown in Figure 2-5,

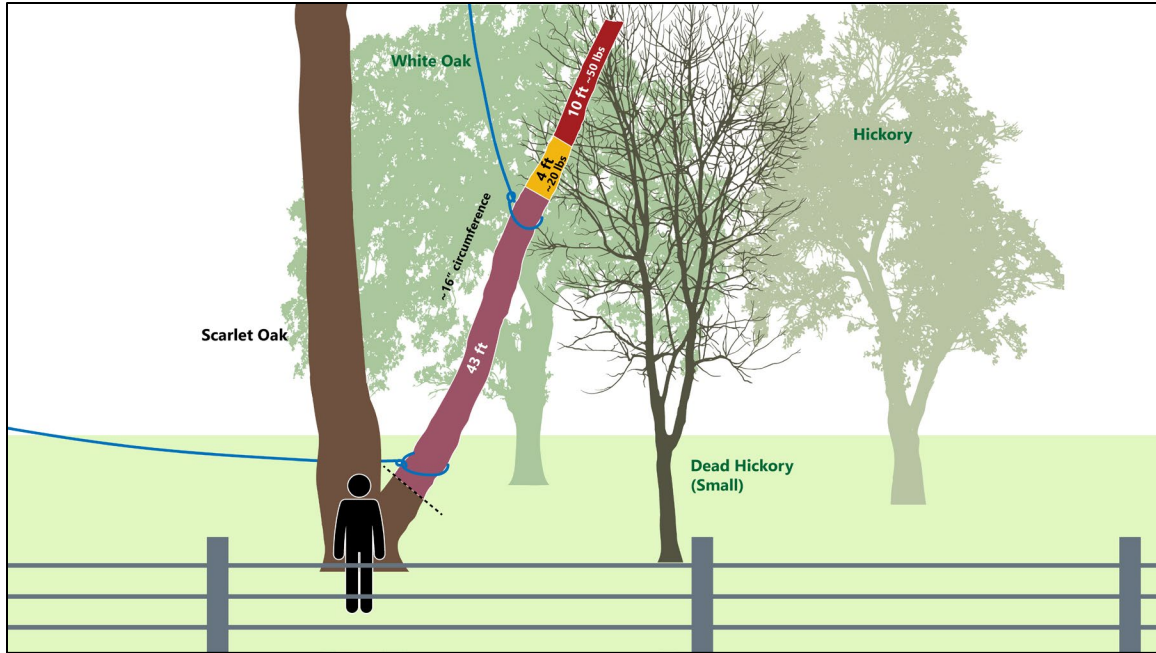
Figure 2-9. Dead Limb as Last Cut is Made (dashed line)

Based on the Board’s interviews, reviews of documents and inputs from other arborists, Figures 2-9 through Figure 2-12 below are viewed as the most likely sequence of events at the time of the accident, however the actual sequence could not be verified due to the inability to obtain direct Davey witness corroboration.

Note: Figures 2-9 through 2-12 are a visual representation of the accident and are not drawn to scale.

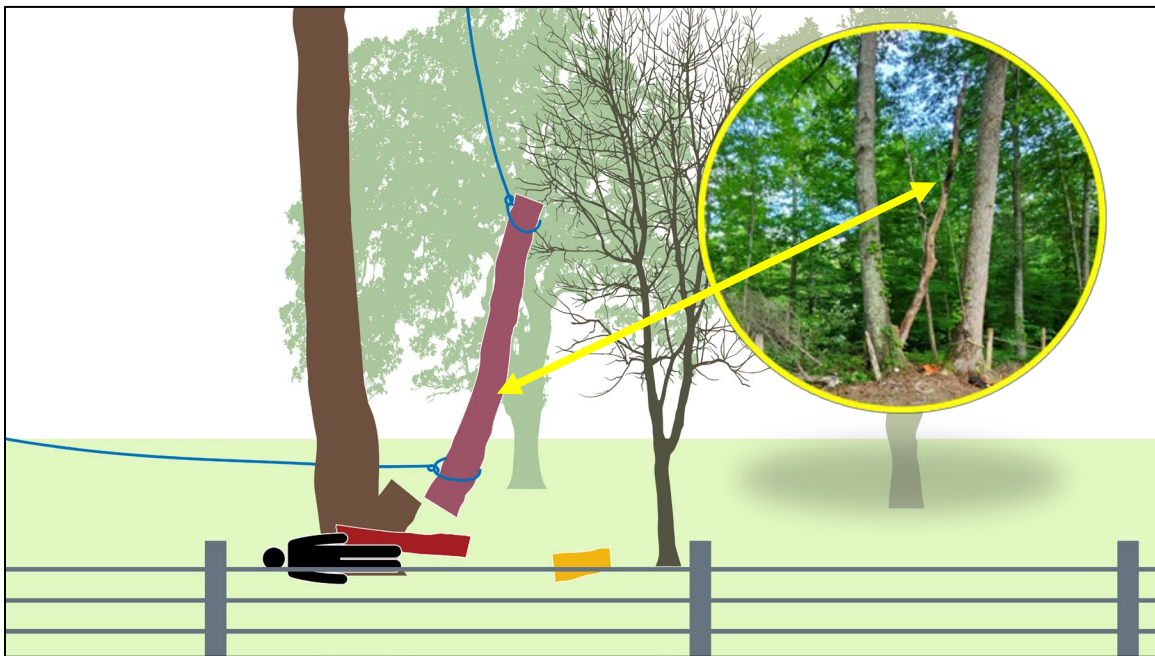
Figure 2-12. Worker Unconscious on Left Side

At the time of the accident, the ETMC work crew (ETW-1 and ETW-2) were sitting in a work truck when ETW-1 stated they saw the 10-foot section of dead limb hit CoTW-1. They immediately left the truck and ran toward CoTW-1. Before they could get to CoTW-1, CoTW-2, who was holding the tag line for the dead limb, had arrived and was assessing the injured worker’s condition. According to the ETMC workers, CoTW-1 was laying on their left side with the 10-foot section of dead limb lying beside them. (see Figure 2-12).

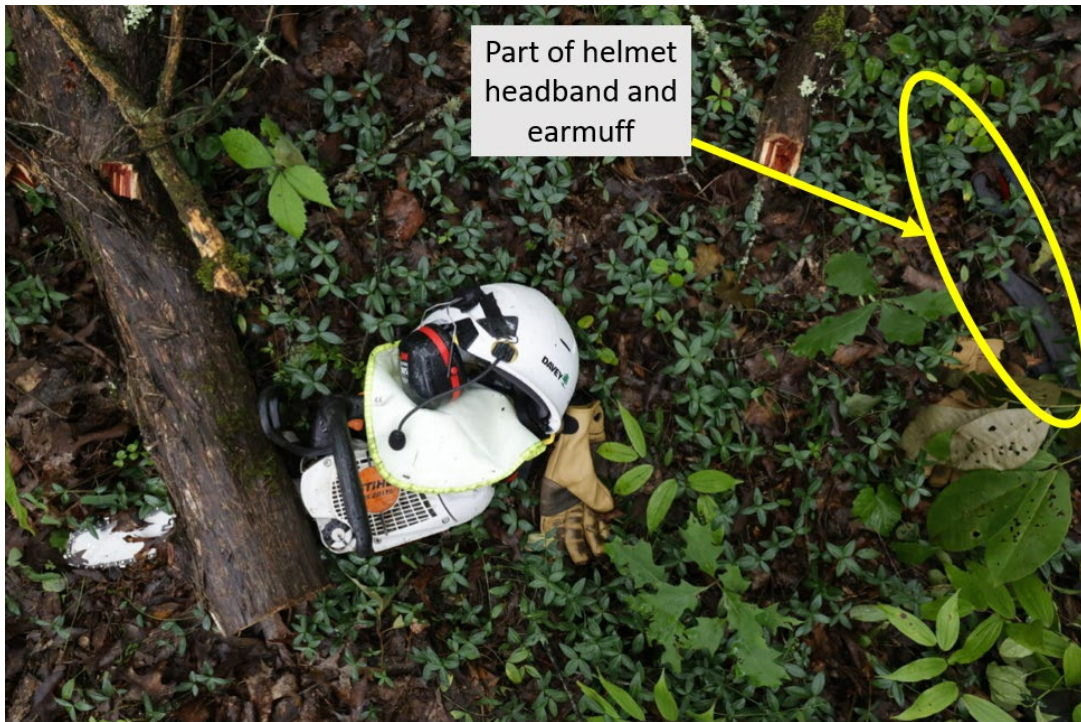
Figure 2-15. Part of Helmet Headband and Earmuff Hidden with Flora

On August 21, 2023, with the concurrence of OSO, the six members of the Board, along with a DOE RM engineer and Board assistant, performed a walkthrough of the accident site to view the condition of the site as left on August 14, 2023. This walkthrough was in support of collecting photographic evidence, as well as discussing site configuration and conditions present at the time of the accident, except those changes previously noted during EMS response. All personnel at the scene that day were advised to ensure no impact was made on any visible evidence and to be watchful for other items which may have been difficult to see given the amount of flora in the area (see Figure 2-15).

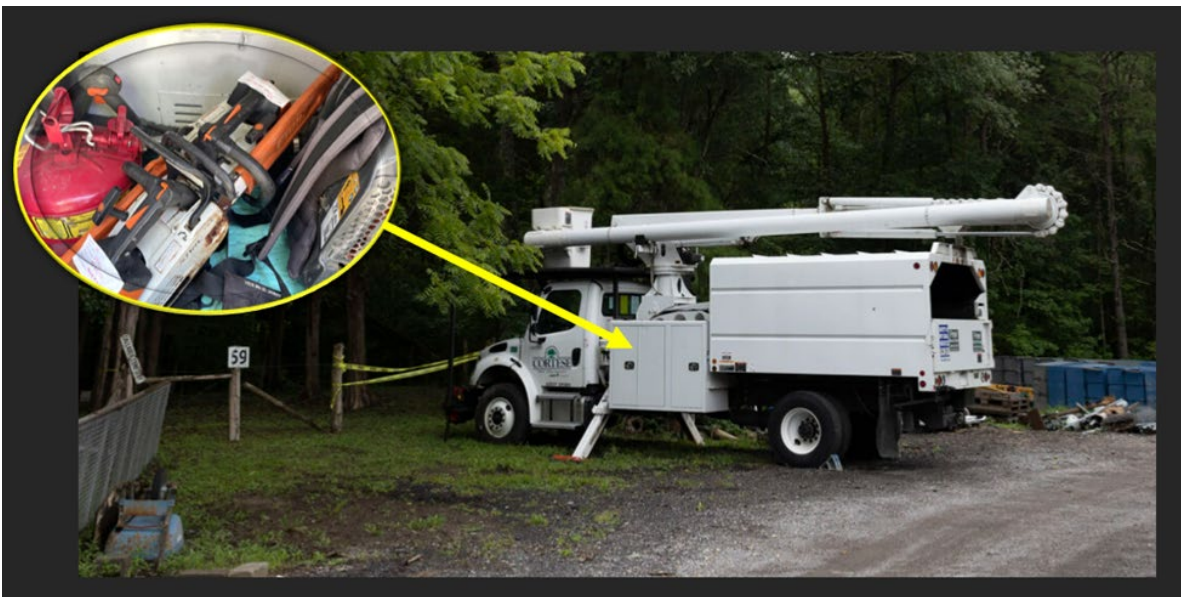
Figure 2-20. Two Stihl Chainsaws Left in the Side Storage Panel of Bucket Truck

A total of 33 items were inventoried on August 23, 2023. Two of those 33 items were the two Stihl chainsaws involved with the day's work, however, were only administratively inventoried and logged on the Evidence Custody Log. Due to the hazardous materials they contained (i.e., gasoline and oil), both chainsaws were left secured inside the driver side storage panel of the Cortese Bucket Truck (see Figure 2-20). The other remaining items were taken into physical custody by the AIB members and brought back to ORNL Building 4500N, Conference Room 210 in the DOE office suite for safekeeping that same day. During the onsite portion of the investigation, this conference room was under the direct control of the AIB and under AIB lock control.

Prior to securing both chainsaws, each one was thoroughly examined to determine if either of them warranted being taken into long term custody by the Board. Nothing was indicated. After consultation with all Board members, the Board Chair elected to release both chainsaws, along with the bucket truck and associated equipment, on August 24, 2023.

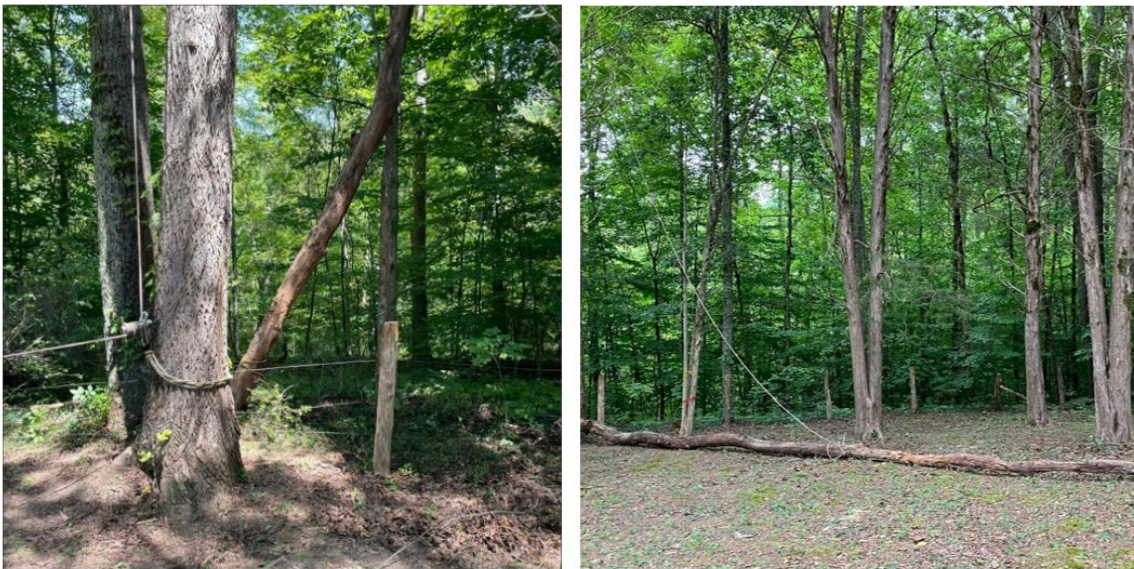
Figure 2-21. Remaining Dead Limb Lowered to Safe Configuration

On August 24, 2023, the Davey VP of Health and Safety, along with another Davey employee, lowered the remaining dead limb to a safe configuration within the cemetery. This evolution was observed by members of the Board and OSO personnel. (See Figure 2-21).

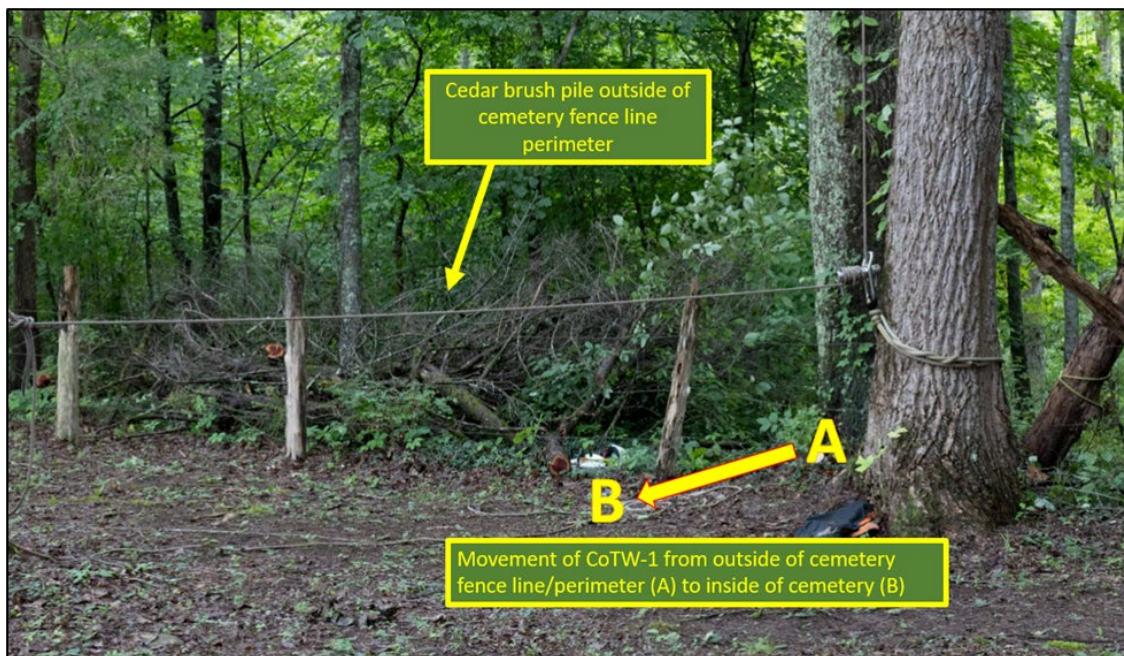
Figure 2-22. Cedar Brush Pile and Movement of CoTW-1

Though the 10-foot section of dead tree limb which struck CoTW-1 had been moved, this action was not analyzed, as it would be considered a requirement for CoTW-2 to initiate immediate actions (i.e., ascertain if CoTW-1 was okay, check for vitals, etc.). Further, movement of CoTW-1 from outside the perimeter of the cemetery fence line to just inside it, would also be expected to facilitate better access and treatment of CoTW-1 by responding EMS personnel. This action eliminated the hinderances presented by the cedar brush pile created earlier that morning, the cemetery fencing wire and wood fence posts, as well as the two trees in which CoTW-1 was located between after being struck (see Figure 2-22).
