# Next Generation Luminaire (NGL) Downlight Demonstration Project:

St. Anthony Hospital

May 2015

PNNL-24247

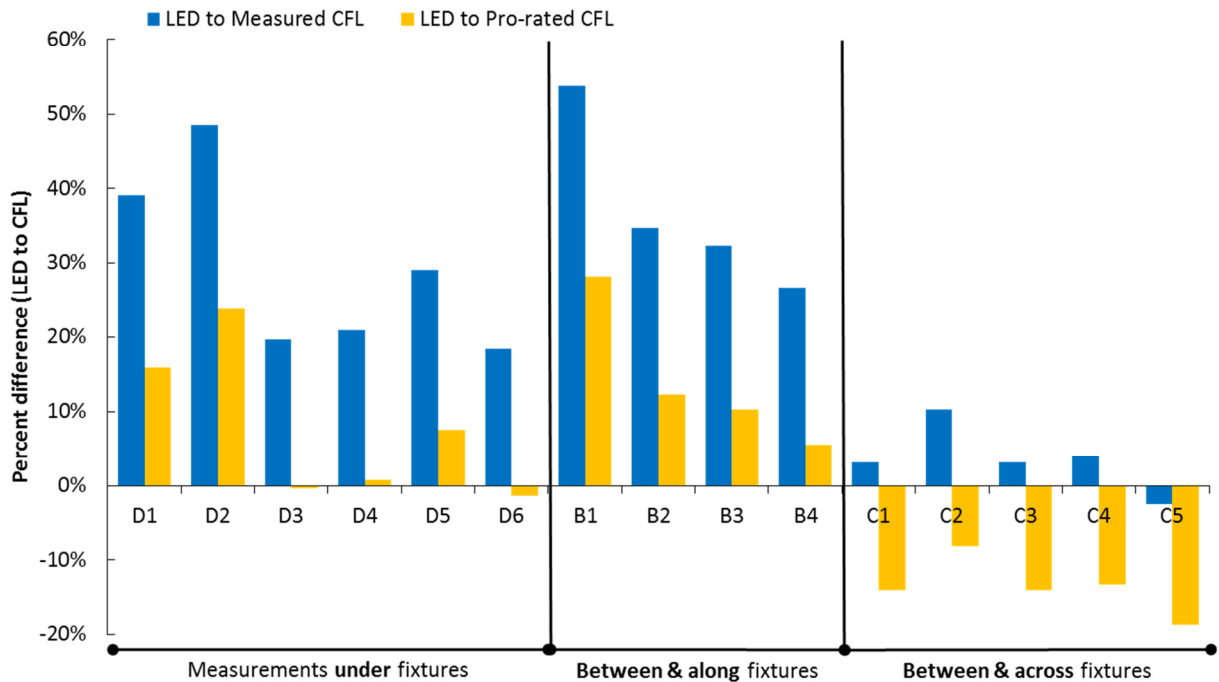
Figure ES-1. Percent difference in LED to CFL horizontal illuminance per measurement point: the blue bar shows the difference in LED to measured CFL; the yellow bar shows the difference in LED to pro-rated CFL (CFL illuminance values were increased by 20% to simulate output from new CFL lamps). The data were grouped by measurement location, with the measurements directly under the fixtures on the left (D1-6), those along the downlight row but between the fixtures in the middle (B1-4), and those between the rows of fixtures (across) on the right (C1-5). Points C1-C5 show the relative drop in light level between the rows of fixtures for the LED replacement lamp measurements.

Although the overall light levels increased with the LED system, the LED replacement lamps changed the distribution of light in the space (Figure ES-1). When lamped with CFLs, the illuminance readings in the rows under the downlights and the row between the downlights were relatively similar. However, when lamped with LEDs, the light levels taken in the rows under the downlights were higher than those in the row between the downlights. This suggested that the LEDs produced a more focused distribution than the original CFL downlights. In this application, the change does not cause any concerns because the overall light levels are above recommended values in all cases and the max:min ratios are within guidelines. But in applications with lower ceilings and/or greater spacing between fixtures, the more focused distribution with the LED replacement lamps could create non-uniform patterns of light with dark areas between the fixtures.

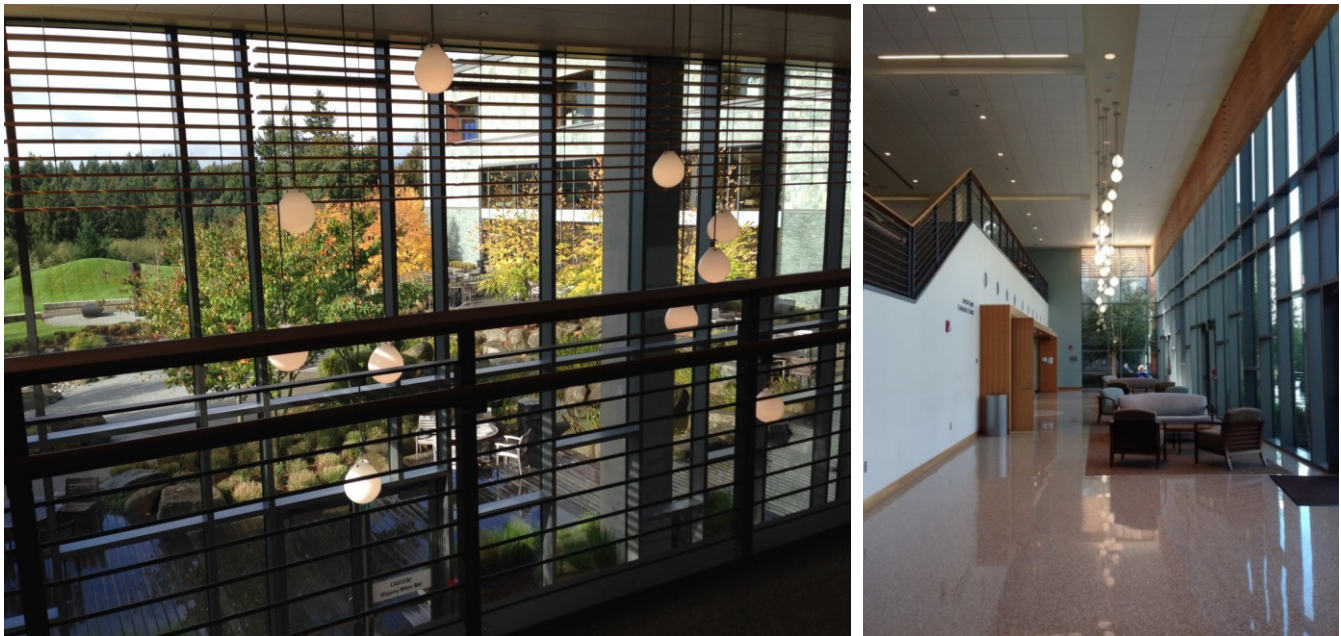
Figure 1. Pendant globe luminaires are lamped with vertically-oriented Lunera<sup>®</sup> Helen lamps. The diffuse, even light is a characteristic of both the vertical lamp and the luminaire itself. Photo credit: PNNL.

St. Anthony Hospital<sup>3</sup> opened in Gig Harbor, Washington in 2009. The hospital provides state-of-the-art medical care to patients, including emergency services, outpatient surgery, cancer care, pharmaceutical services, and other care options. There are currently 80 beds in the hospital, with room for an additional 32 on the unfinished top (5<sup>th</sup>) floor. While linear fluorescent luminaires are the primary source of lighting for the ground floor and labs, downlights originally lamped with compact fluorescent lamps (CFL) provide direct lighting in the patient rooms, lobbies, and bathrooms (Figure 1).

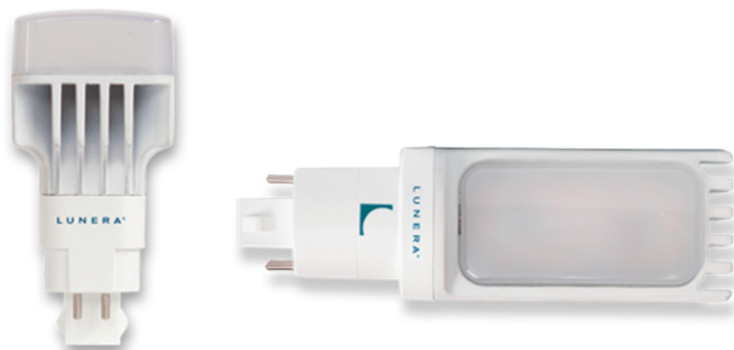
Figure 2. Lunera's Helen lamp – vertical (left) and horizontal (right). © Lunera.

After evaluating several options, the facility staff decided to replace their 1,262 CFLs (794 horizontal lamps and 468 vertical lamps) with Lunera® Helen lamps (Figure 2). These 2-pin or 4-pin LED replacement lamps fit into existing CFL sockets, run on the CFL electronic ballasts, and are compatible with non-lensed and non-dimming downlights. The 900 lumen 13 W product is designed to directly replace a 26 or 32 W CFL, reducing energy by at least 50%. Although there is some variation among ballast brands and series, the Helen lamp generally draws the same ballast power as the original CFL lamp. The lamp specifications are provided in Appendix A. The hospital selected 3,500 K LED replacement lamps, which matched the rated correlated color temperature (CCT) of the CFL lamps. Beginning in December 2013, the facilities department initiated small-scale mock-up

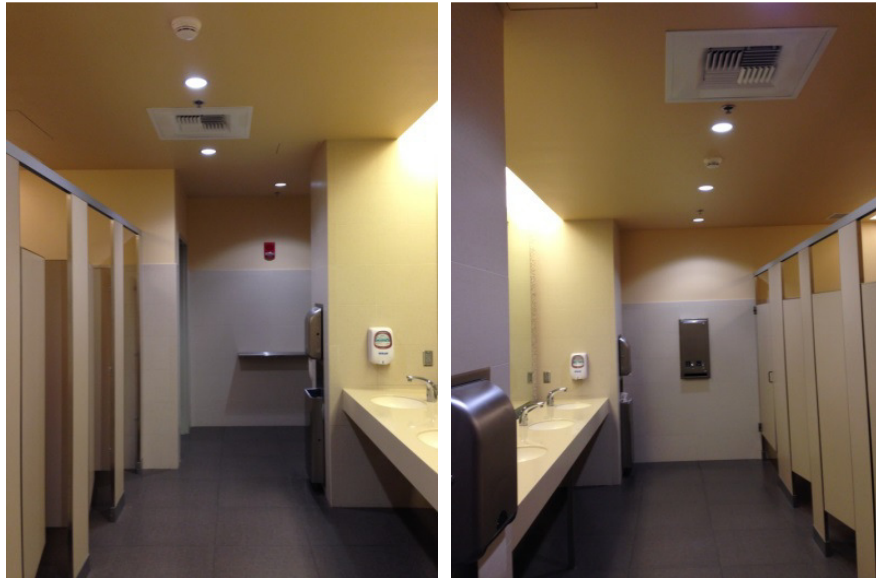
**Figure 3. The CFL downlights in the restrooms were re-lamped with LED replacement lamps. The photos show the ground floor ladies' restroom after the LED conversion. Photo credit: PNNL.**

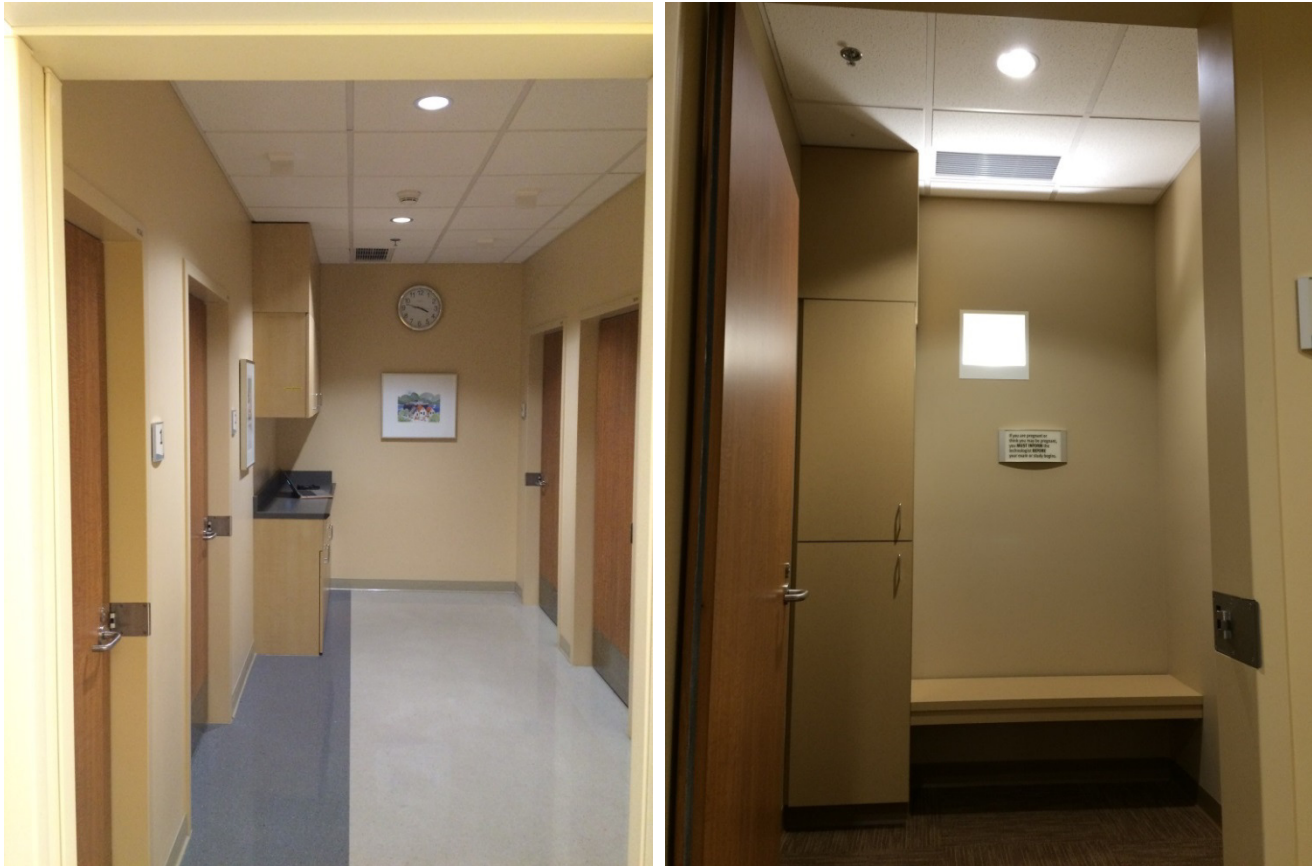
Figure 7. Diagnostic imaging patient preparation area (left) and a typical changing room (right), shown after the LED conversion. Photo credit: PNNL.

The diagnostic imaging changing room area encompassed a hallway with two center-aligned downlights and three changing rooms, two on one side and one on the other (shown in the photo above on the left). Each changing room had one downlight roughly in the middle of the room and one recessed wall upright on the far wall (shown in Figure 7, right). The luminaires are Spectrum Lighting® vertical downlights with a clear cone, round aperture. When lamped with LEDs, the vertical long Helen lamps were pulled as close to the opening of the fixture as possible to spread the light as wide as possible.

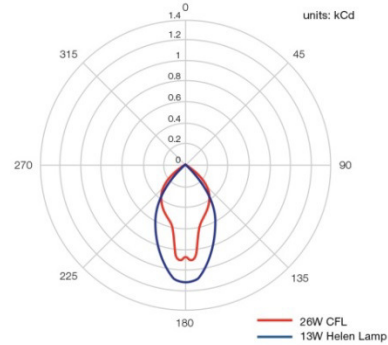
## Photometry

The Helen Lamp vs. 26W CFL, compared in the same downlight fixture.
