Fact Sheet

This fact sheet provides information about the **Durango** sites. These sites are managed by the **U.S. Department** of Energy Office of Legacy Management under Title I of the Uranium Mill Tailings Radiation Control Act of 1978.

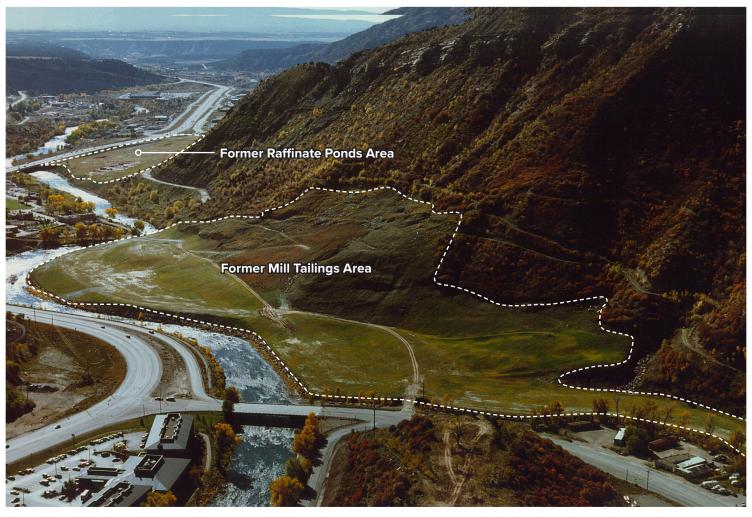
View of Durango, CO, Remediated Processing Site (1991).

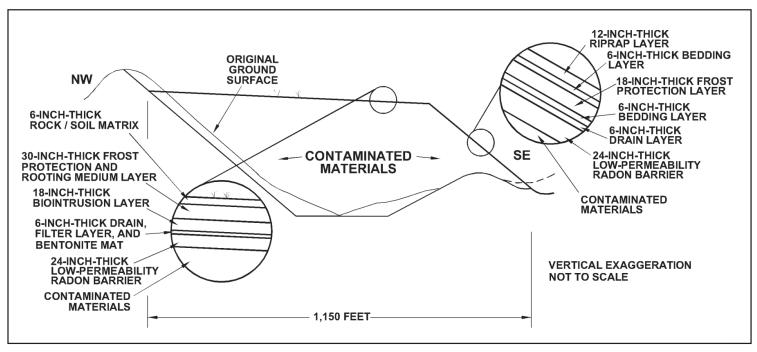
Northwest-Southeast Cross Section of the Durango Disposal Cell.

The Durango disposal cell is irregularly shaped and measures approximately 2,400 feet on its long axis by 1,300 feet across. The cell cover is a multicomponent system designed to encapsulate and isolate the contaminated materials.

The cover consists of: (1) a low-permeability radon barrier (first layer placed over compacted tailings), (2) a sand filter/drainage layer and a bentonite mat, (3) a layer of rock to prevent biointrusion, (4) a frost-protection/rooting-medium layer, and (5) a rock/soil matrix layer on the top and rock (riprap) on the side slopes to protect against wind and water erosion. The top of the disposal cell is planted with native grasses. Riprap is keyed into bedrock around the base of the cell to prevent erosion at the cell boundary.

The cell cover design promotes rapid precipitation runoff mitigating water infiltration. Runoff from the top slope of the cell flows to a surrounding rock apron that carries water away. Native vegetation has been re-established in disturbed areas at the site.

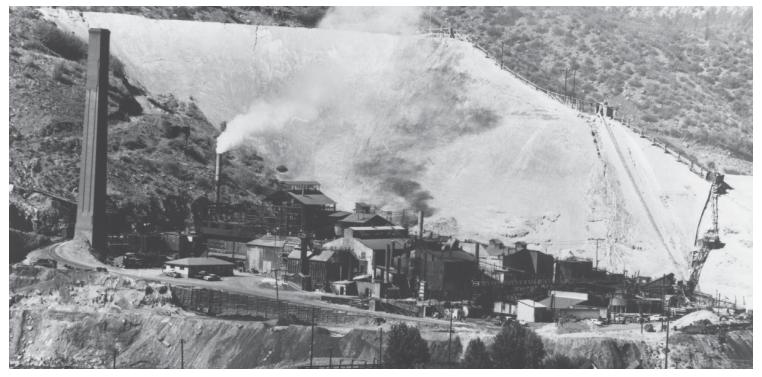
Durango mill during active operations (date unknown). The smokestack for the old lead smelter is to the left, with the large tailings pile and conveyances across the center.

In 1942, a vanadium mill was built on the site of an old lead smelter plant by the United States Vanadium Corporation (USV). In 1943, USV began reprocessing vanadium tailings for the recovery of uranium for sale to the Manhattan Project and operated the mill until 1946 when the mill was shut down. Beginning in 1949, the Vanadium Corporation of America operated the mill and sold uranium to the U.S. Atomic Energy Commission for national defense purposes until 1963, when it was shut down permanently. Approximately 1.2 million cubic yards of radioactive mill tailings, a predominantly sandy material, resulted from the milling operations.
