LOCALIZED DEFORMATION IN IRRADIATED AUSTENITIC STEELS

Light Water Reactor Sustainability R&D Program

ORNL: M.N. Gussev*, K.G. Field, J.T. Busby, K.J. Leonard,
PNNL: T.S. Byun,
University of Michigan: K.J. Stephenson, G.S. Was.

LOCALIZED DEFORMATION AND IASCC

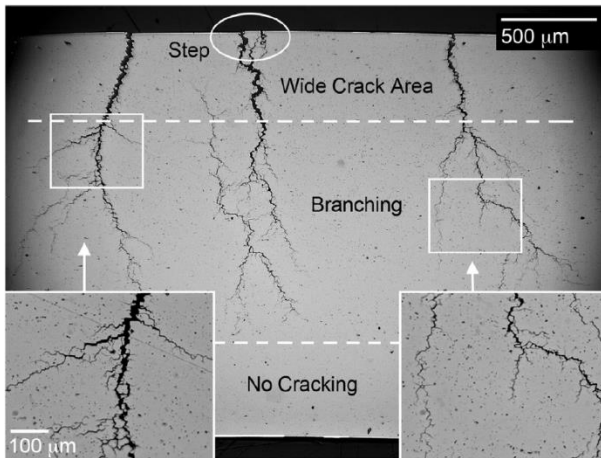
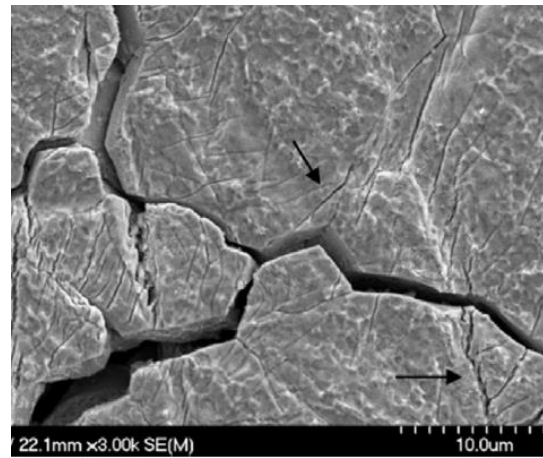
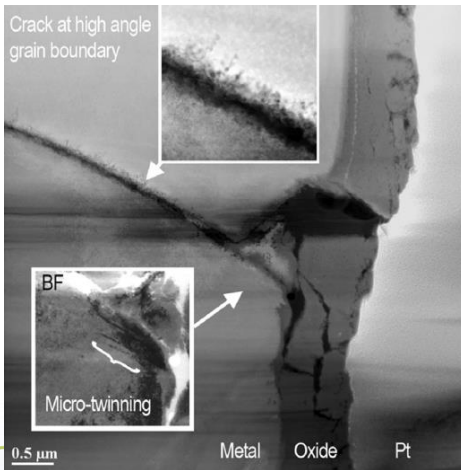
An example of low IASCC predictability

- Well-known, trusted, and (as was thought) well-understood 718-alloy demonstrated stress-corrosion cracking under LWR conditions.

- A full post-irradiation examination performed on irradiated components assemblies showed damage following in-service exposure.
- According to the preliminary conclusion, the IASCC was caused by combination of stress level above yield stress (which was not a sole reason) and **slightly decreased amount of delta-phase**.
- It is important that all damaged and non-damaged components were produced within the same specification.

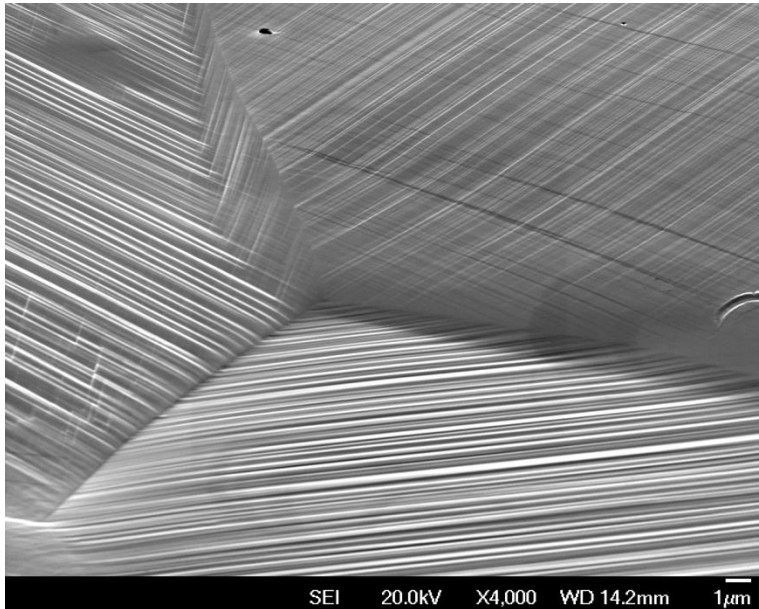
Non-irradiated 304 steel, 6% strain

Non-irradiated steel demonstrates multiple, fine slip lines.

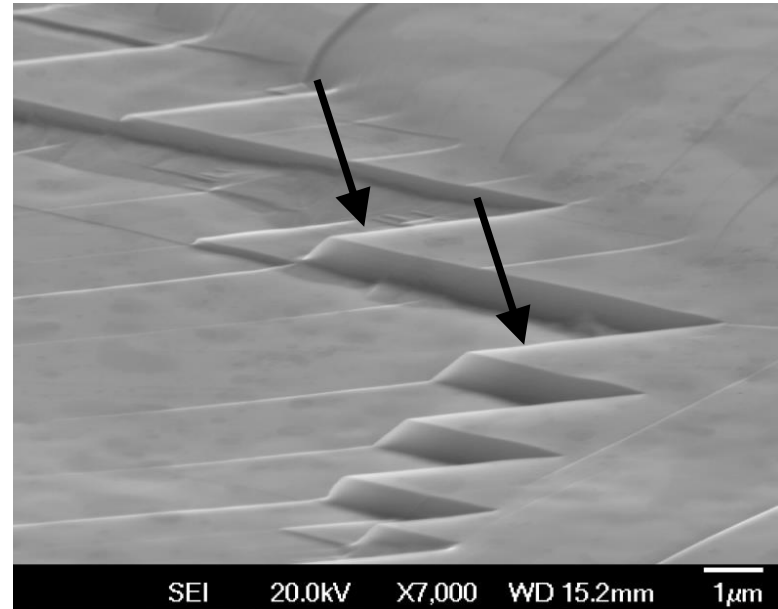
304 steel, 4.4 dpa, 0.8% plastic strain

Irradiated steel has significantly smaller slip line density (orders of magnitude!) and the slip lines are more pronounced; their height at the surface is much higher.

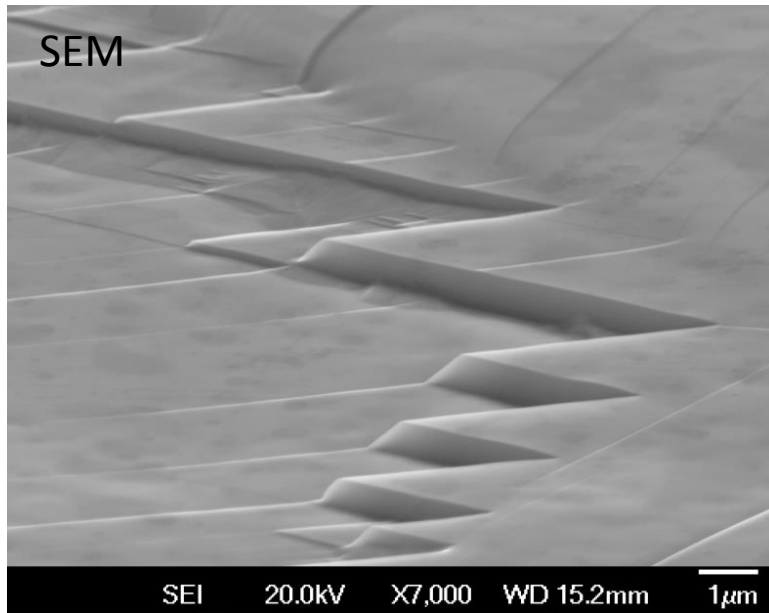
304 steel, 4.4 dpa, 0.8%

- Dislocations interact with radiation-induced defects, sweeping them out.
- The defect removal process results in a clear, defect-free pathway for the following dislocations (positive feedback loop).

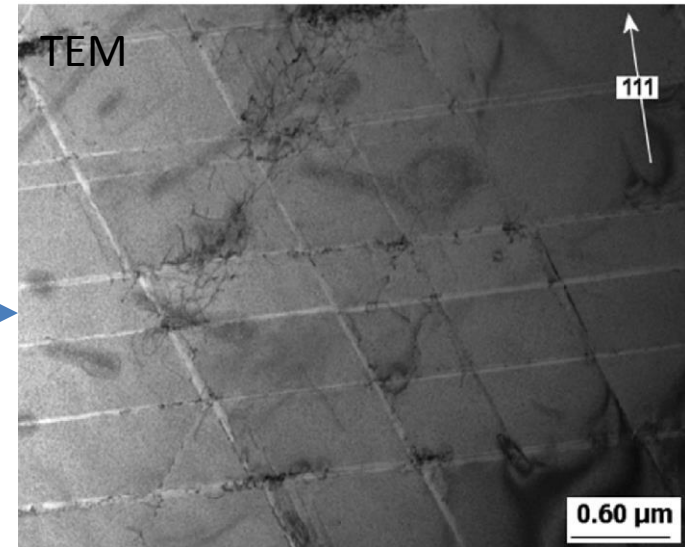
Regular pattern of dislocation channels in irradiated 304L SS (after Sauzay et al., JNM, 2010).

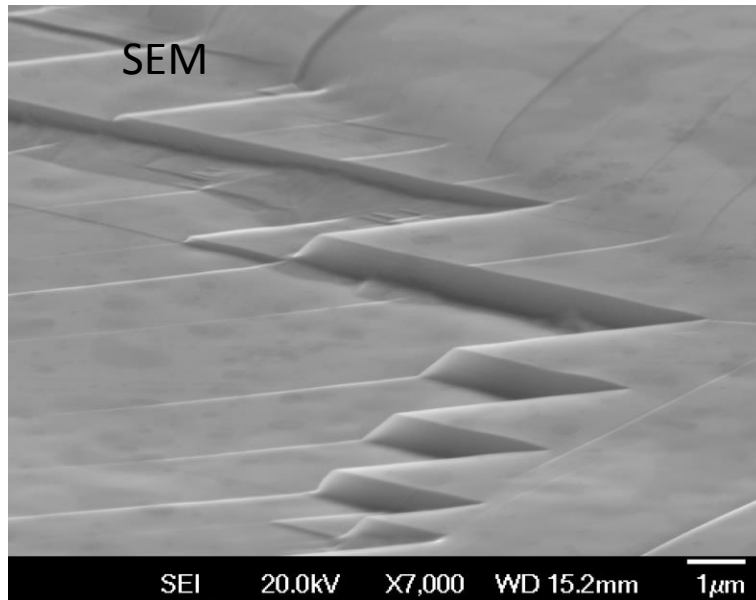
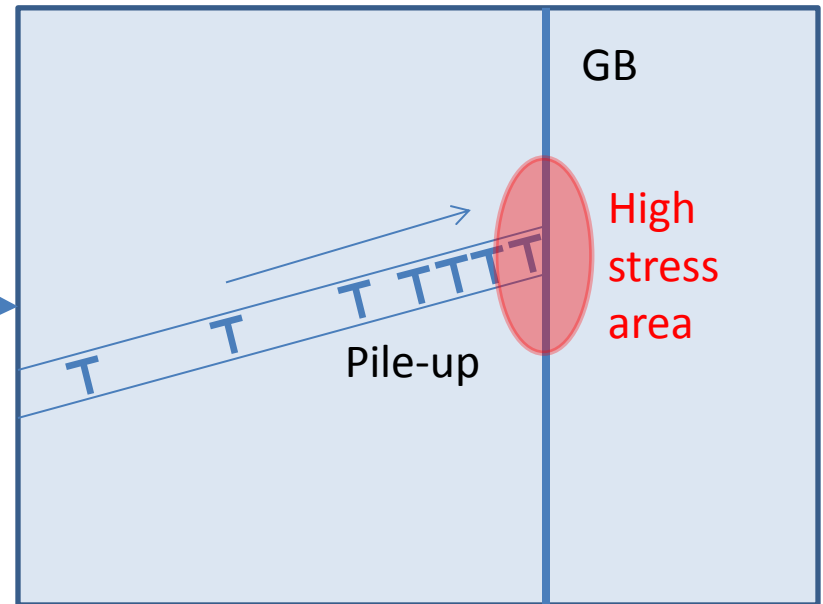
304 steel, 4.4 dpa, 0.8%

- For bulk material, a simplified classical approach predicts dislocation accumulation at the grain boundary, formation of dislocation pile-up (under certain conditions), and the appearance of area with increased stress level.
- At the surface, channels may lead to protective film rupture and local corrosion and dissolution.

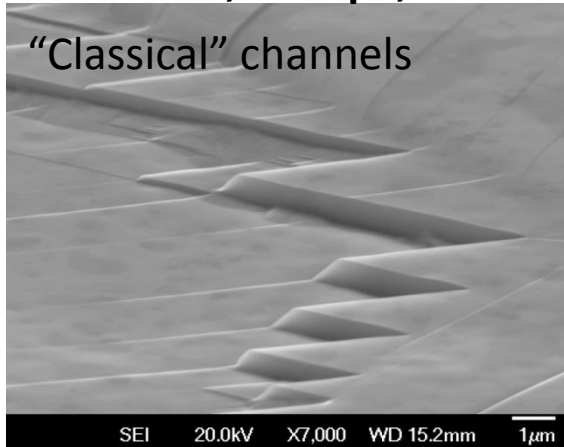
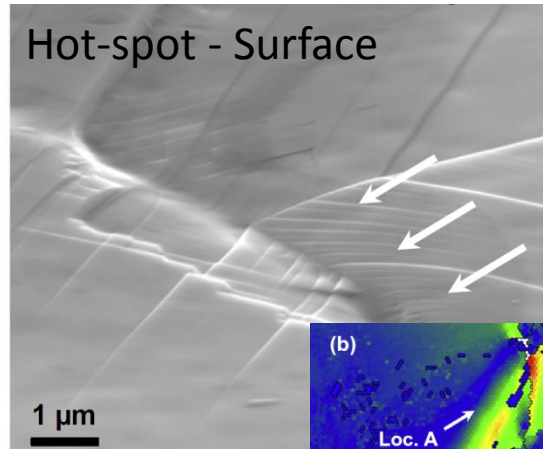
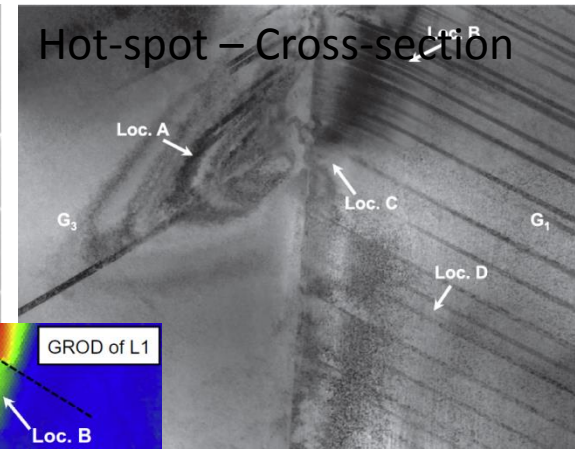
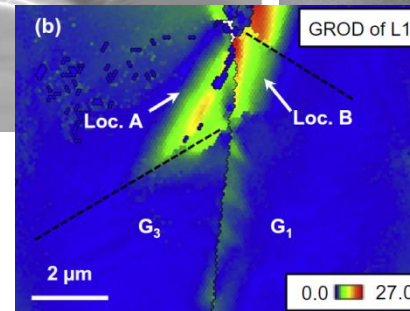
304 steel, 4.4 dpa, 0.8%

“Classical” channels

- However, the reality is much more complex.
- “Pure channels” and “pile-ups” are, as a rule, extremely simplified terms.
- Highly-deformed areas (“hot spots”) may appear near the grain boundary (our recent finding).
- Dislocation channel may contain deformation twins (material with different crystallography orientation!). And - deformation twinning is not limited by near-room temperature range.

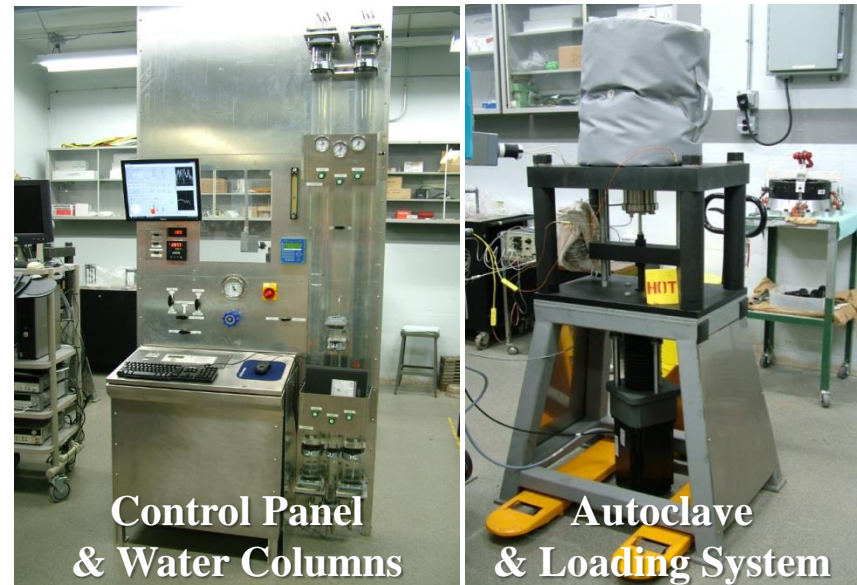
- Constant extension rate tensile (CERT) tests performed at the University of Michigan in simulated LWR environment.
- Strain rate $\dot{\epsilon} = 3.5 \times 10^{-7} \text{ s}^{-1}$.
- Samples strained to failure without interruption.

Environment	Dissolved Gas	Chemical Addn.	Conductivity	Potential
320°C PWR PW	3 ppm H ₂	1000 ppm B, 2 ppm Li	20.5 μS/cm	-860 mV _{SHE}

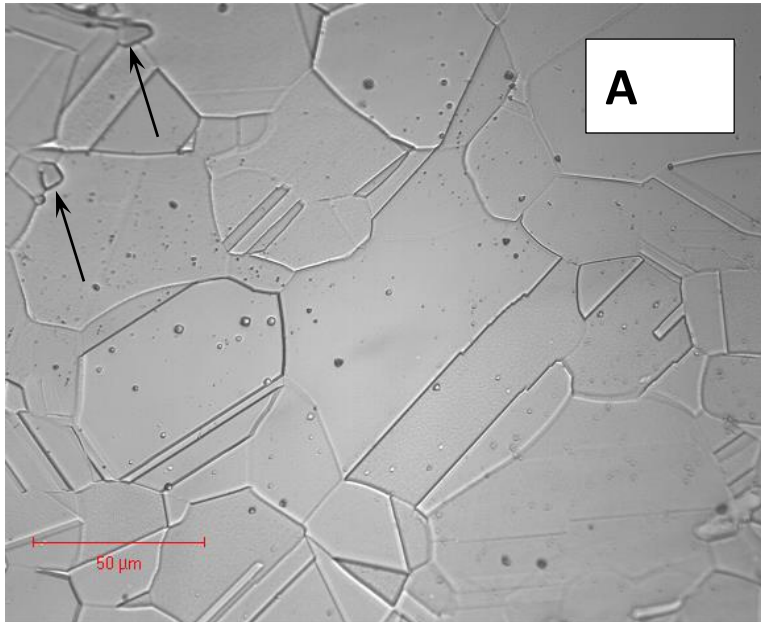
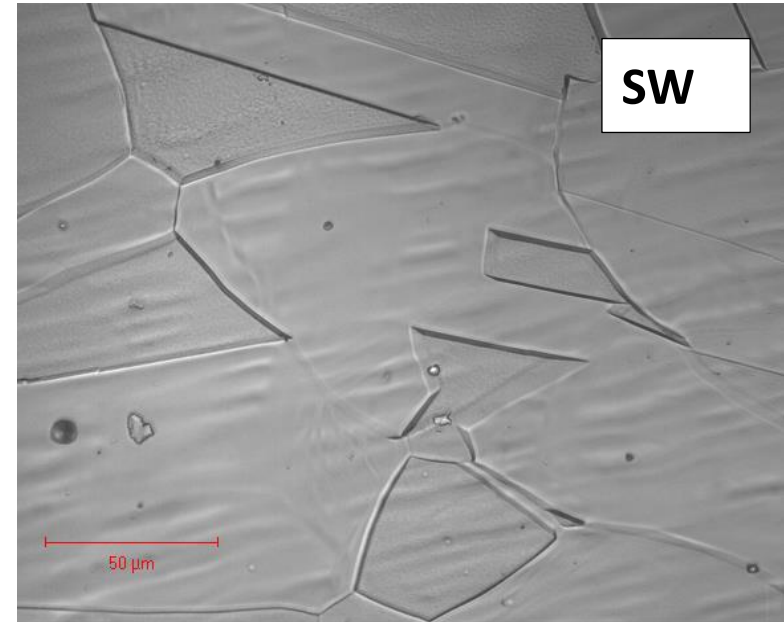
Left: structure of irradiated A-alloy prior CERT test, light microscope, 400 \times . Black arrows point to retained ferrite grains. Right: structure of irradiated SW-alloy prior CERT test, light microscope, 400 \times (electrolytic etching with 10% oxalic acid at 6 V for 60–80 s for both A- and SW-alloys).

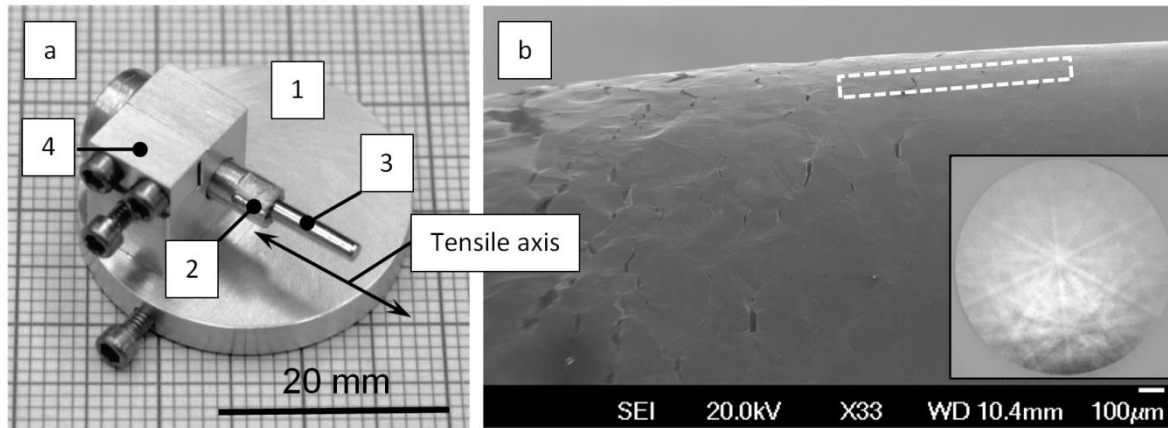
a) Tensile round bar holder (1) with a tubular fixture (2) and dummy specimen (3). A small additional grip (4) may be used to hold the grids for FIB-TEM specimens. b) Surface of the irradiated specimen (SW-alloy) after testing. The white rectangle shows an area that can be EBSD scanned without specimen rotation operations. c) A typical EBSD scan of the cracked area.

Special holder was designed to handle round tensile bars allowing for the analysis of the whole surface. The specimen tensile axis was always aligned with the TD (horizontal) axis of the EBSD system. Due to surface erosion and strain-induced relief, the EBSD analysis was limited by areas with low local strain.

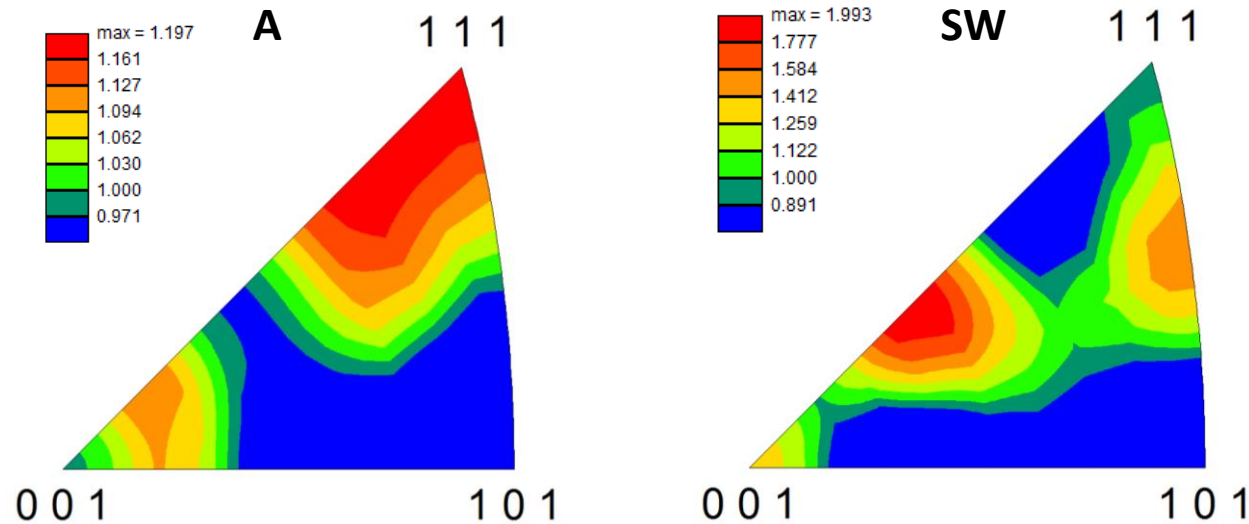
Typical texture plots for the investigated materials. The Inverse Pole Figures (IPFs) generated from EBSD technique are shown with respect to the straining direction during the CERT test.

- Both steels had a typical annealed austenite structure.
- No signs of pre-irradiation cold-work or post-irradiation deformation.
- Relatively weak texture (just $\sim 1.9 \times$ random for the given loading direction).
- SW-alloy had a slightly increased fraction of soft grains (i.e., grains with a high Schmid factor) compared to the A-alloy

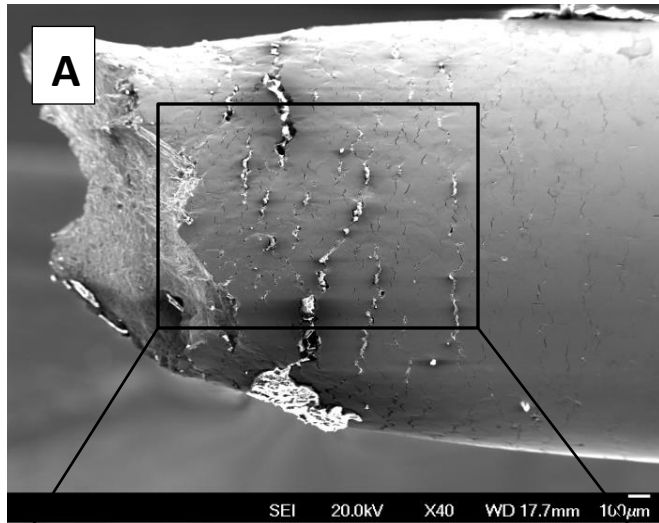
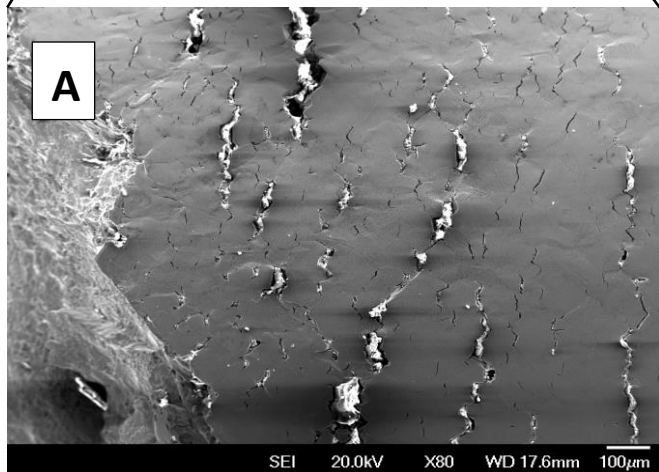
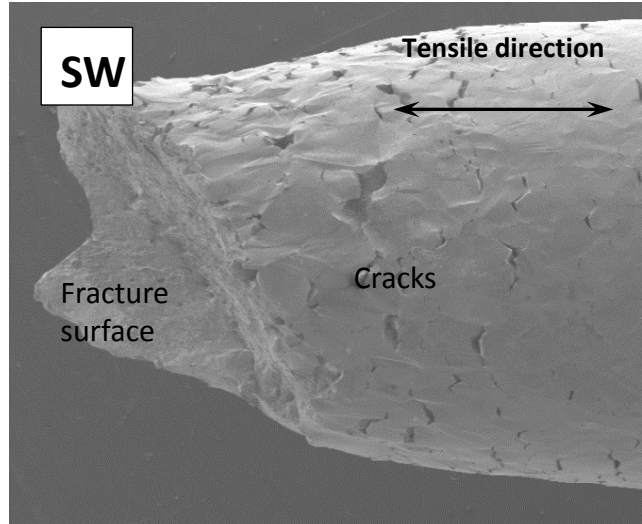
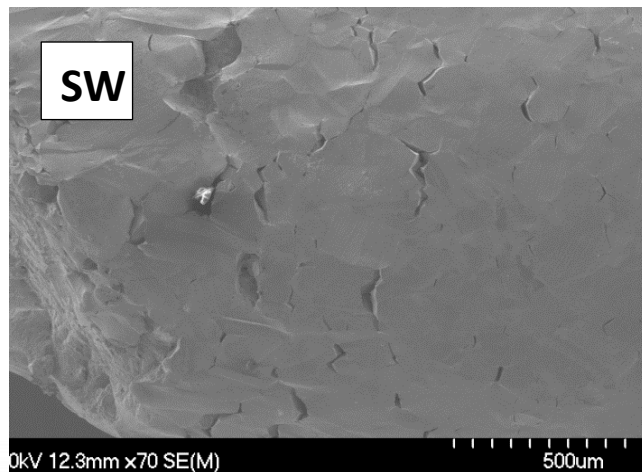
General appearance of stress corrosion cracking

- Multiple cracks formed along the gauges with crack density and size increasing towards the fracture surface.
- Crack density was ~3–3.5 times higher in the A-alloy compared to the SW-alloy.
- Crack width was generally larger in the SW-alloy.

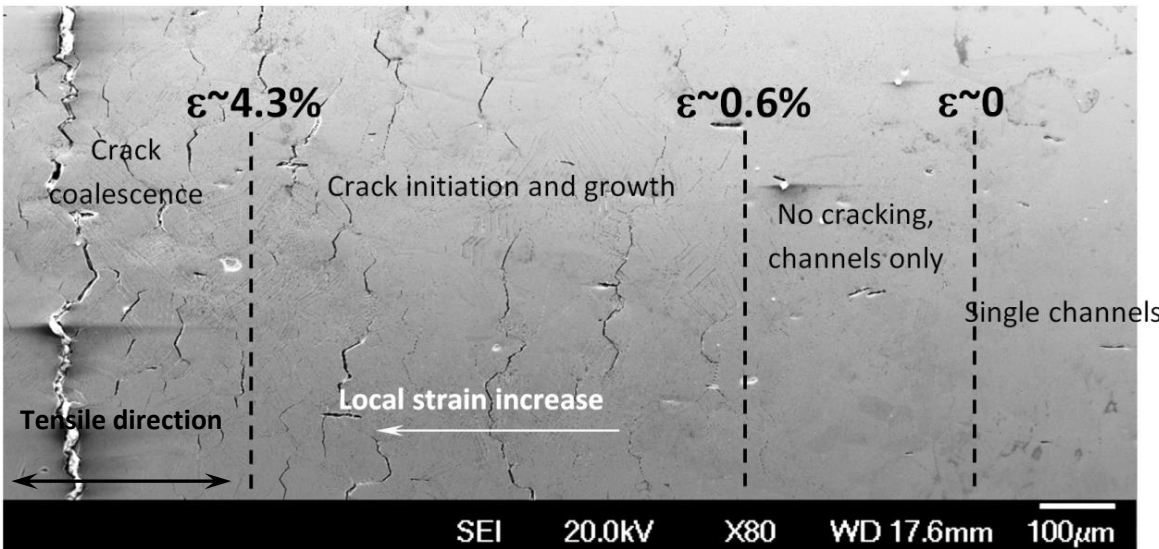
The local strain was calculated as $\epsilon = (d_0^2/d_i^2) - 1$, where d_i and d_0 are current and initial diameters, respectively.

Cracks appeared at the surface at local strain of $\sim 0.6\%$; below this strain level, only dislocation channels were observed at the surface and no cracks.

Surface of the deformed tensile bar with the strain levels shown (A-alloy).

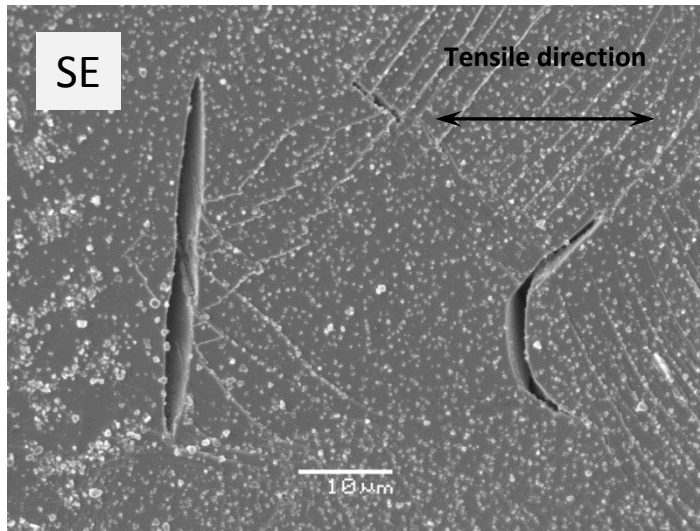
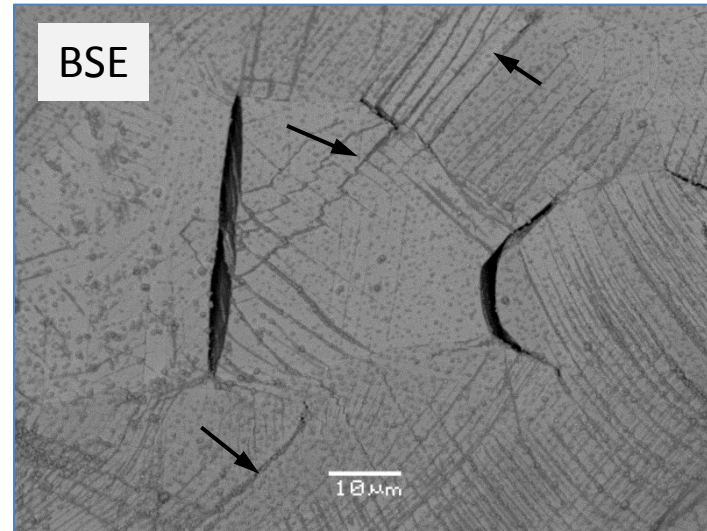
AS19 specimen, the same area in secondary electrons (SE) and back-scattered electrons (BSE).

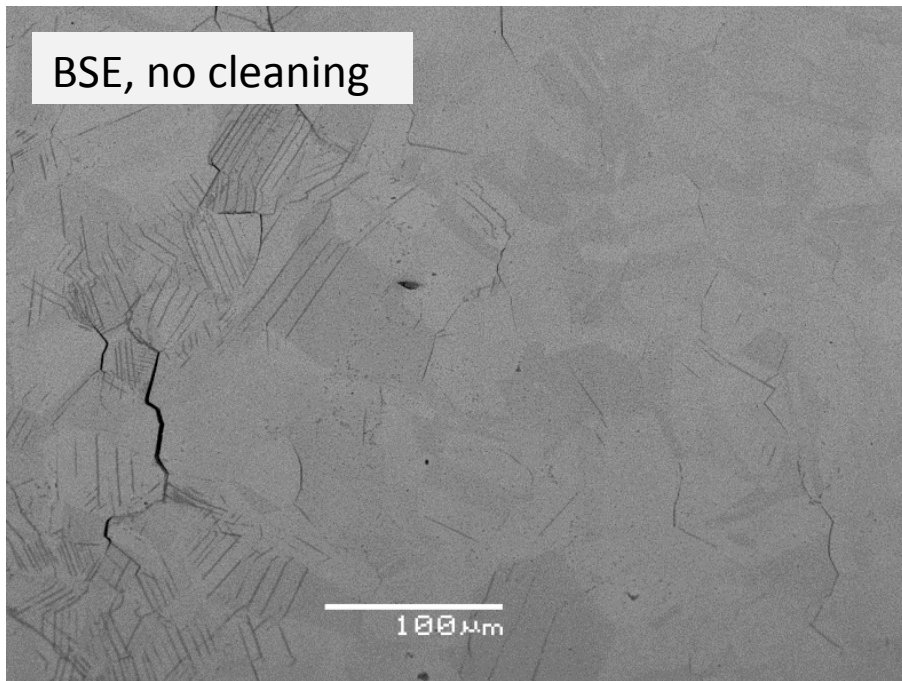
SEM BSE image of the A-alloy specimen gauge after CERT test

Dislocation channels in BSE mode often appeared as wide smooth-edged lines edges. It was assumed that the BSE-contrast may be caused by element contrast and presence of oxides (light elements/oxides are “darker”), not by surface topology only. After cleaning many channels revealed the eroded surface suggesting specific oxidation processes. It was decided to prepare FIB-lift out samples to analyze oxidation in more detail.

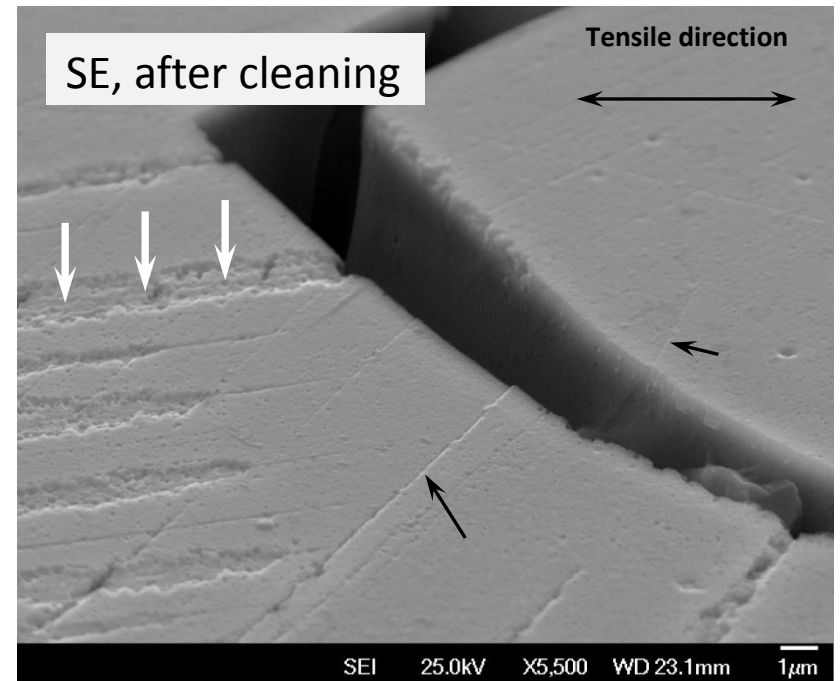
Cracked grain boundary and slip lines at the surface (70-degree tilted image). One can see step caused by dislocation channels (black arrows). The surface is eroded along some channels (white arrows). A-alloy.

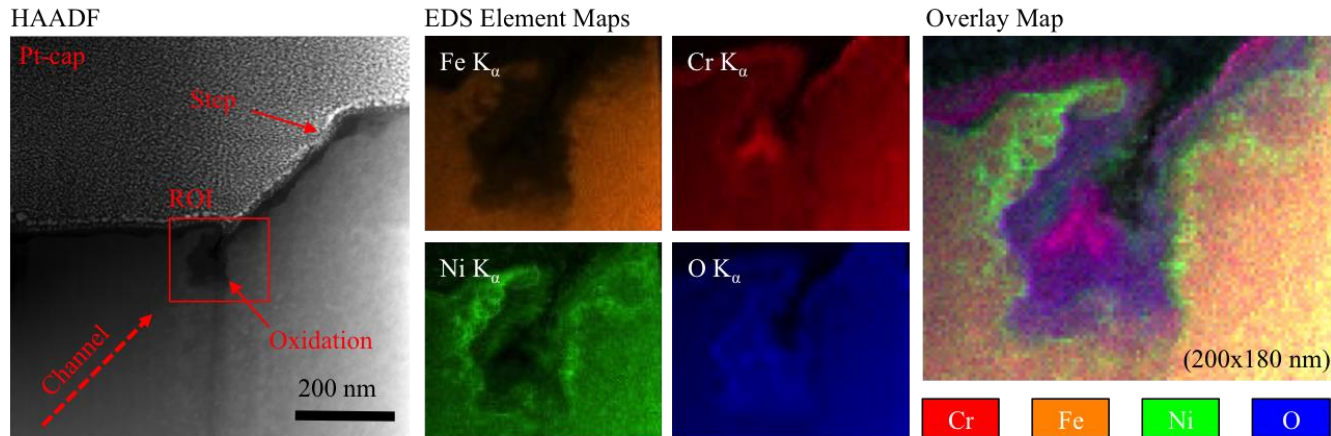
The local corrosion damage associated with defect-free channels was observed.

Two different oxide morphologies are noted, the first being a Cr-rich oxide along the unperturbed surface and at the top of the erosion pocket and a Cr-depleted oxide protruding into the base metal at the base of the erosion pocket.

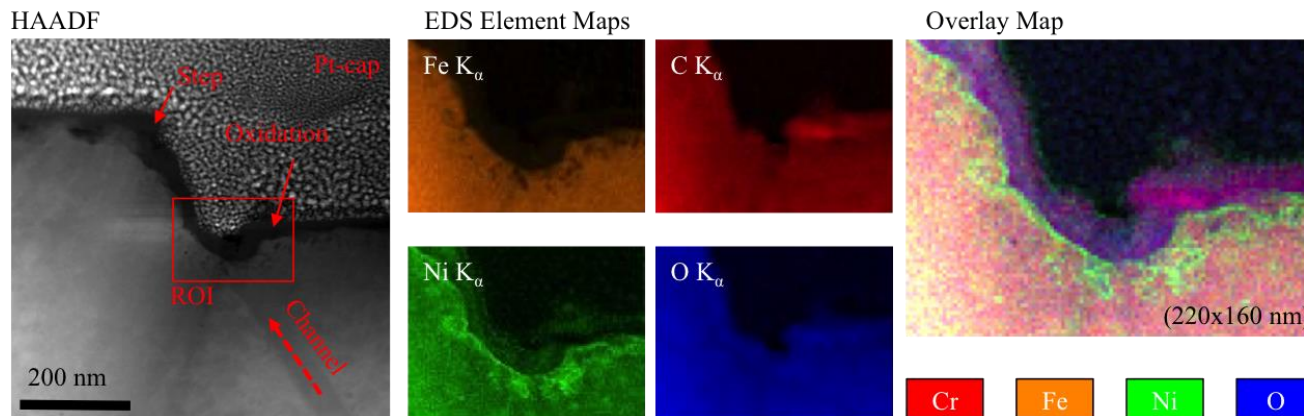
High-angle annular dark field (HAADF) image, EDS element maps, and color-overlay maps of a dislocation channel showing localized corrosion at the base of the surface step (top) and a dislocation channel showing limited attack at the base of the surface step (bottom).

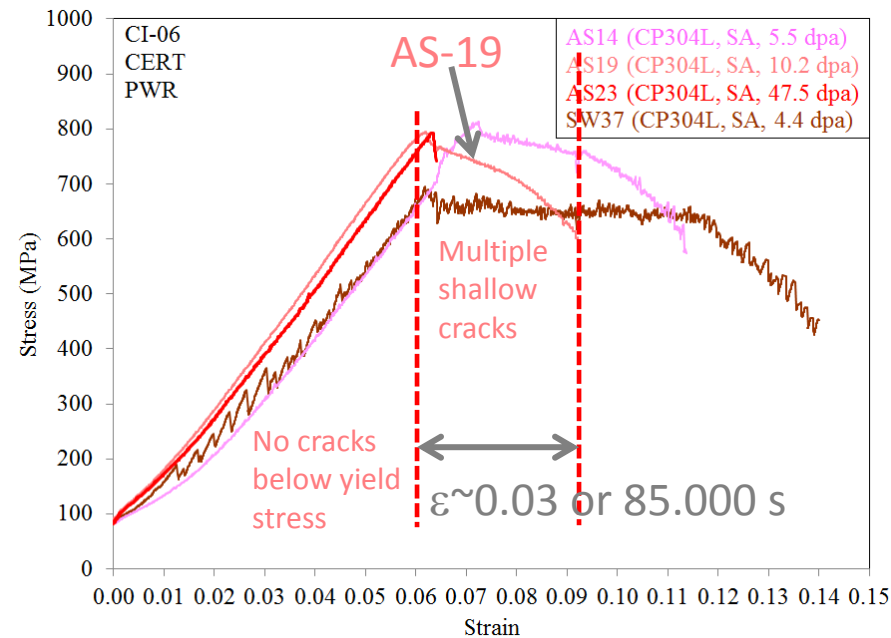
Engineering strain-stress curves for tested specimens

A number of events - crack formation, neck development, and fracture – have occurred in the engineering strain interval of only 0.03. Given the strain rate of $3.5 \times 10^{-7} \text{ s}^{-1}$, the time interval was $\sim 85.000 \text{ s}$.

Thus, it may be speculated that the near-surface cracks formed at crack propagation rate of ($\sim 100 \mu\text{m} / 8.5 \text{ e}4 \text{ s}$) $\sim 10^{-6} - 10^{-7} \text{ mm/s}$. This value is unexpectedly high for PWR conditions.

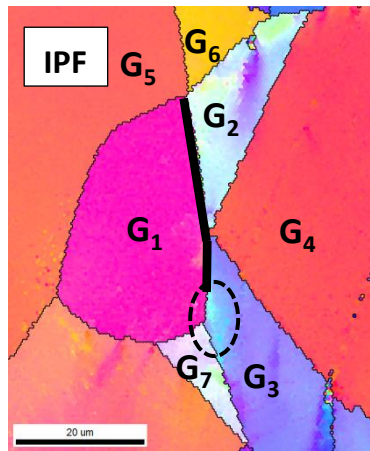
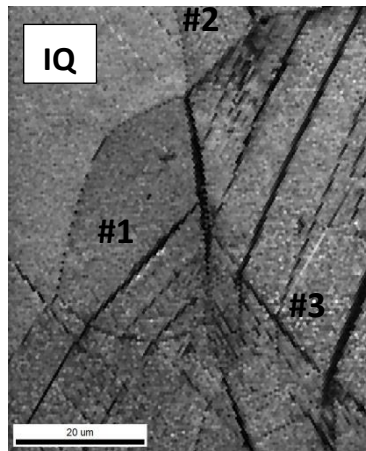
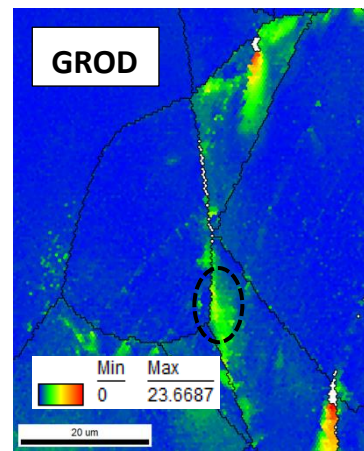
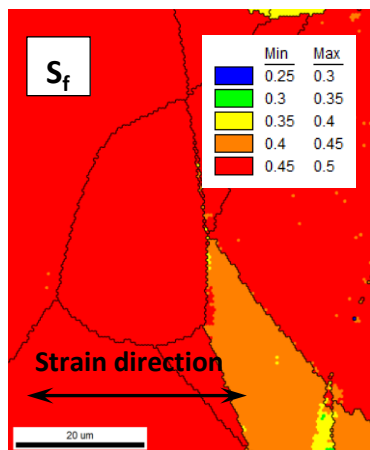
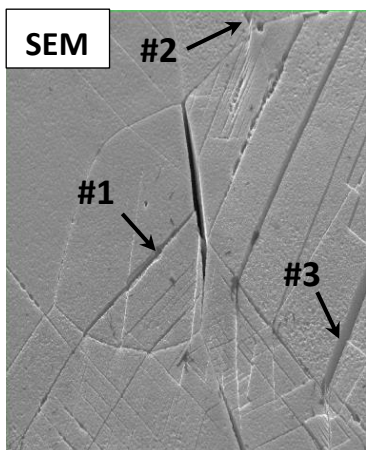
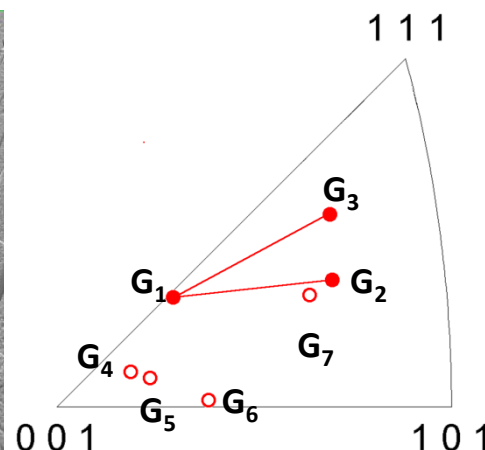
EBSD analysis of a typical crack

Multiple crack provided an opportunity to accumulate large enough statistics on crack initiation.

Using SEM-EBSD, the orientation of crack-adjacent and neighbor grains was investigated in detail as well as Schmid factor, in-grain misorientation, and morphology of dislocation channels.

Since grain orientation with respect to the tensile axis defines its elastic properties, Schmid factor, etc., thus it was possible to expect that grain orientation influences also crack initiation.

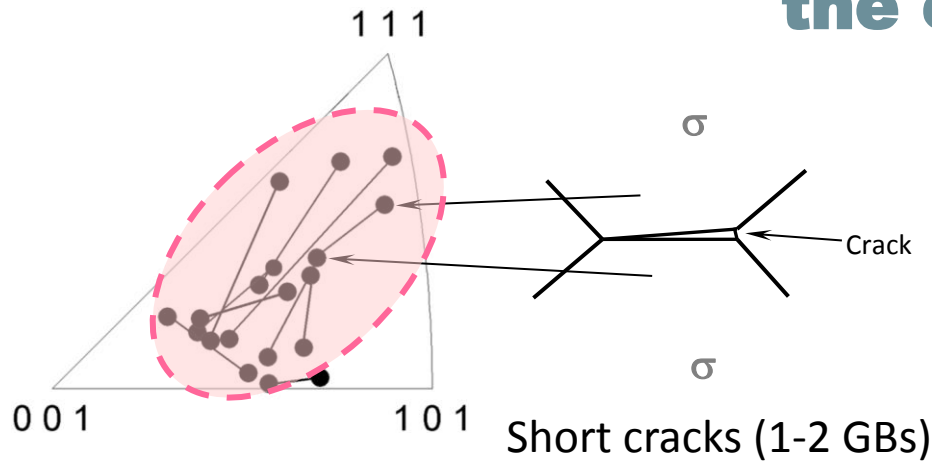
Crystallographic orientation patterns for the crack-adjacent grains

- **Crack initiation is not a random process.** Grain orientation strongly influenced the appearance of stress corrosion cracks.
- For short cracks, one or both grains adjacent to the cracked GB were often oriented close to the center of the unit triangle (softest grains) or close to the [111]-corner.
- Grain orientation role became less pronounced for long cracks. Widest portion of the crack (i.e. crack initiation location) still tended to follow the rule discussed above; however, grain selectivity became weaker with crack length increase.

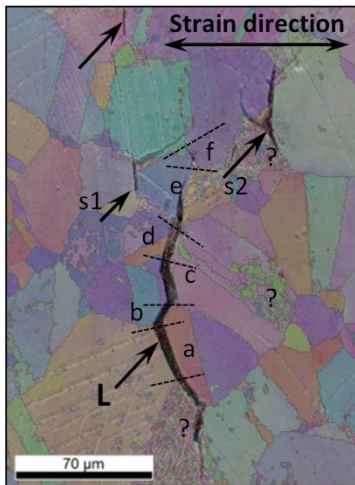
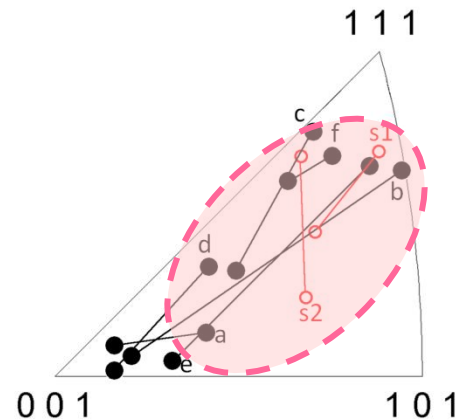
Grain orientation data for relatively large crack (L) in A-alloy. Local strain value $\sim 2.3\%$.

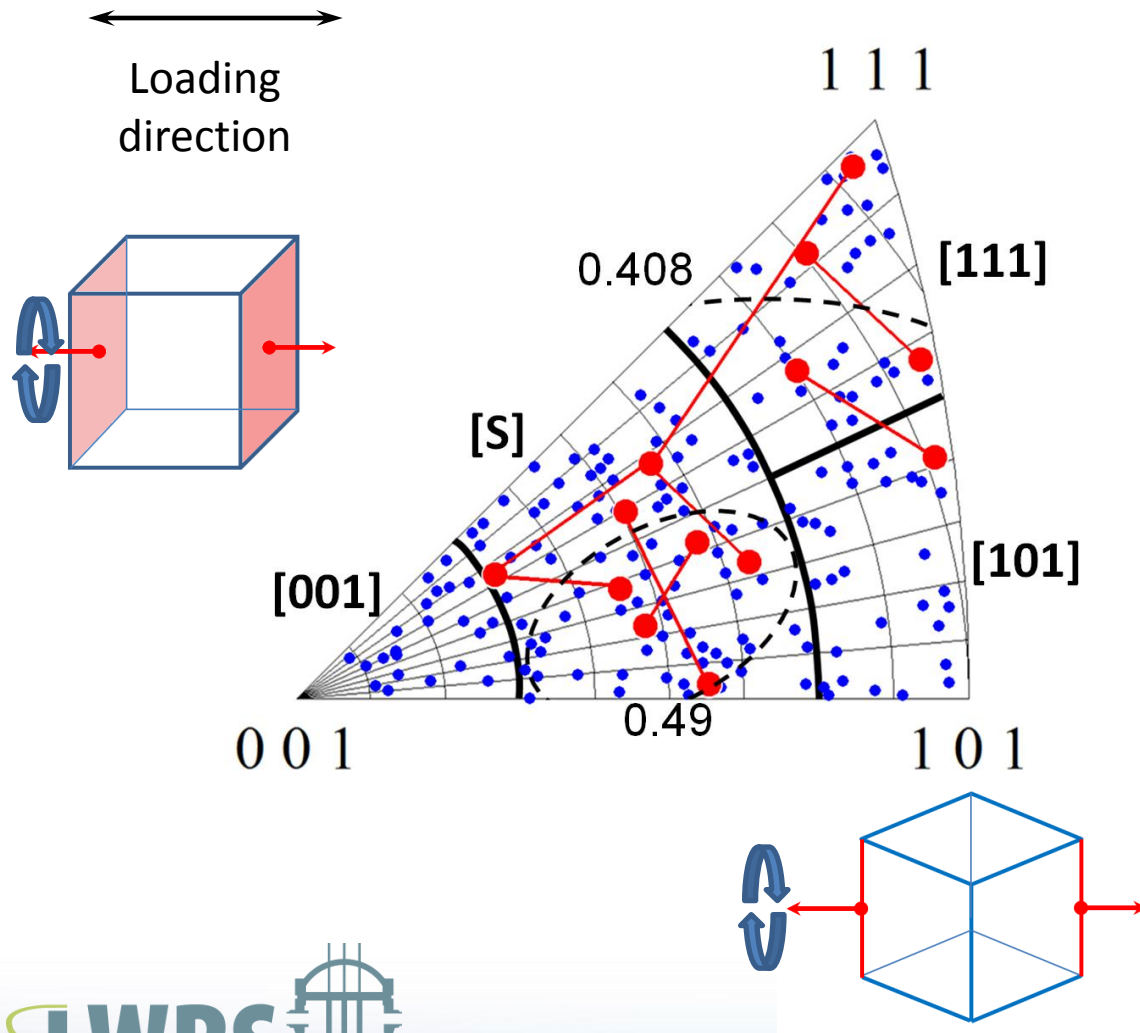
The scheme of triangle partitioning

To analyze the role of grain orientation, the unit triangle was arbitrarily divided into four areas:

- The [001]-area contained grains oriented close to the [001]-corner and with the lowest elastic stiffness.
- Grains oriented close to the [111]-corner had the largest elastic stiffness and the lowest Schmid factor.
- Grains from the [S]-area were mainly the softest grains with a high Schmid factor.

For the studied specimens, the largest cracking intensity was observed for grains belonging to the **[111]-partition and for the softest grains.**

Grains from **[001]- and [010]-partitions** were much less frequently involved in cracking.
