Novel Infiltration Diagnostics based on Laser-line Scanning and Infrared Temperature Field Imaging

(New Project)

2017 Building Technologies Office Peer Review

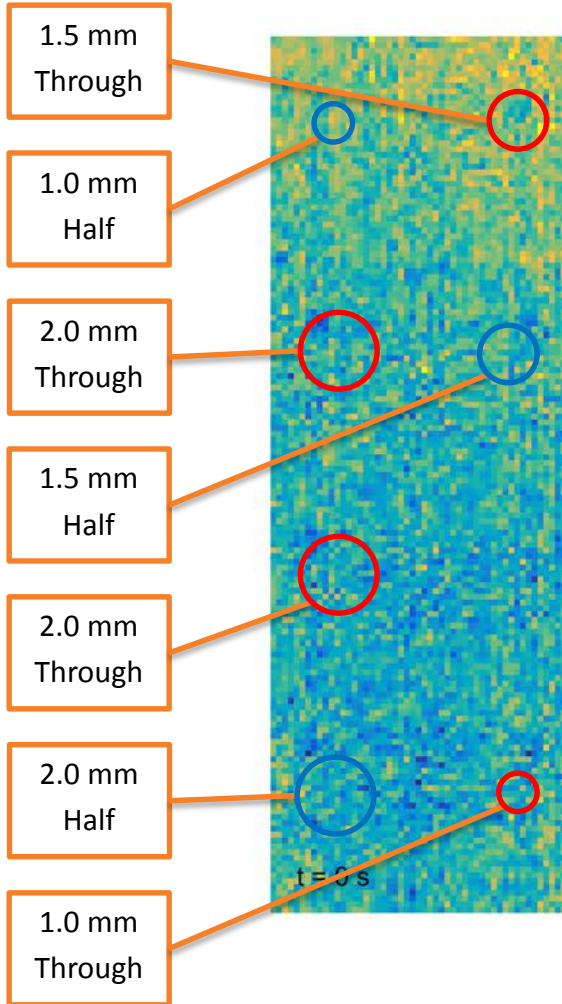
Spray cooling temperature field videography

Plywood, $\Delta p = 15$ Pa, Water.

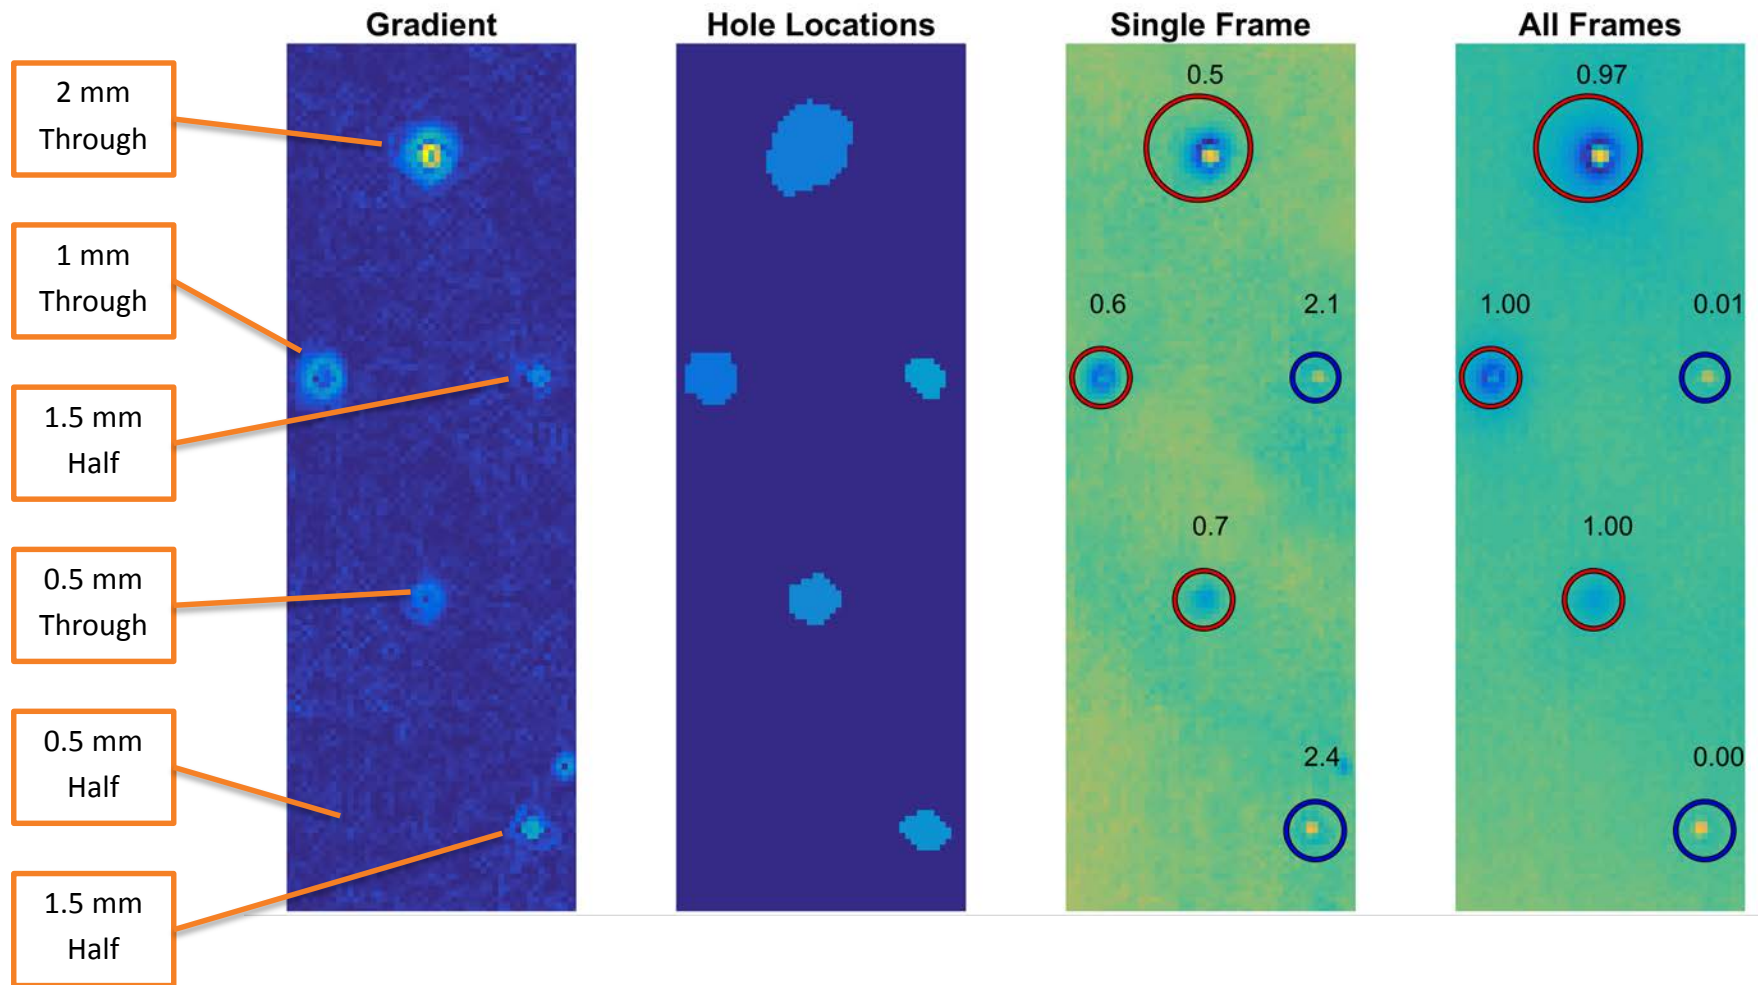
Finding infiltration areas
