**GEOLOGIC FEATURES AND THEIR
POTENTIAL EFFECTS ON CONTAMINANT
MIGRATION, SANTA SUSANA FIELD
LABORATORY**

Howard G. Wilshire, Ph.D.

October 5, 2006

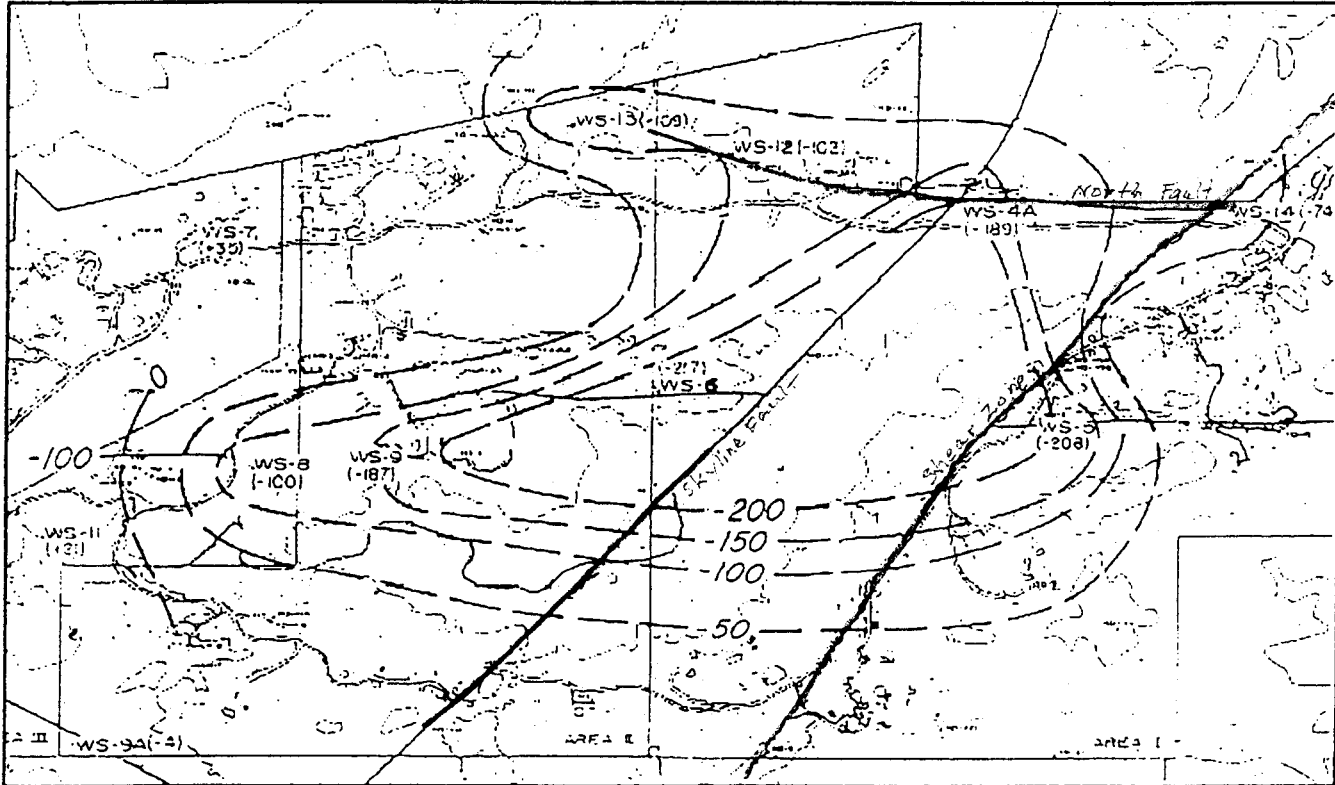
Exhibit 1. Drawdown contours (in feet) from water extraction, 1954-1997 in the northeastern part of the SSFL. From L. P. Smith (Haley & Aldrich), Appendix B, Conceptual Site Model, Santa Susana Field Laboratory, Hydrogeology Summary Report (April 2000), Figure 1.9.
