Gasbuggy, New Mexico, Site A Plowshare Site/Offsite

This fact sheet provides information about the **Gasbuggy Site**. Long-term stewardship responsibilities for this site are managed by the **U.S. Department of Energy Office of Legacy Management**.

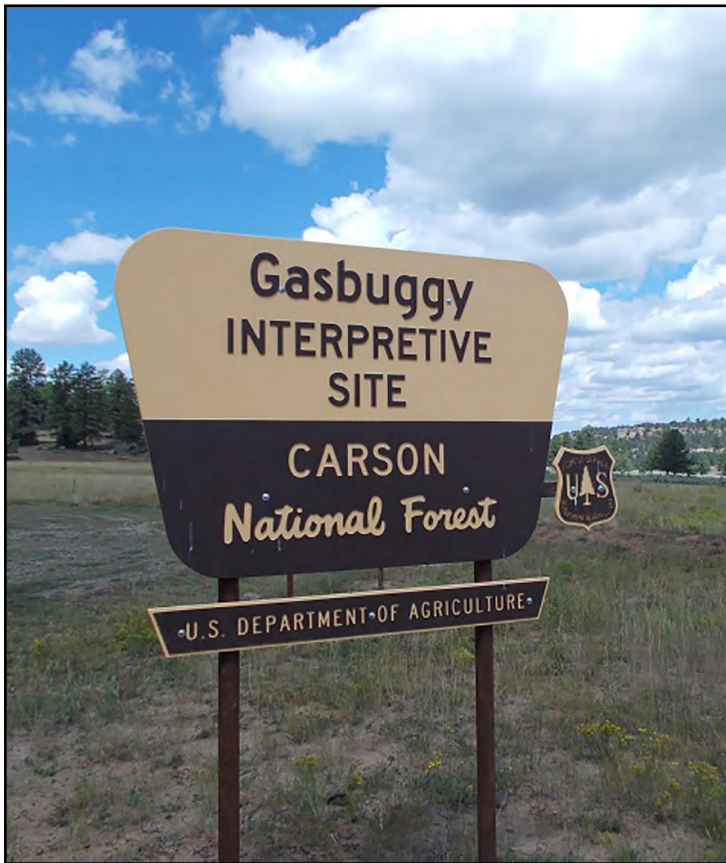
DOE placed a permanent monument at surface ground zero consisting of a brass plaque mounted in a concrete base. Wording on the plaque describes the historical significance of the project and restrictions on subsurface excavation.

Gasbuggy, New Mexico, interpretive site.
