WESTERN AREA POWER ADMINISTRATION

**FINAL
MITIGATION ACTION PLAN**

**AN ENVIRONMENTAL ASSESSMENT FOR
RIGHT-OF-WAY MAINTENANCE
IN THE SACRAMENTO VALLEY, CALIFORNIA**

AUGUST 2005

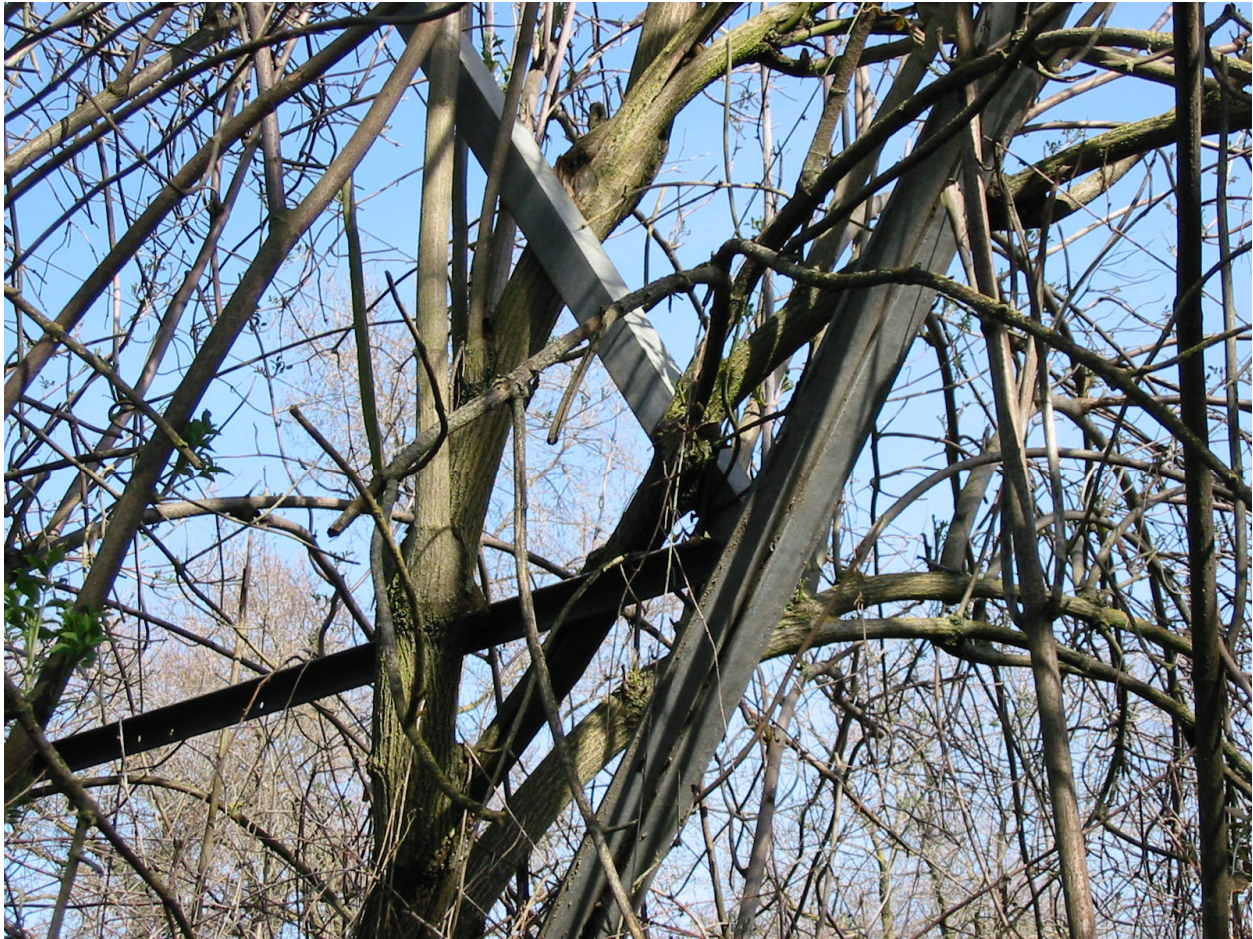
**FIGURE 2-1. ELDERBERRY CAUSING STRESS TO TOWER 9/4,
ELVERTA-HURLEY TRANSMISSION LINE**

Under the proposed action, 422 stems, 1-inch or greater diameter, would be removed from areas within 40 ft of tower centers (approximately 20 ft from tower legs) and within 20 ft of poles. This action is necessary for the safety and reliability of the system; elderberry have been observed growing within tower structures and causing stress to towers that could lead to structural failure (Figure 2-1). This is a serious public safety and environmental issue. The consequences of structural failure include

- Fire (to structures and vegetation),
- Loss of electricity to customers (with attendant effects on emergency services and other public infrastructure), and
- Habitat destruction resulting from gaining access to towers and conductors as part of an emergency action (Figure 2-2).

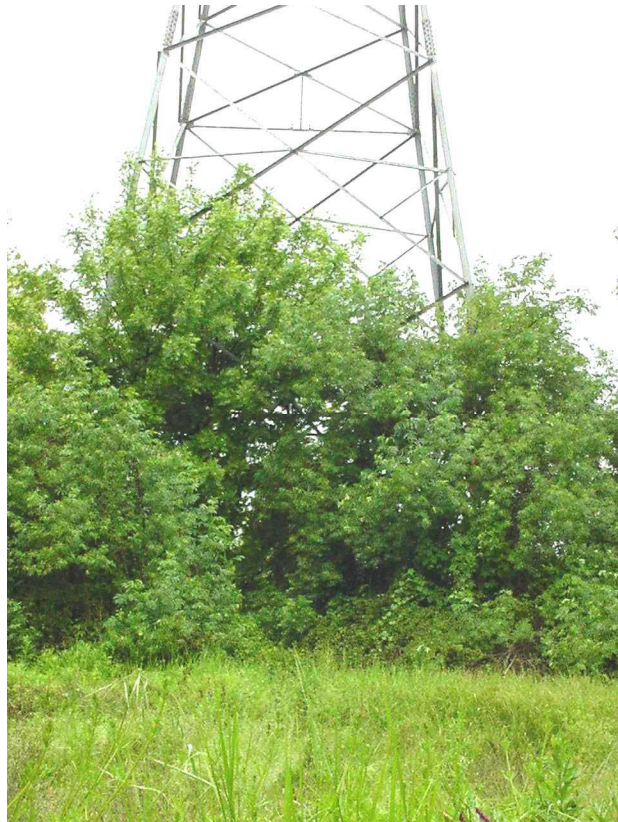
**FIGURE 2-2. ELDERBERRY AND OTHER VEGETATION
BLOCKING TOWER ACCESS**
