U.S. Department of Energy  
Office of Legacy Management

# Weldon Spring Site Fifth Five-Year Review

September 2016

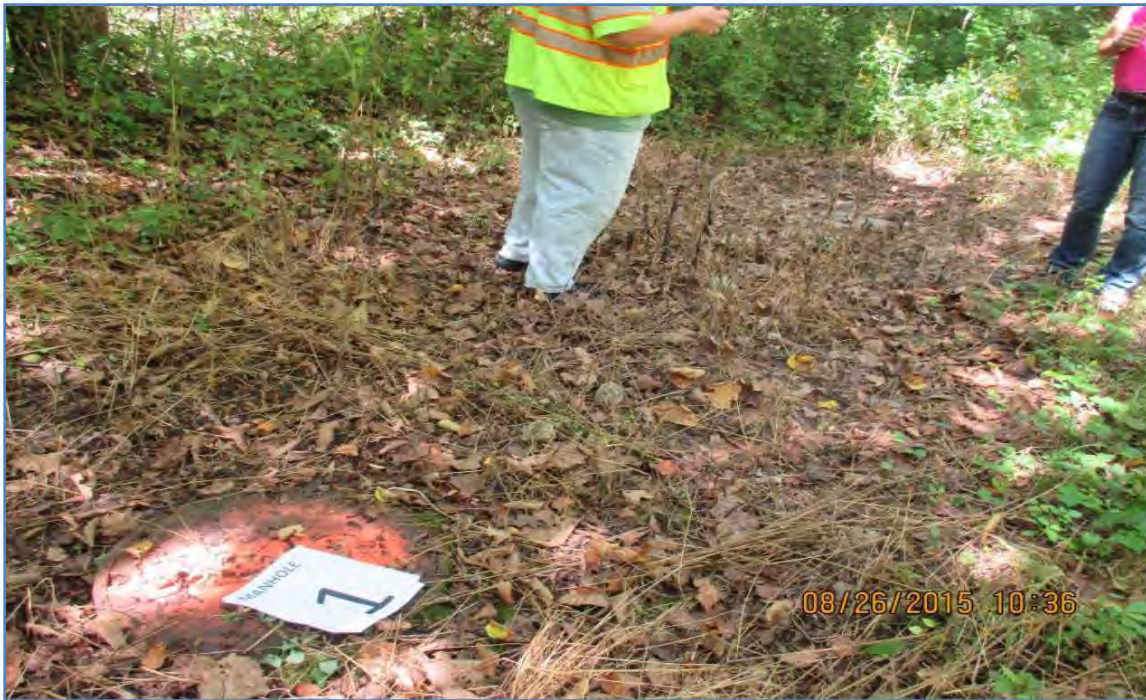
*Manhole 1: Closest to Missouri River*

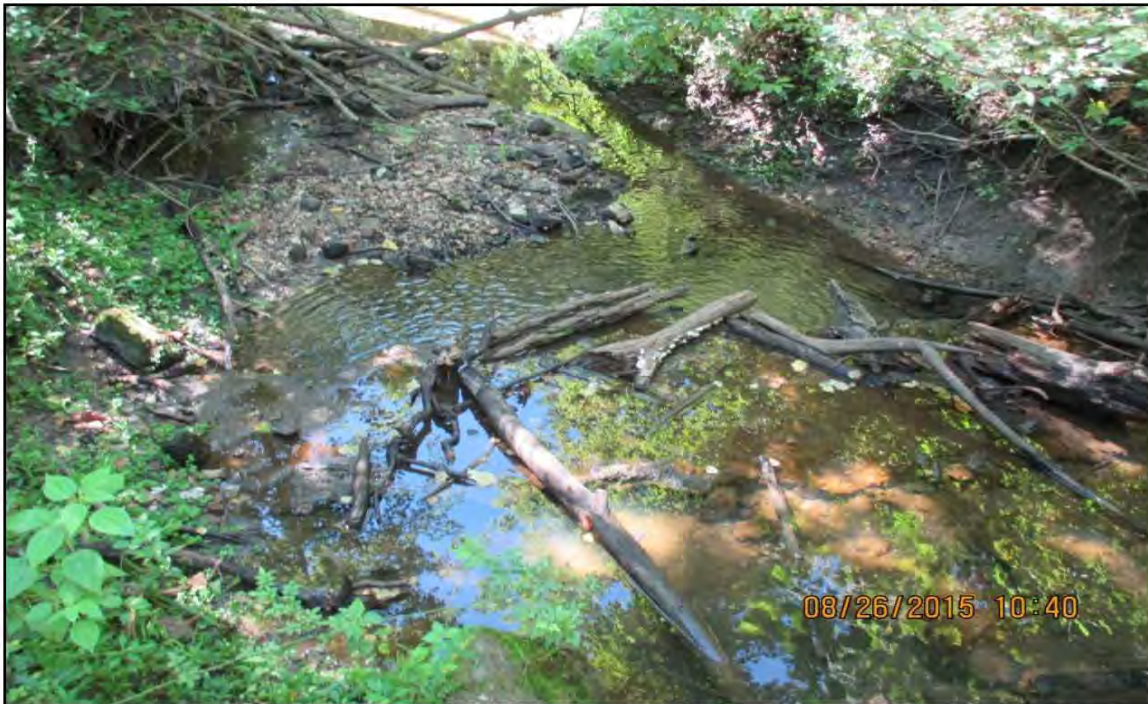
*Pipeline crossing under small creek*

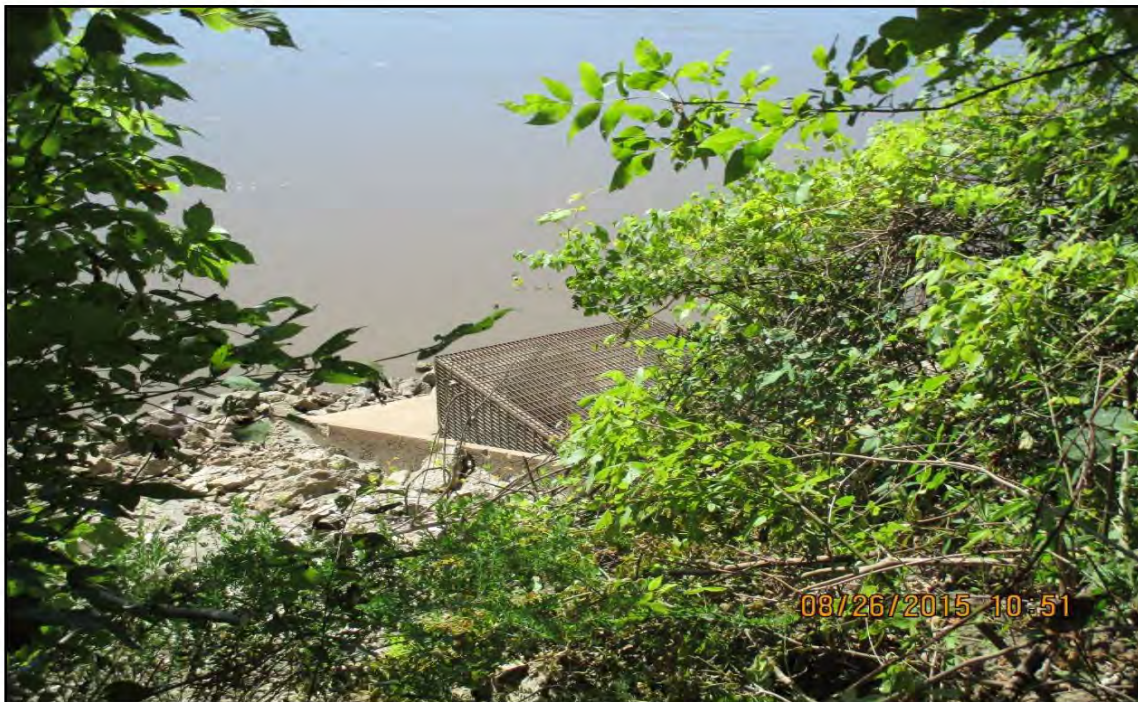
*Discharge Outfall Structure at Missouri River*
