Moab UMTRA Project
Crescent Junction Disposal Cell Interim
Completion Report Addendum - L

Revision 0

December 2022

**Moab UMTRA Project
Crescent Junction Disposal Cell Interim Completion Report
Addendum L**

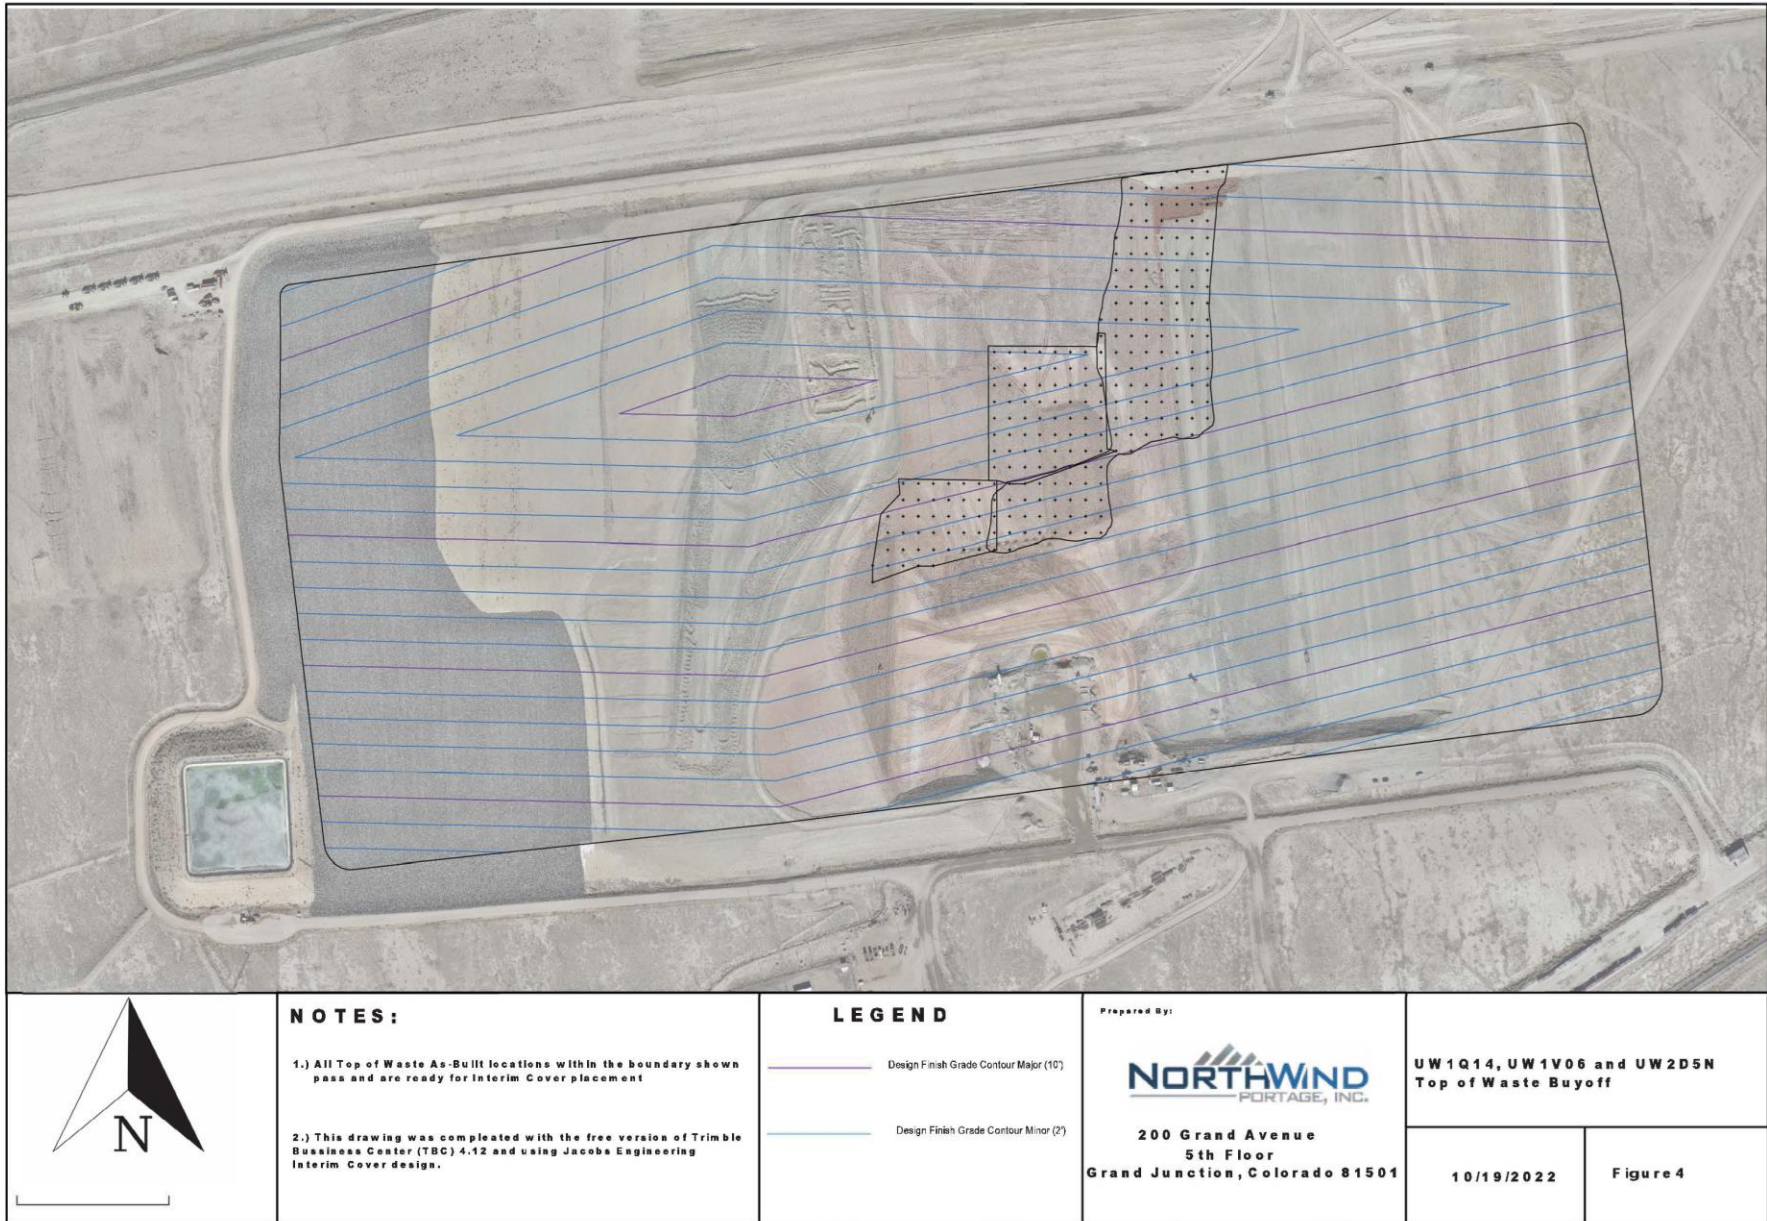
Figure 4. Distribution of Survey Points to Verify Compliance with RRM Specifications

RRM inspections and tests are shown in Table 3. The distribution of survey points is shown in Figure 4. The standard proctor test results summary, lift approval summaries, one lift approval package for RRM, and top-of-waste buyoff survey are provided in Appendix A2.
