OE-3: 2023-02

Preventing Injuries from Power Saws

PURPOSE

This Operating Experience Level 3 (OE-3) is to bring attention to multiple incidents across the Department of Energy (DOE) complex resulting in serious injuries from power saws.

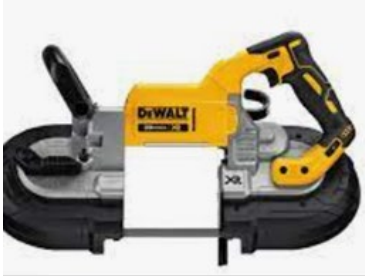
A portable band saw is a hand-held machine equipped with an endless steel band saw blade around two wheels and through saw blade guides used for sawing materials.

- On March 21, 2022, a worker was cutting electrical conduit, holding the pipe in the left hand and operating the saw with the right hand. The blade tipped and the worker's left hand got caught in the blade, resulting in a laceration to the finger.
- On April 30, 2022, a worker was cutting a piece of metal using a portable band saw. When finished with the cut, the worker's glove was caught by the blade. This pulled their hand towards the blade making contact with the back of the left index finger, resulting in a laceration.

- On September 12, 2022, a worker was putting tools away at the end of a job and met resistance trying to close the tool bin door. The worker opened the door, picked up the cordless portable band saw (with the battery installed) and pushed the tools all the way inside the tool bin. The band saw activated, resulting in a laceration to the worker's finger.
- On November 11, 2022, a worker was using a battery-operated portable band saw to cut 2-inch conduit when the band saw slipped off the conduit and contacted the base of the worker's right thumb resulting in a laceration requiring 6 sutures.
- On December 9, 2022, a worker was using a portable band saw to cut off some metal hooks and it slipped, cutting the worker's left hand resulting in a laceration.

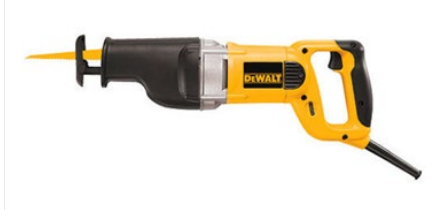
A reciprocating saw is a hand-held machine equipped with a moving blade that alternately changes direction on a linear cutting axis used for sawing materials.

- On December 6, 2022, a worker was cutting a 4-inch diameter pipe with a reciprocating saw. The saw slipped and cut the employee's left hand between their thumb and index finger, resulting in a laceration that required 6 sutures.

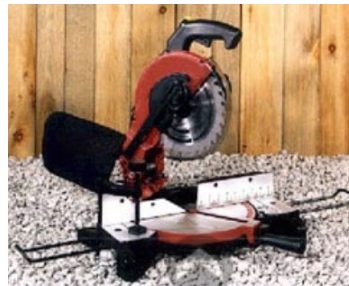
A miter saw is a circular power saw that is mounted on a frame and designed to make accurate angle cuts. The saw blade and motor are mounted on an elbow hinged arm, which is fixed at the rear of the saw. When the blade is lowered in a chopping motion, the blade cuts through the work piece, passing through a slot in the base.

- On May 23, 2022, a worker was operating a 10-inch miter saw. After a cut, the worker released the trigger switch, removed their hand from the saw handle, and placed their hand under the blade to push new material into position. The saw blade was still spinning, and their right hand contacted the blade resulting in a laceration below the first knuckle of the index finger. The saw arm had not gone

up to its fully upright position after being released and the guard was only partially deployed.

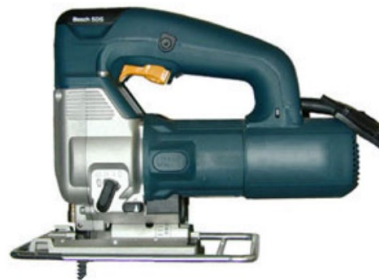
Jig saws are a hand-held machine that are useful for precision-cutting, intricate curves and patterns in thin stock. They have thin blades that move rapidly up and down. The blade is held in upper and lower chucks that pull it tight and keep it from bending.

- On July 7, 2022, a worker was using a jigsaw to cut a 30-gallon poly drum when the blade bounced out of the kerf and cut the worker's hand between the wrist and thumb, requiring 5 sutures.
