FINAL
RADIOLOGICAL CHARACTERIZATION OF SOILS
AREA IV AND THE NORTHERN BUFFER ZONE

AREA IV RADIOLOGICAL STUDY
SANTA SUSANA FIELD LABORATORY
VENTURA COUNTY, CALIFORNIA

HydroGeoLogic, Inc.
5023 North Parkway Calabasas
Calabasas, California 91302

December 21, 2012

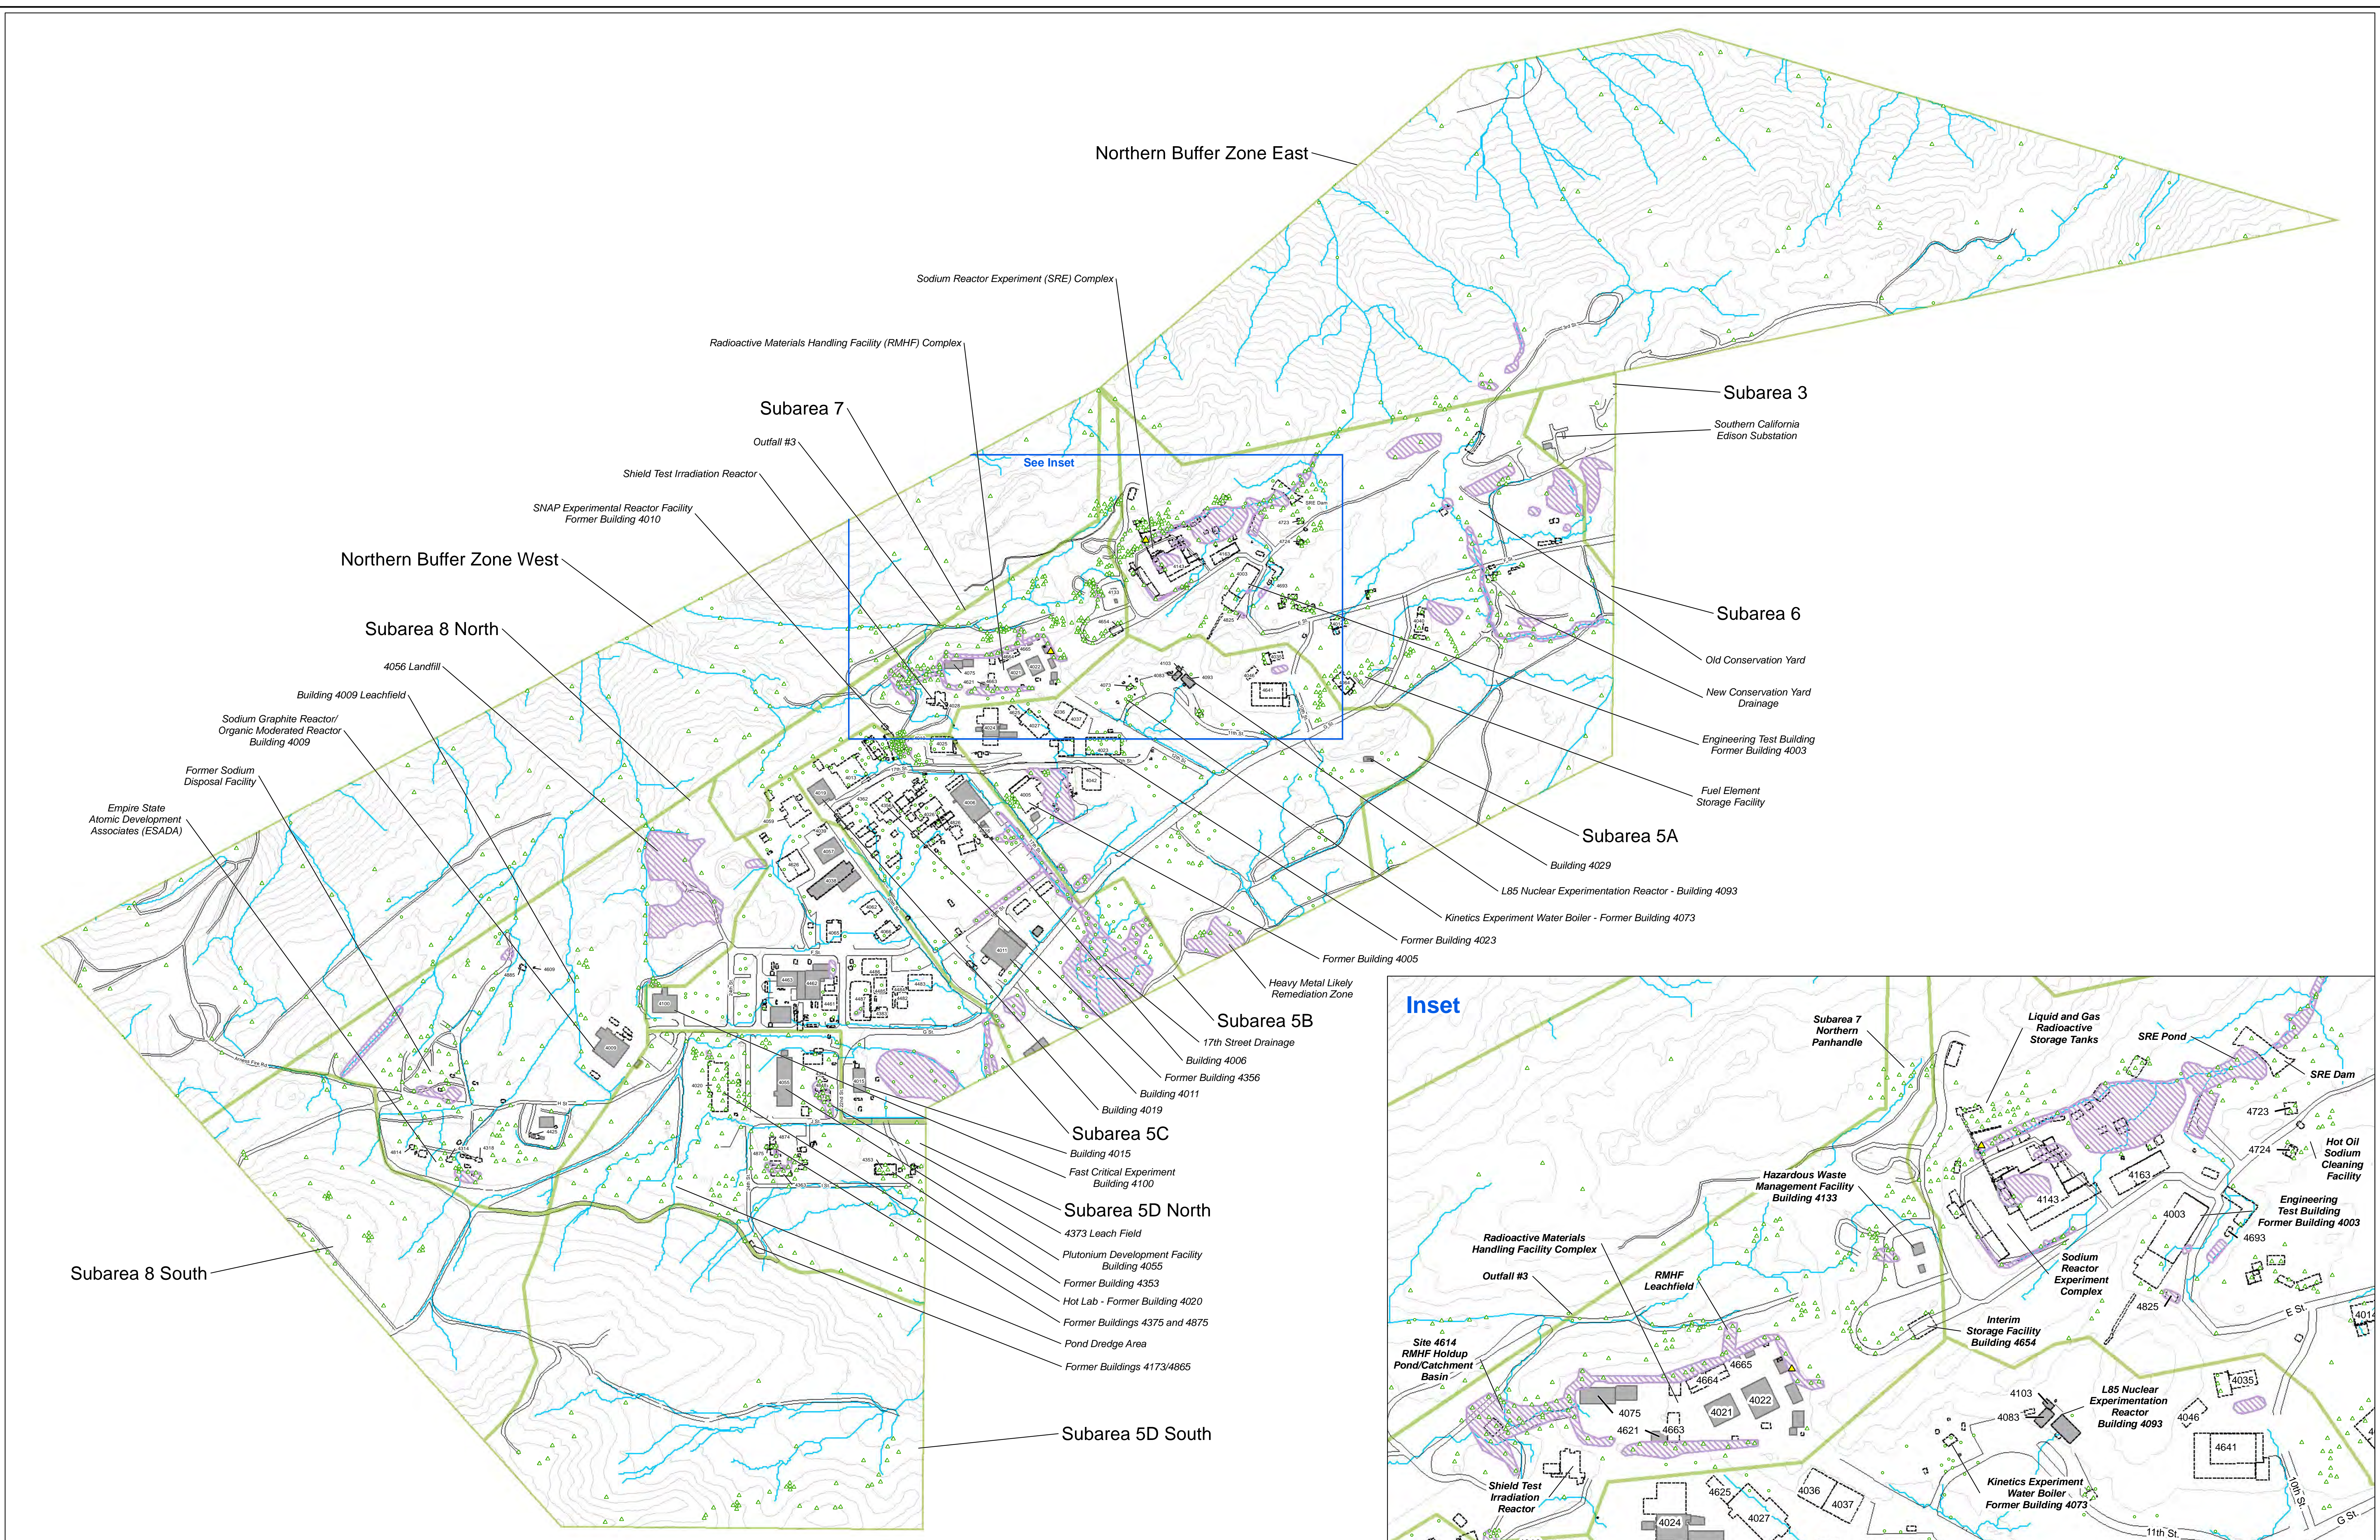
Figure 4.7
Cobalt-60
Round 1 and 2 Surface Soil
and Sediment Results
Santa Susana Field Laboratory
Area IV and NBZ Radiological Study

Cobalt-60

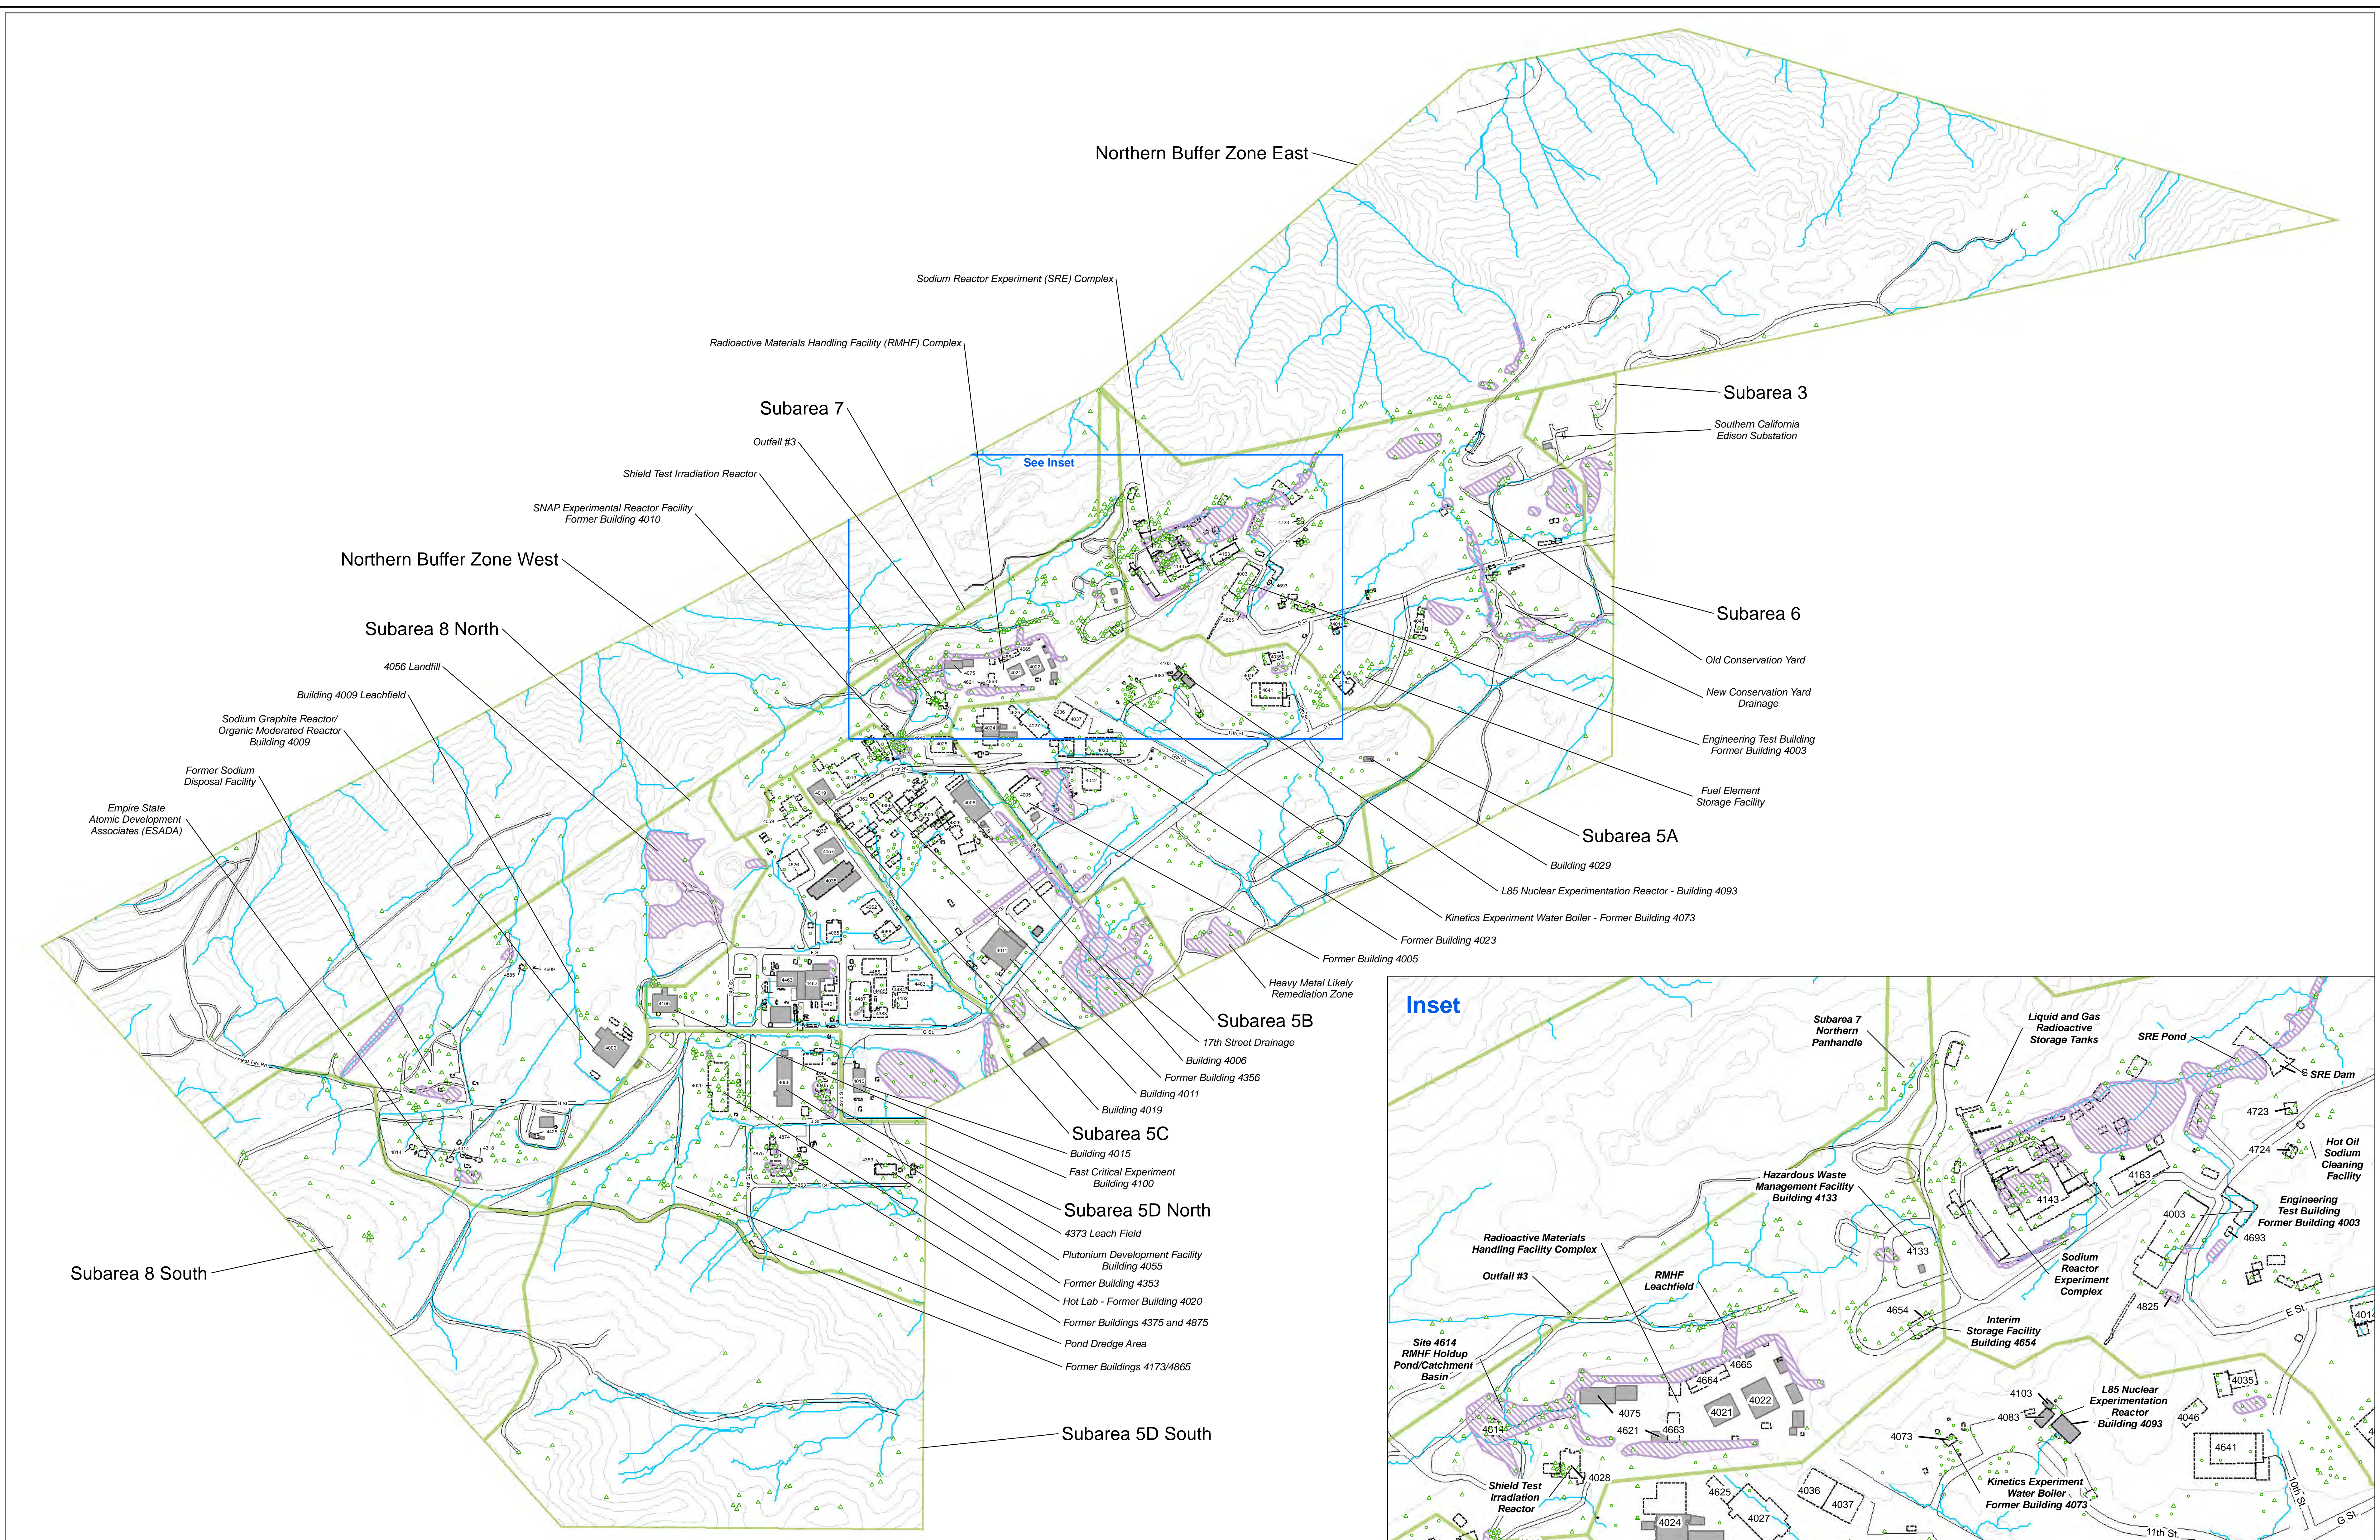
Figure 4.8
Cobalt-60
Round 1 and 2 Subsurface Soil and Sediment Results
Santa Susana Field Laboratory
Area IV and NBZ Radiological Study

Cobalt-60

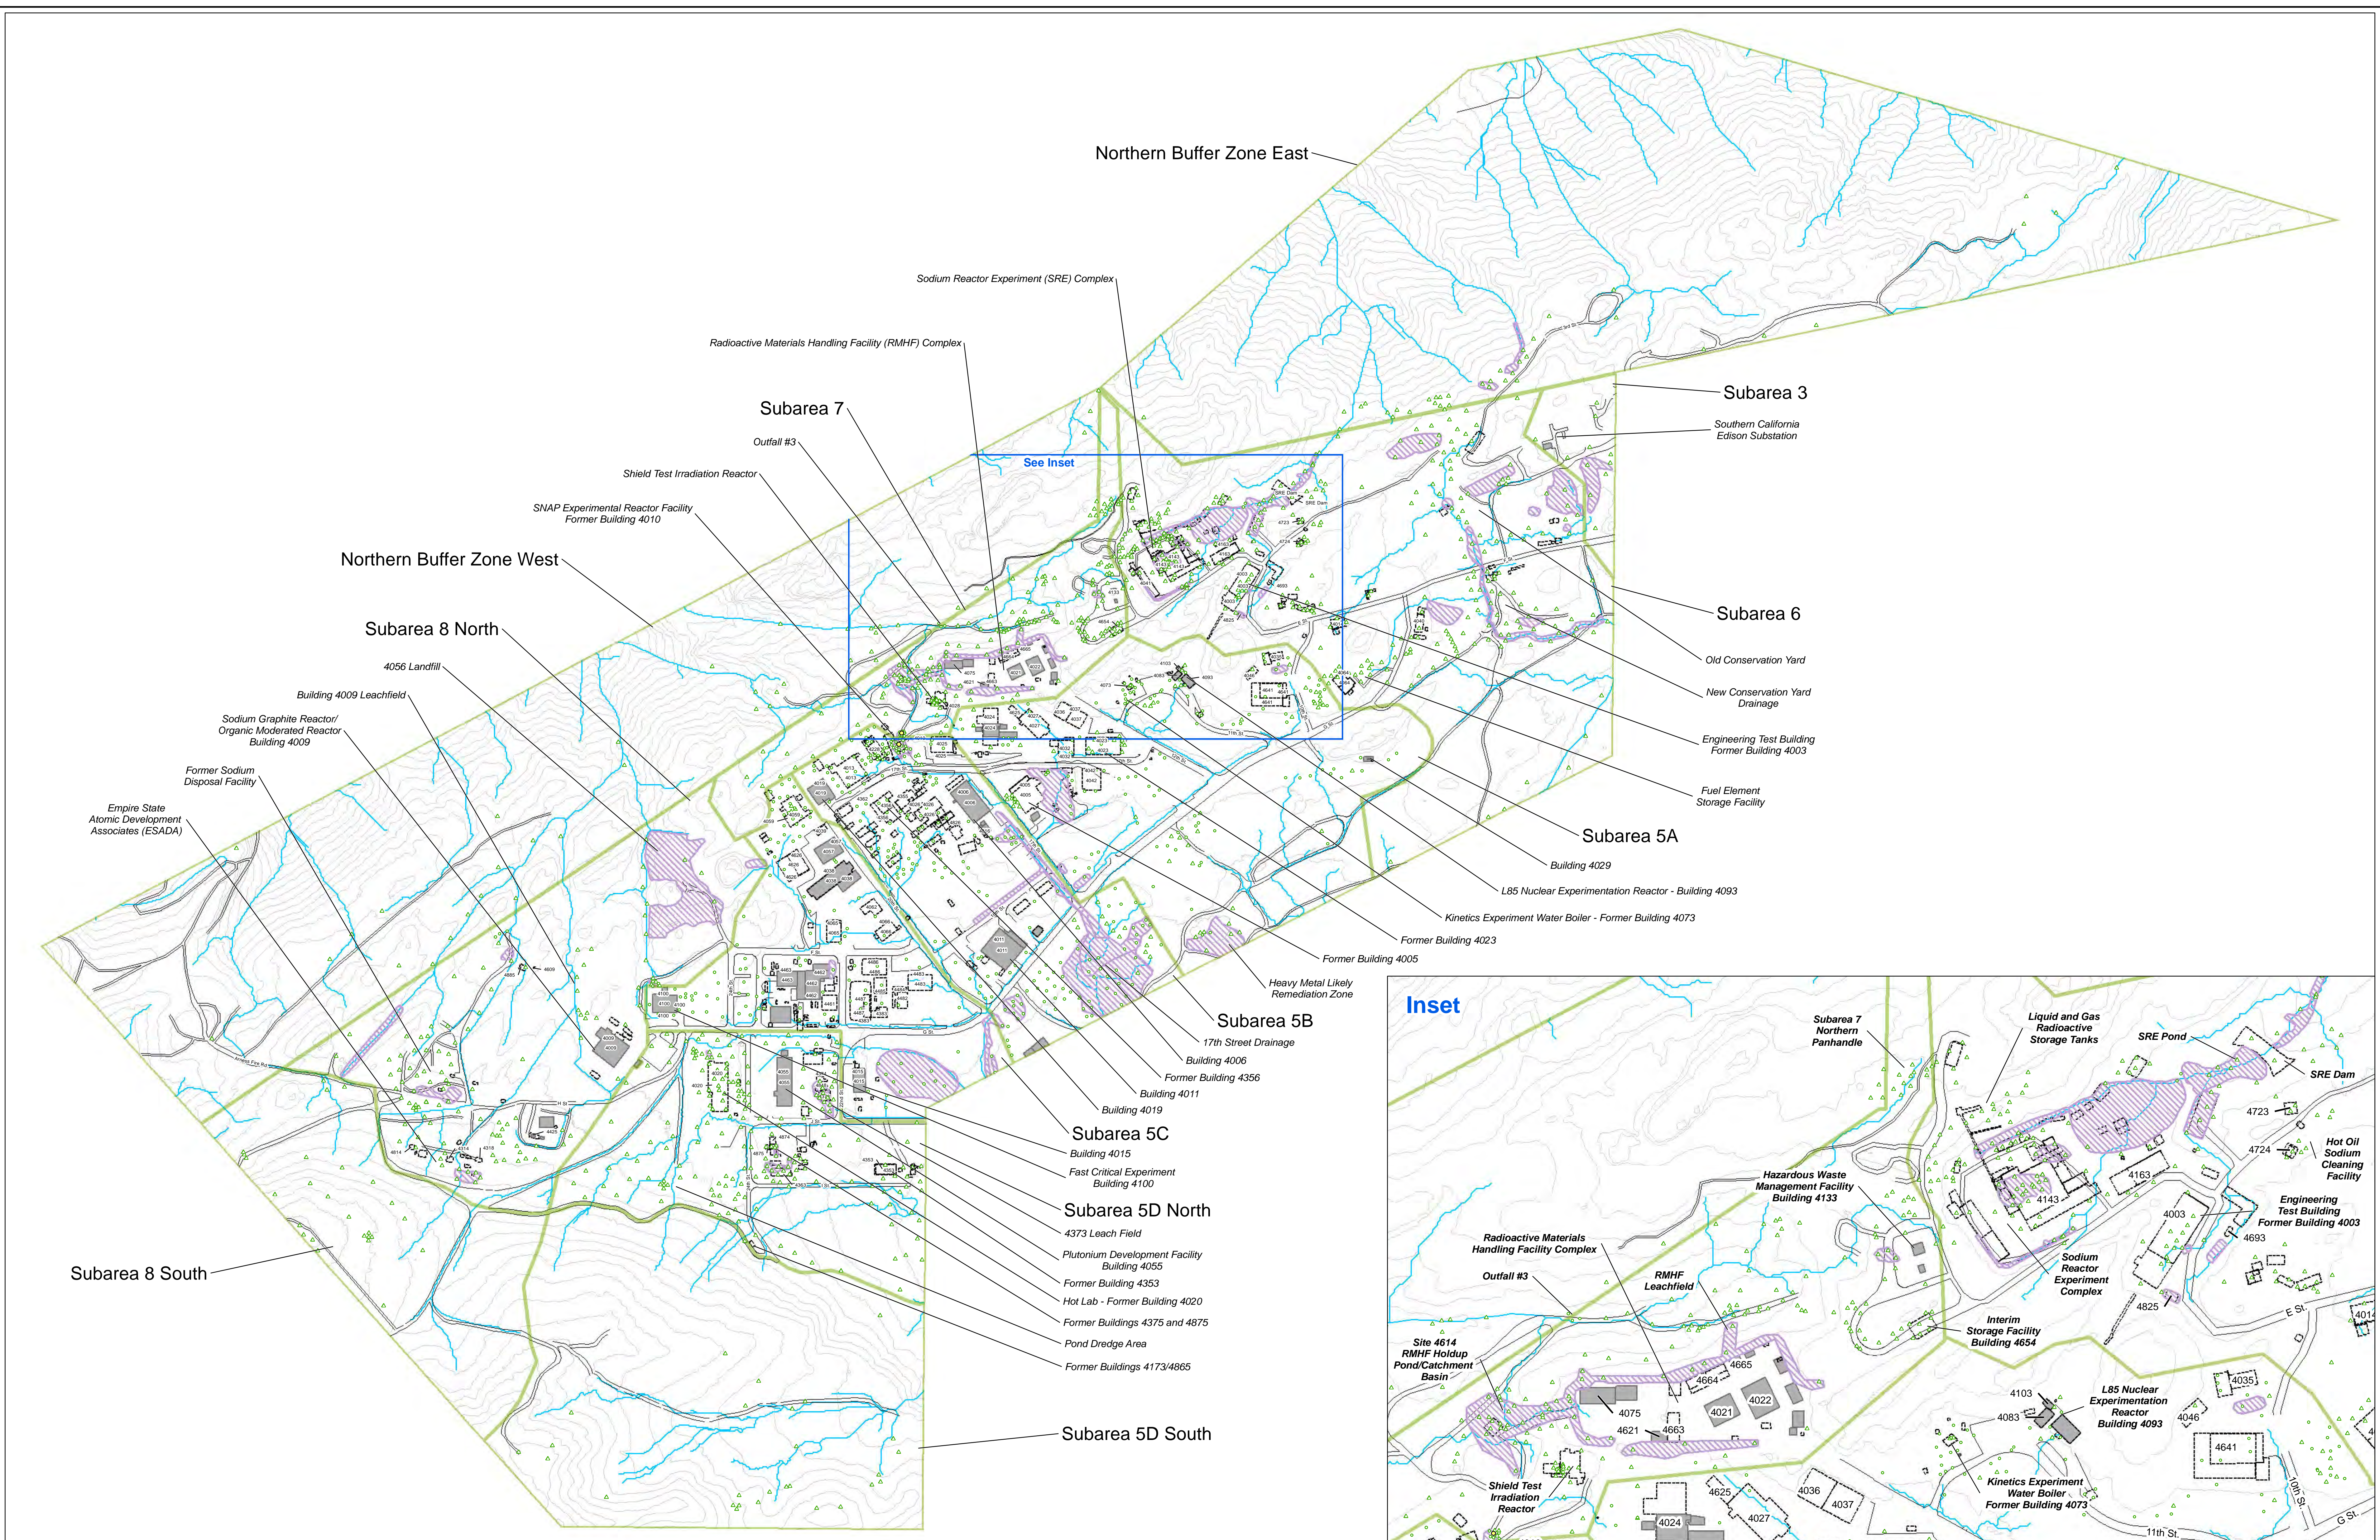
Figure 4.10
Europium-152
Round 1 and 2 Subsurface Soil and Sediment Results
Santa Susana Field Laboratory
Area IV and NBZ Radiological Study

Europium-152	GEL (FAL = 0.670)	TAL (FAL = 0.0459)
Below FAL	(Below 0.670 pCi/g)	(Below 0.0459 pCi/g)
FAL to less than 2 times FAL	▲ (0.0670 to 0.133 pCi/g)	● (0.0459 to 0.0917 pCi/g)
2 times to less than 3 times FAL	▲ (0.134 to 0.200 pCi/g)	● (0.0918 to 0.137 pCi/g)
3 times to less than 4 times FAL	▲ (0.201 to 0.267 pCi/g)	● (0.138 to 0.183 pCi/g)
Greater than 4 times FAL	▲ (0.268 to x.xxx pCi/g)	● (0.184 to x.xxx pCi/g)
